**Project Name:** 1 - 3 Market Street\_ SO50 5RL  
**Project Description:** Building Works  
**Project Number:** JSD7105  
**Project Status:** Complete  
**Project Date:** 19/03/2024  
**Inspection Standard:** MSCC4 Sewers & Drainage GB (SRM4 Scoring)

1 - 3 Market Street, SO50 5RL

## Section Inspection - 13/03/2024 - Red.Gully1X

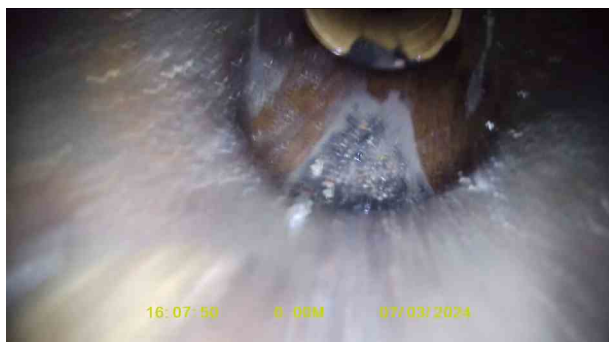
Manhole  
10X\_edd32b4f-5ecd-478b-b1df-b00fcd28c93c\_20240320\_135  
340\_224.jpg, 00:00:11, 0.10 m  
General remark, Drops into main channel

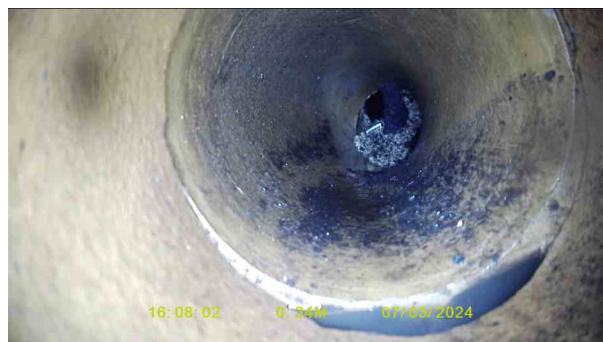
Manhole  
10X\_06eaf6d7-a0e7-4971-8a16-8103644500ac\_20240320\_13  
5420\_600.jpg, 00:00:23, 0.40 m  
Open joint, medium

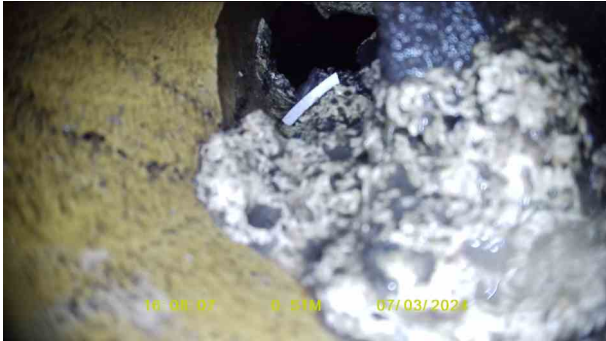
Manhole

10X\_21199e96-e701-4adc-bc3c-6bd1b072c866\_20240320\_135449\_444.jpg, 00:00:28, 0.51 m

Attached deposits, encrustation from 11 o'clock to 9 o'clock,  
75% cross-sectional area loss
