Project name :  
**143and145PASSFIELD AVENUE**

Date :  
**30/01/2023**

Site: **143 - 145 PASSFIELD AVENUE**

## Inspection pictures

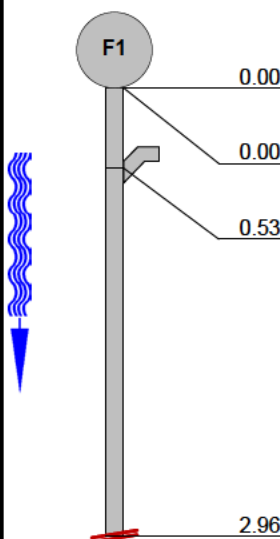
| 1:50 | Position | Observation | Photo | | | | | | |
|---|---|---|---|---|---|---|---|---|---|
| | 0.53 | Junction from/at 10 o'clock diameter: 100 mm | 20230130-082748-snap0001.jpg | | | | | | |
| | 2.96 | Survey abandoned Remarks: ROOT BLOCKAGE IN PIPE | 20230130-082748-snap0002.jpg | | | | | | |

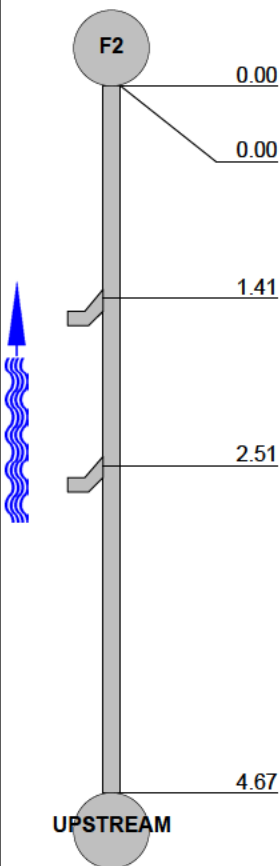
| 1:50<br>Depth: 0.90 | Position | Observation | Photo |
|---|---|---|---|
| | 0.00 | Water level 05 % of the vertical dimension | 20230130-083212-snap0001.jpg |
| | 1.41 | Junction from/at 02 o'clock diameter: 100 mm | 20230130-083212-snap0002.jpg |
