**ALPHA PARK, CHANDLER'S FORD, EASTLEIGH**

**THE BUILDING MANUAL**  
(incorporating the Health & Safety File)

**DRAINAGE SURVEY**

| Project name<br><b>C3414, Alpha Park, Chandlers Ford,</b> | Project number<br><b>PV041452</b> | Contact | Date<br><b>11/11/2016</b> |

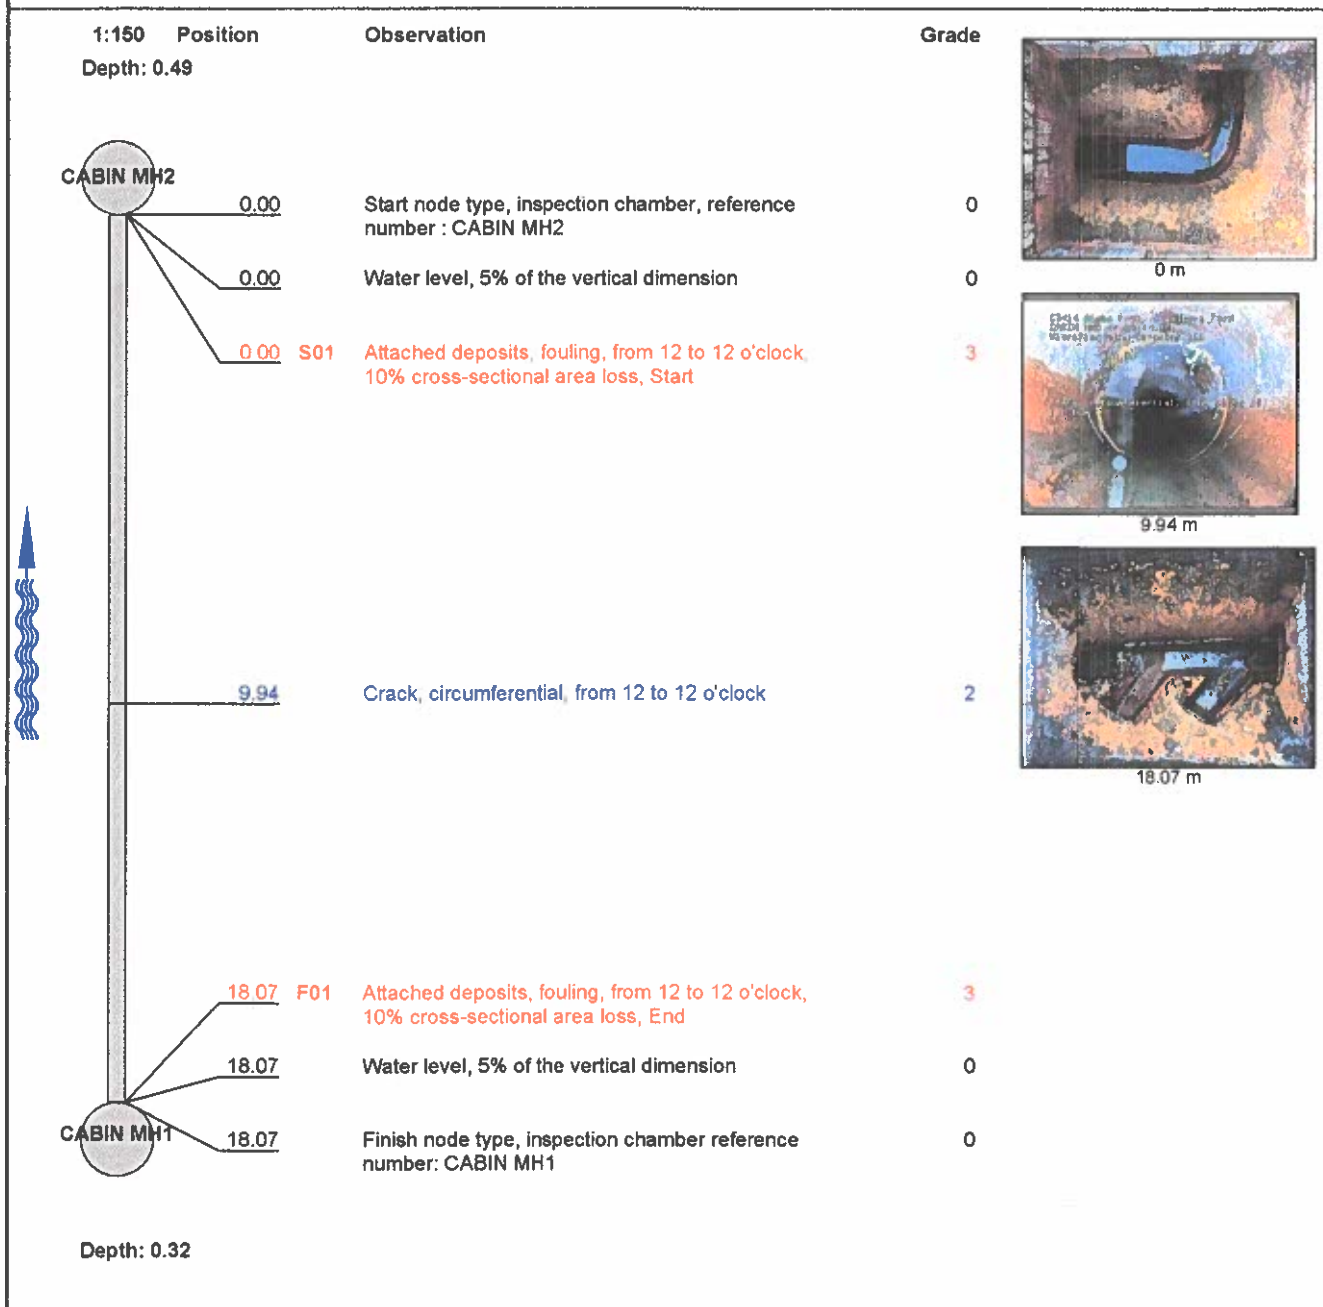
| STR no def | STR peak | STR mean | STR total | STR grade | SER no def | SER peak | SER mean | SER total | SER grade |
|---|---|---|---|---|---|---|---|---|---|
| 1 | 10 | 0.56 | 10 | 2 | 1 | 2 | 1.99 | 36 | 3 |

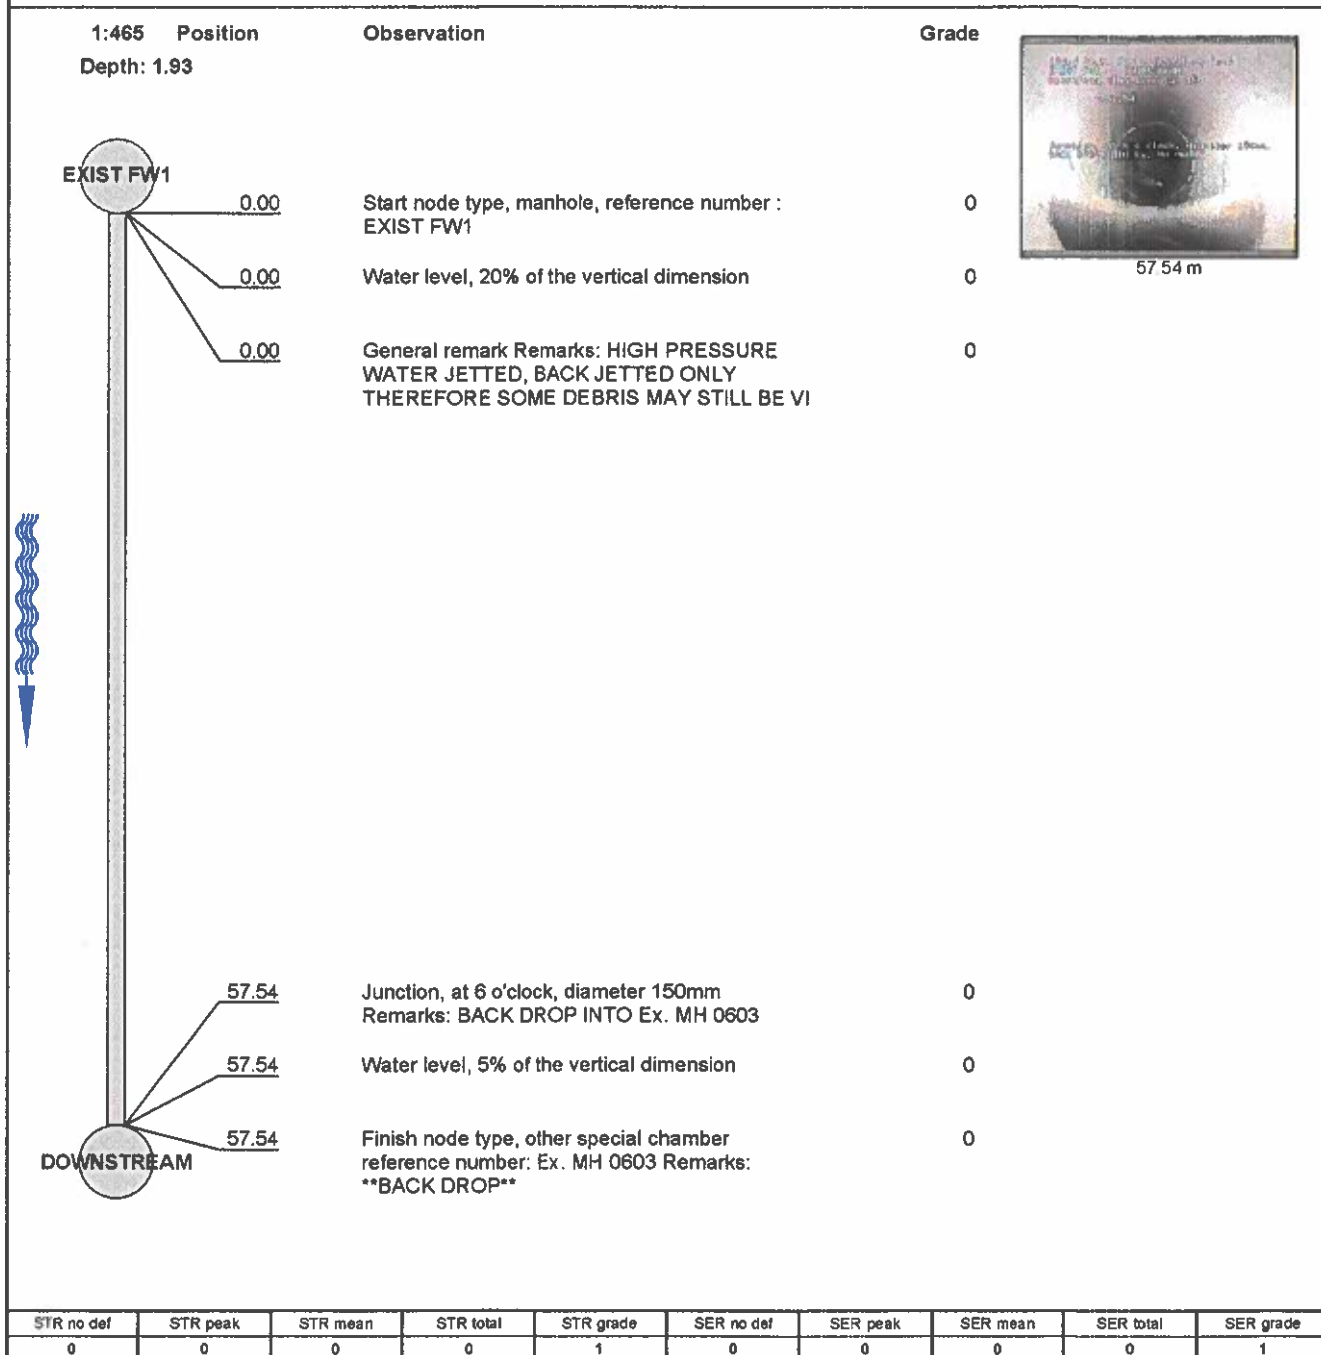
| STR no def | STR peak | STR mean | STR total | STR grade | SER no def | SER peak | SER mean | SER total | SER grade |
|---|---|---|---|---|---|---|---|---|---|
| 0 | 0 | 0 | 0 | 1 | 0 | 0 | 0 | 0 | 1 |
