Gas Membrane Installation  
Validation Report  
Elivia Homes  
2 Grange Road  
Abbey Fruit Farm  
Phase 2  
Netley  
SO31 5HZ  
V2 30/04/2024

## Appendix 1 – Site Survey Sheets

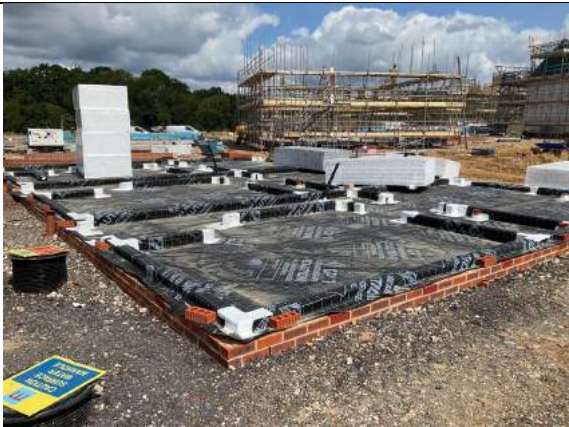
Overview of the full footprint installation to Plots 12-13-14.

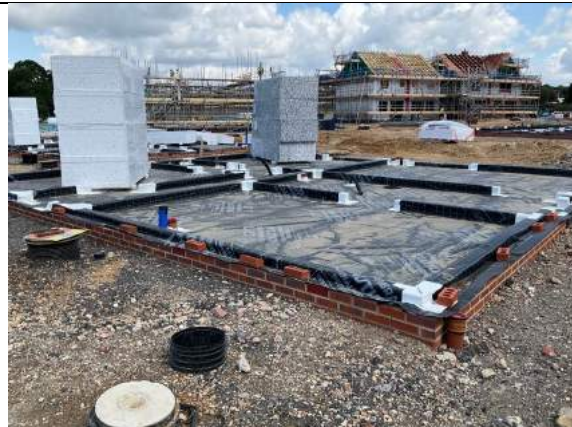
Overview of the full footprint installation to Plots 15-16.

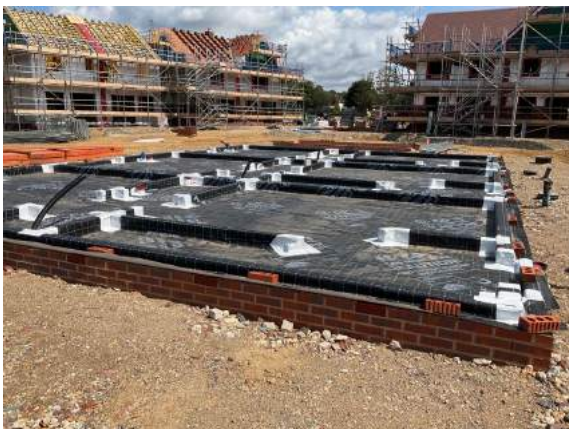
Overview of the full footprint installation to Plots 17-18-19.

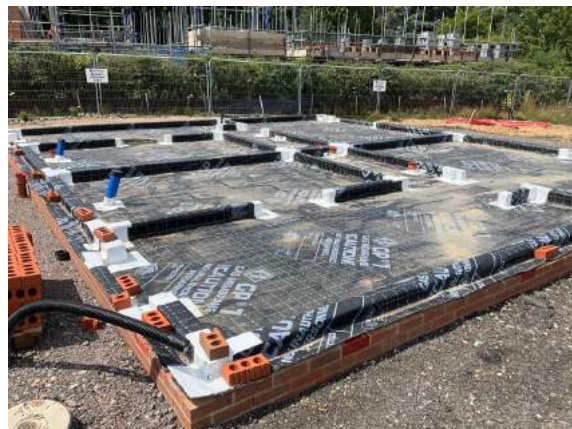
Overview of the full footprint installation to Plots 20-21.

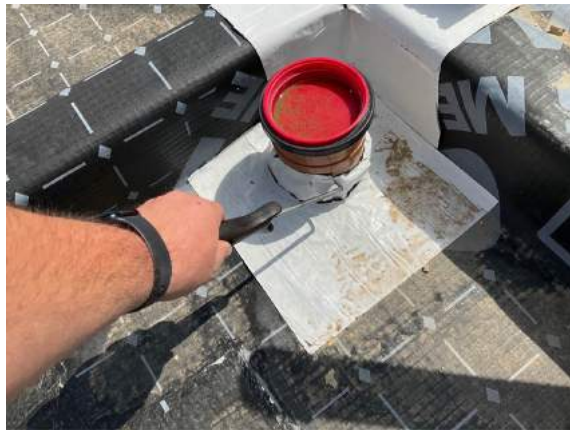
Plot 13. Pick testing to sealed pipe entry.

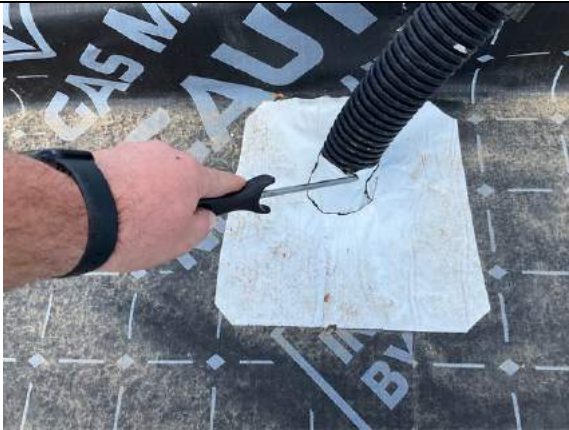
Plot 15. Pick test to sealed pipe entry.

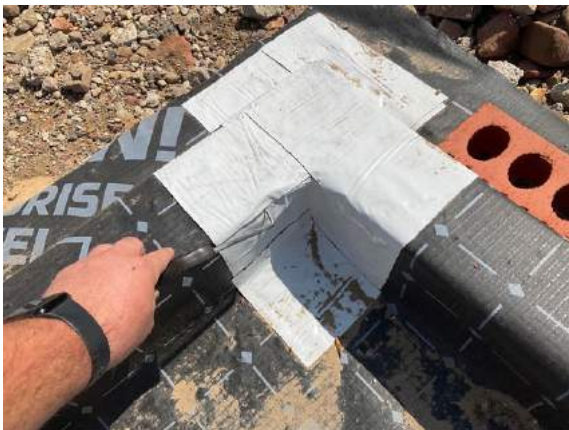
Plot 16. Pick test to sealed corner details.

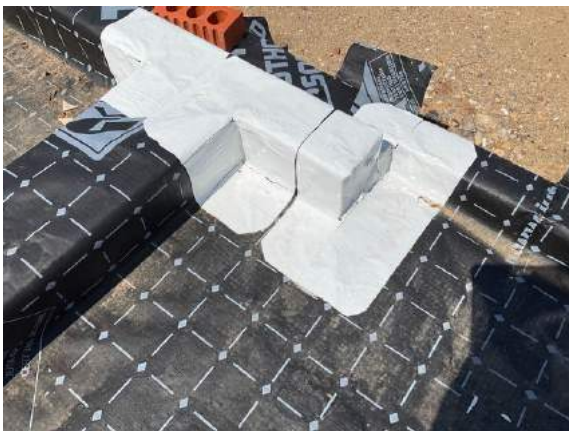
Plot 19. Corner and threshold details sealed with SAGM.

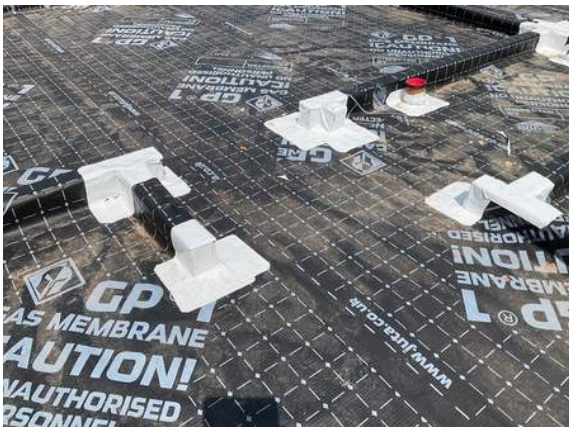
Plot 20. Multiple corner details sealed with SAGM.

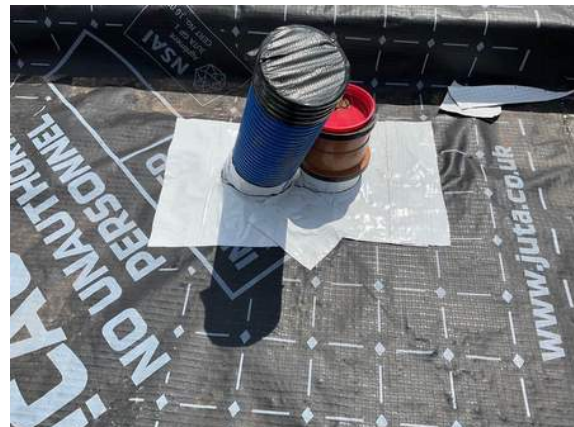
Plot 20. Typical pipe penetration's sealed with SAGM.

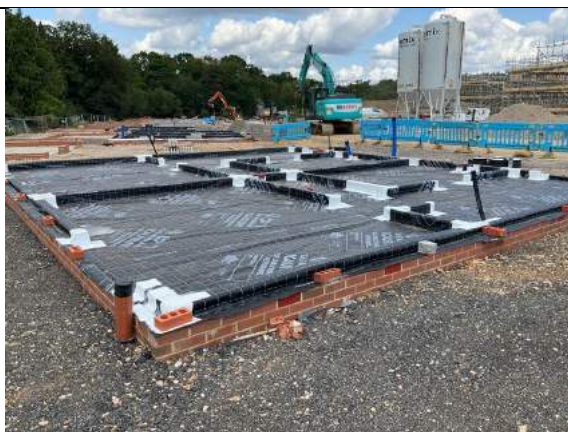
Overview of the full footprint installation to Plots 23-24.

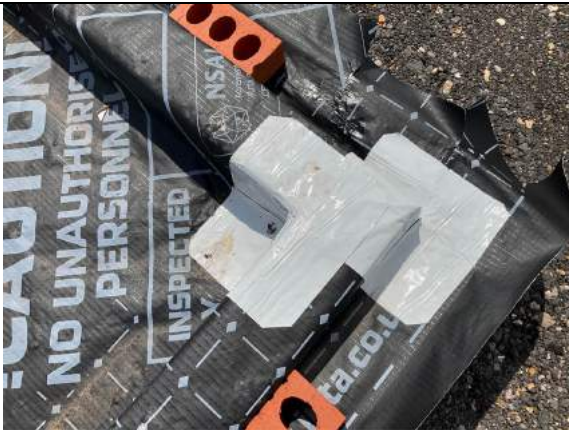
Plot 22. Internal & external corner details sealed with SAGM.

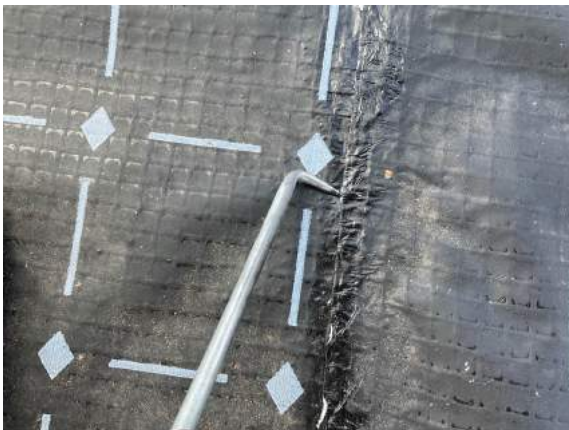
Plot 23. Pick test to hand welded membrane lap joint.

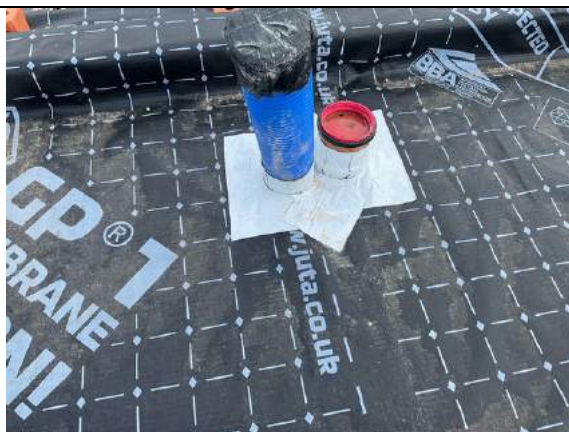
Plot 24. Typical dual pipe penetration's sealed using SAGM.

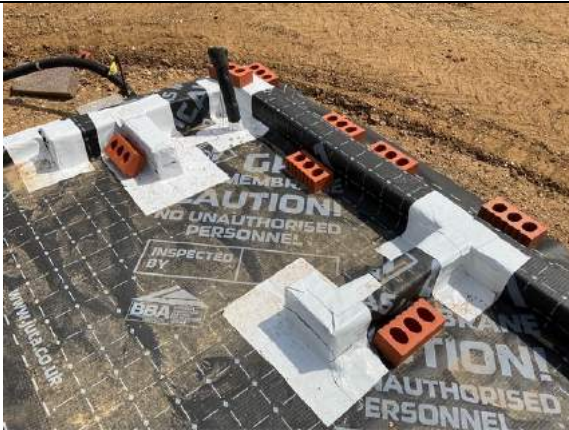
Plot 50. Multiple corner and pipe entry sealed using.

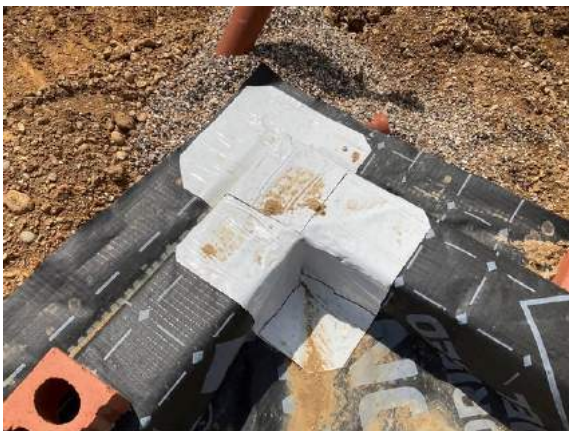
Plot 51. Internal & external corner details sealed with SAGM.

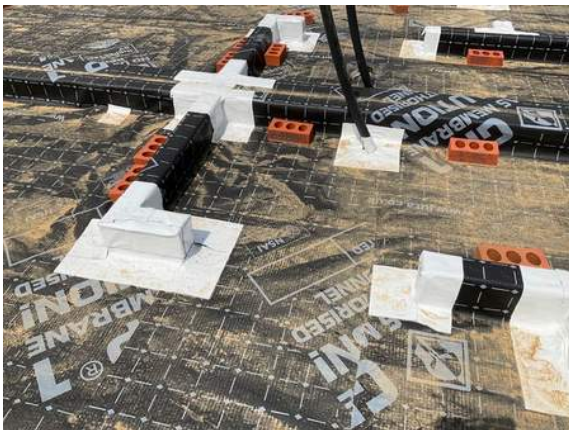
Plot 52. Multiple corner details & pipe entry sealed using SAGM.

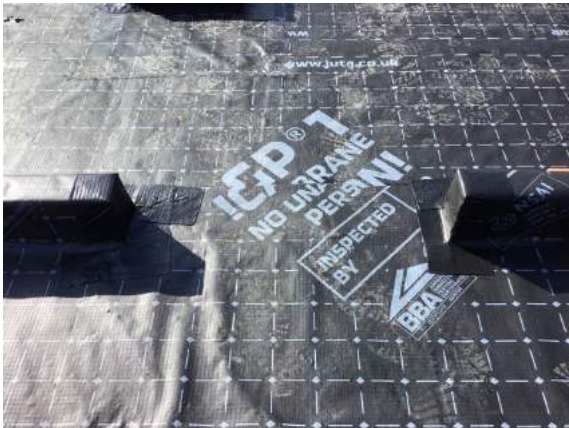
Sealed internal door threshold using SAGM in plot 29.

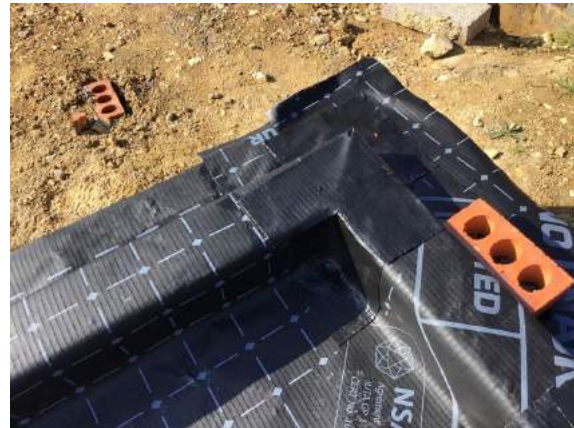
Sealed corner detail using SAGM in plot 29.

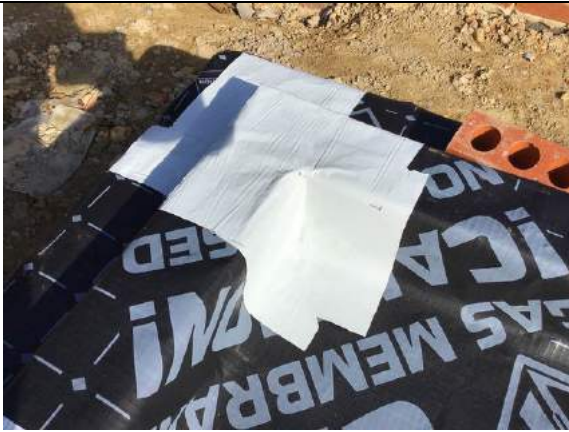
Typical corner seal using SAGM in plot 30.

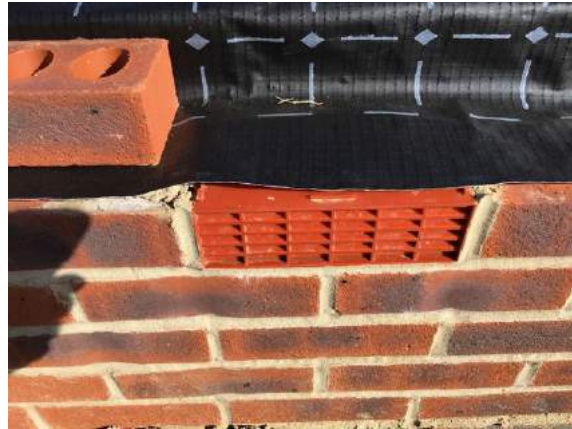
Air brick in place under the membrane to plots 28,29 & 30.

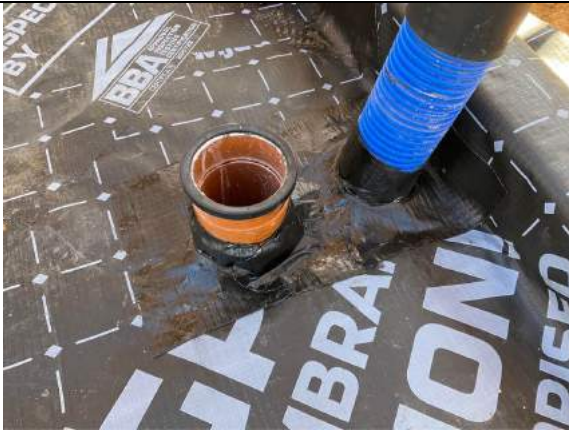
Plot 27. Typical pipe penetration's sealed with SAGM.

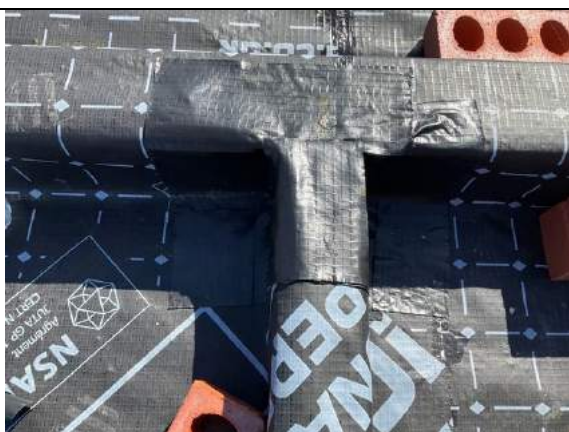
Plot 38. Typical corner details sealed using SAGM.

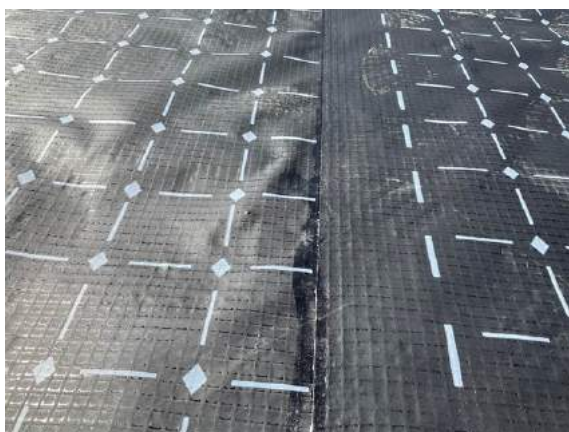
Plot 39. Overview of a hand welded membrane lap joint.

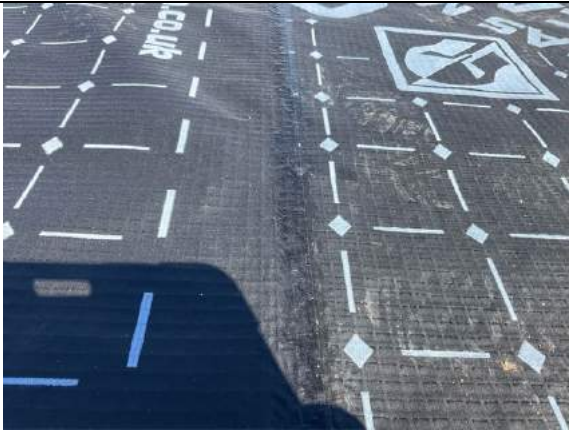
Plot 40. Overview of a hand welded membrane lap joint.

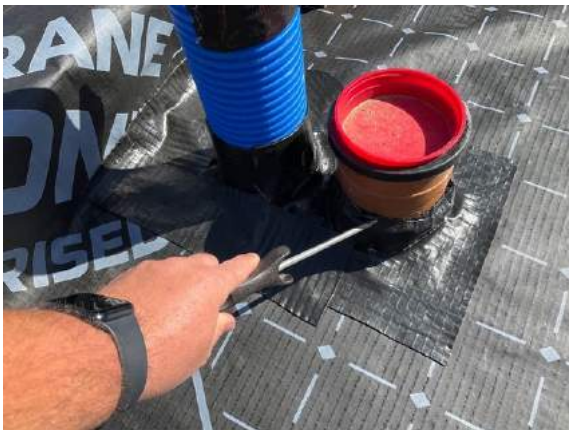
Plot 40. Pick testing to sealed pipe penetration's.

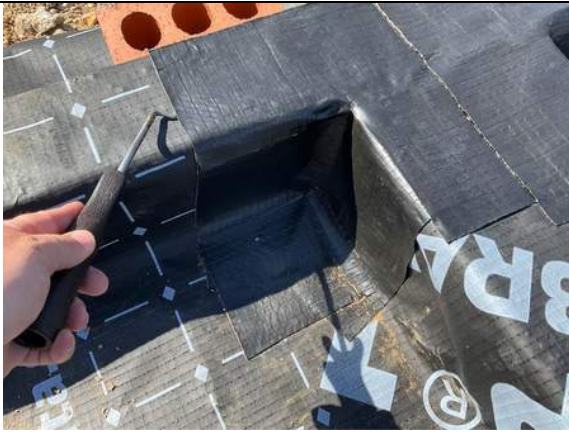
Plot 41. Pick testing upon sealed corner detail.

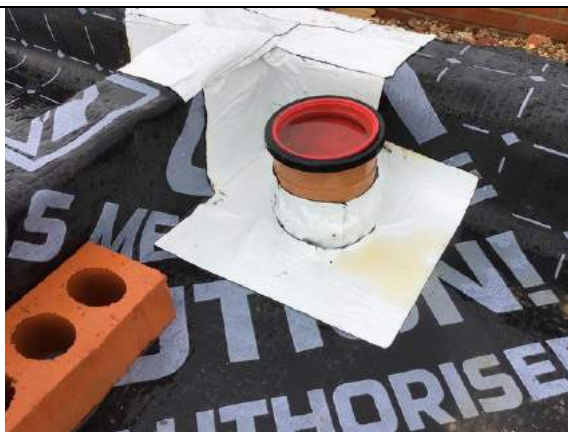
Typical pipe penetration and corner seal using SAGM in plot 77.

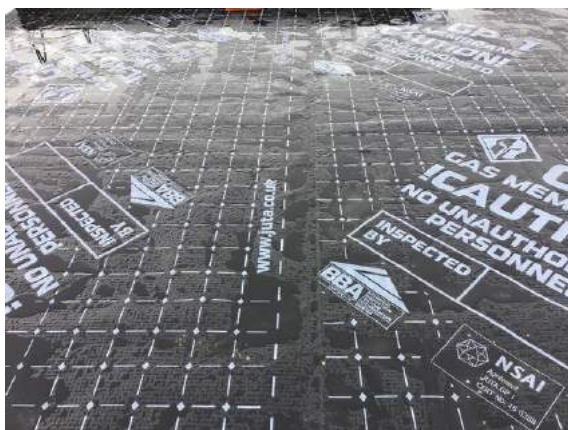
Typical hand welded membrane lap in plot 78.

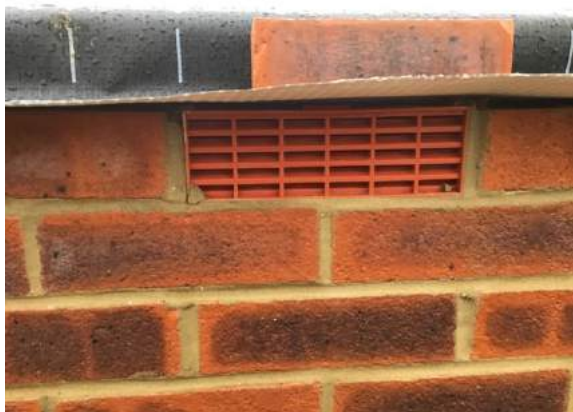
Air bricks were in place under the membrane to plots 31,36,77 & 78 at the time of our inspection.

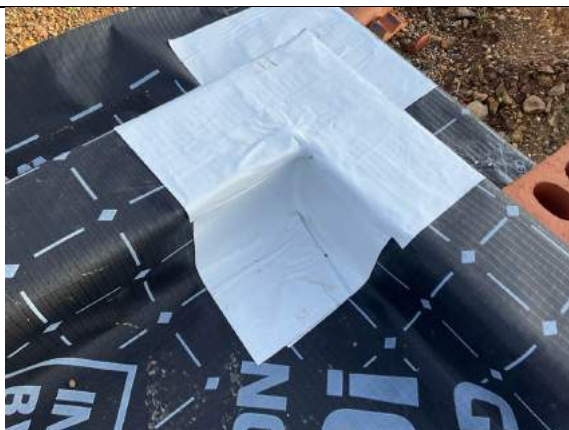
Plot 34. Typical corner details sealed using SAGM.

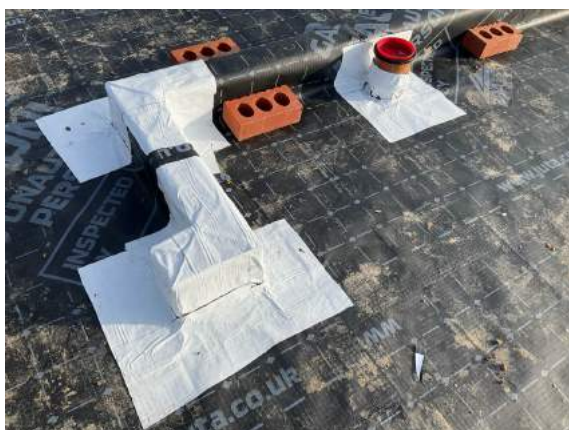
Plot 34. Multiple corner and pipe entry details sealed using SAGM.

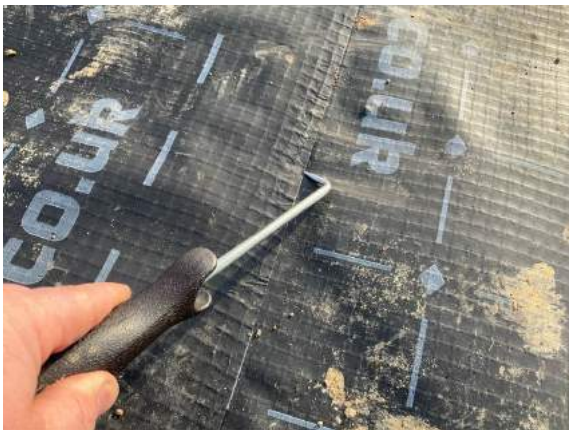
Plot 34. Pick & Probe testing along all hand welded lap joints.

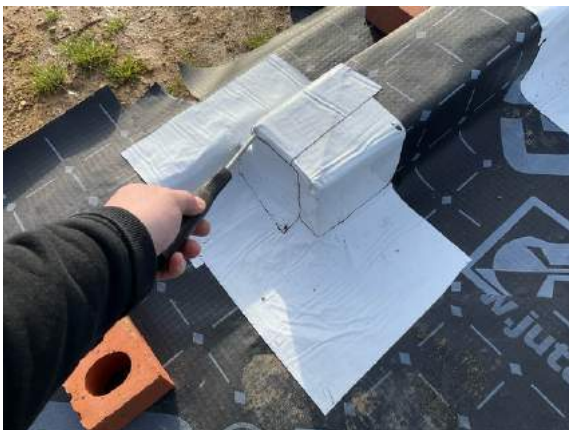
Plot 34. Pick testing upon sealed door threshold details.

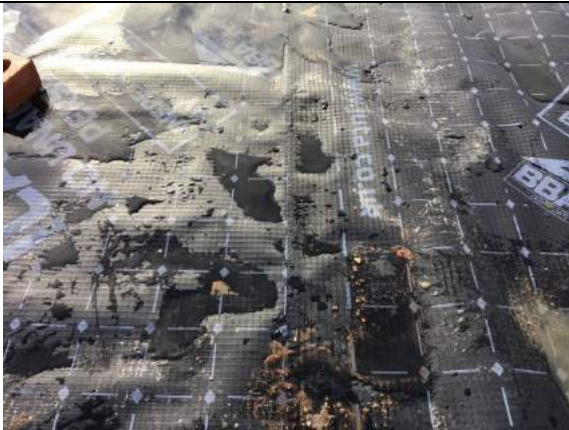
Typical hand welded membrane lap.

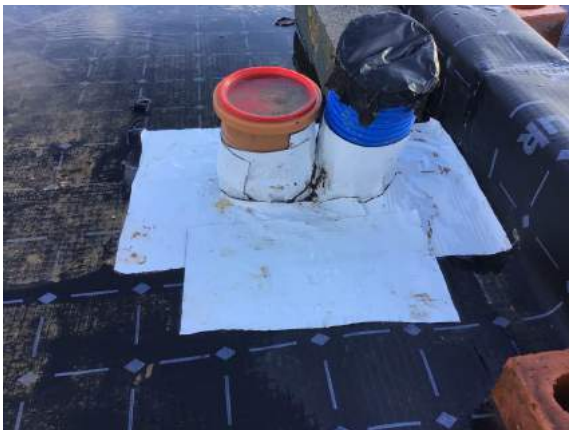
Typical double pipe penetration seal using SAGM.

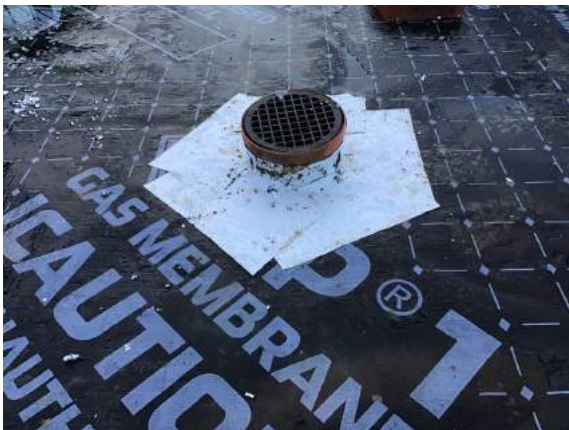
Sealed pipe penetration using SAGM in apartment plots 62-66.

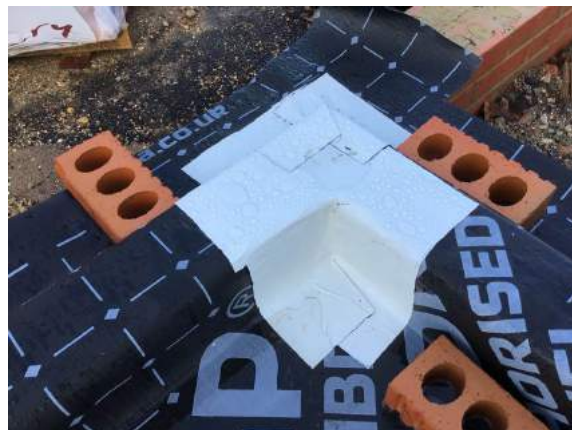
Typical corner seal using SAGM in plot 59.

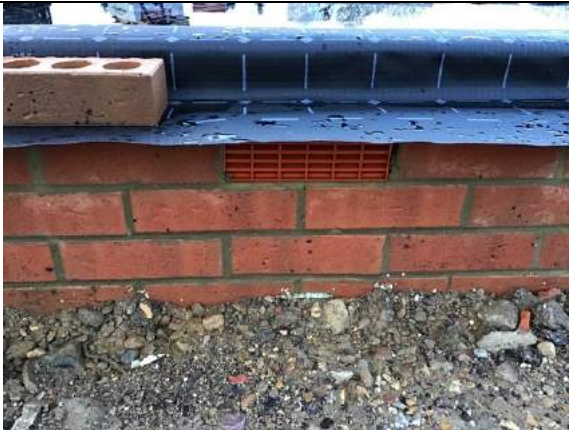
Air brick in place under the membrane at the time of our inspection.

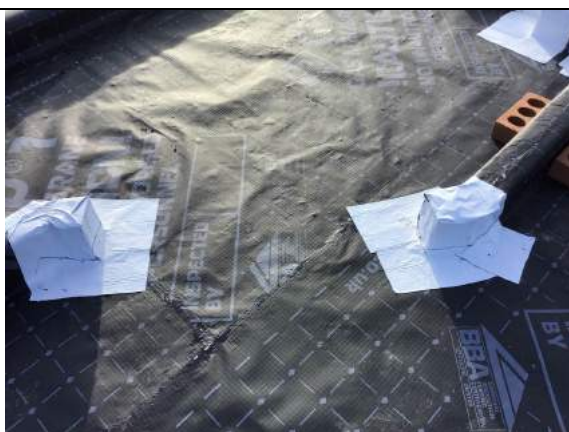
Sealed internal door threshold seal using SAGM in plot 56.

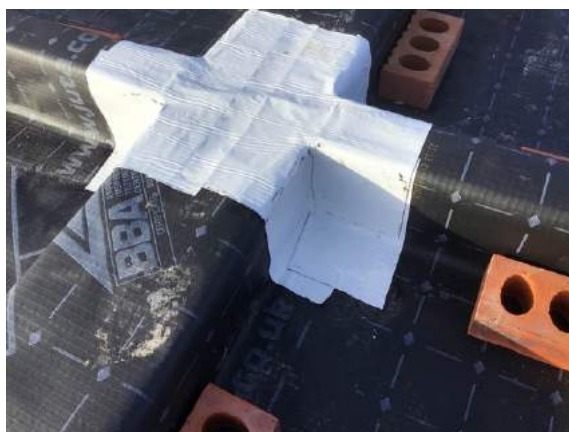
Typical corner seal using SAGM in plot 61.

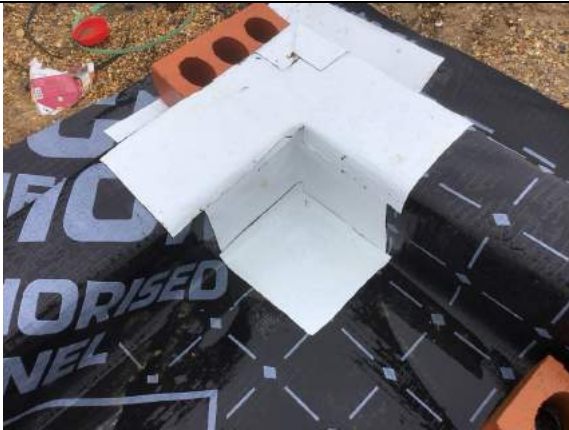
Typical corner seal using SAGM in plots 73-76.

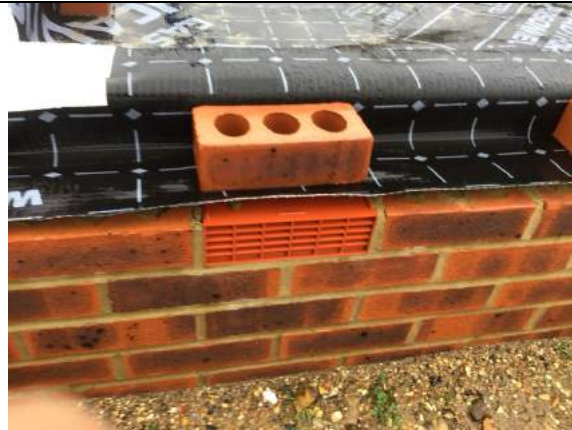
Air brick under the membrane at the time of our inspection to plots 73-76.

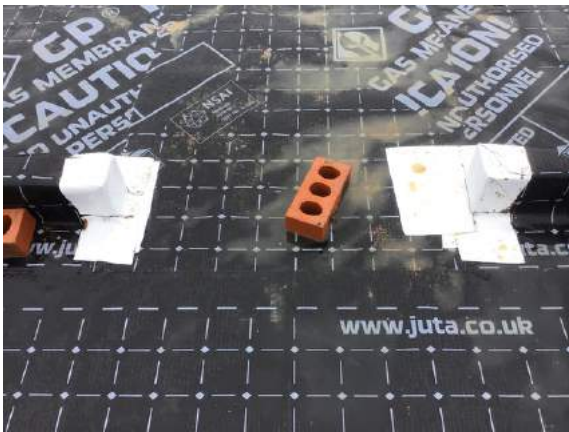
Sealed internal door threshold using SAGM in plot 68.

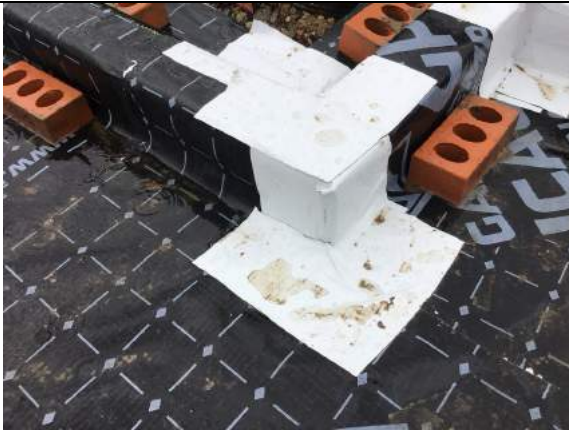
Typical corner seal using SAGM in plot 83.

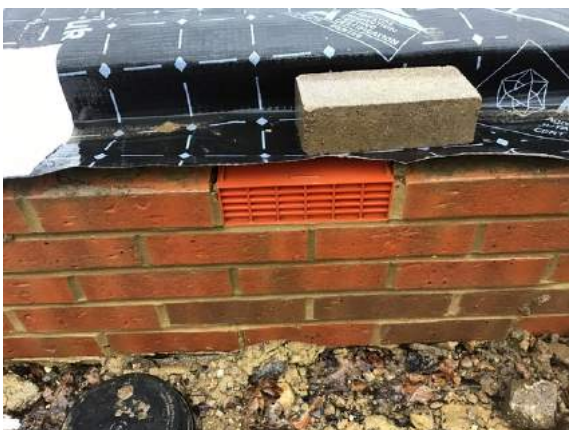
Air brick in place under the membrane to all inspected plots during our visit.
