Gas Membrane Installation  
Validation Report  
Eliva Homes  
Royale Victoria Grange  
2 Grange Road  
Netley  
Southampton  
SO31 5HZ  
V2 09/05/24

## Appendix 1 – Site Survey Sheets

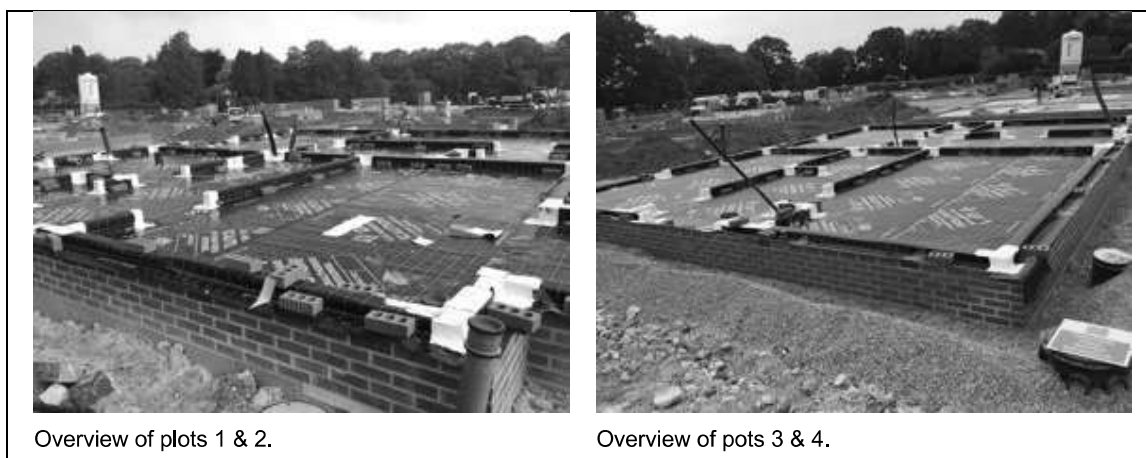
#### Plot Overview Photographs

| Plot Number | (Section 3, Defects List) | Action Required |
|---|---|---|
| 1,2,3 & 4. | No Defects recorded at the time of our inspection. | N/A |
