## **Resistograph Tree Report**

**Vivid Housing Limited**

**Prepared by  
Richard Daubeney Our Ref 0624-RD  
26th June 2024**

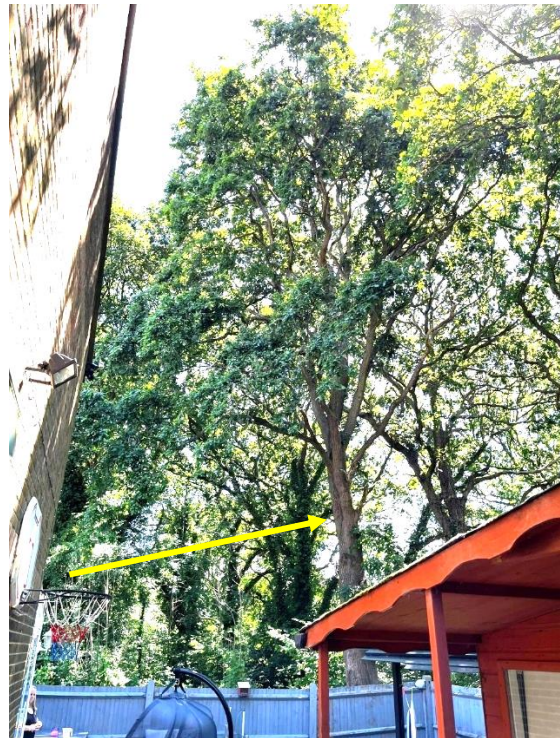
**T1 English oak looking South**

| Tree No.<br>Tree Tag. | Tree Species | Hgt (m) | Past Management | Age Class | Risk Target | Defects | Works | Work Priority |
|---|---|---|---|---|---|---|---|---|
| T1 Tree tag: N/A | English oak | 20-25m | No significant recent management noted. | Mature | High/<br>reinspect in 2027 | Gross Defect Noted<br>Large cavity on stem at 1.2m to the West. With fruiting body of <i>Laetiporus sulphureus</i> (Chicken of the woods) located within the cavity, fresh in appearance. The cavity when tapped with sounding hammer is hollow sounding. Co dominant stems at 9m above ground level. Deadwood throughout canopy. Crown weighted towards Southeast due to tree group pressure from North and West. | Reduce to 8-10m above ground level.<br><br>Tree works to BS3998 (2010) | Urgent Within 3 months |

We recommend these tree works is carried out within 3 months from the date of this report.

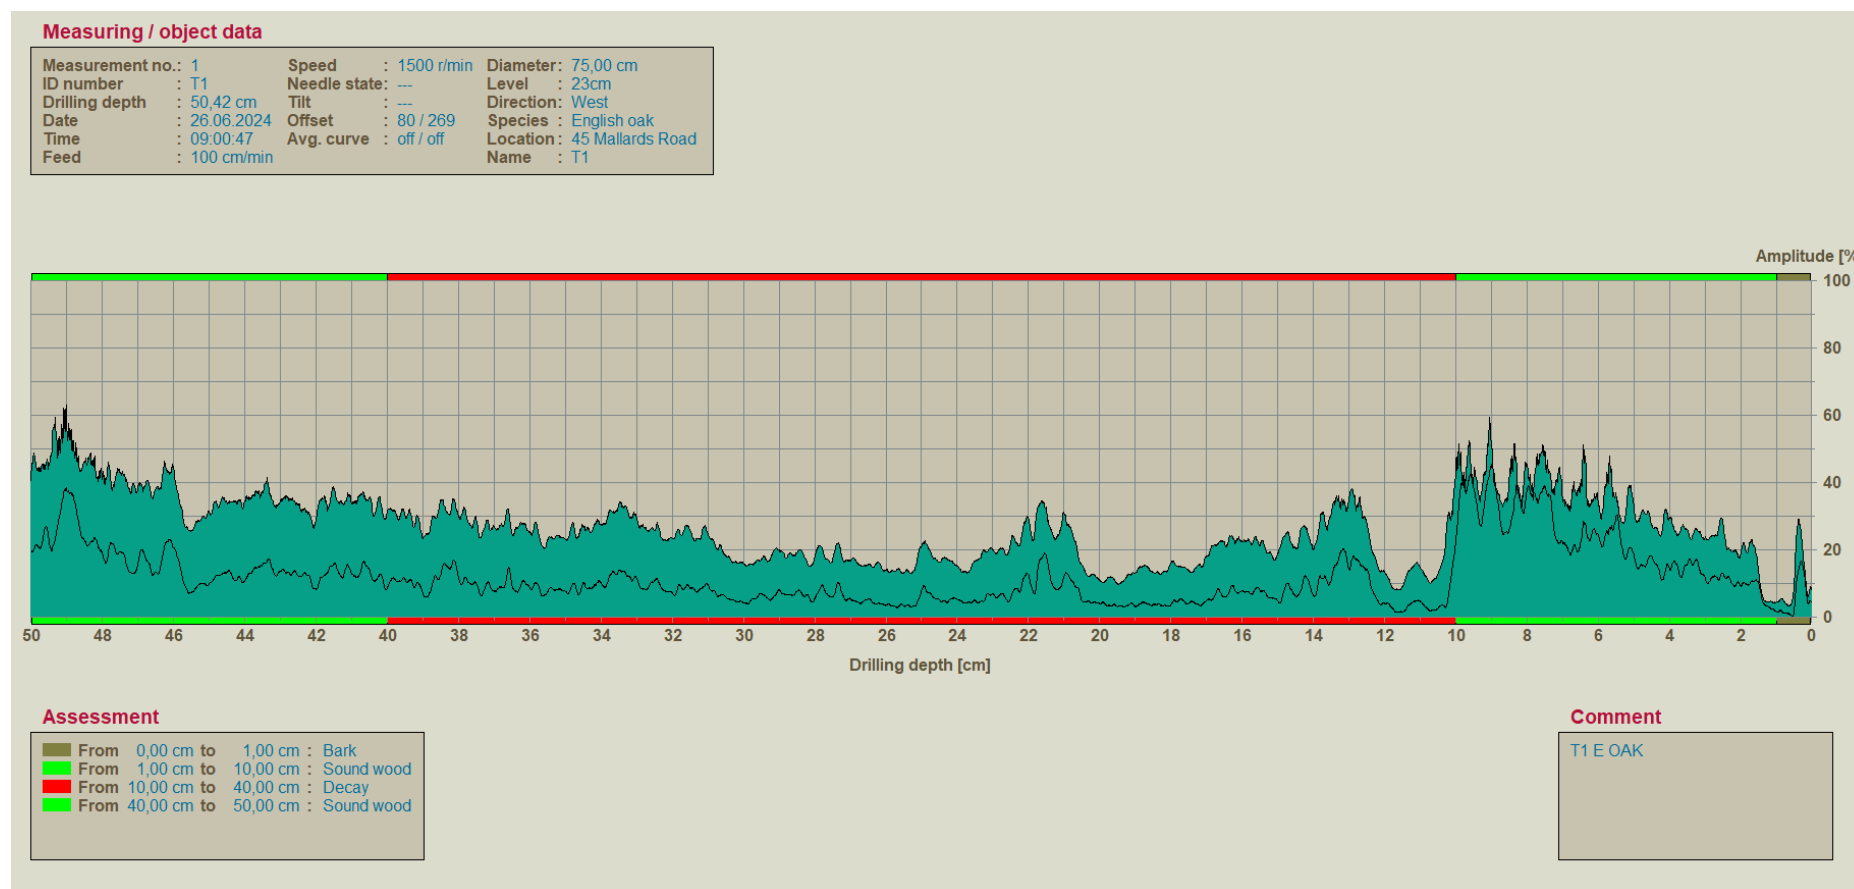
### T1 English oak Measurement 1

- 5.3 Following the testing of the T1 English oak tree it showed areas of significant decay within the stem. This is highlighted within readings 5 and 8, which were positioned either side of the cavity area, this was carried out to demonstrate the sound live wood available centered around the cavity area. Both readings 5 and 8 showed little in terms of sound residual holding wood and the significant areas of decayed wood present within the stem. Reading No.6 also demonstrated areas of moderate decayed wood within the stem, but however there is also sound holding wood within this reading. The remaining readings showed significant area of decayed wood present within the stem. The cavity on the stem currently has a fruiting body *Laetiporus sulphureus* (Chicken of the woods) bracket, which is fresh in appearance. (See below for further information on this fungus) The large cavity with internal decay at 1.2m to the West side of stem shows moderate reaction wood surrounding the cavity. The tree has large standing deadwood present throughout the canopy.
