## SITE VISIT REPORT

**Project:** Kestrel Park, Bursledon

**Client:** Taylor Wimpey UK Ltd (Southern Counties)

**Contract No.:** C-08162-C

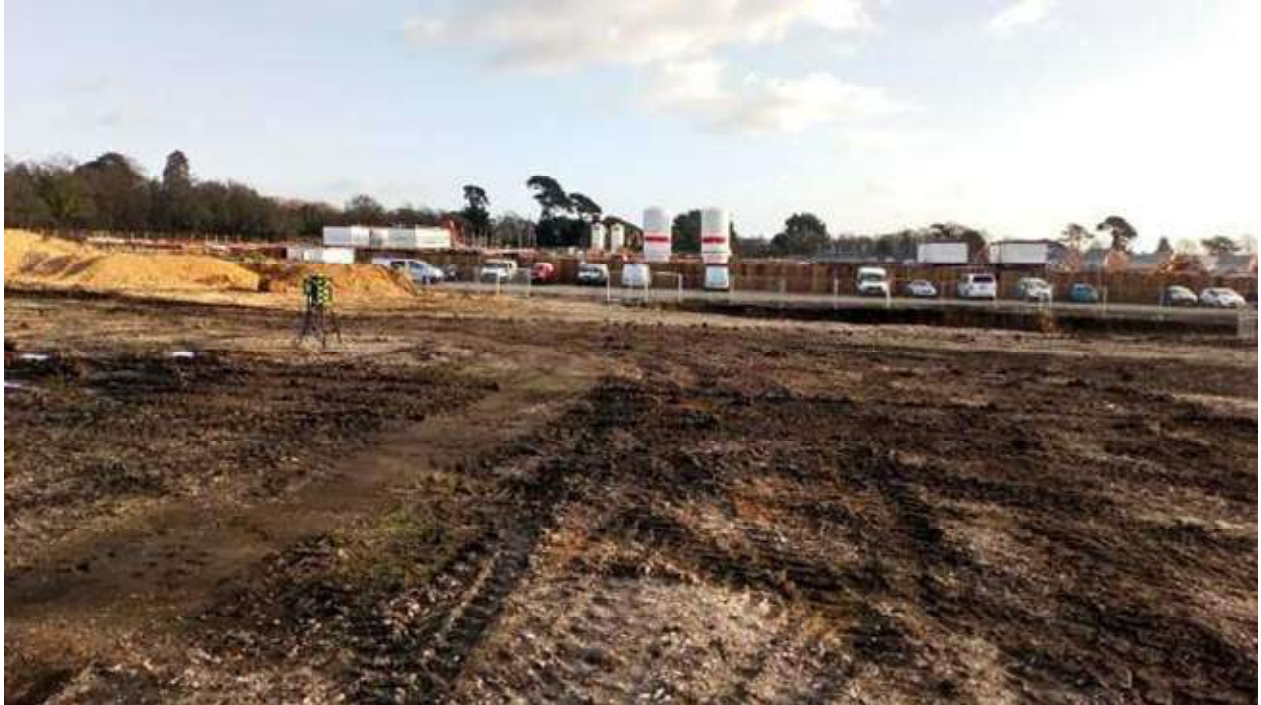
**Photograph 3: View toward Taylor Wimpey Compound and parking area**

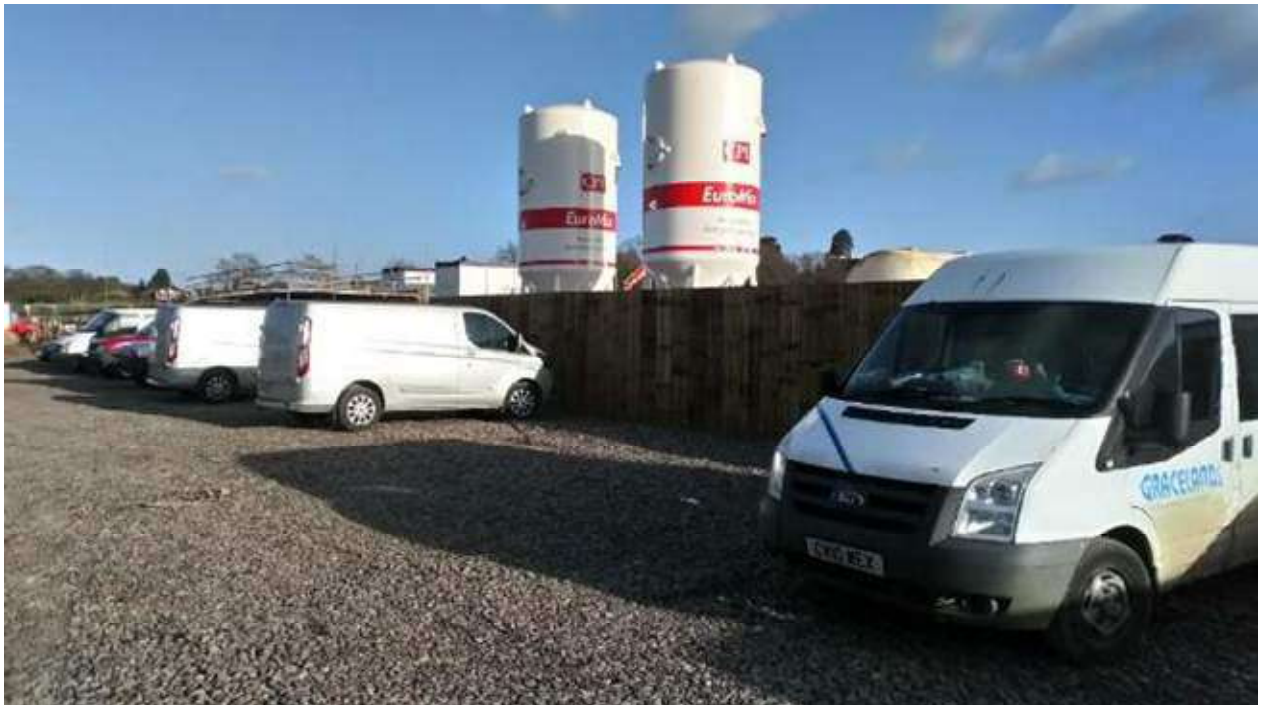
**Photograph 6: View of Taylor Wimpey compound, parking in foreground and batching plant present.**

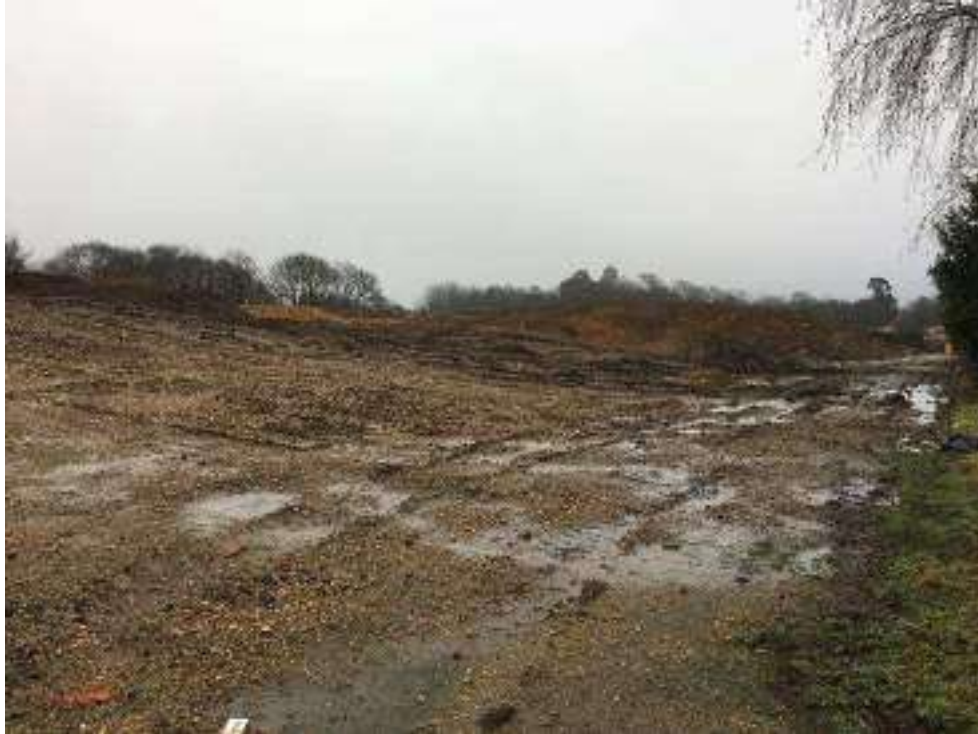
**Photograph 3: view looking north across stockpile area (left)**

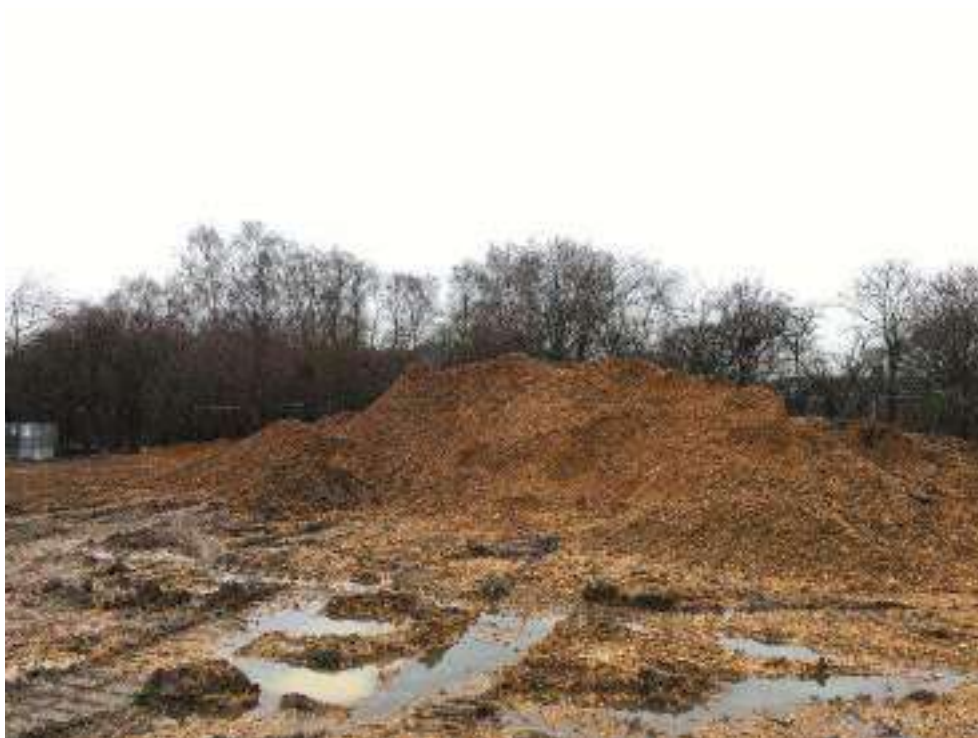
**Photograph 4: surplus arisings from knotweed burial cell excavation**

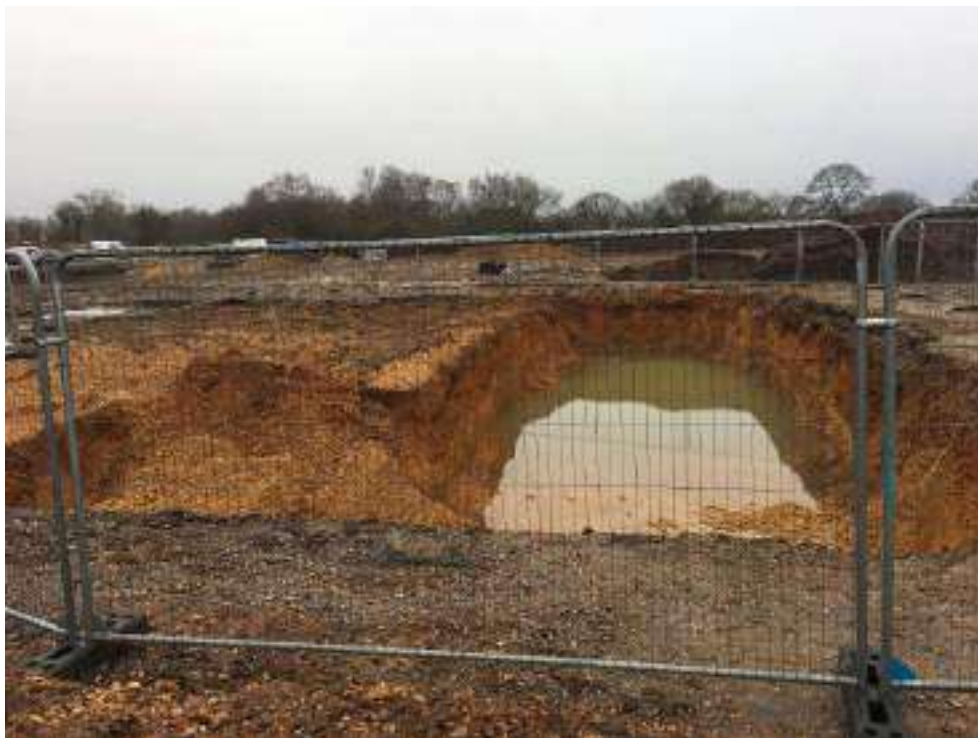
**Photograph 6: new borrow pit excavation**

- Asbestos impacted soils should be disposed off-site.
- Excavation works for the new borrow pit must be halted and no further excavation undertaken.
- Any materials to be reused on site should be won from the main stockpile of drainage basin, road construction and foundation excavation arisings.
- Surveying of the existing stockpiles must be done on a regular basis to provide tracking data for materials management.
- Site meeting to be held between TW, Gracelands and Hydrock to determine way forward with materials management.

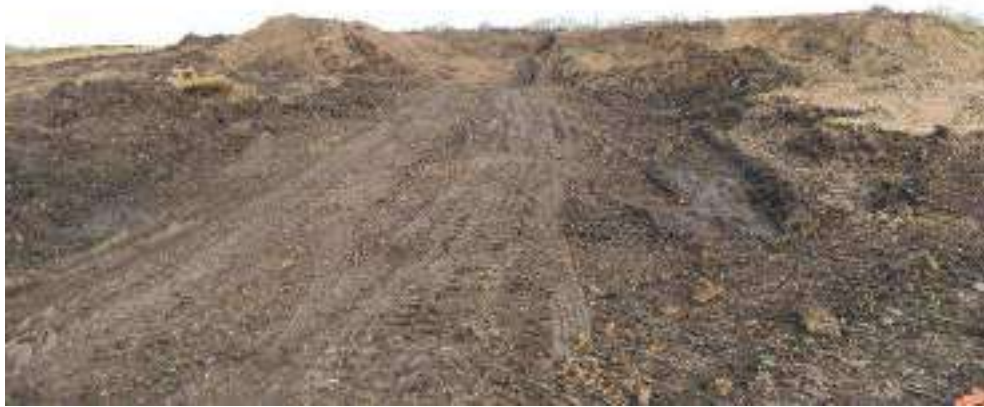
**Photograph 1: View looking north towards topsoil stockpile**

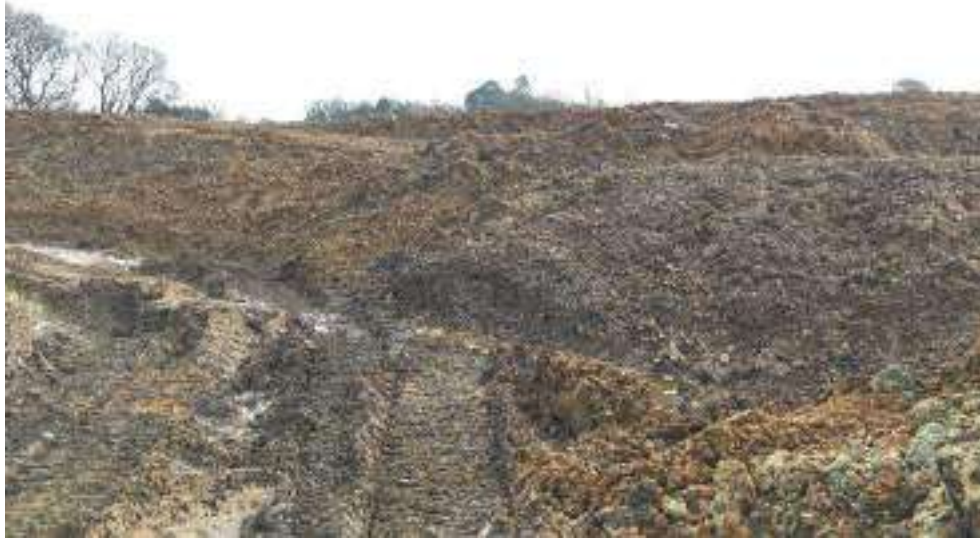
**Photograph 3: mixed stockpile further south east of topsoil stockpile**

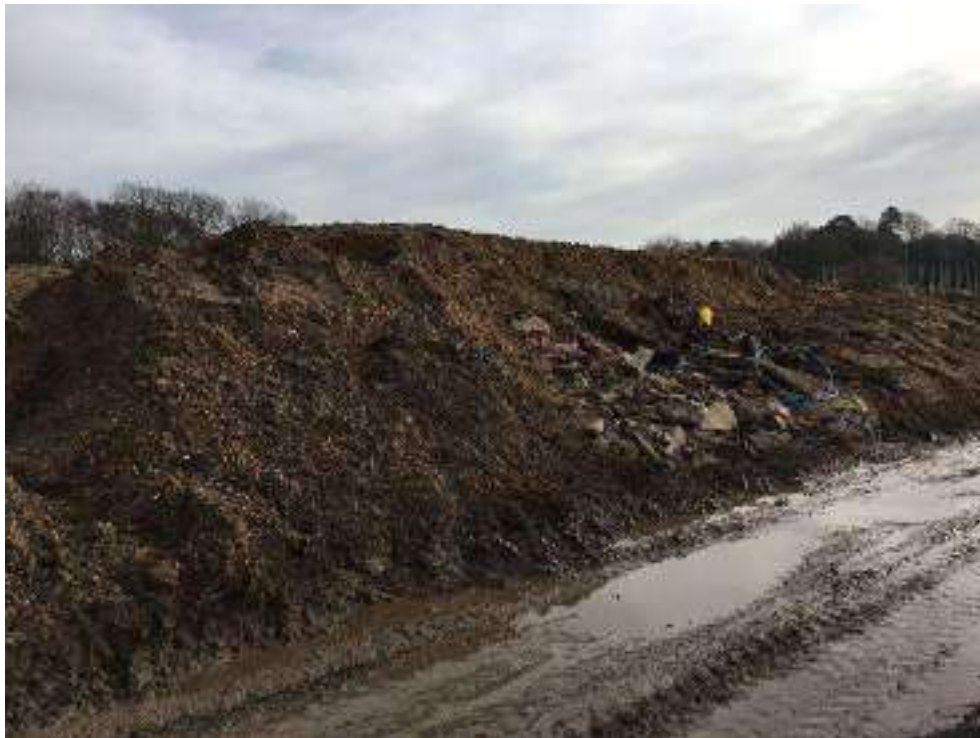
**Photograph 4: anthropogenic waste materials placed on mixed stockpile**

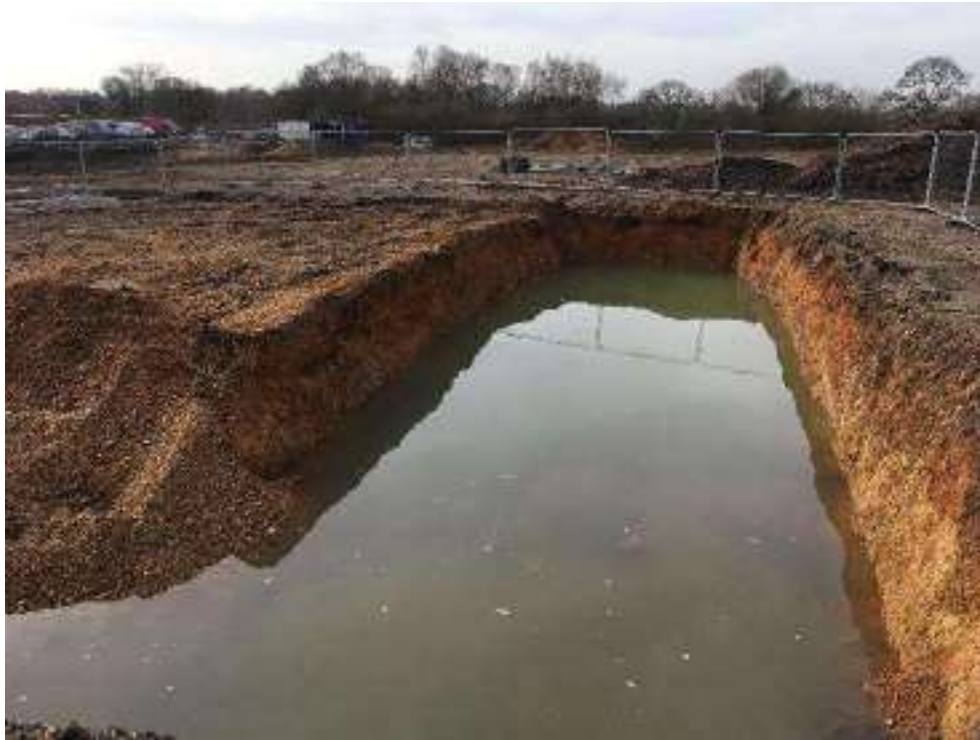
**Photograph 5: “borrow pit” excavation**

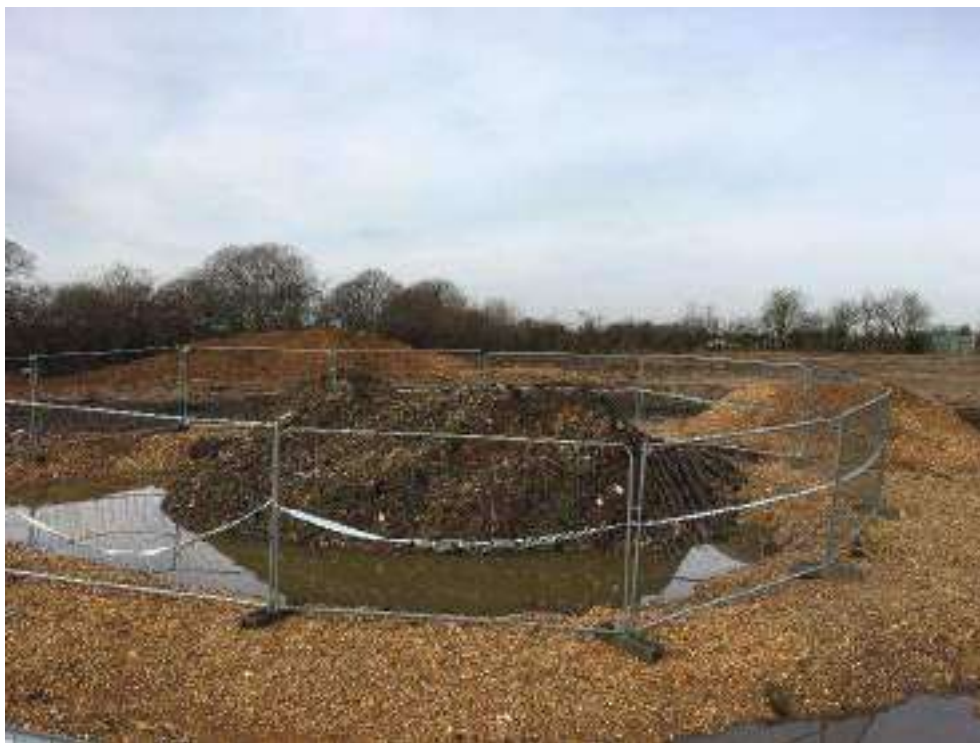
**Photograph 6: asbestos impacted soils remain on site following completion of knotweed remediation**

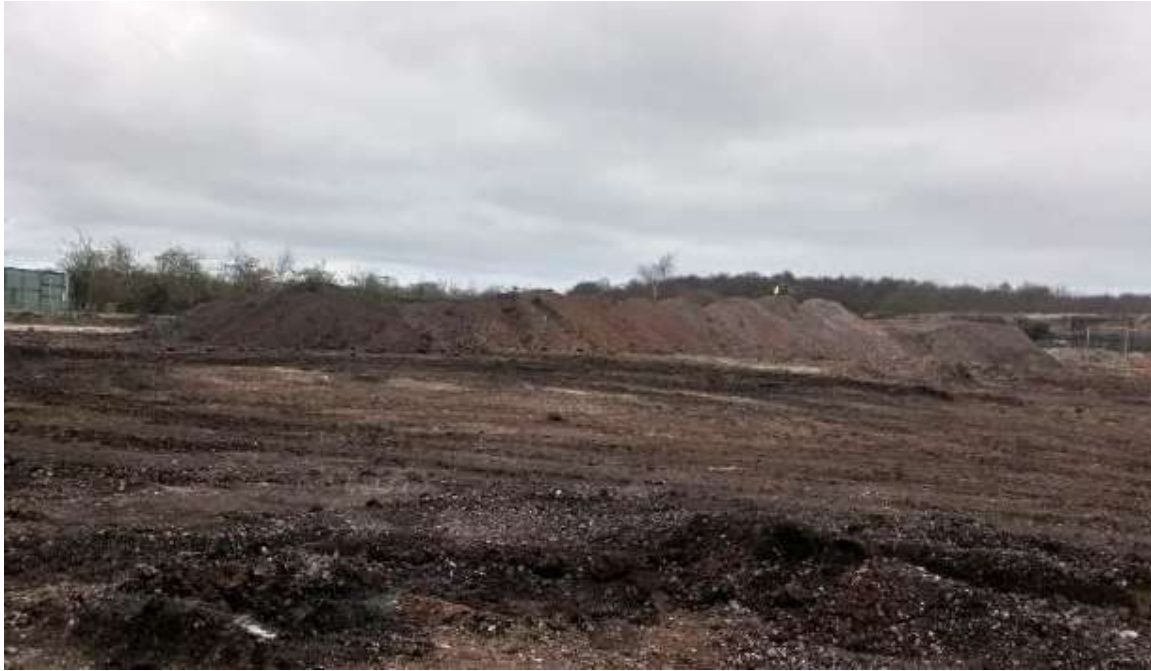
**Photograph 1: New stockpiles behind TW compound looking northwest**

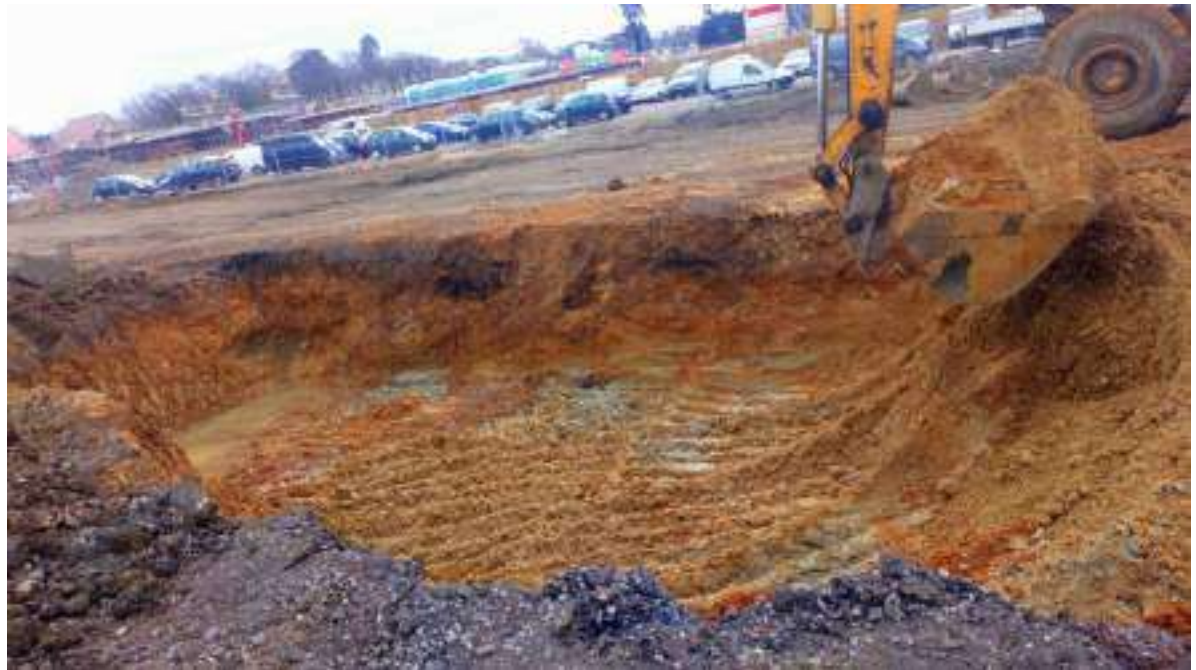
**Photograph 5: "borrow pit" excavation**

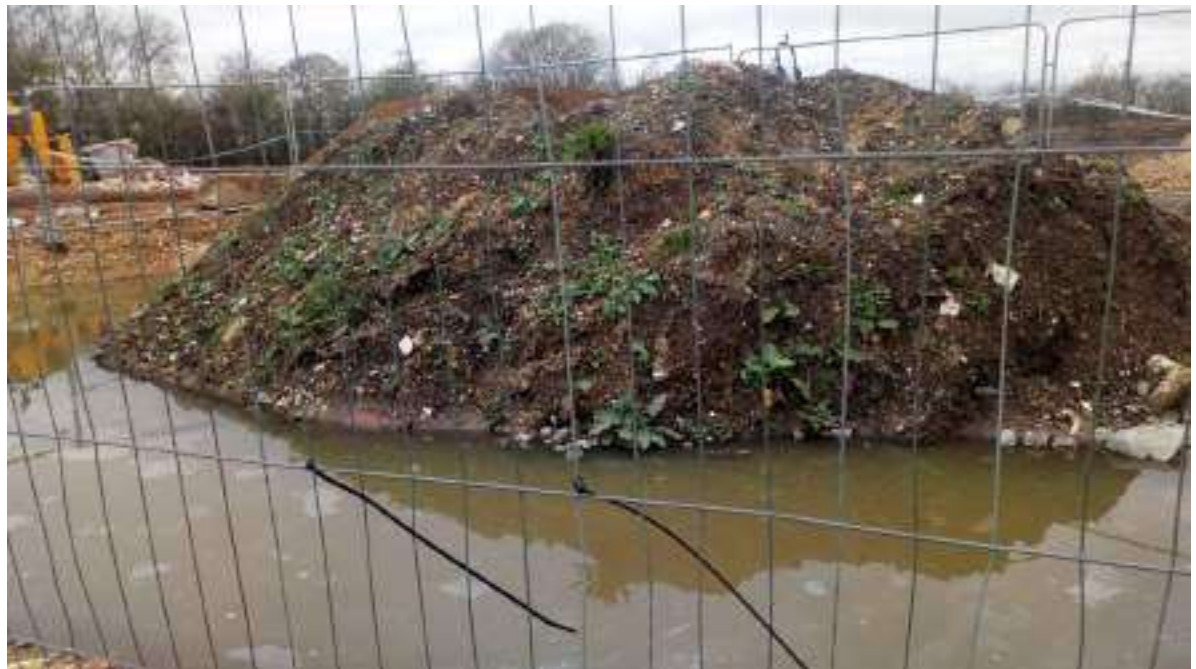
**Photograph 6: asbestos impacted soils remain on site following completion of knotweed remediation**

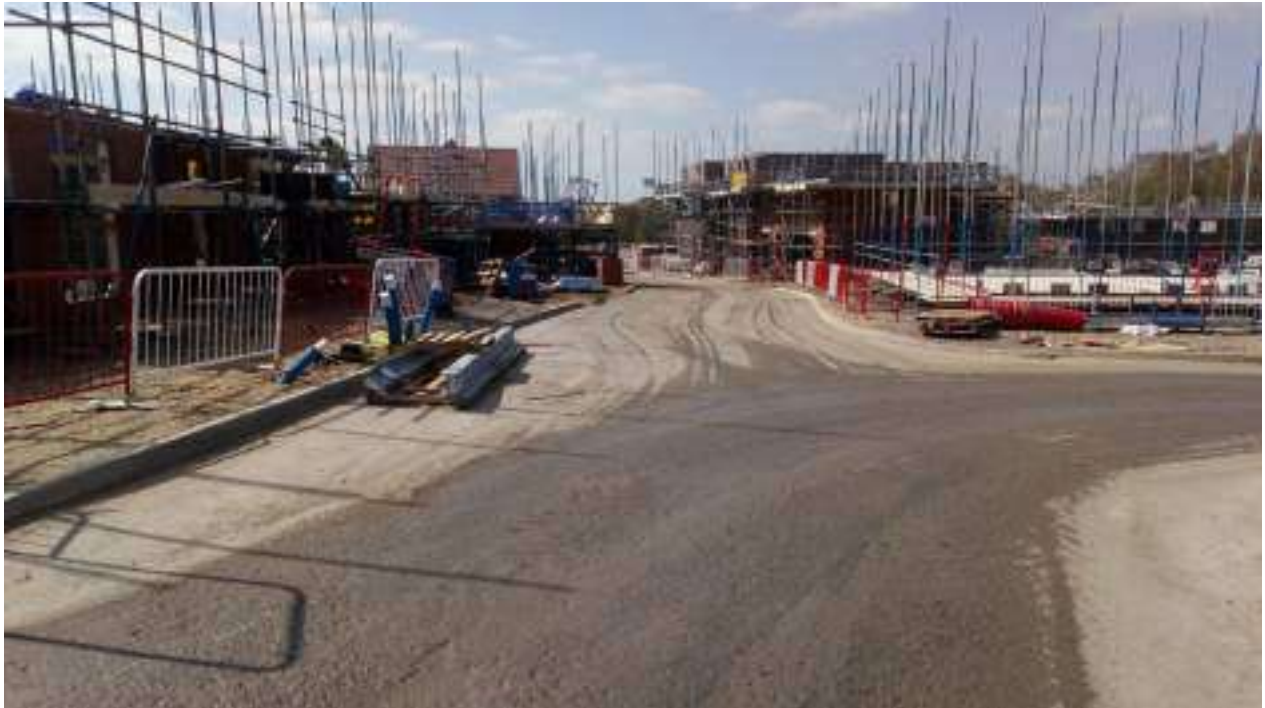
**Photograph 1: Ongoing construction of houses, roadways are being wetted/cleaned for dust suppression**

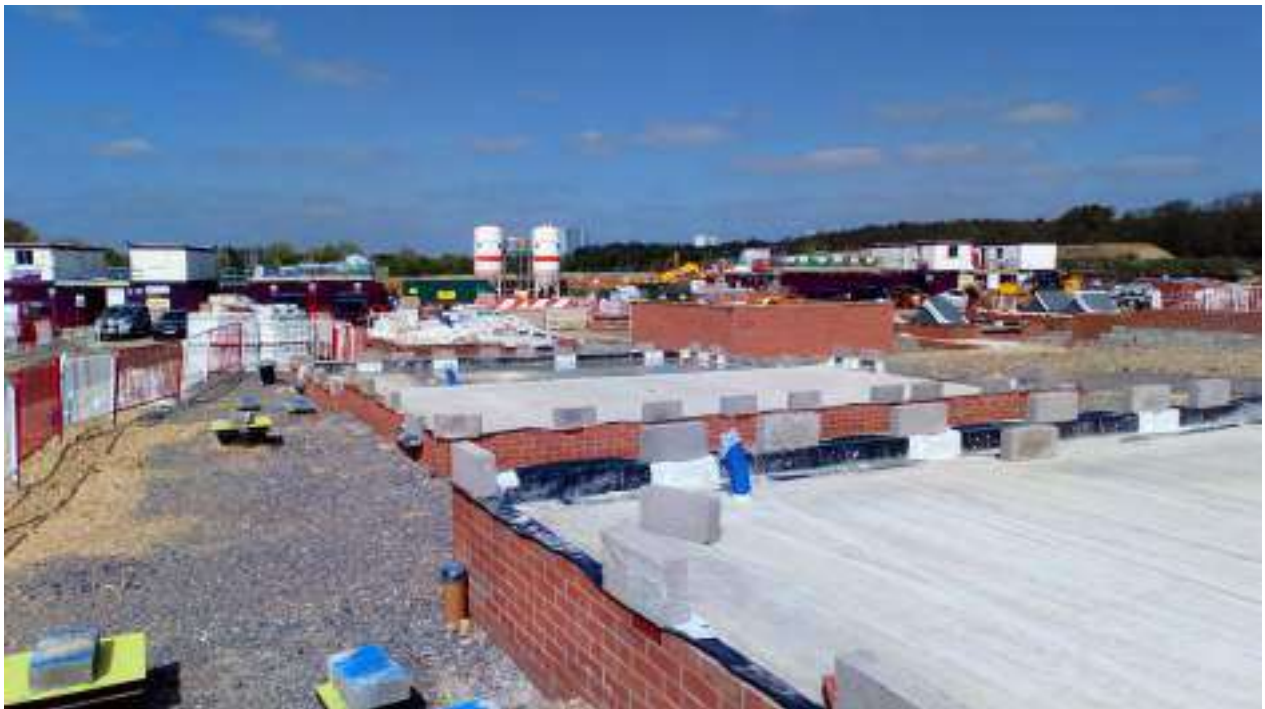
**Photograph 2: View across site towards TW compound. Services are clearly identified**

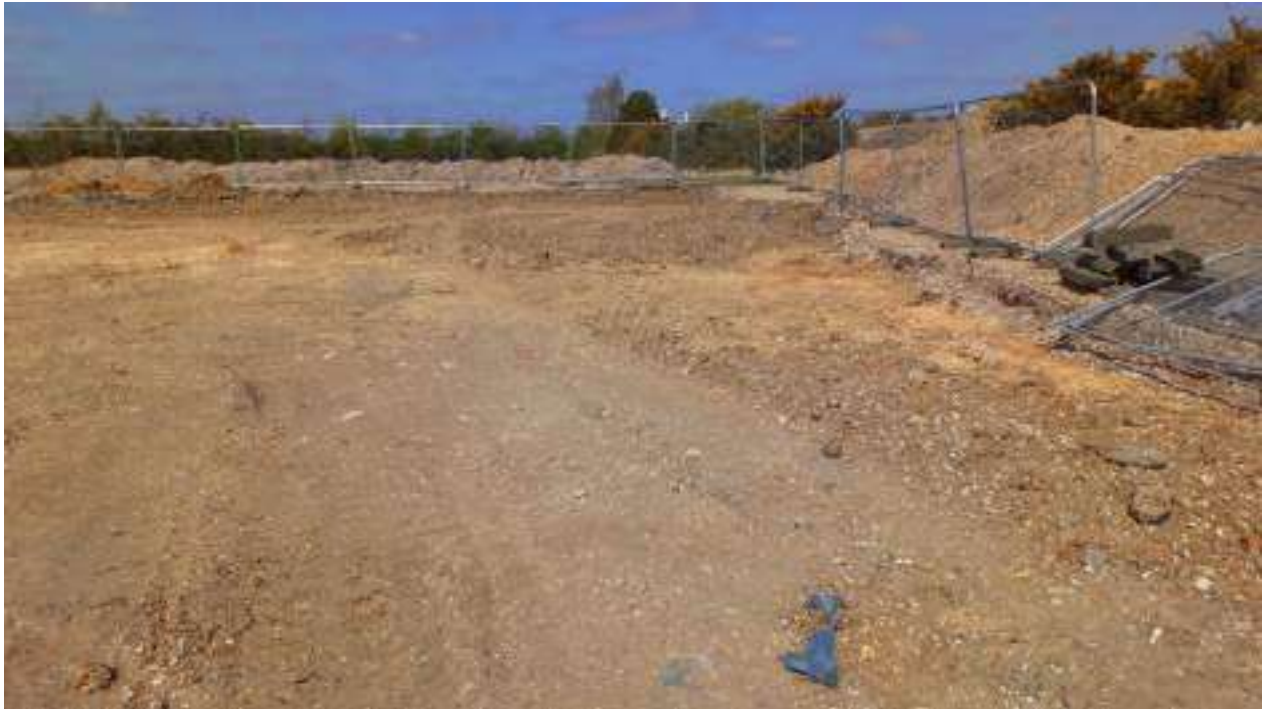
**Photograph 5: View looking west across Japanese Knotweed burial cell.**

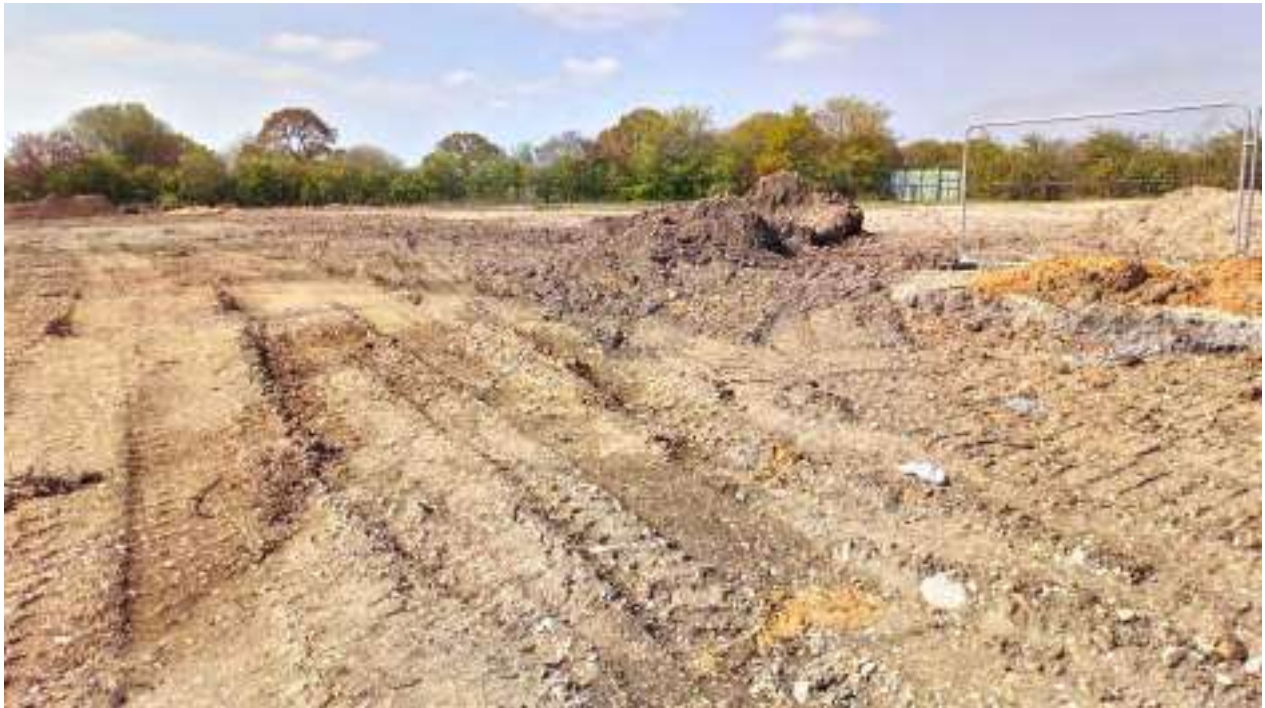
**Photograph 6: View looking south west across Japanese Knotweed burial cell**

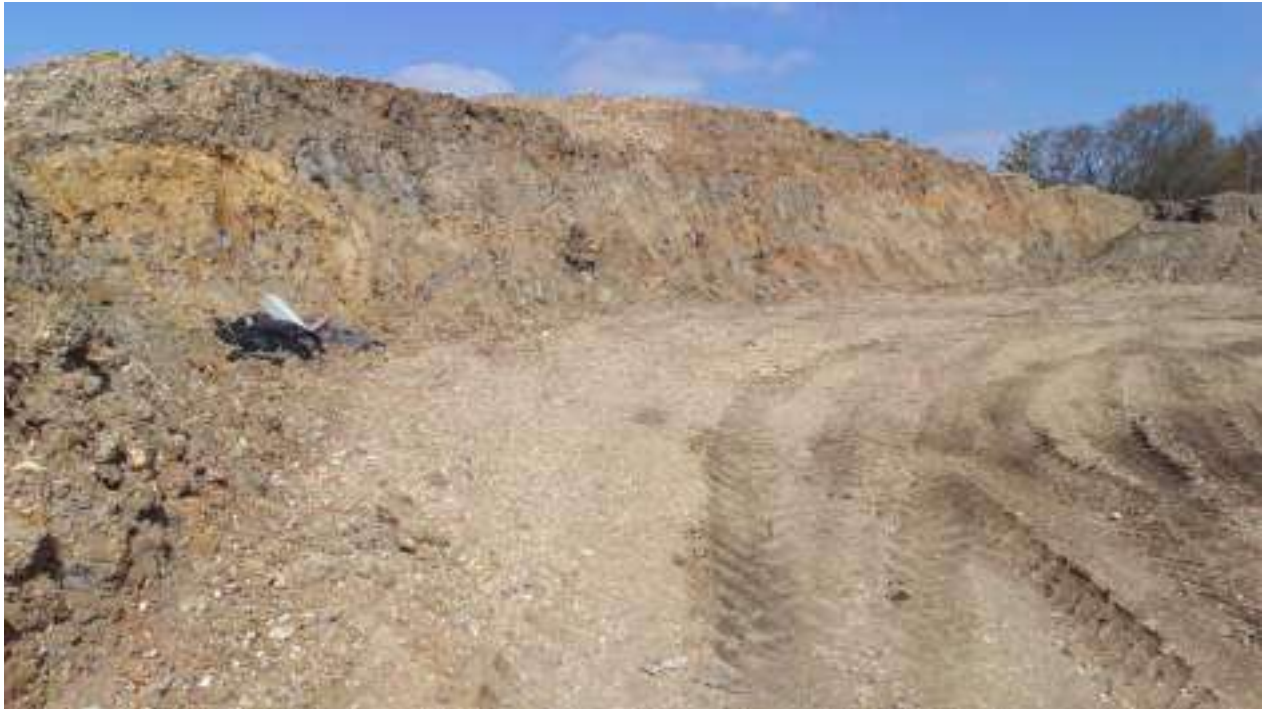
**Photograph 7: Stockpiled materials being used. Stockpile at eastern end of stockpile area in north west of the site**

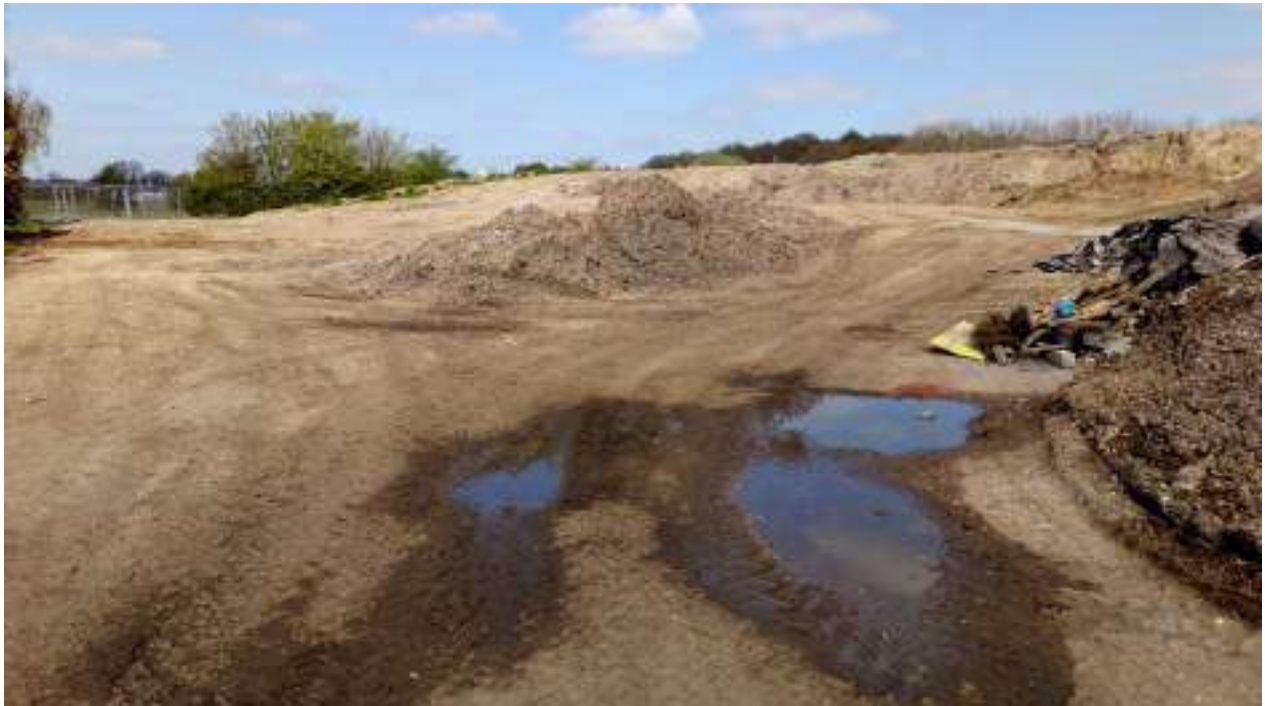
**Photograph 8: Western end of stockpile area in north west of the site.**

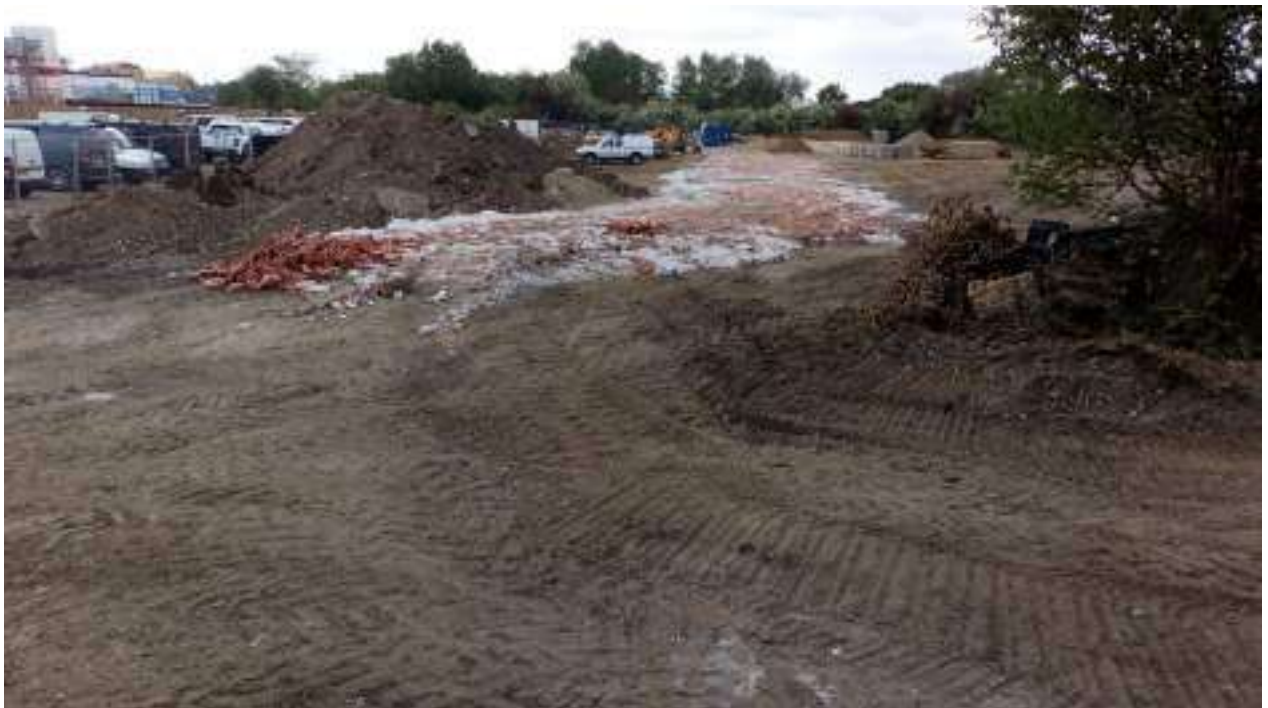
**Photograph 6: Looking south toward the constructed access track**

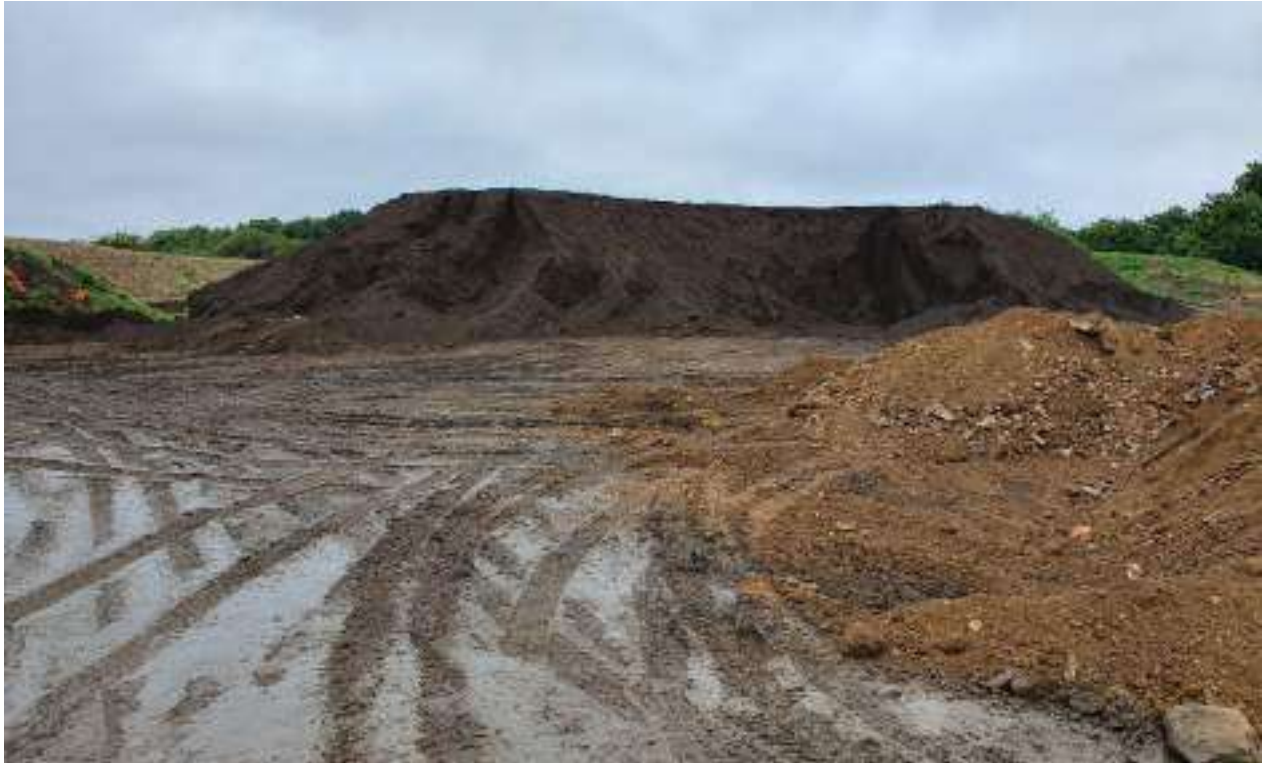
**Photograph 3: Screened Topsoil stockpile in north west of site**

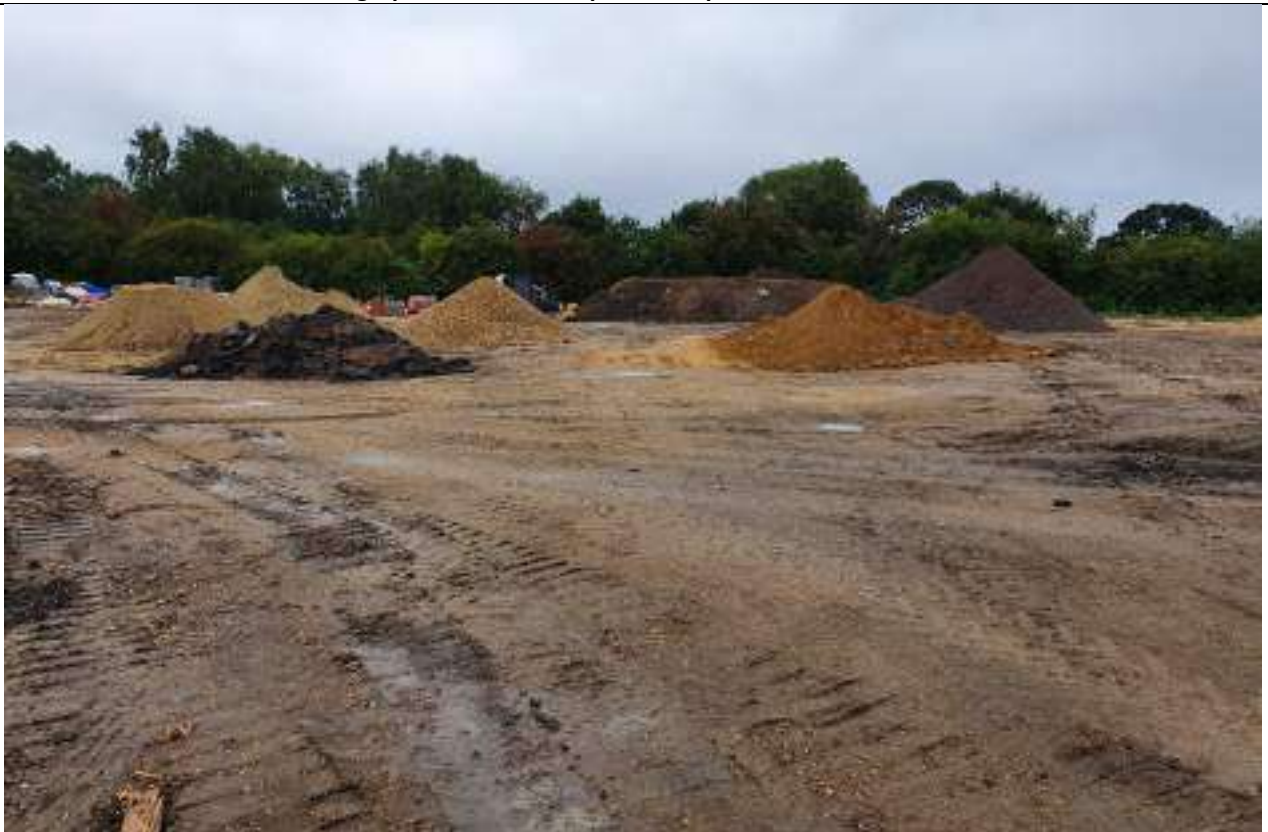
**Photograph 4: Various small stockpiles of aggregates to west of TW compound**

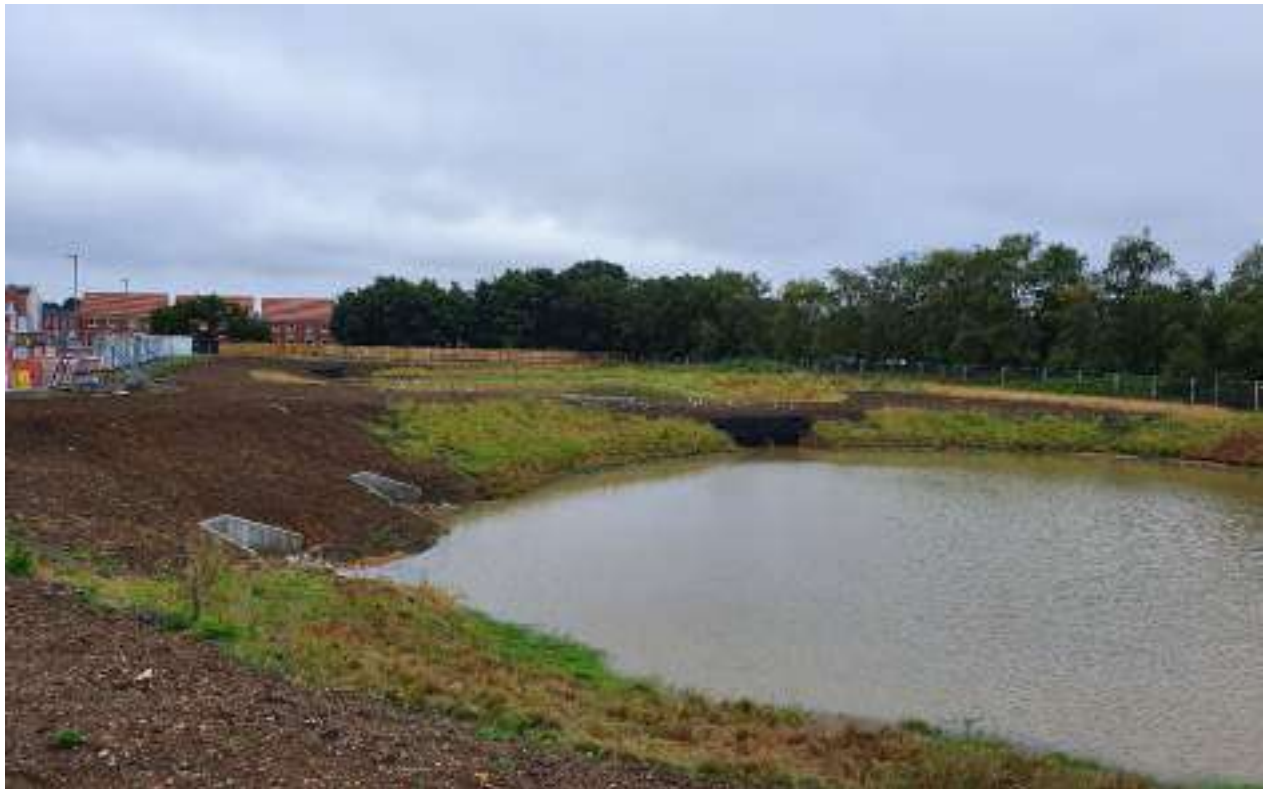
**Photograph 5: View of northern most attenuation basin now complete with headworks and Topsoils**

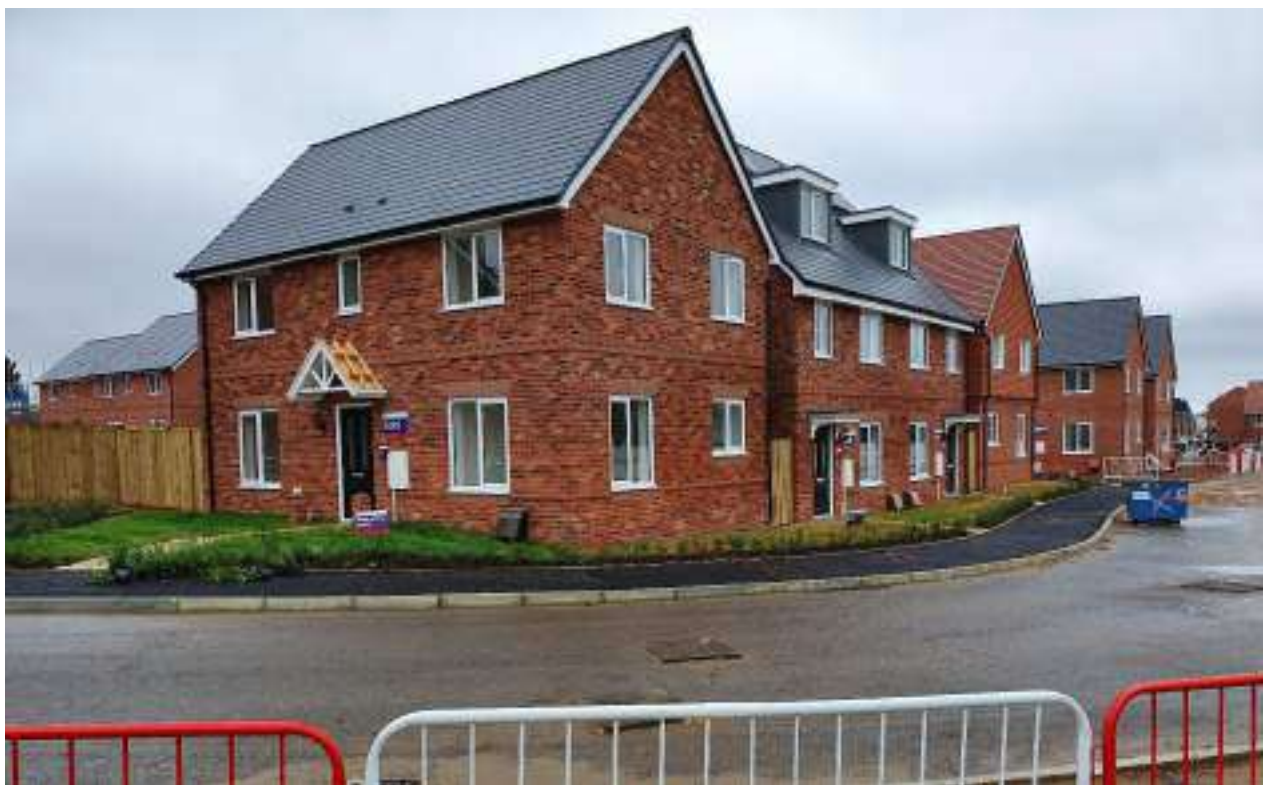
**Photograph 6: Nearly completed residential properties in the north west of the site**

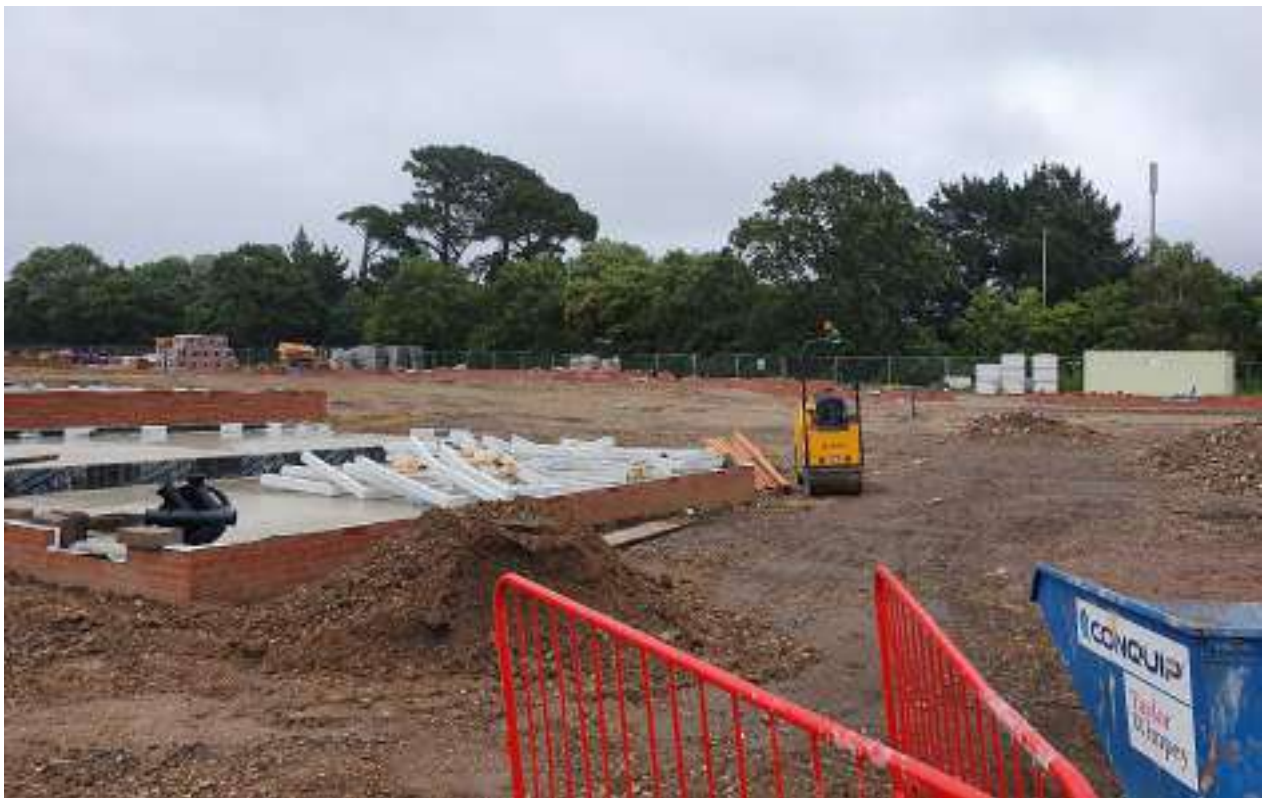
**Photograph 8: Preparation of eastern parts of the site for construction**

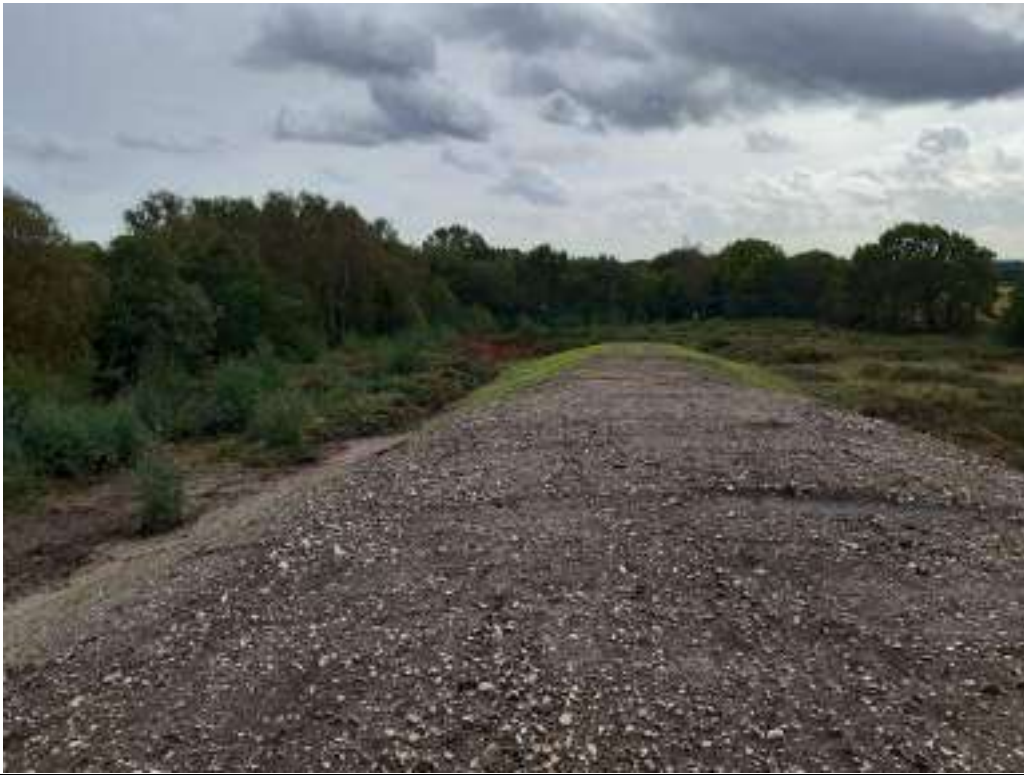
**Photograph 1: Looking across the top of the bund, facing southeast.**

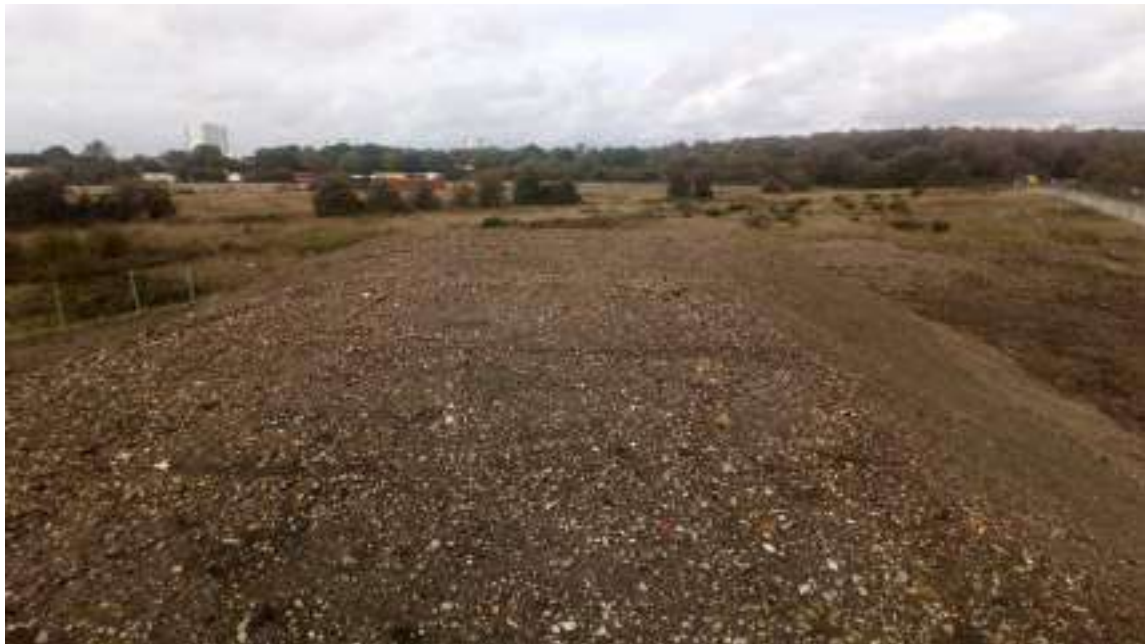
**Photograph 2: Looking across the top of the bund, facing northwest.**
