## SITE VISIT REPORT

**Project:** Kestrel Park, Bursledon

**Client:** Taylor Wimpey UK Ltd (Southern Counties)

**Contract No.:** C-08162-C

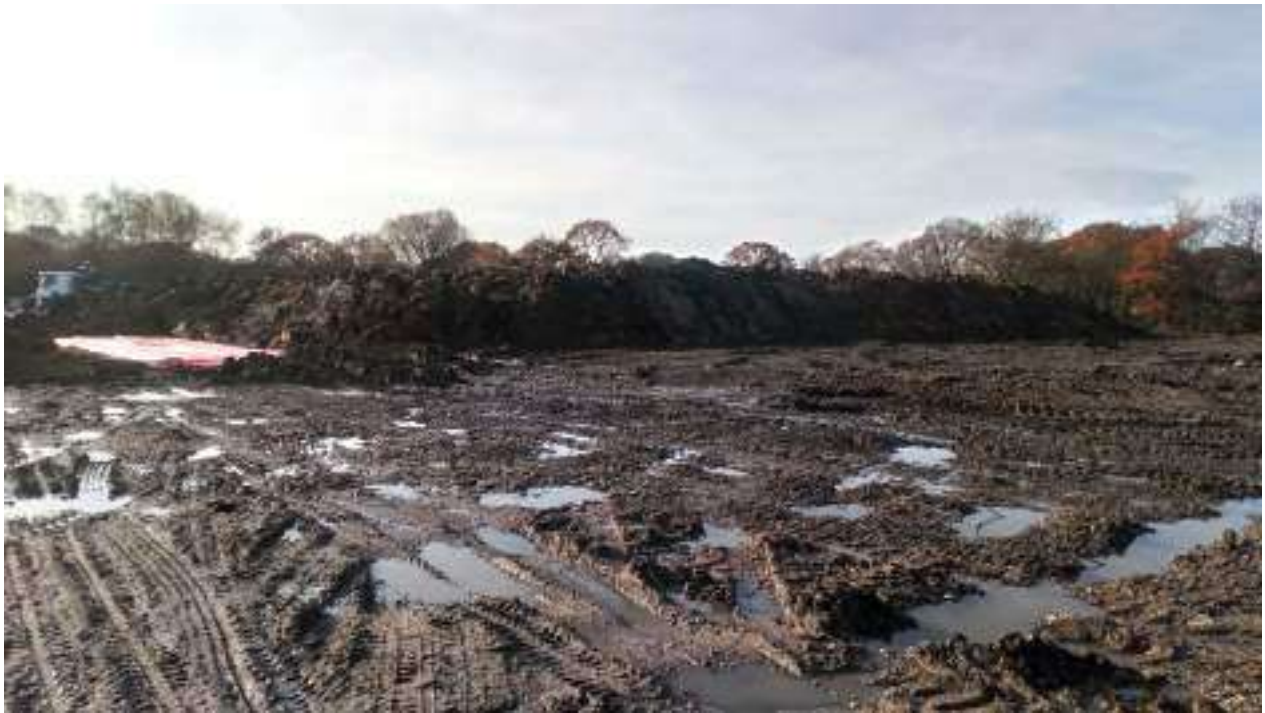
**Photograph 1: Looking towards the new stockpile of soil from Burr ridge Green, facing southwest.**

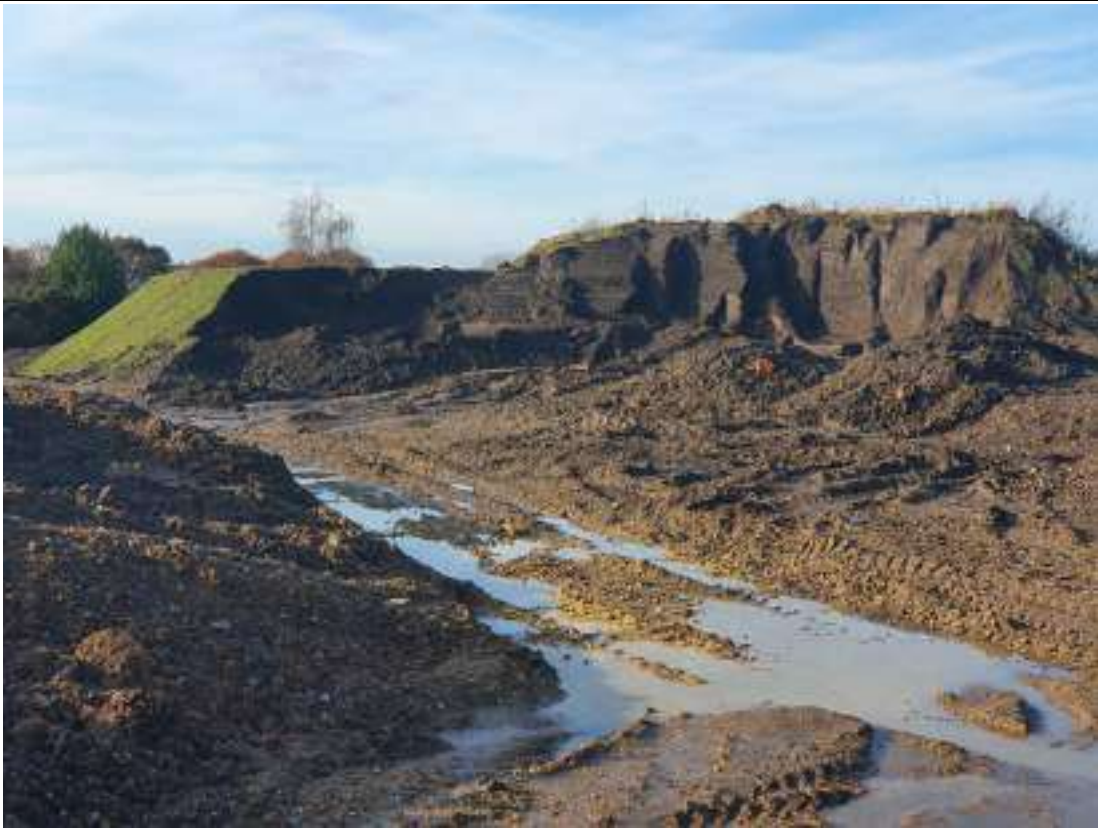
**Photograph 3: Remainder of topsoil stockpile. Facing southwest.**

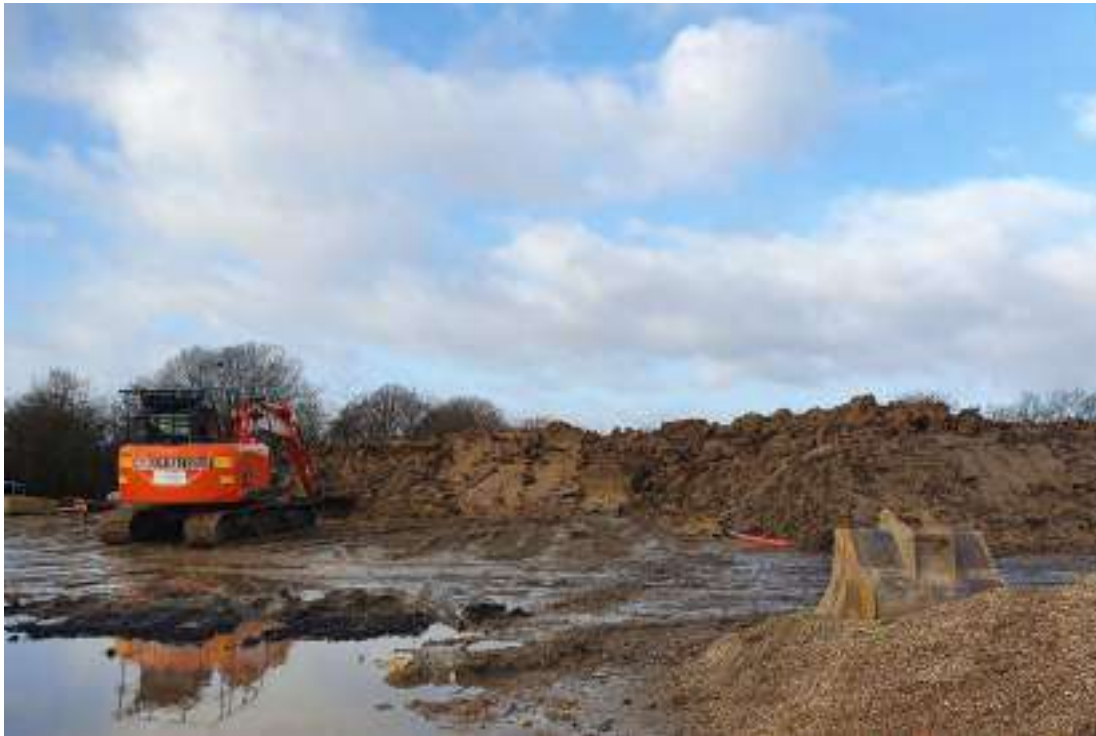
**Photograph 1: Looking west towards ongoing stockpiling of soil from Burr ridge Green.**

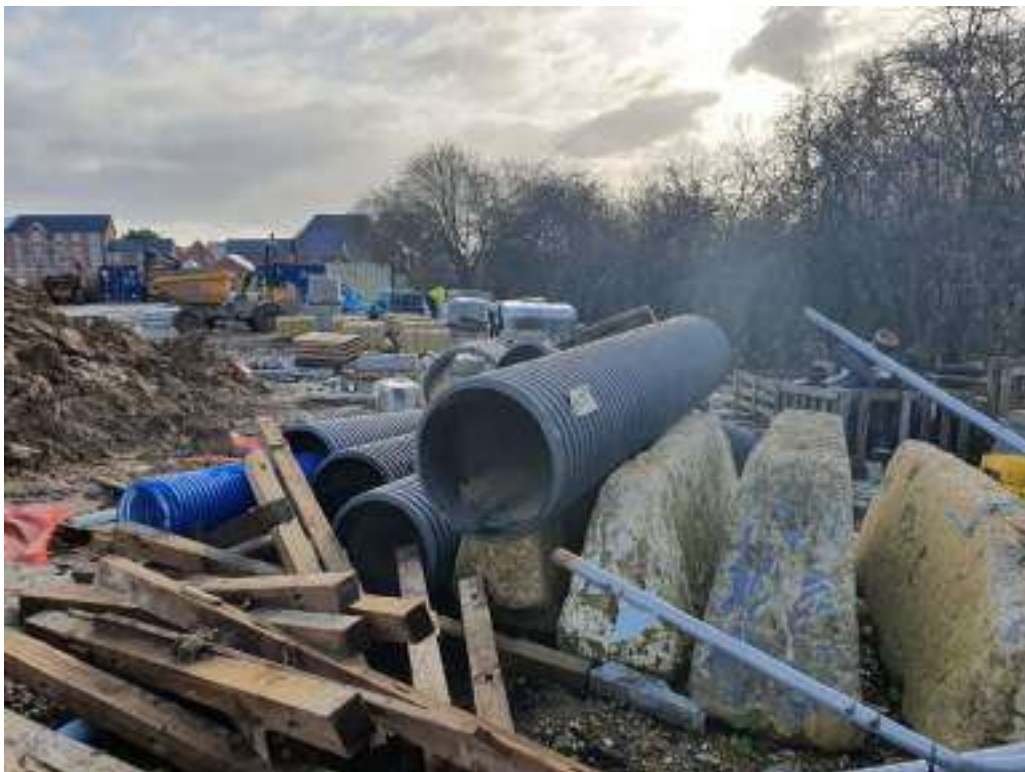
**Photograph 2: Storage of general construction waste at southern most end of Burr ridge Green TS stockpile.**

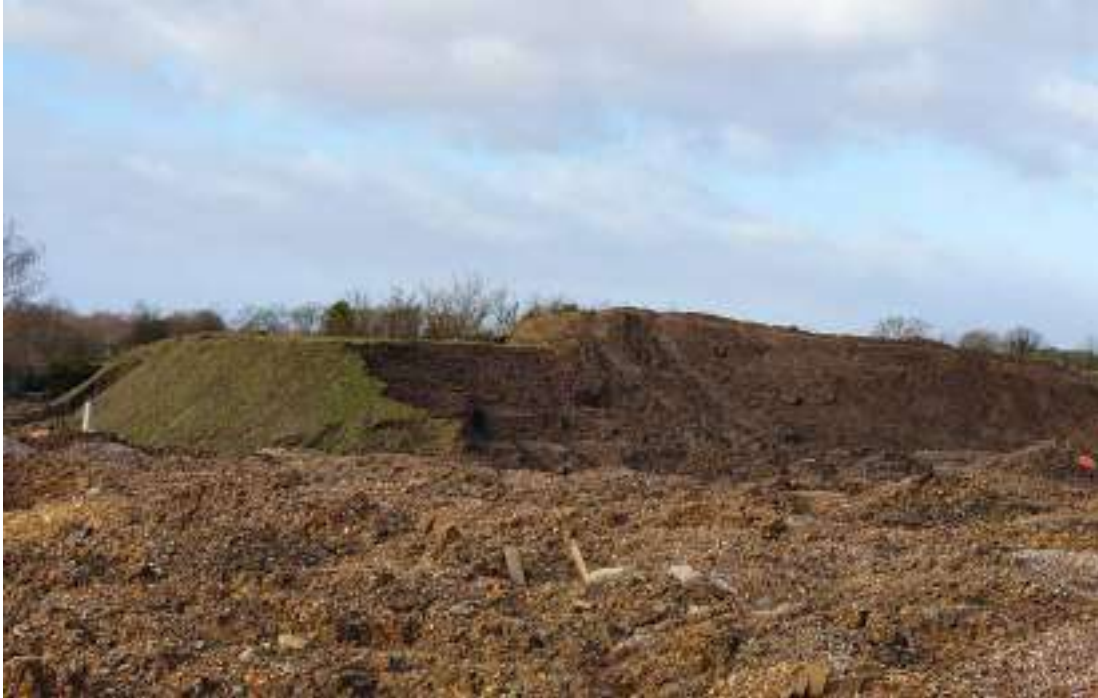
**Photograph 5: Remaining topsoil stockpile (in northern stockpile area).**

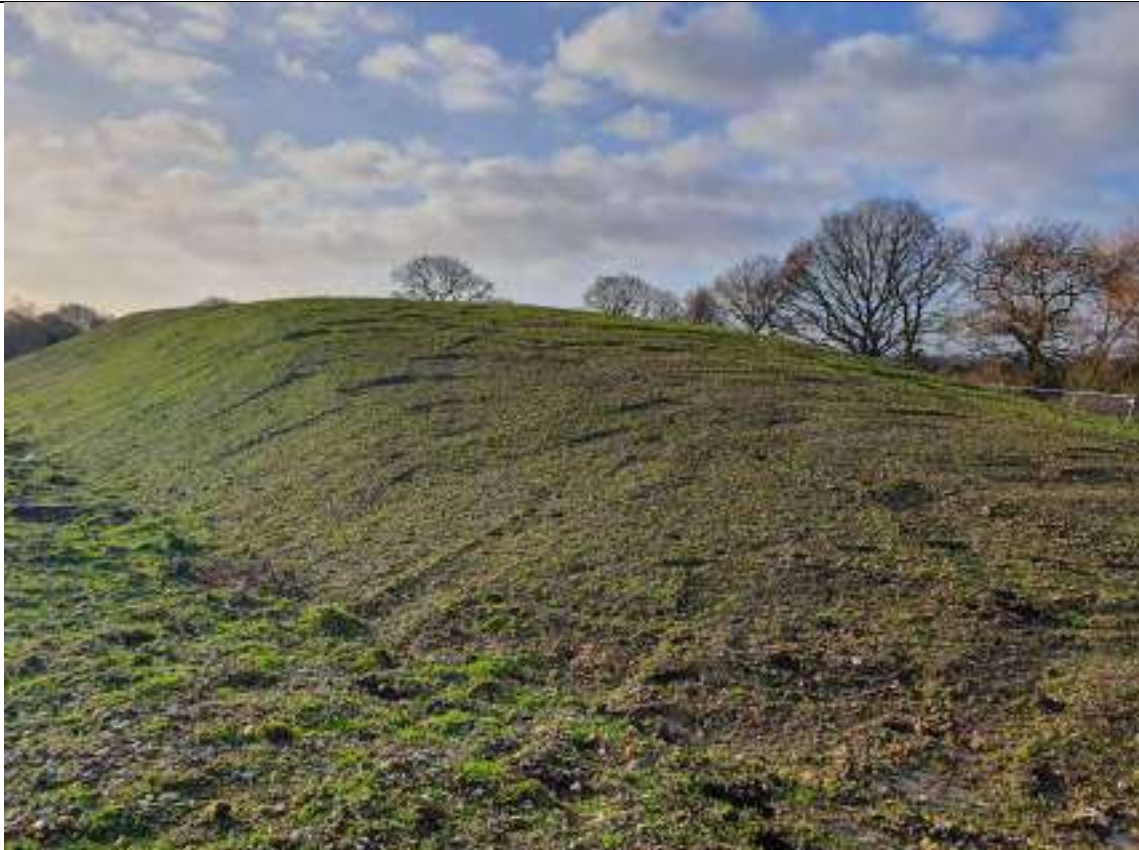
**Photograph 6: Overview of the bund to the west of the haul road, looking southeast.**

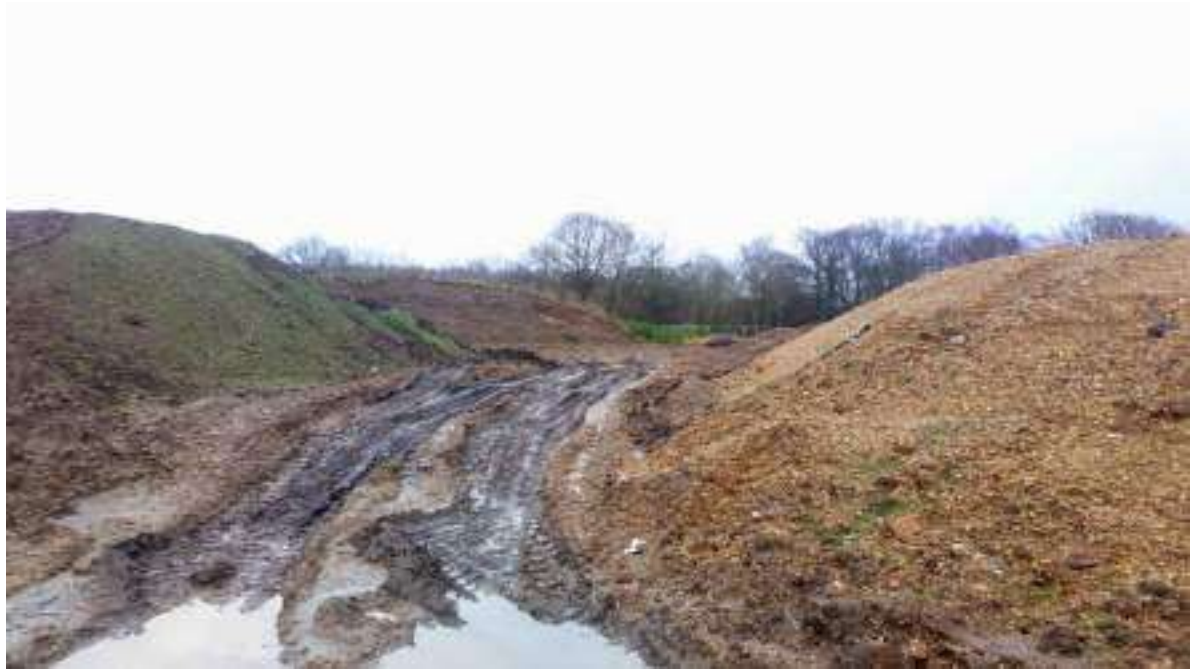
**Photograph 3: Topsoil stockpile (left) and mixed materials stockpile (right), facing North.**

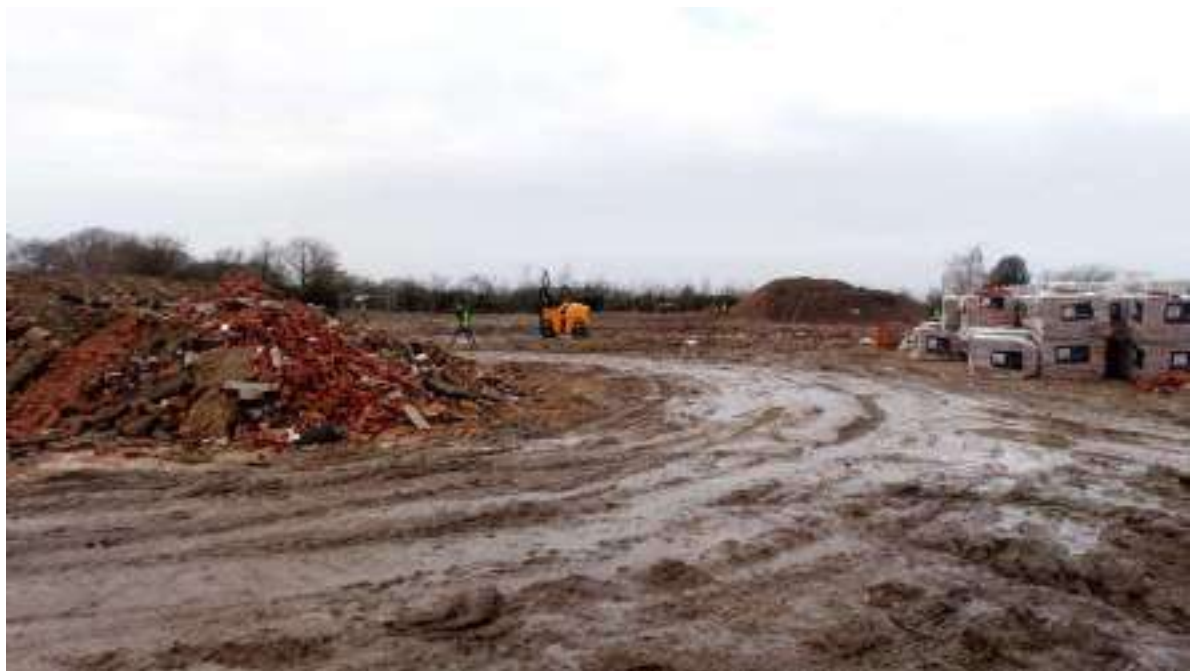
**Photograph 4: Area of materials storage (right) and construction waste (left), facing west.**

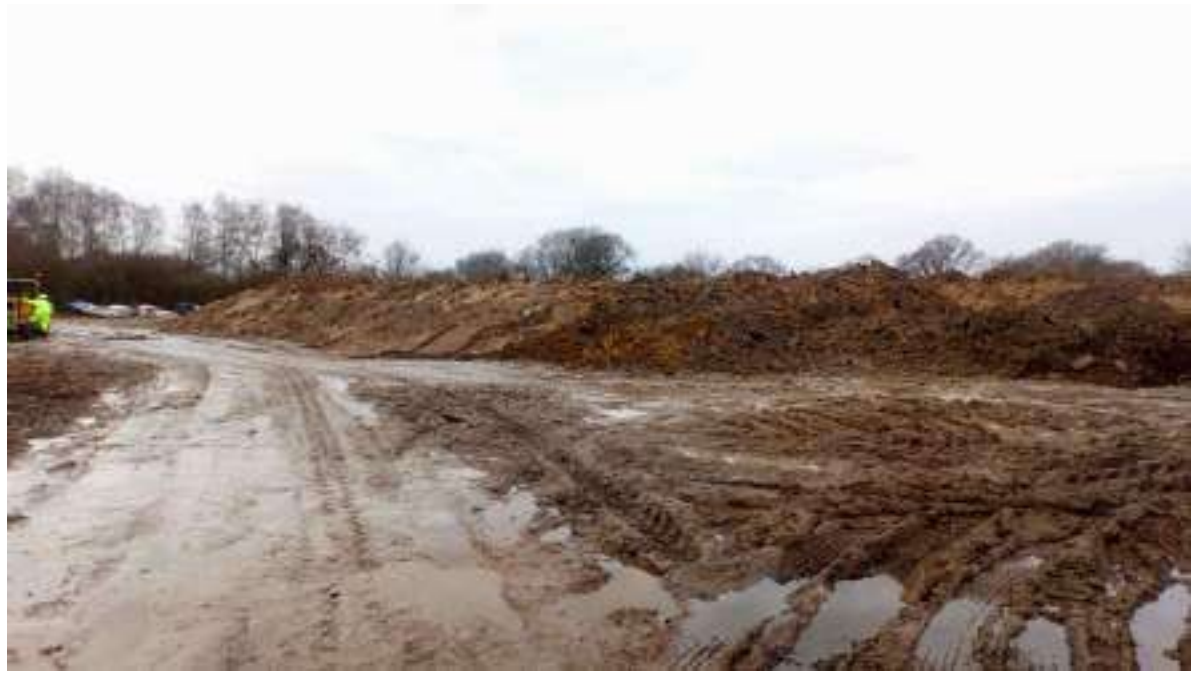
**Photograph 5: Burrage Green soil stockpile, facing south.**

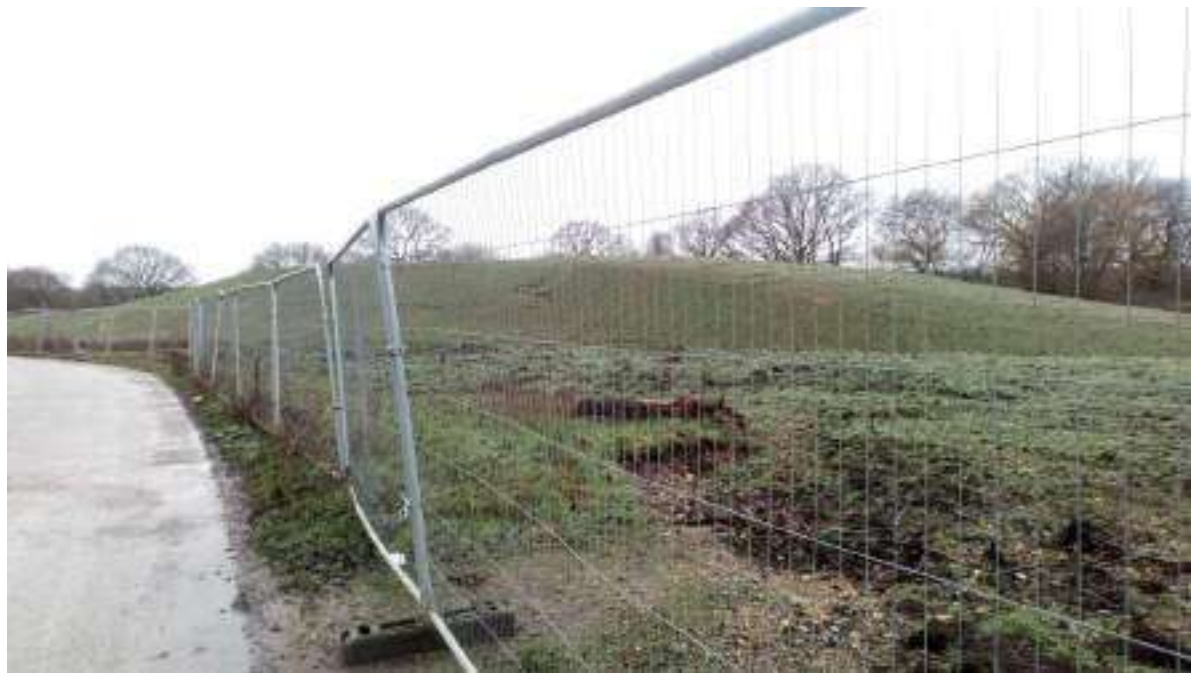
**Photograph 6: Overview of the bund to the west of the haul road, looking south. (No access possible).**

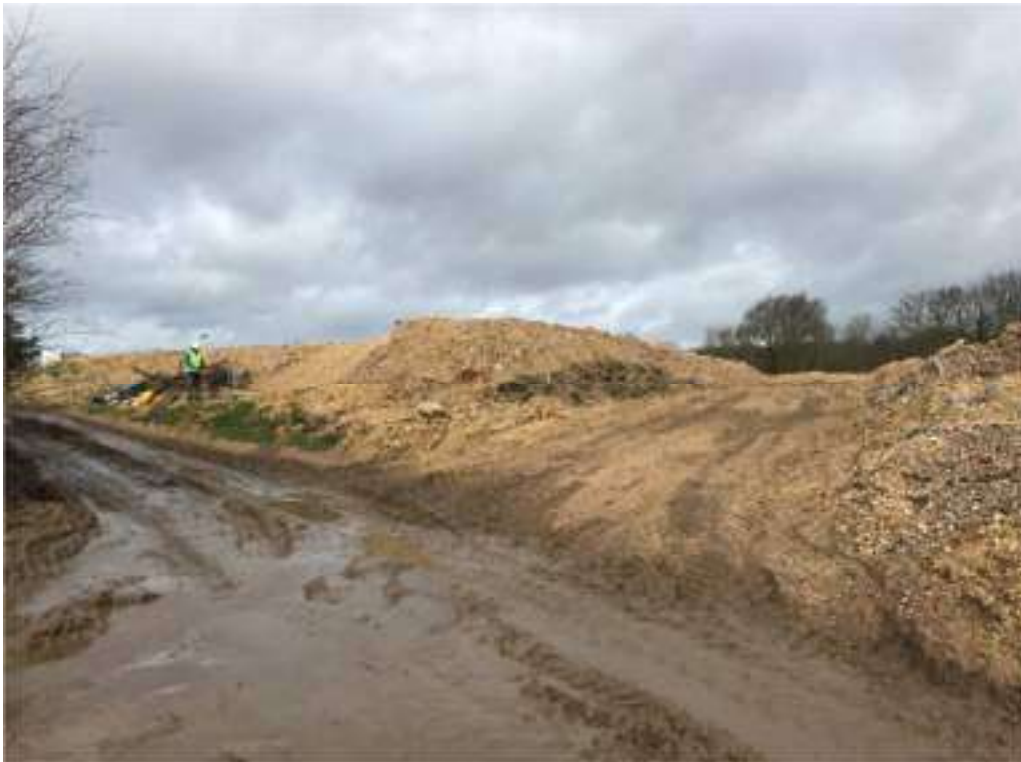
**Photograph 4: SP-MM01: Mixed materials stockpile.**

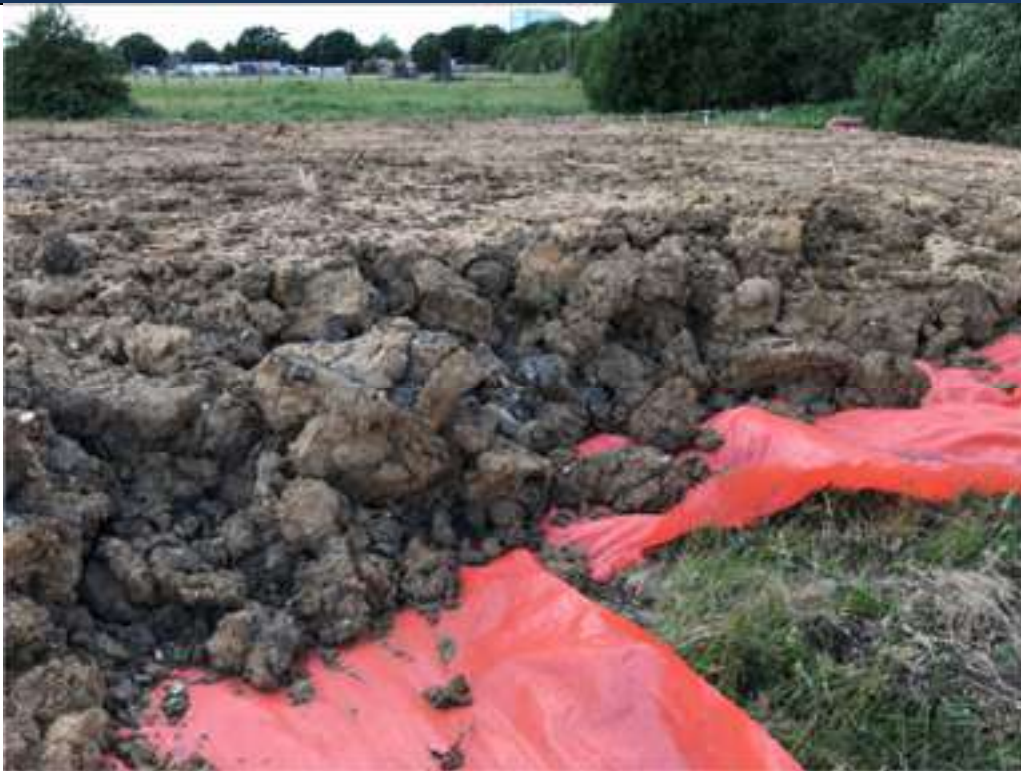
Photograph 1: Cover system in former landfill area

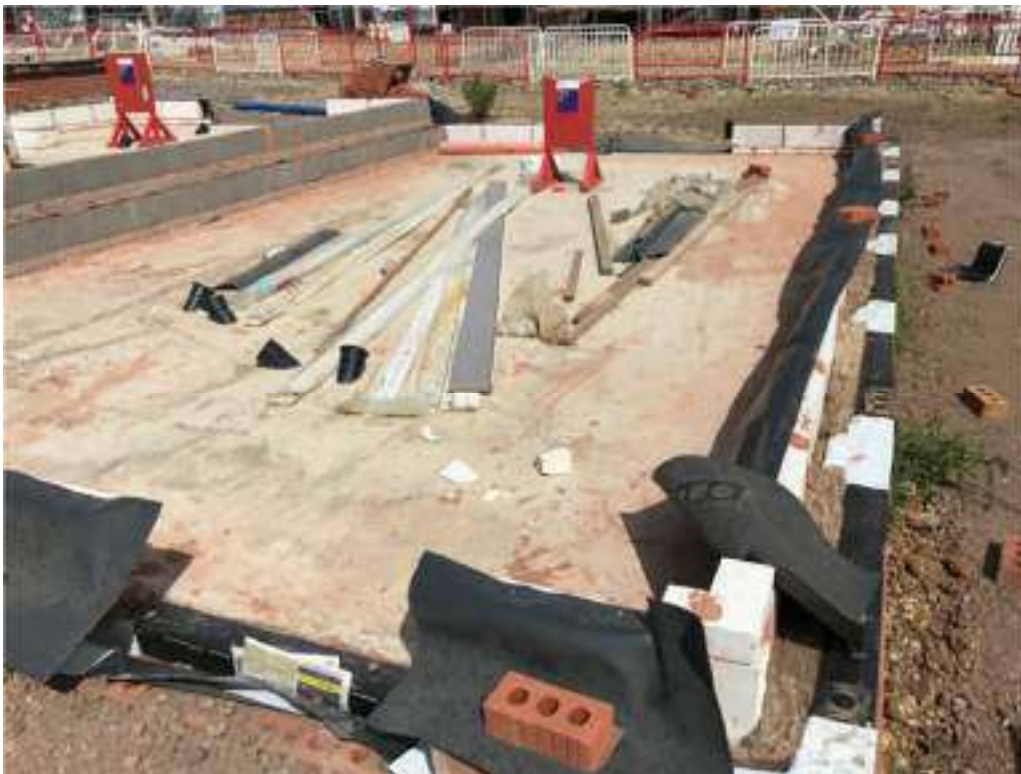
Photograph 2: Re-inspection of gas membranes P63 – P64

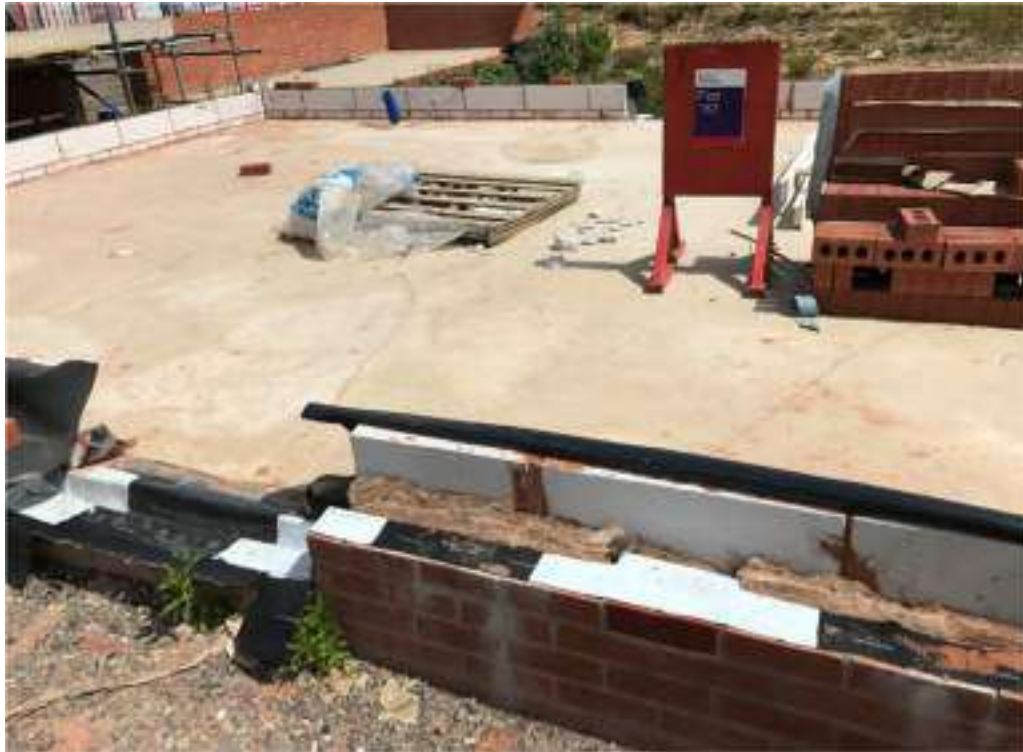
- Inspection of gas membrane Plot 182. As 181, edges of thresholds a little tatty.
- Inspection of Plot 183. Issues with exposed membrane at thresholds. Missing vent.

**Photograph 3: Re-inspection of gas membranes P182**

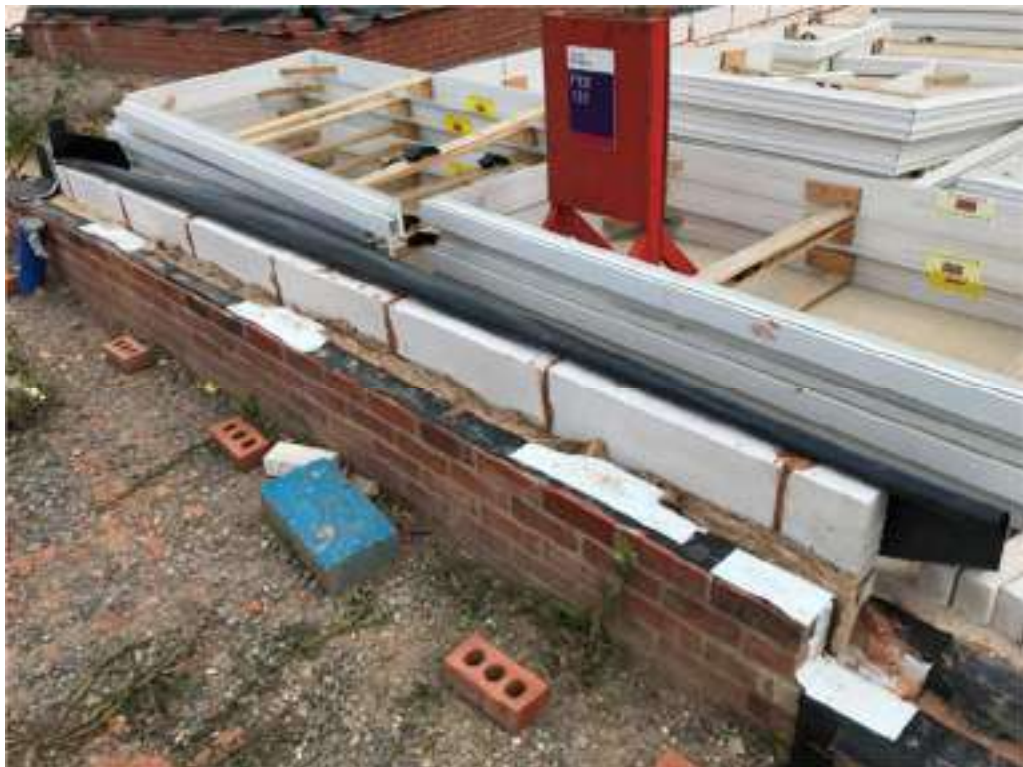
- Inspection of gas membranes P181-187. Majority of cavity areas covered by dpc as temporary measure to protect. Stapled down.
- Inspection of gas membranes Plot P181. Membrane seems ok where exposed at thresholds. No delamination or tearing. Cannot confirm membrane still continues over cavity above vents due to block work over build. Previously seen to be properly installed based on initial inspection. Water sitting on top, not leaking through. Check supplier guidance on exposure to weather vs guarantee.

**Photograph 4: Re-inspection of gas membranes P181**

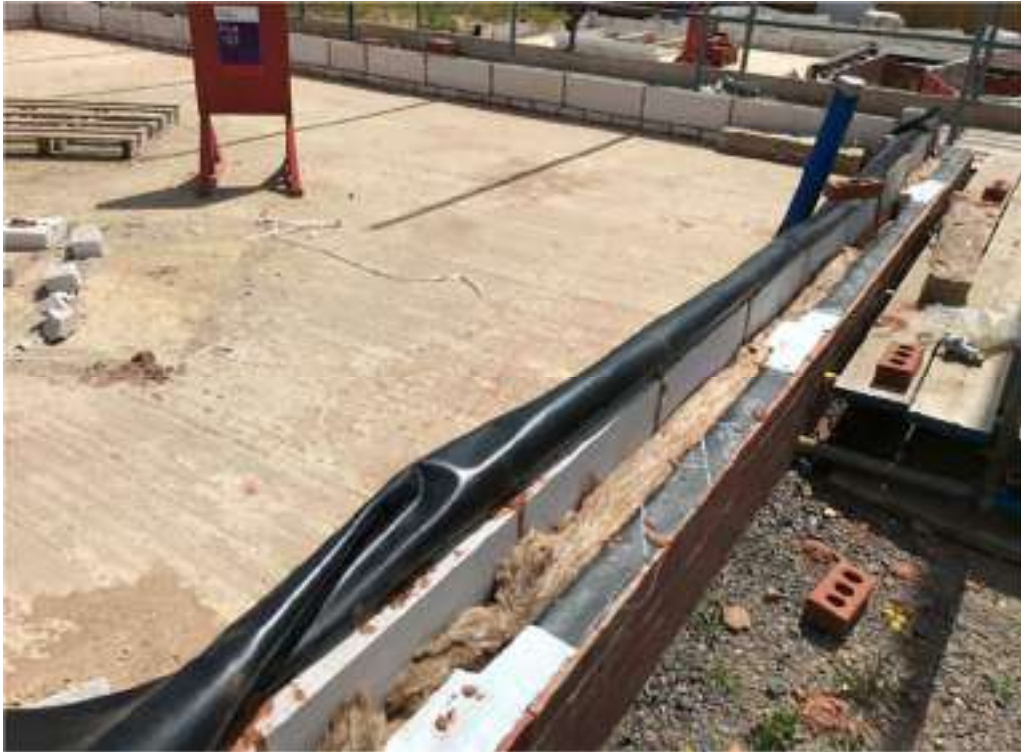
- briefly looked at 183 to discuss block work added since membrane repair. Internal wall added 1.5 layers of block work. DPC covers over new membrane repairs reinstated to protect from potential UV damage prior to final block work installation.

- 181, 182, 183 - cleared. All replaced around edge and thresholds. Internal 1.5 courses of block work constructed but can see built over new membrane. Date stamps show Feb 2020 manufacture of membrane.

**Photograph 5: Re-inspection of gas membranes P183**

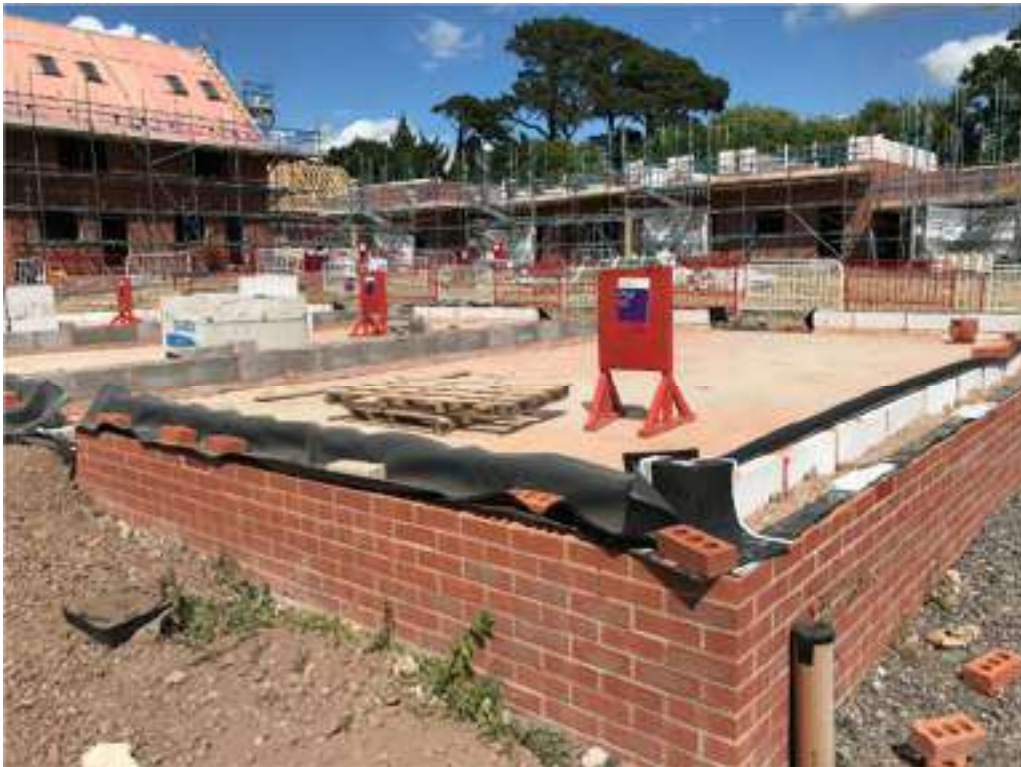
- 60-62 - 1.5 courses of internal block work installed. Not obstructing membrane inspection except party walls.
- 63-64 as above. Cleared.
- 67-69 - doesn't look like these have been repaired/replaced. Neil at NEA says likely overlooked. Sean has certificate of works completed showing 67-69 done yesterday, AJ took photo.

**Photograph 6: Re-inspection of gas membranes P61 – P62**

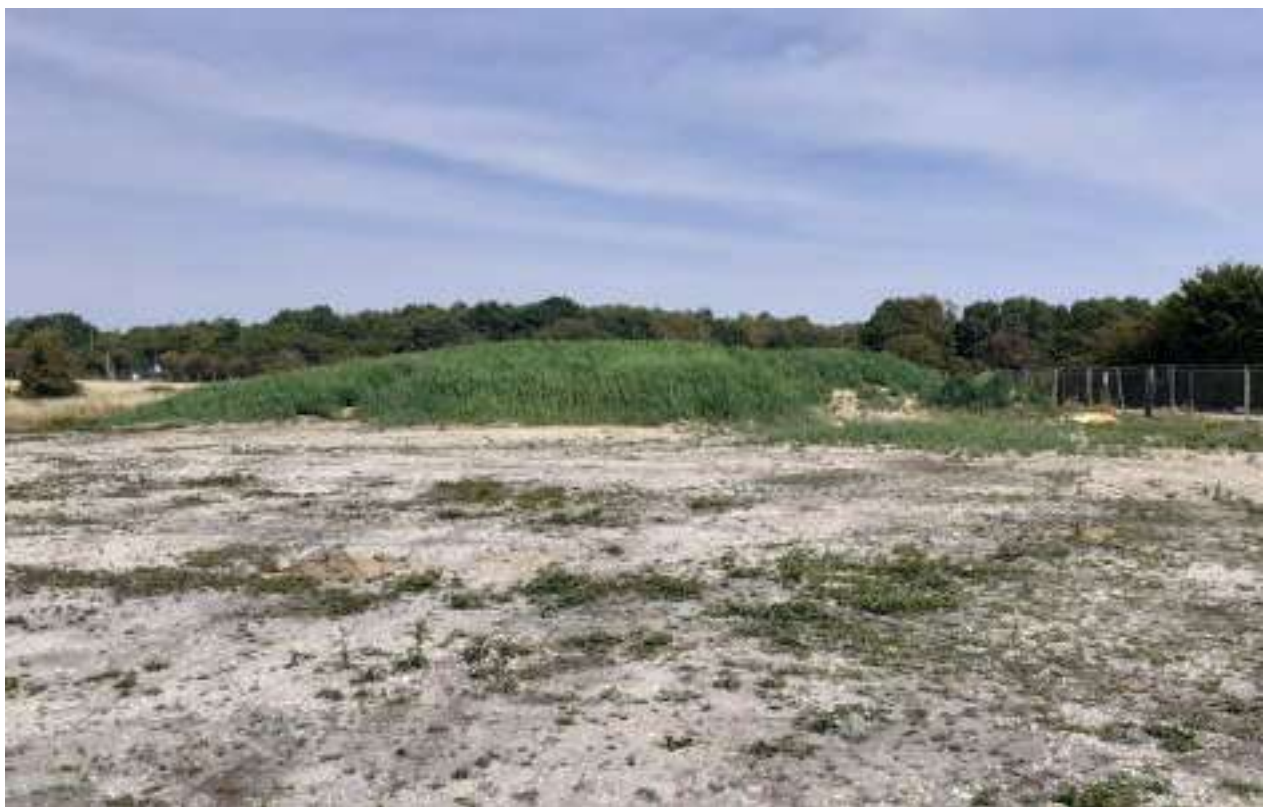
**Photograph 4: Looking north toward stockpile in north of country park area.**

- Stockpiles should be appropriately managed to ensure retention of good quality materials for reuse and no cross-contamination.
- Waste soils and materials noted in the vicinity of the Japanese Knotweed burial pit should be disposed of appropriately.
- Materials management tracking info on soil import from Burr ridge Green must be provided e.g. consignment notes. Some records have been provided to date. Details of where soils are being placed should be provided to Hydrock.
- Monitoring of the bund to ensure that cracks do not increase which could potentially cause bund failure.
- Tracking info to be provided for movement of topsoil from Heron Walk.
- Membrane to be placed beneath capping layer prior to placing clean soils in the former landfill area – Hydrock to be informed in advance of capping layer construction to allow for inspections and testing.

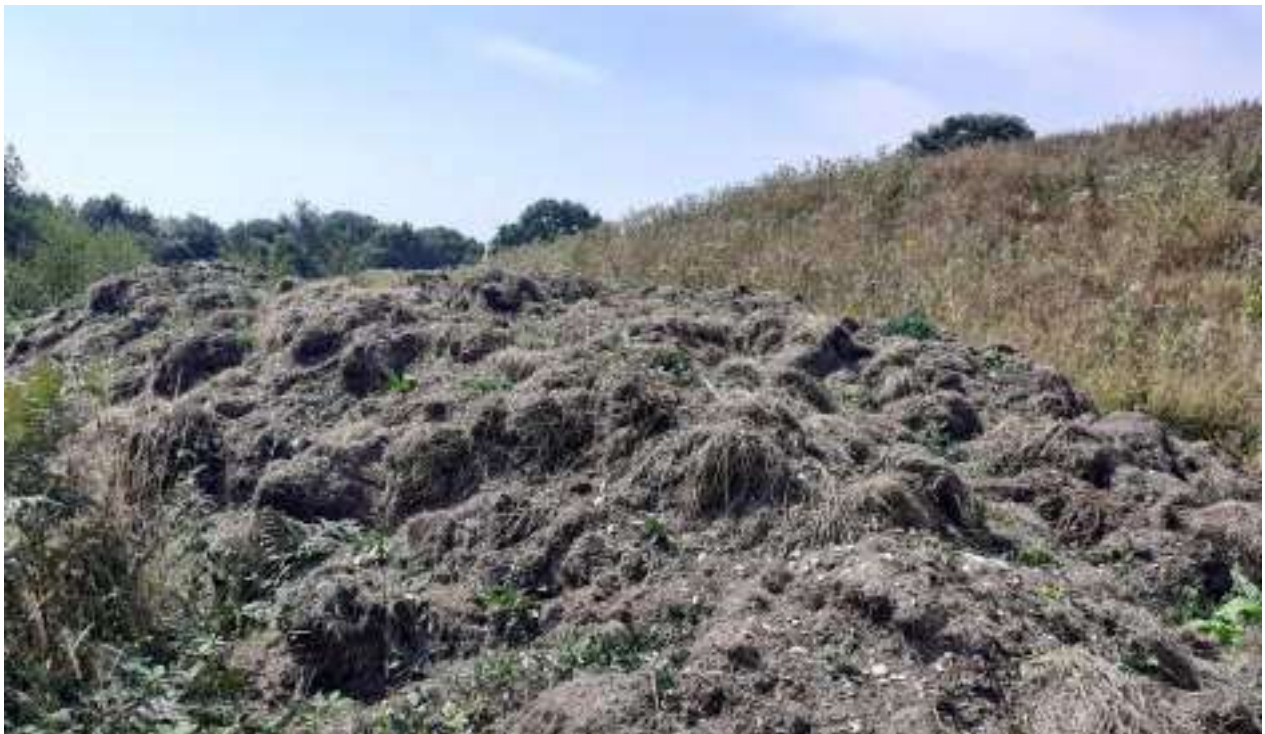
**Photograph 5: Recently placed organic soils to east of bund in the south of the country park area.**

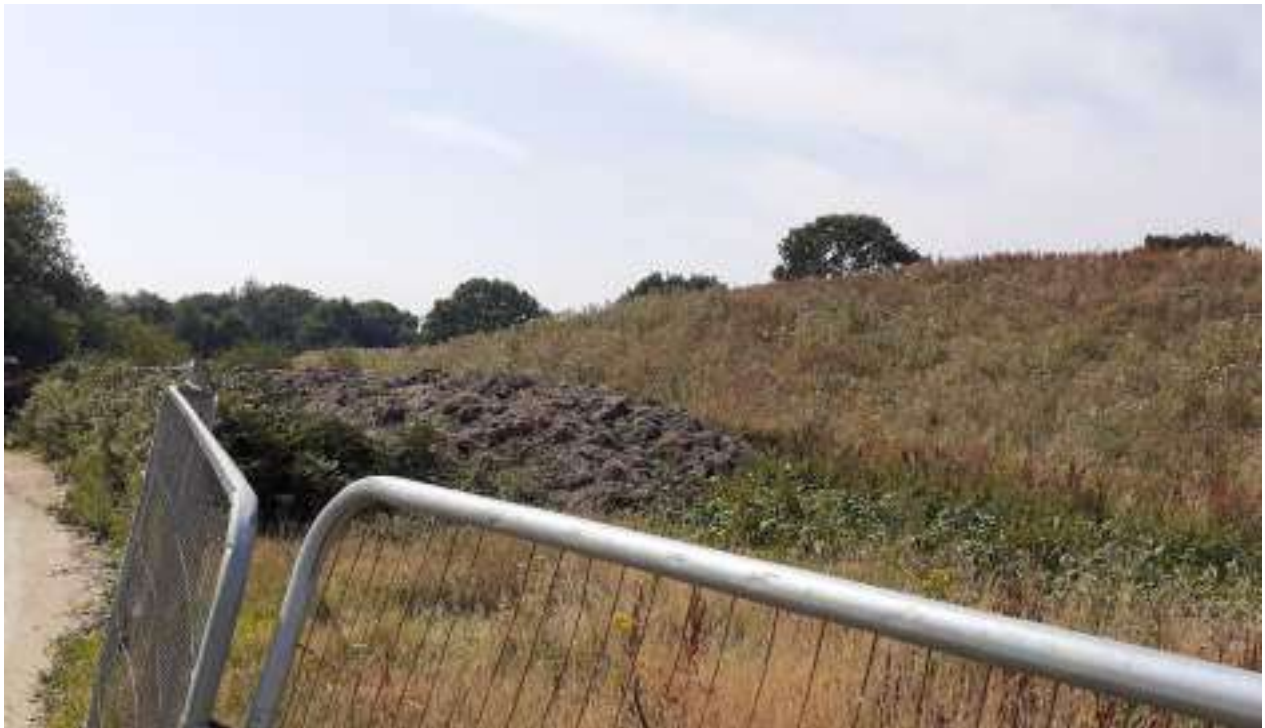
**Photograph 6: Bund and recently placed soils in south of country park area**
