## **Resistograph Tree Report**

**Vivid Housing Limited**

**54 & 25,**

**Prepared by  
Richard Daubeney Our Ref 0624-RD  
28th June 2024**

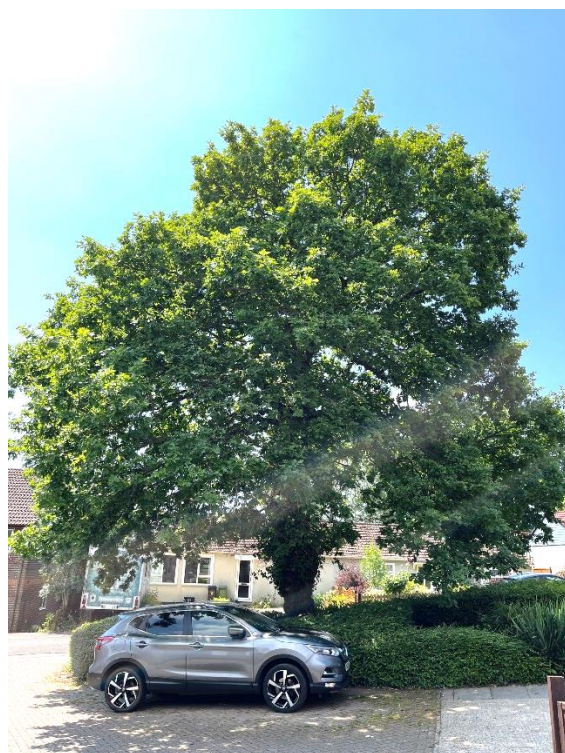
- 5.3 Following the resistograph testing of the tree T3787.5 English oak, the testing showed a moderate area of decay present to the North side within reading No.3, this is likely considered to be linked to the external stem decay to the North side also. The reading no. 2 also showed small minor area of decay present within the stem to the West side. However, it is reading no.1 which showed good areas of live sound wood present to the South side of the stem. The external stem wound to the North side at 43cm will continue to deteriorate over time, this will require regular monitoring to ensure there is further change to tree health and condition. The tree is heavily dense with Ivy clad stem and canopy, unable to fully inspect the stem and canopy. The crown is also low and overhanging the road and car park, including the public footpath. Deadwood over 100mm throughout canopy.

**T3787.5 English oak Looking East**

- 6.1 Following the results of T3787.5 and T3787.8 English oak trees mentioned within this report, we now provide our conclusions.
- 6.2 The readings gathered from the testing of T3787.5 English oak show there is moderate areas of dysfunctional decayed wood within the stem, but based on the overall results of the testing, there is still suitable sound and live wood remaining within the stem, however the tree does have significant canopy over the road and car park, with low branches over these areas. With this in mind this is likely creating loading to the lower stem and rooting area of the tree. The tree is in area of high risk with targets such as road, car park and public footpath all within striking distance of tree. Therefore, we recommend a crown reduction of 2m all round, with a crown lift of 6m over roadside. And crown lift over car park and public footpath to 3.5m. We also advise removal of deadwood over 50mm throughout canopy, sever Ivy at ground level to allow for future inspections of stem and canopy.

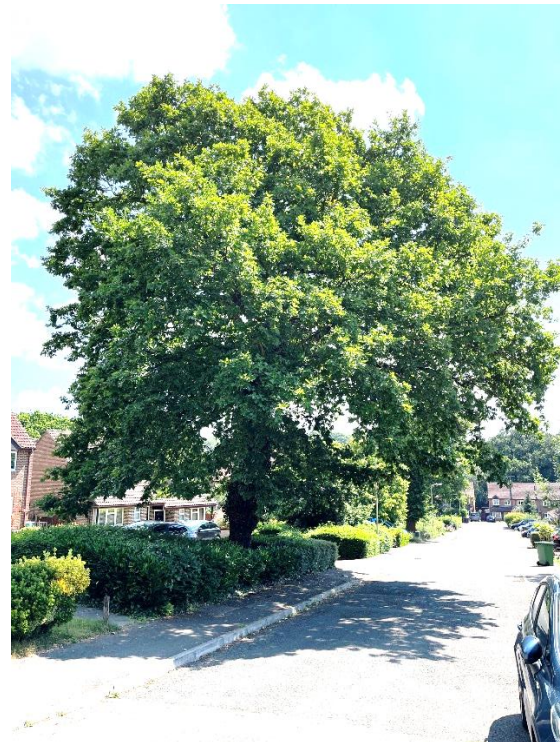
- 5.4 Following the resistograph testing of the tree T3787.8 English oak, the testing showed areas of moderate decay present within readings No. 1 to the West and 4 to the South, this is considered likely a large column of decay has formed within those readings, which is considered likely linked to the large external basal wound to the South side. However, it is reading no. 2 which showed some residual sound wood present to the North side of the stem. The tree has previously been tested following the initial inspection of the tree back in 2021, the results conclude that the decay within the stem has decreased the sound wood available throughout the stem diameter of the tree. The tree has significant epicormic growth throughout the canopy and stem. The tree has been crown reduced as part of the previous testing to the tree. The stem is heavily clad with Ivy.

**T3787.8, English oak looking North towards drill location No. 4 and Basal and stem wound.**

- 6.3 The testing taken from T3787.8 English oak tree showed areas of dysfunctional and decayed wood within the stem, however, the tree still showed some moderate signs of sound residual wood remaining within the stem, but the large basal wound to the South side is and will continue to be an ongoing concern, which over time will lead to further decreased residual sound wood within the stem. The tree location has targets such as buildings, road, public footpath all within striking distance of tree. Therefore, given the above information we recommend a crown reduction of 3m all round, this will ensure the loading to the lower section of the stem and rooting area is reduced. We also advise that the Ivy is severed to allow for future inspections of the stem and crown, including removal epicormic growth to 4m above ground level.

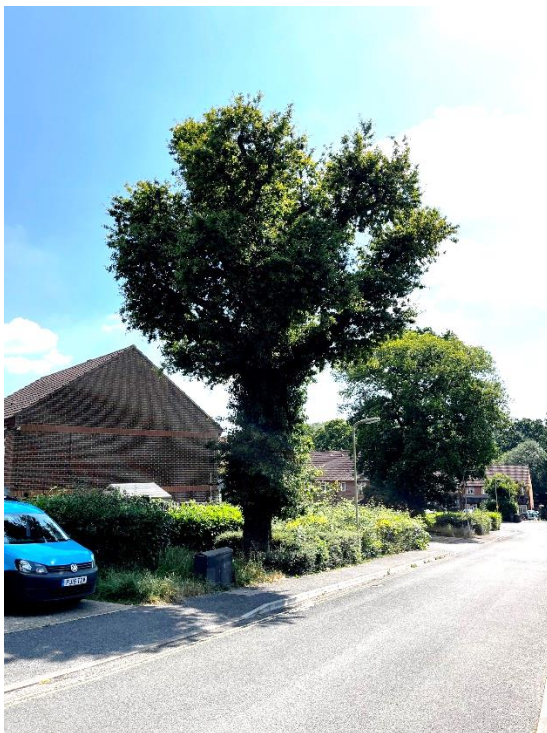
**T3787.8 English oak looking North**
