**Project Name:** 1 - 3 Market Street\_ SO50 5RL  
**Project Description:** Building Works  
**Project Number:** JSD7105  
**Project Status:** Complete  
**Project Date:** 19/03/2024  
**Inspection Standard:** MSCC4 Sewers & Drainage GB (SRM4 Scoring)

1 - 3 Market Street, SO50 5RL

## Section Inspection - 13/03/2024 - Red.Gully1X

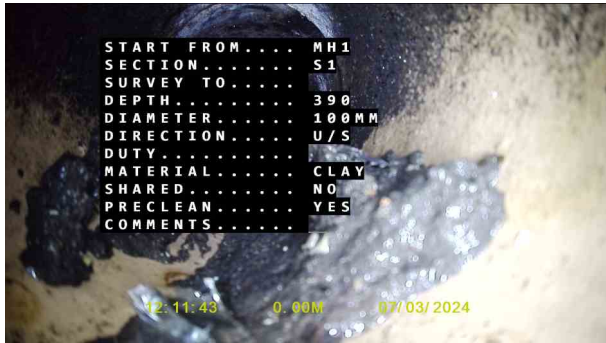
Red.Gully1X\_d67abab1-b279-485c-bafa-ddca64df70fe\_20240319\_153734\_321.jpg, 00:00:07, 0.00 m  
Start node, manhole, reference: Manhole 1

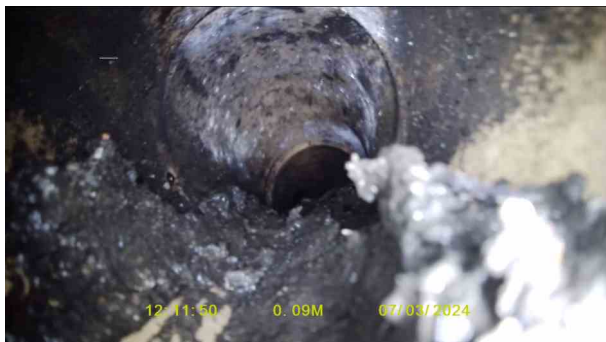
| Scale: | 1:50 | Position [m] | Code | Observation | MPEG | Photo | Grade |
|---|---|---|---|---|---|---|---|
| | | 0.09 | DER | Settled deposits, coarse, 20% cross-sectional area loss | 00:00:14 | Red.Gully1<br>X_1c9f763<br>0-78b9-40 | 3 |

Red.Gully1X\_1c9f7630-78b9-4089-a67f-0beb4fd04bda\_20240319\_153801\_569.jpg, 00:00:14, 0.09 m  
Settled deposits, coarse, 20% cross-sectional area loss

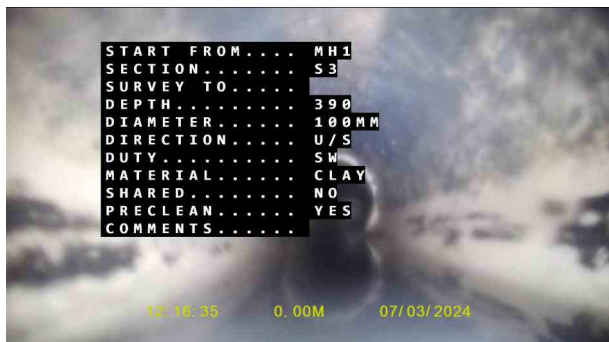
RWDP  
2X\_82b21668-a75d-4476-8667-1dbbfaa6c5fc\_20240319\_154  
757\_806.jpg, 00:00:00, 0.00 m  
Start node, manhole, reference: Manhole 1

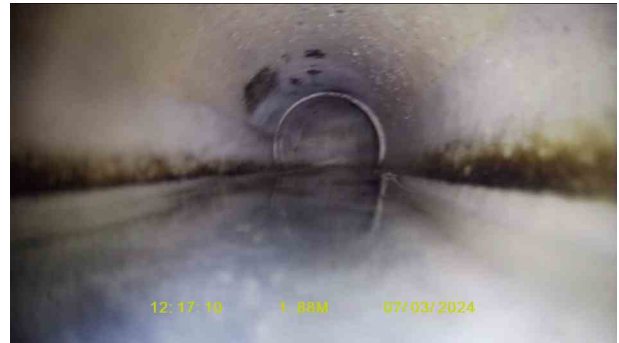
RWDP  
2X\_9fbec5db-38b8-4e31-b742-2a2926d9441f\_20240319\_154  
949\_655.jpg, 00:00:34, 1.88 m  
Water level, 20% of the vertical dimension

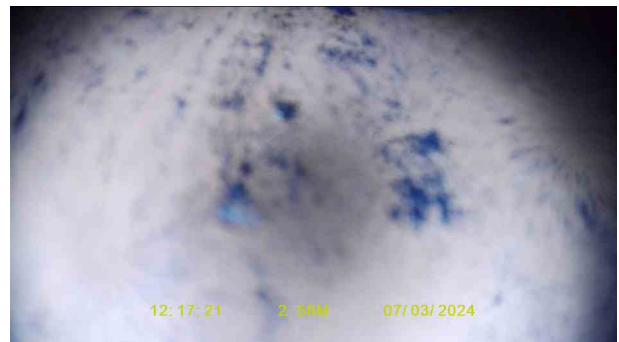
RWDP  
2X\_8bb81125-9563-48ef-a8ae-6fb3e7c92c27\_20240319\_155  
056\_094.jpg, 00:00:46, 2.58 m  
Line deviates up, Rest Bend

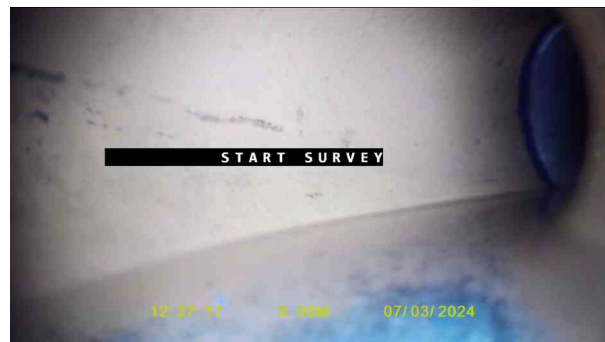
SVP  
1X\_5125d4a0-8112-4484-b823-44a4e98630e4\_20240319\_15  
5253\_070.jpg, 00:00:03, 0.00 m  
Water level, 5% of the vertical dimension

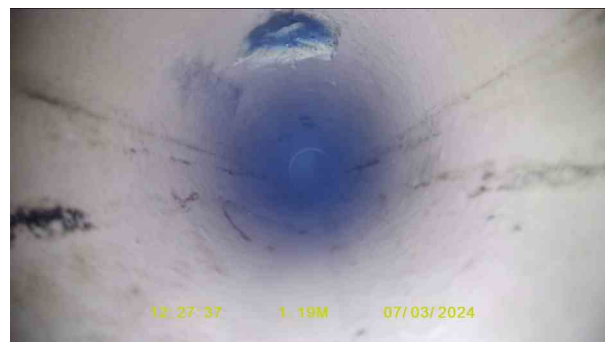
SVP  
1X\_6ab0d985-bda8-45b0-b6b3-ee43bb88a5e5\_20240319\_15  
5342\_769.jpg, 00:00:23, 1.19 m  
Hole in drain or sewer from 11 o'clock to 1 o'clock

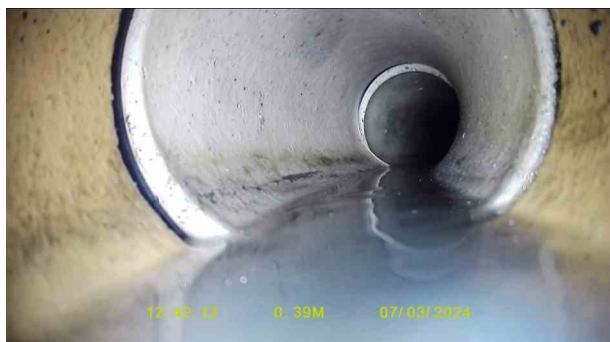
Manhole  
1X\_be6a1078-00da-4a70-9e33-1aae59830423\_20240319\_16  
2437\_590.jpg, 00:00:11, 0.39 m  
Open joint, medium

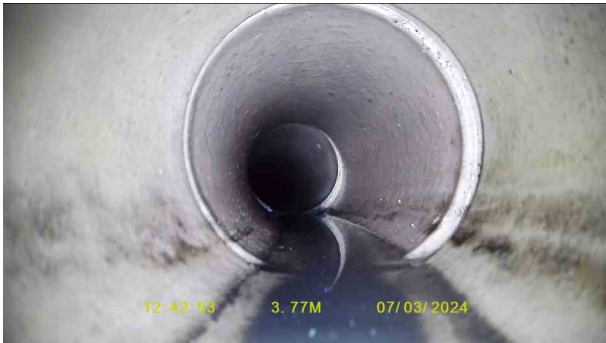
Manhole  
1X\_5db8b1cc-a2de-418a-80ff-518f9ca7d06b\_20240319\_1626  
23\_110.jpg, 00:00:53, 3.77 m  
Line deviates left

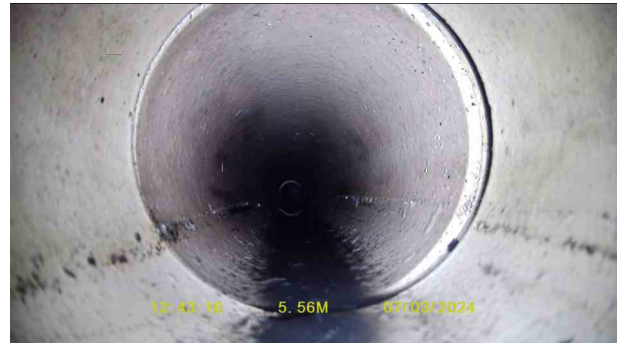
Manhole  
1X\_ac00c660-a1ef-4401-a0fe-c4bf8f745155\_20240319\_1628  
48\_159.jpg, 00:01:16, 5.56 m  
Open joint, medium

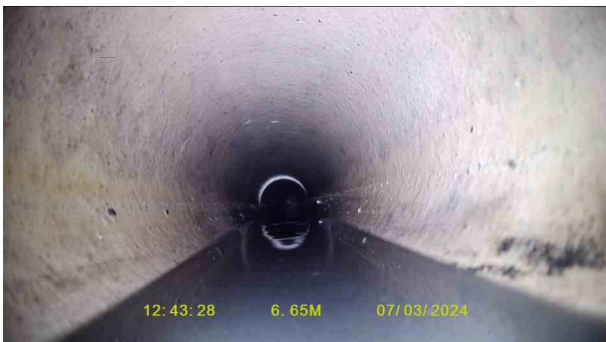
Manhole  
1X\_ff8504fd-99a1-47a8-8c13-b34a3054bacc\_20240319\_1629  
17\_420.jpg, 00:01:28, 6.65 m  
Water level, 10% of the vertical dimension

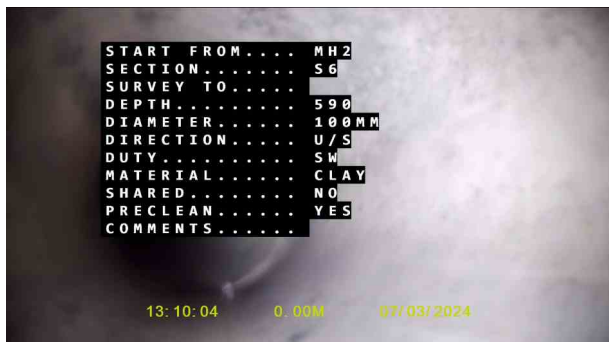
RWDP  
3X\_8b8239b8-0918-4484-84c3-ed8b17c3a6a2\_20240319\_16  
3758\_621.jpg, 00:00:00, 0.00 m  
Start node, manhole, reference: Manhole 2

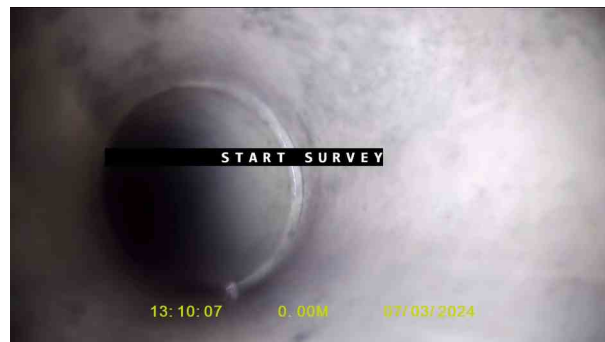
RWDP  
3X\_45ac6d64-5417-43ed-96d7-ce2675e34ed0\_20240319\_16  
3812\_035.jpg, 00:00:03, 0.00 m  
Water level, 0% of the vertical dimension

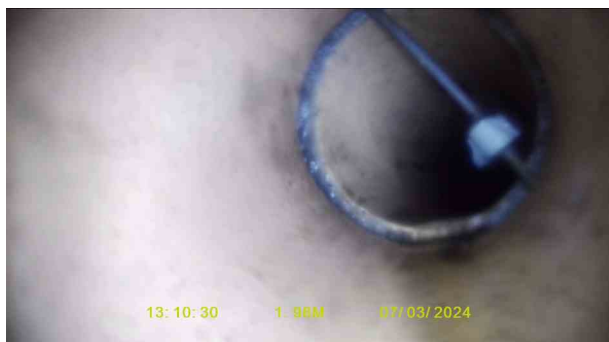
RWDP  
3X\_309eca70-1727-4a80-8d5f-45cb40712d1f\_20240319\_163  
925\_249.jpg, 00:00:26, 1.98 m  
Other obstacles at joint from 11 o'clock to 4 o'clock, 15% cross-sectional area loss, Piece of metal obstructing line

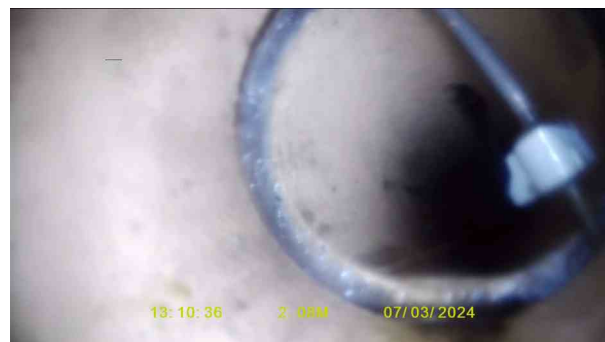
RWDP  
3X\_e47d0e27-f4e0-4eac-83af-a74fd2adac8a\_20240319\_1640  
24\_438.jpg, 00:00:32, 2.08 m  
Open joint, medium

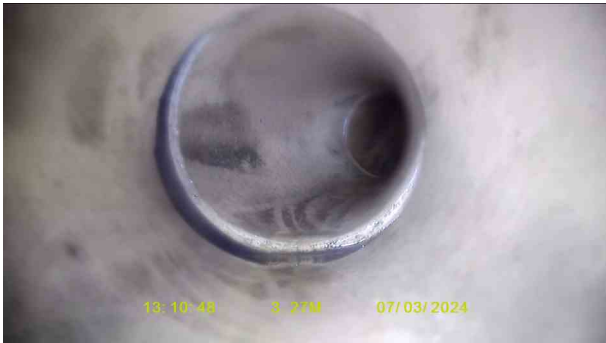
RWDP  
3X\_f5d68d39-689f-419d-aa9b-e6d821e21ac8\_20240319\_164  
057\_528.jpg, 00:00:44, 3.27 m  
Open joint, large

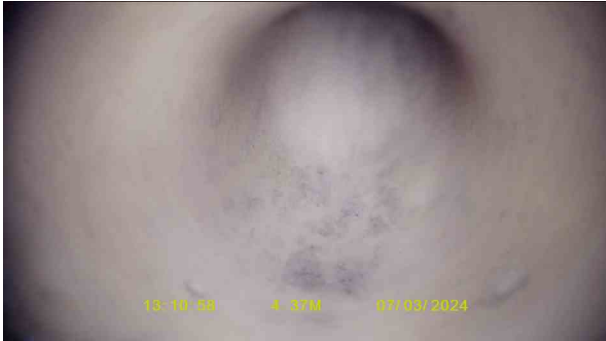
RWDP  
3X\_ccf954a8-0561-48b4-8ef0-9151b7da0c65\_20240319\_164  
223\_998.jpg, 00:00:54, 4.37 m  
Line deviates up, Rest Bend

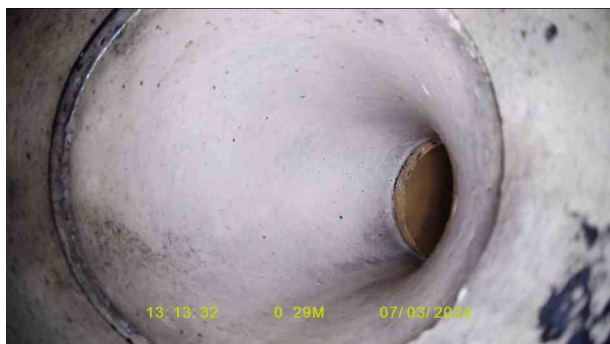
RWDP  
4X\_d06778ee-4b35-41b7-a975-a2ec3efeab10\_20240319\_170  
954\_011.jpg, 00:00:09, 0.29 m  
Line deviates right

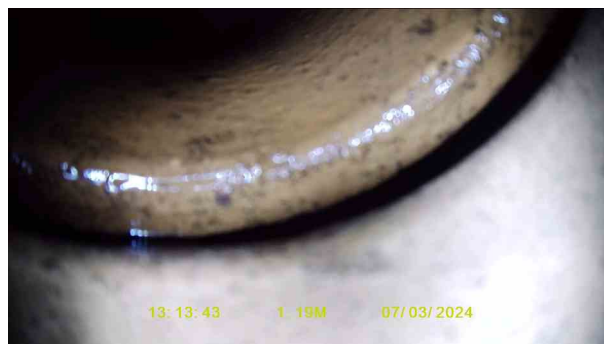
RWDP  
4X\_f5d31879-6314-4b1d-bd5e-a7c18aba2ff8\_20240319\_1710  
26\_337.jpg, 00:00:20, 1.19 m  
Open joint, medium

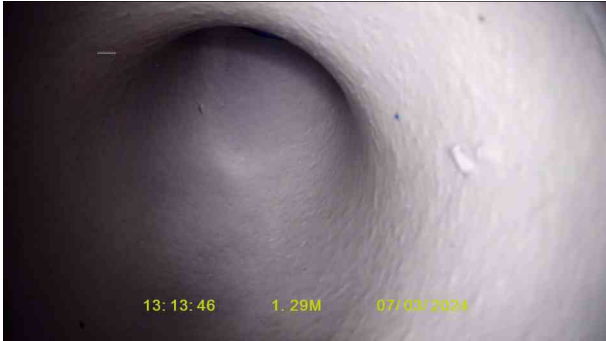
RWDP  
4X\_7f295baa-493c-471f-8fad-4155afe5b947\_20240319\_171053\_652.jpg, 00:00:23, 1.29 m  
Line deviates up, Rest Bend

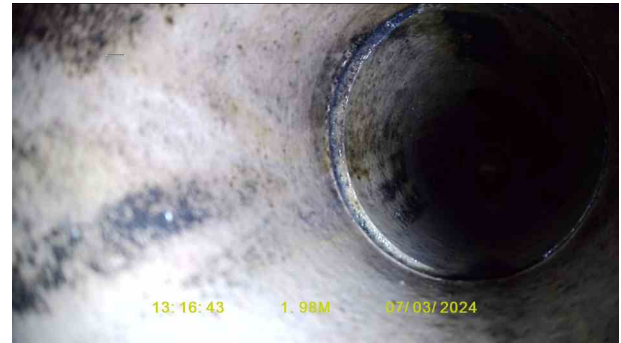
RWDP  
5X\_3513b94c-a5cf-44b8-ab46-8533a9c5dd41\_20240320\_084  
608\_577.jpg, 00:00:47, 1.98 m  
Open joint, medium

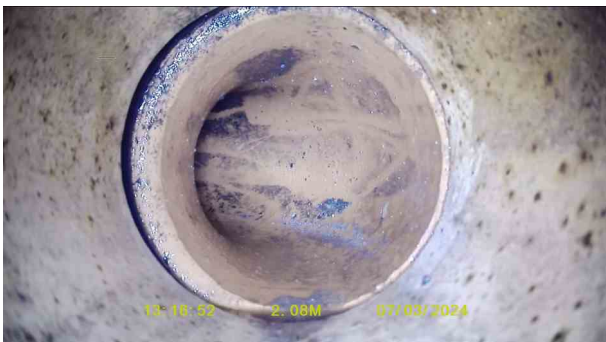
RWDP  
5X\_70f1eed3-d8d3-4af1-ab1c-c26661957663\_20240320\_084  
631\_783.jpg, 00:00:57, 2.08 m  
Open joint, medium

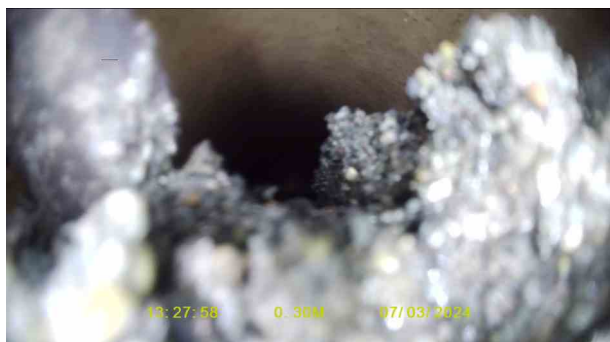
Buried  
MHX\_39589844-ef90-42dc-84a6-54c9bb852f6f\_20240319\_172450\_152.jpg, 00:00:12, 0.30 m  
Settled deposits, fine, 30% cross-sectional area loss

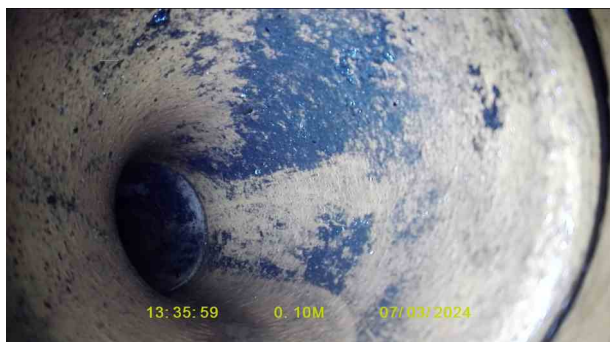
Manhole

Open joint, medium

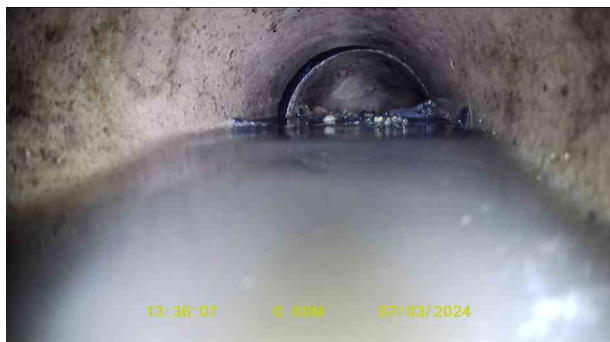
Manhole  
2X\_e180e7ba-86a9-4a04-bb00-ab7548002c6b\_20240320\_095628\_250.jpg, 00:00:16, 0.69 m  
Water level, 30% of the vertical dimension

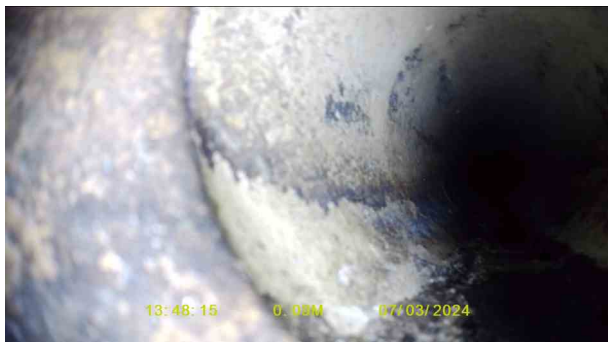
SVP  
2X\_e701ce62-48ed-4728-9bb5-4982212dbe85\_20240320\_10  
0724\_664.jpg, 00:00:09, 0.09 m  
Line deviates right

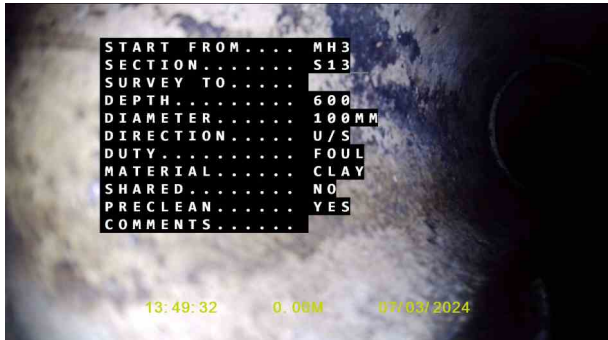
SVP  
3X\_c527f355-1d31-4274-a555-1137ebc4aaf2\_20240320\_101  
019\_569.jpg, 00:00:00, 0.00 m  
Start node, manhole, reference: Manhole 3

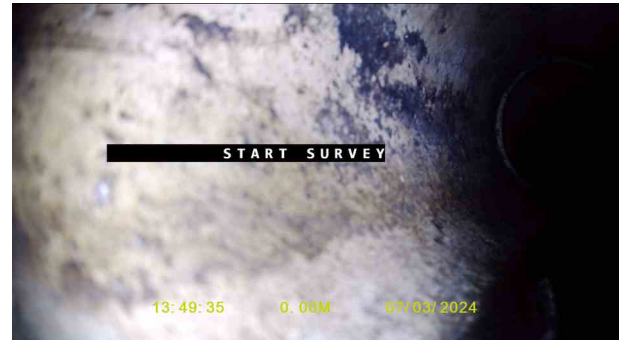
SVP  
3X\_4c4a2141-899f-474a-8b49-c8e07a04d1b4\_20240320\_101  
030\_571.jpg, 00:00:03, 0.00 m  
Water level, 0% of the vertical dimension

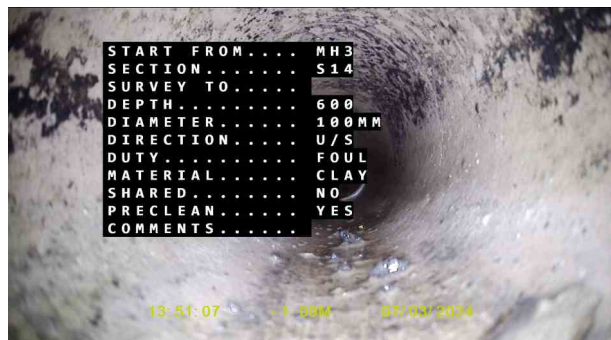
Gully  
1X\_e1f70322-f45c-41b0-8a61-ce2b02db6a63\_20240320\_102  
231\_744.jpg, 00:00:00, 0.00 m  
Start node, manhole, reference: Manhole 3

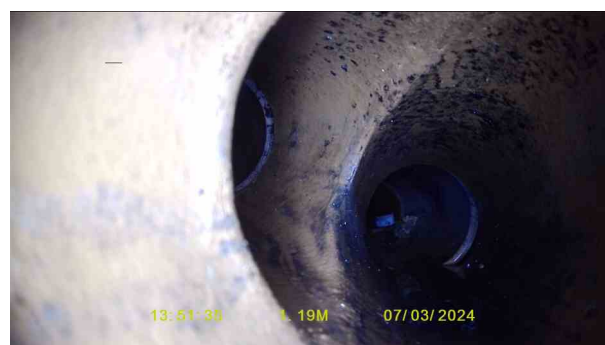
Gully  
1X\_6b781769-2e2b-4a2a-b658-b91de4cd7f0c\_20240320\_102  
435\_277.jpg, 00:00:28, 1.19 m  
Junction at 9 o'clock, diameter: 100mm

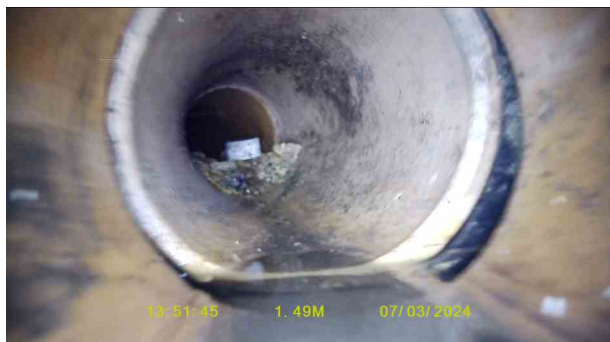
Gully  
1X\_ce571131-df52-4d57-822c-c7a8c5ad5515\_20240320\_102  
503\_528.jpg, 00:00:38, 1.49 m  
Open joint, large

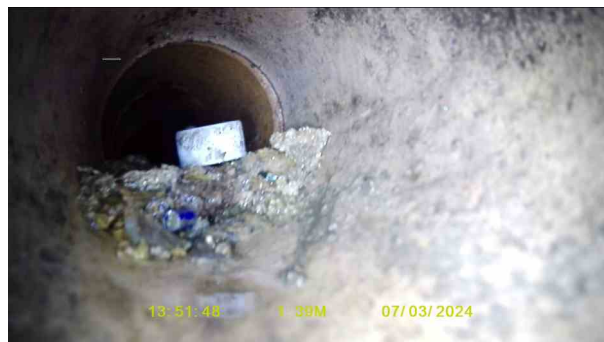
Gully  
1X\_56dbc946-710d-462b-b4e0-fb8535b12485\_20240320\_102  
558\_250.jpg, 00:00:41, 1.50 m  
Settled deposits, coarse, 15% cross-sectional area loss

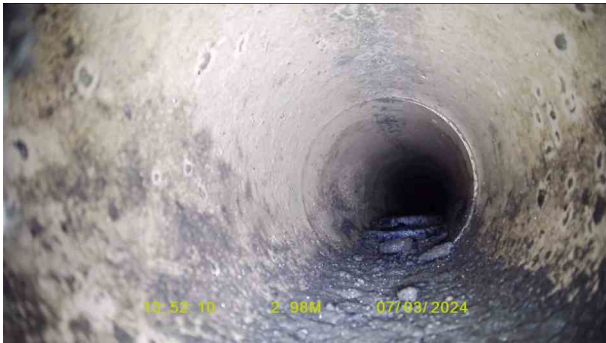
Gully  
1X\_4a890346-184e-48ea-aada-441c30087dbd\_20240320\_10  
2722\_748.jpg, 00:01:03, 2.98 m  
Line deviates right

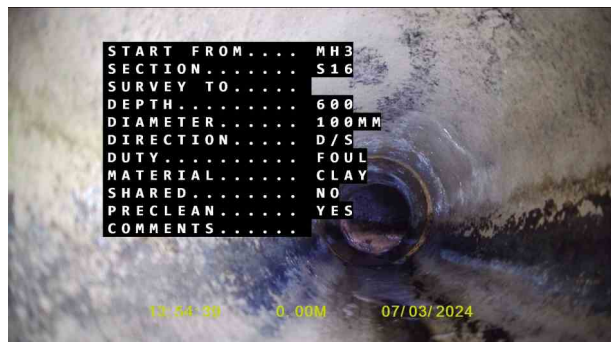
Manhole  
3X\_12842336-abf2-45fb-84b0-83f78cc49ba8\_20240320\_1036  
28\_451.jpg, 00:00:00, 0.00 m  
Start node, manhole, reference: Manhole 3

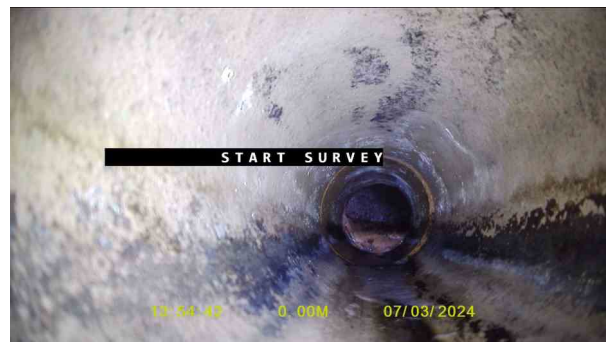
Manhole  
3X\_44409749-1ceb-407c-a097-f7767082c0fc\_20240320\_103  
639\_718.jpg, 00:00:03, 0.00 m  
Water level, 0% of the vertical dimension

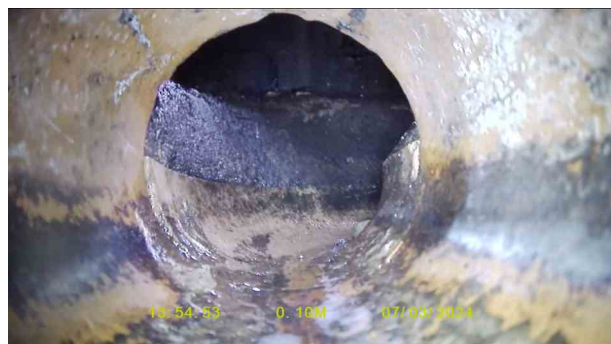
Manhole  
3X\_74ec6c76-09a0-4968-a7fd-79c163981c3e\_20240320\_103  
722\_672.jpg, 00:00:13, 0.10 m  
Line deviates right

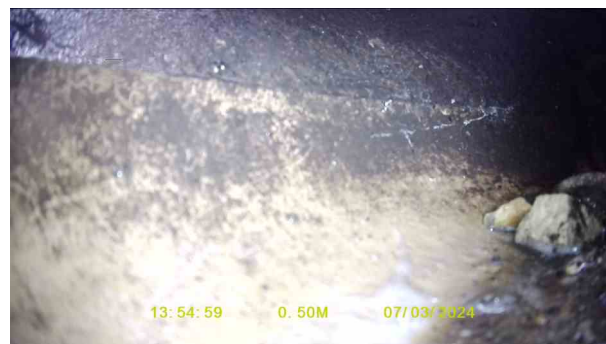
Manhole  
3X\_3570854f-b8d7-4fc6-a521-be4dba34f3e8\_20240320\_1037  
52\_149.jpg, 00:00:19, 0.50 m  
Finish node, manhole, reference: Manhole 4

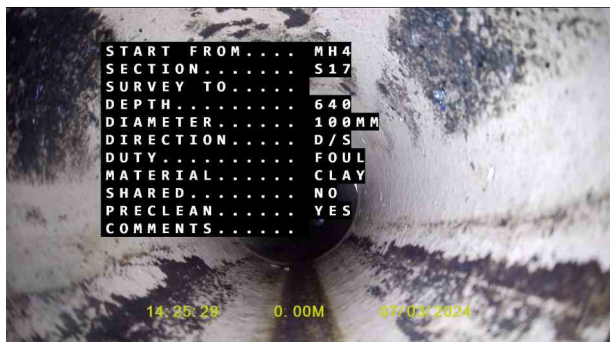
Manhole  
4X\_2e843ea6-c5e3-4873-839c-892c0a61098a\_20240320\_104306\_183.jpg, 00:00:00, 0.00 m  
Start node, manhole, reference: Manhole 4

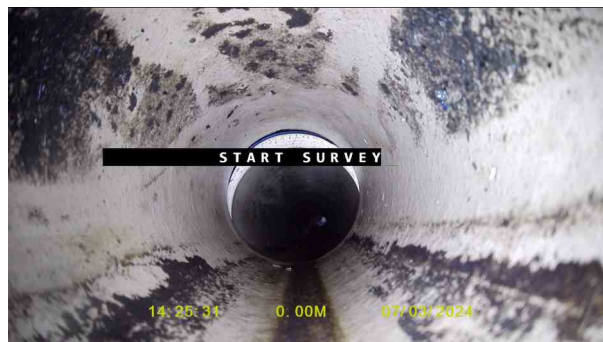
Manhole  
4X\_f07848c6-1dfe-4669-8032-c440a459f597\_20240320\_104317\_089.jpg, 00:00:03, 0.00 m  
Water level, 0% of the vertical dimension

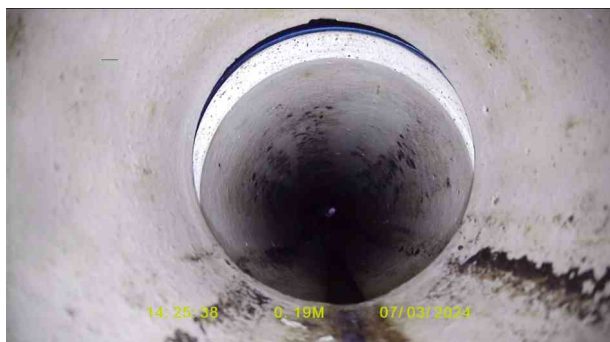
Manhole  
4X\_4bd82246-b6d0-42a2-a844-e36aa7aeacc7\_20240320\_104337\_194.jpg, 00:00:10, 0.19 m  
Joint displaced, large

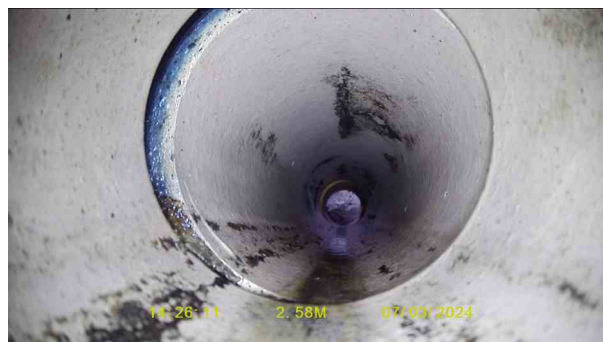
Manhole  
4X\_33011e05-1a2d-476f-8880-bcb86fc60f80\_20240320\_104427\_334.jpg, 00:00:43, 2.58 m  
Open joint, medium

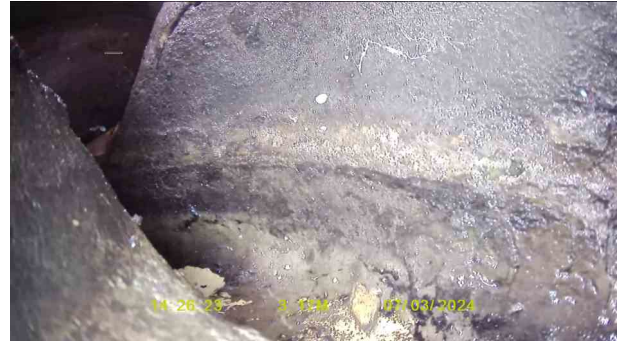
Manhole  
4X\_4b661bed-236d-4e69-a513-e573027e07ed\_20240320\_10  
4618\_877.jpg, 00:00:55, 3.27 m  
Finish node, manhole, reference: Manhole 5

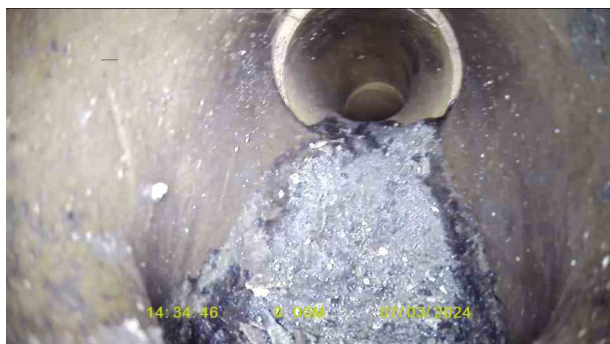
Manhole  
5X\_58e5fa59-be5e-434e-8fd9-ab32cc1e031b\_20240320\_111  
348\_530.jpg, 00:00:10, 0.10 m  
General remark, Drops into main channel

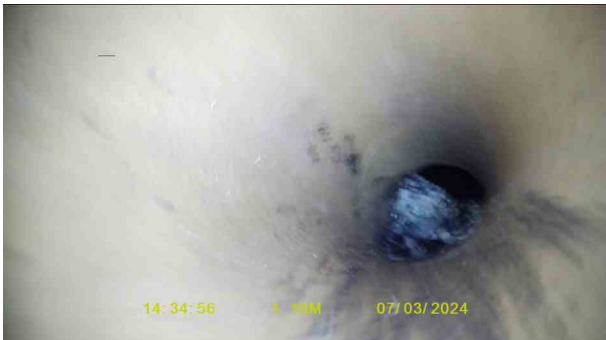
Manhole  
5X\_56eb968e-8c13-4651-a0f5-145292a4b94e\_20240320\_111  
540\_066.jpg, 00:00:20, 1.10 m  
Line deviates right

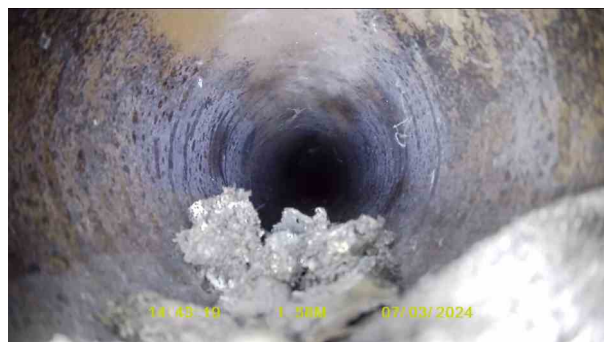
SVP  
5X\_c7001d65-6fa7-4f87-af60-9f809919c3db\_20240320\_1121  
26\_446.jpg, 00:00:33, 1.58 m  
Settled deposits, coarse, 10% cross-sectional area loss

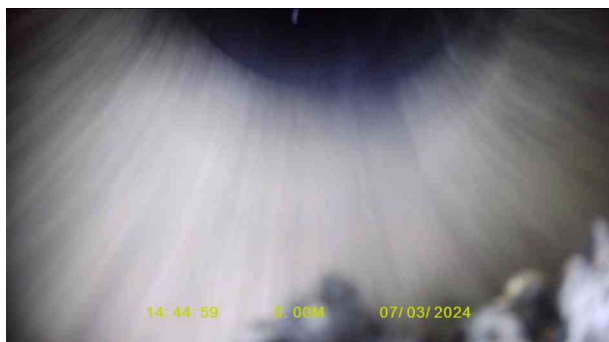
SVP  
6X\_94780432-1803-47ab-a24f-15b1bd62ac64\_20240320\_112  
713\_436.jpg, 00:00:07, 0.02 m  
Line deviates up, Rest Bend

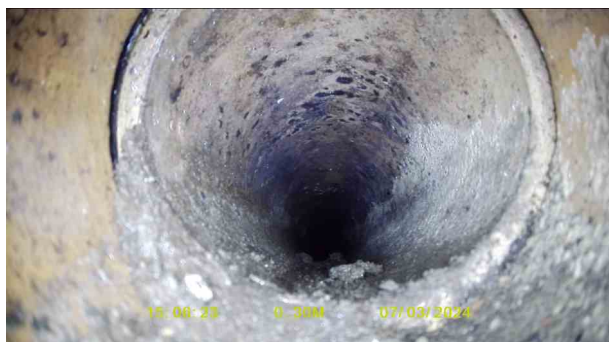
SVP  
7X\_efdaccdd-08b8-4519-a31f-c7a016f1bbbc9\_20240320\_1241  
50\_253.jpg, 00:00:13, 0.30 m  
Open joint, medium

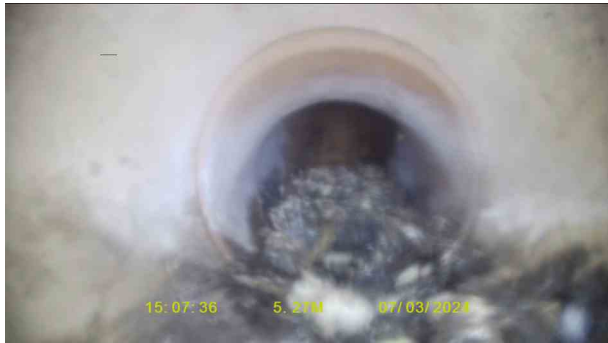
SVP  
7X\_d92e0fec-d581-491d-bf6a-4a85e52dd0c3\_20240320\_124  
337\_035.jpg, 00:01:26, 5.27 m  
Settled deposits, coarse, 15% cross-sectional area loss

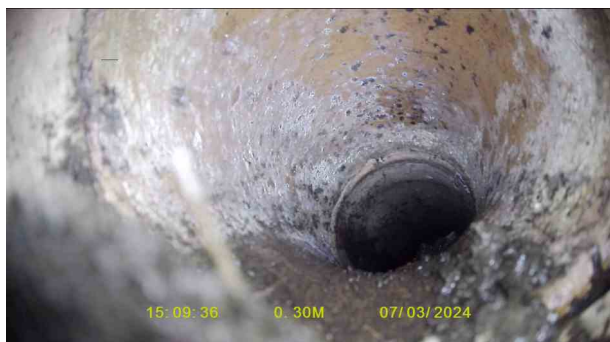
RedundantX\_bfcb4812-3e59-4124-8a38-283a3c0081ef\_2024  
0320\_124609\_171.jpg, 00:00:11, 0.30 m  
Line deviates right

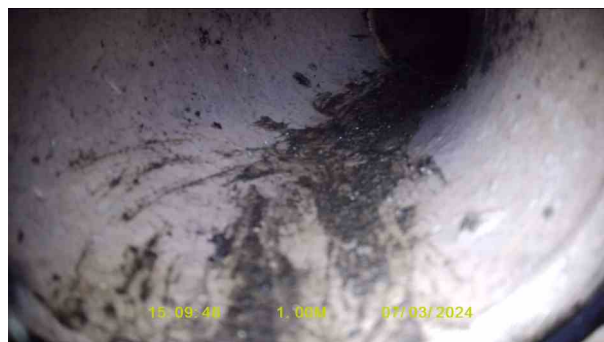
RedundantX\_c8767487-f8e0-44a2-9499-a46fabd9522c\_2024  
0320\_124639\_995.jpg, 00:00:22, 1.00 m  
Line deviates right

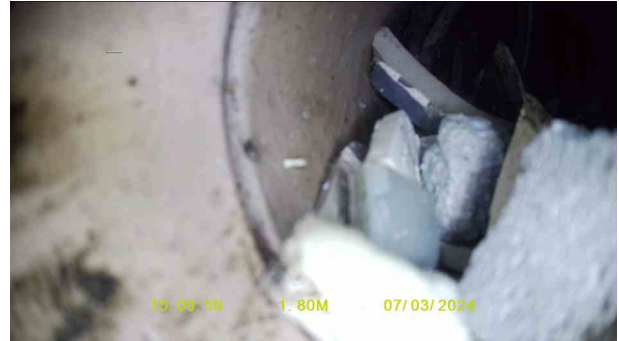
RedundantX\_a6a01423-180f-4823-a742-2afe8737d258\_2024  
0320\_124722\_821.jpg, 00:00:33, 1.80 m  
Survey abandoned, Redundant line

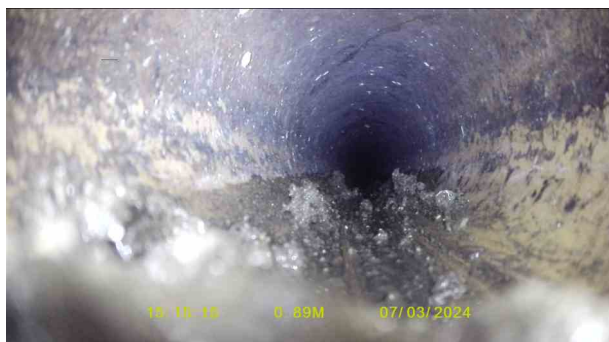
Manhole  
7X\_4cc60a64-7052-48d9-8096-f8aa2f18c6fa\_20240320\_1251  
09\_892.jpg, 00:00:22, 0.89 m  
Settled deposits, coarse, 10% cross-sectional area loss

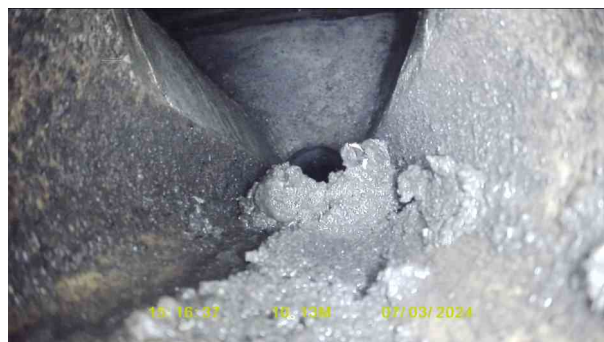
Manhole  
7X\_4631b8ee-d8a7-41d9-aef7-febc9e868cdd\_20240320\_125  
256\_481.jpg, 00:01:43, 10.10 m  
Settled deposits, fine, 15% cross-sectional area loss

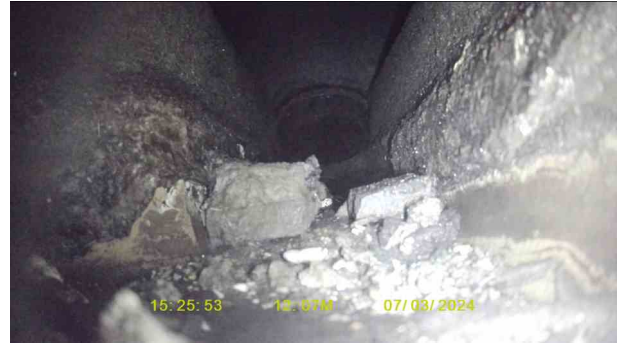
8X\_3f6c8c9d-dace-4f54-8b56-d33c3b432846\_20240320\_130  
957\_398.jpg, 00:02:29, 12.07 m  
Finish node, manhole, reference: Manhole 9

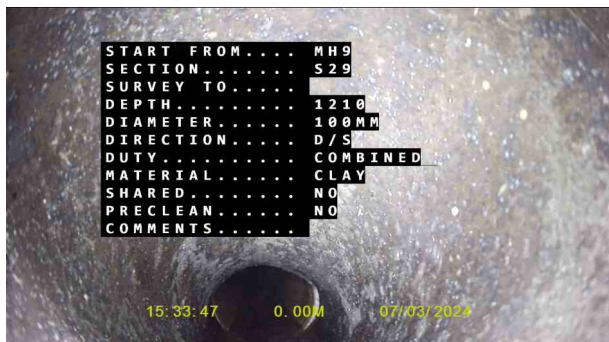
Manhole  
9X\_7c2b195b-ffc8-4480-b49d-b5ff50bbbe01\_20240320\_1313  
09\_757.jpg, 00:00:00, 0.00 m  
Start node, manhole, reference: Manhole 9

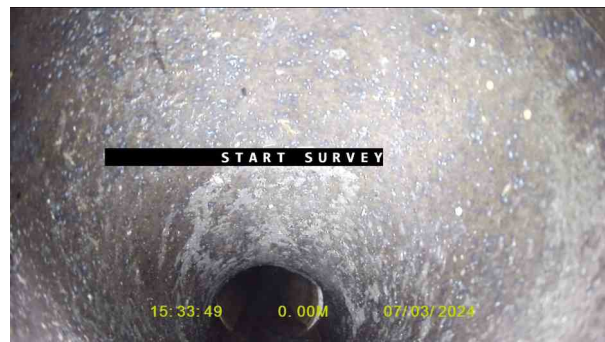
Manhole  
9X\_e7f38a73-21a8-4bad-9fe2-7e61806e3789\_20240320\_131  
321\_040.jpg, 00:00:03, 0.00 m  
Water level, 0% of the vertical dimension

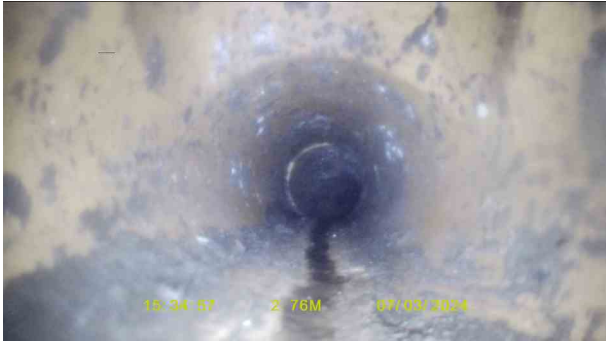
Manhole  
 9X\_385afa2a-6e1e-4242-9b34-913fe13c0d46\_20240320\_131  
 543\_709.jpg, 00:01:10, 2.76 m  
 Junction at 12 o'clock, diameter: 100mm

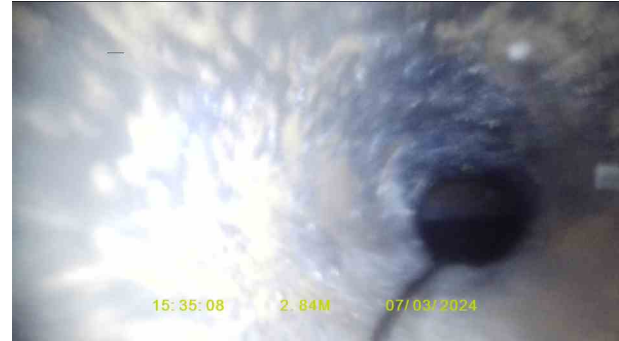
Manhole  
 9X\_67d544b8-23ad-4995-bc94-3a9a1c98fc62\_20240320\_131  
 611\_014.jpg, 00:01:21, 2.84 m  
 Line deviates right

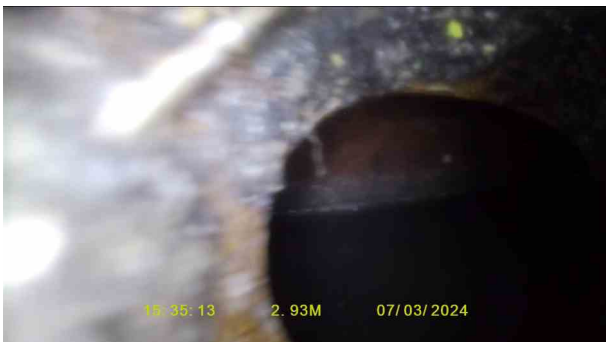
Manhole  
 9X\_24c0d3f5-80ff-4a2a-b965-53c5cd5ef516\_20240320\_1319  
 13\_907.jpg, 00:01:26, 2.93 m  
 General remark, Drops into main line via junction

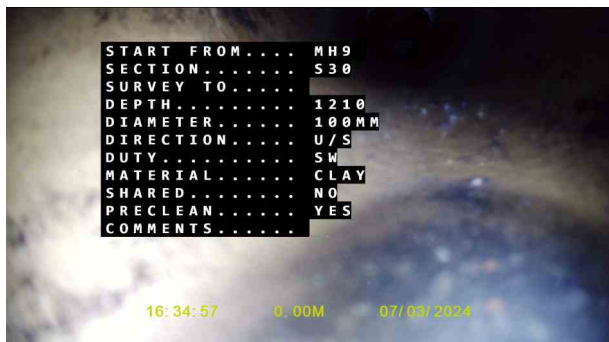
RWDP  
7X\_079726c1-a1db-4e31-96a3-ab805d90c909\_20240320\_13  
2606\_401.jpg, 00:00:00, 0.00 m  
Start node, manhole, reference: Manhole 9

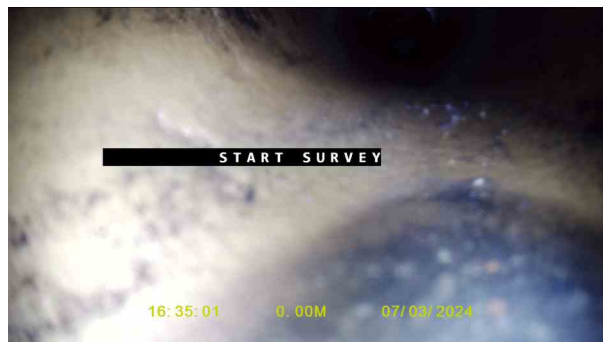
RWDP  
7X\_ef0e8696-c963-4252-870c-db508bc6ccf6\_20240320\_132  
621\_323.jpg, 00:00:03, 0.00 m  
Water level, 0% of the vertical dimension

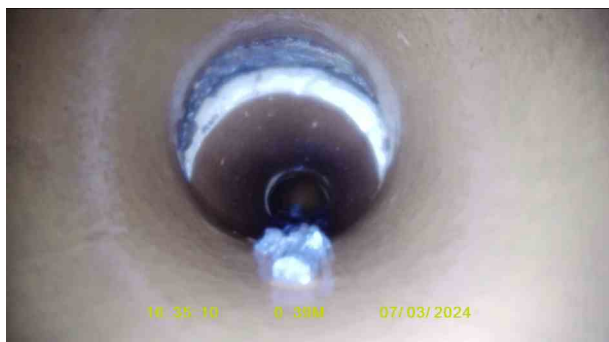
RWDP  
7X\_d0d7c3e2-48f9-4c71-9200-9e59110ae0e5\_20240320\_132  
659\_050.jpg, 00:00:12, 0.39 m  
Joint displaced, large

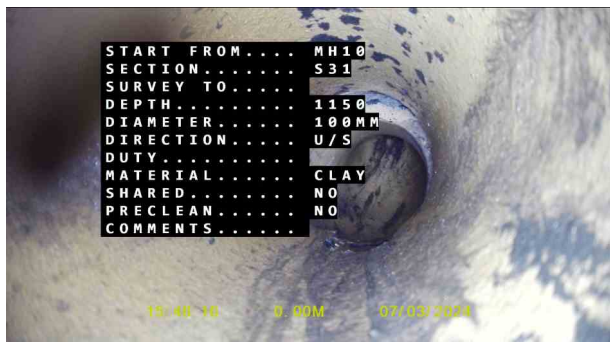
RedundantX\_19581056-f0ce-4593-a567-1ac8569a34a2\_2024  
0320\_134210\_883.jpg, 00:00:00, 0.00 m  
Start node, manhole, reference: Manhole 10

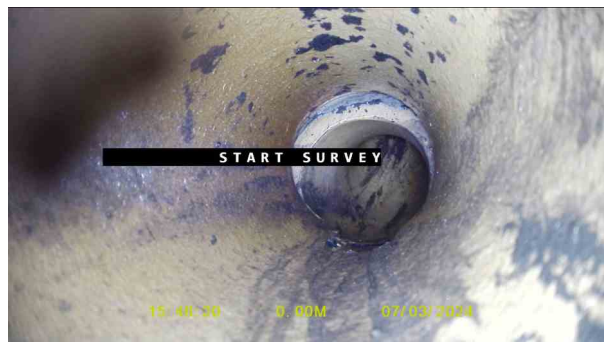
RedundantX\_10747301-0ddb-4567-a807-511cebf3667b\_2024  
0320\_134226\_478.jpg, 00:00:03, 0.00 m  
Water level, 0% of the vertical dimension

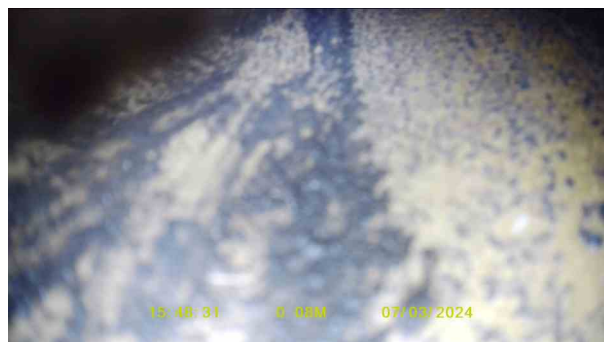
RedundantX\_8665a7a0-298a-4a06-9f21-3be9d9540a98\_2024  
0320\_134329\_996.jpg, 00:00:14, 0.08 m  
Line deviates up, Rest Bend

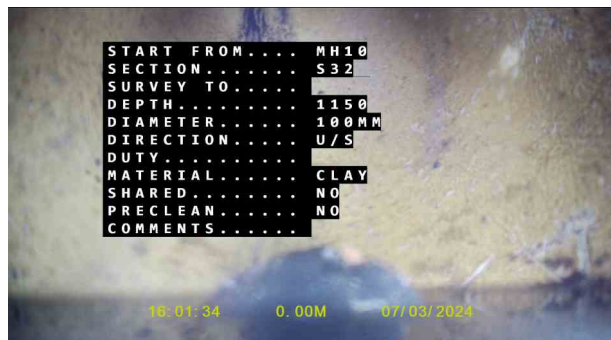
RedundantX\_ffe9b83d-0ebd-414b-a04f-fb2861c169c9\_2024  
320\_134554\_297.jpg, 00:00:00, 0.00 m  
Start node, manhole, reference: Manhole 10

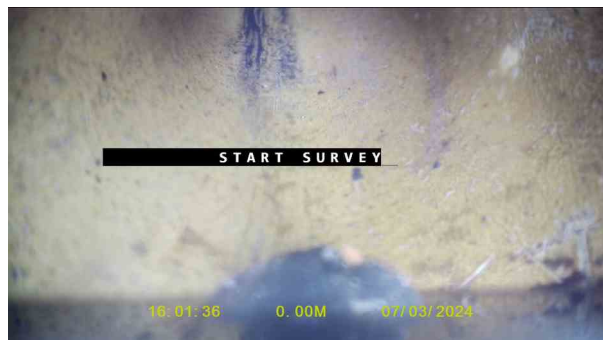
RedundantX\_1f8bda91-01e9-4201-ac58-86674de51a23\_2024  
0320\_134604\_887.jpg, 00:00:03, 0.00 m  
Water level, 10% of the vertical dimension

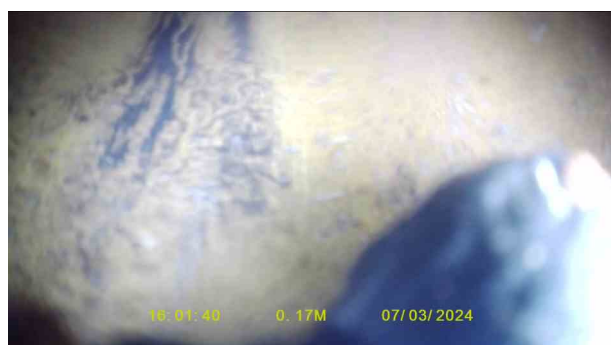
RedundantX\_d158e46e-ebc0-42f9-8892-dd4de3553af9\_2024  
0320\_134625\_863.jpg, 00:00:07, 0.17 m  
Line deviates up, Rest Bend

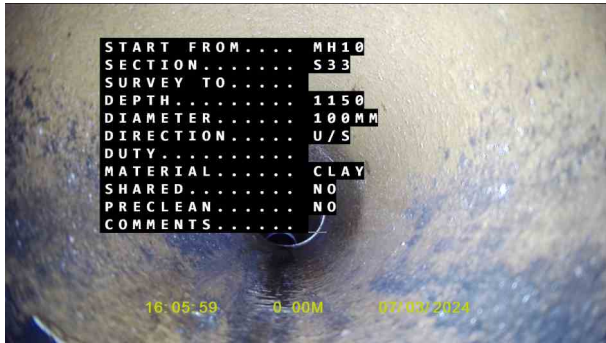
RedundantX\_d1af7950-b401-4c06-a258-425c5d1aecb8\_2024  
0320\_134838\_279.jpg, 00:00:00, 0.00 m  
Start node, manhole, reference: Manhole 10

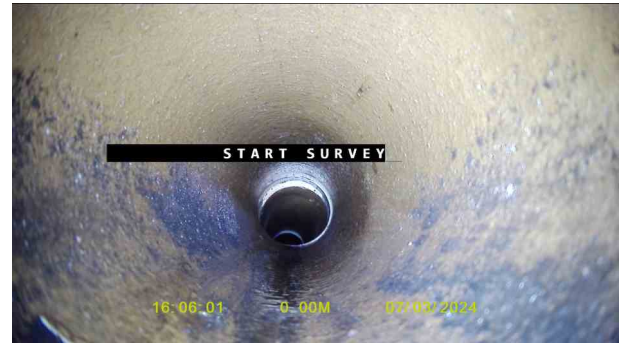
RedundantX\_f7dcf4ae-5c58-468d-8345-dd075aafa3ee\_20240  
320\_134846\_538.jpg, 00:00:02, 0.00 m  
Water level, 0% of the vertical dimension

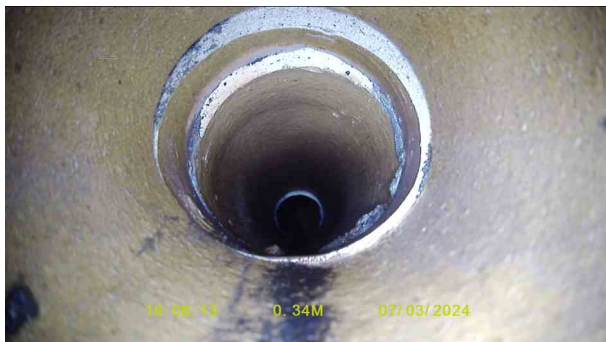
RedundantX\_560928bb-2841-4d01-9e39-9ce7daa3e46d\_202  
40320\_134924\_385.jpg, 00:00:15, 0.34 m  
Open joint, large

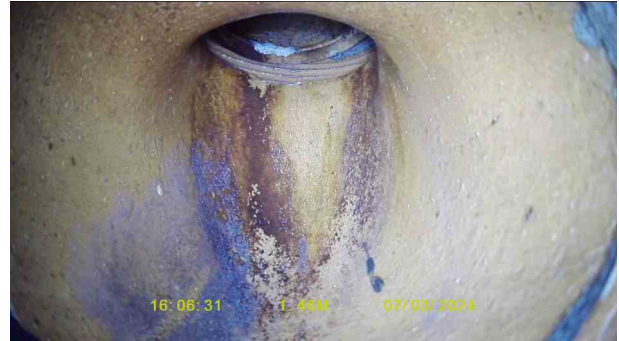
RedundantX\_0855396a-043d-45f7-ac83-5b960e2d9bb7\_2024  
0320\_135030\_087.jpg, 00:00:33, 1.46 m  
Line deviates up, Rest Bend

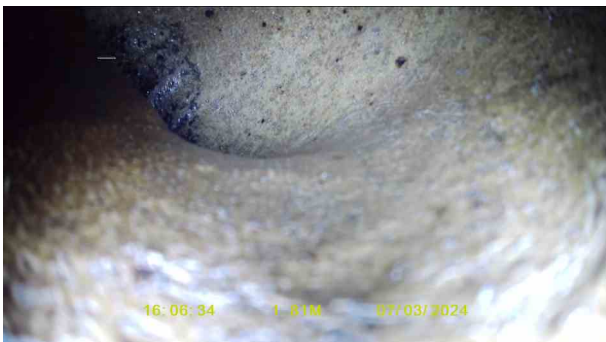
RedundantX\_a7706047-31ab-4719-a32b-0bd0bdfd8916\_2024  
0320\_135054\_566.jpg, 00:00:35, 1.81 m  
Survey abandoned, Line is redundant

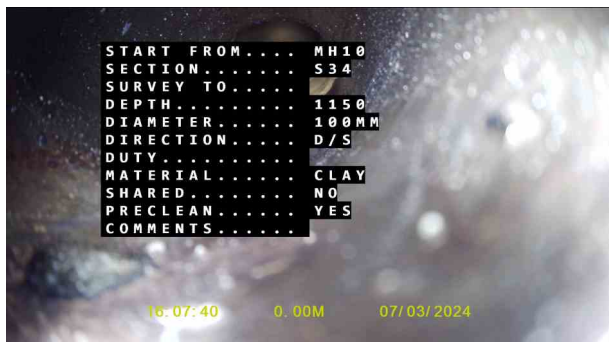
Manhole  
10X\_a307cee2-fd27-4e30-9867-04a519dffdc\_20240320\_135  
245\_772.jpg, 00:00:00, 0.00 m  
Start node, manhole, reference: Manhole 10

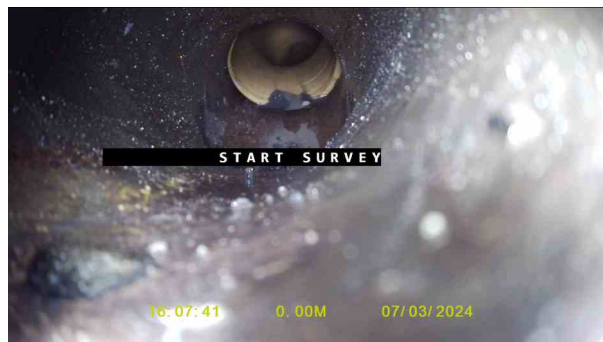
Manhole  
10X\_2ac0b7c4-a544-4421-adf7-bcacb684004c\_20240320\_13  
5300\_970.jpg, 00:00:02, 0.00 m  
Water level, 0% of the vertical dimension

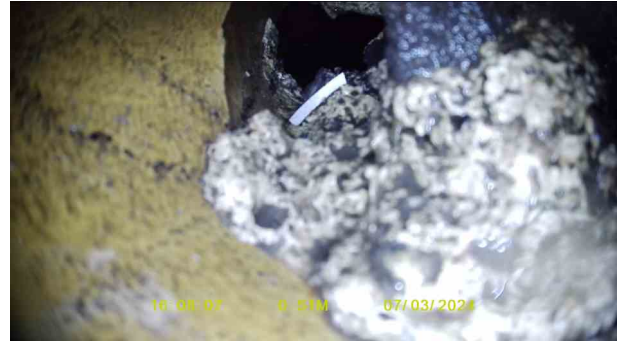
Manhole

10X\_fd6ac0da-e10d-4135-b849-7d8f9eba9443\_20240320\_135516\_224.jpg, 00:00:28, 0.51 m
