**VERIFICATION REPORT**

**BLOCK B & PLOTS 22-28, 83-85 & 92-94,**

**BARGATE HOMES**

| Reference: | GE20045/VR/BLOCK B & PLOTS 22-28, 83-85 & 92-94/JAN23v2 |

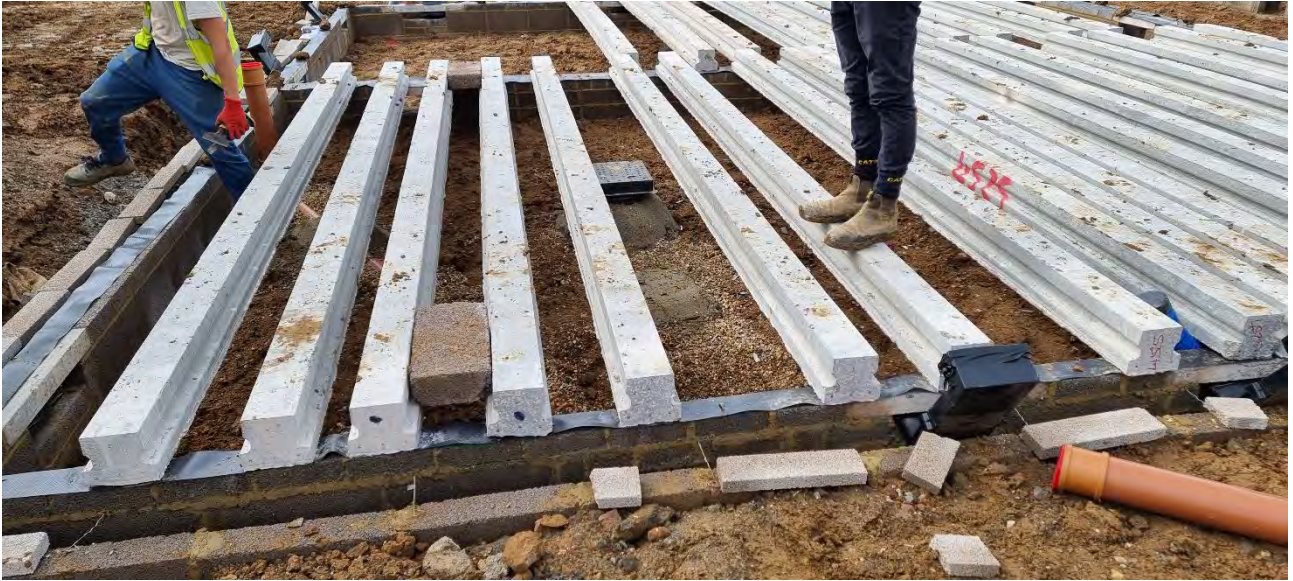
Plate 1 View of sub-floor void construction – Block B
