**ADDENDUM ARBORICULTURAL REPORT**

**SUBSIDENCE CLAIM**

**Crawford Reference: 1784480  
Insurer Claim Reference: 12562946G**

**23a Crows Nest Lane, Botley, Southampton, SO32 2DD**

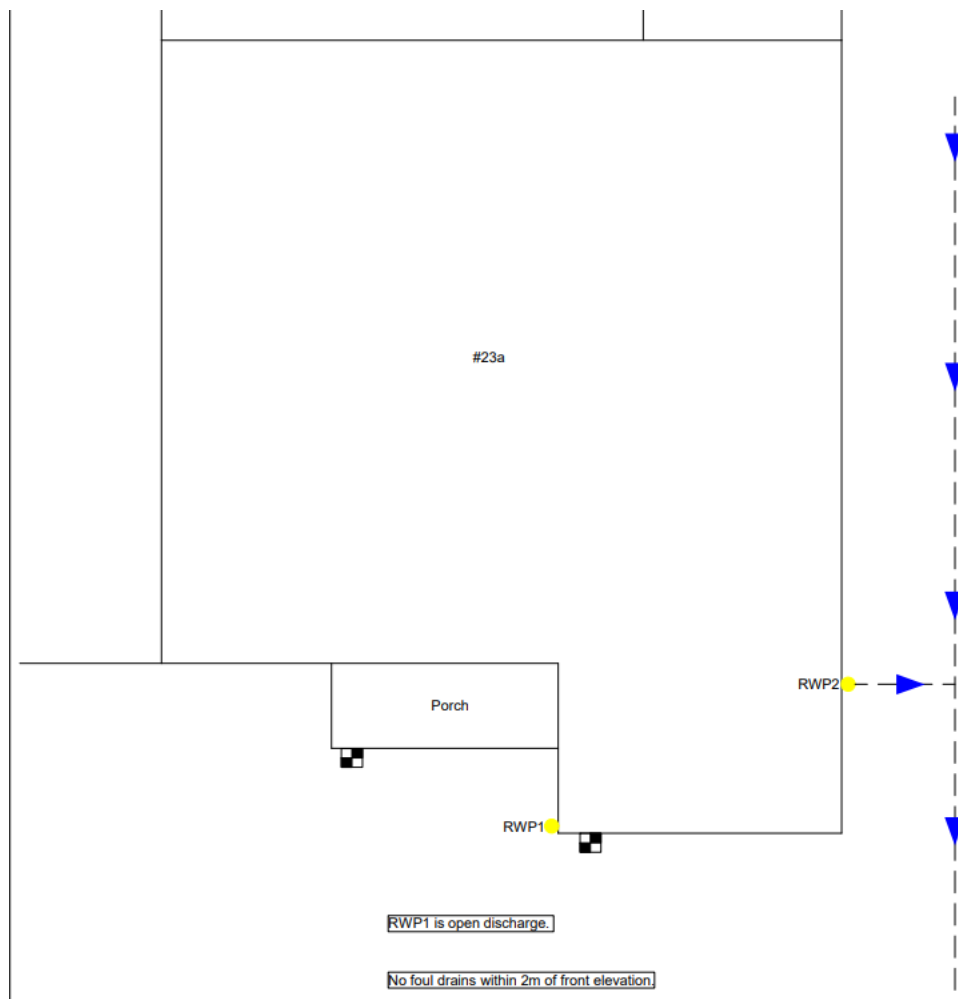
Site investigations confirm 900mm deep foundations to the damaged porch bearing on clay that has high to very high plasticity, meaning it can significantly change in volume due to seasonal variations in moisture content, particularly if influenced by tree roots extracting moisture.

Laboratory tests confirm the onset of desiccation has occurred where roots were observed, the moisture contents being less than 0.5x the Liquid Limit, this indicates abnormal soil drying in the presence of tree roots.
