## Engineers Report

**Risk Address** 62 Thistle Road  
Hedge End  
Southampton  
SO30 0TT

**360 Reference** LIV-SN-22-004886  
**Claim Reference** 100-50-192954  
**Policy Holder** Mr. Antony Marsh

**Date Notified** 22/08/2022  
**Date Instructed** 22/08/2022  
**Report Date** 26/09/2022

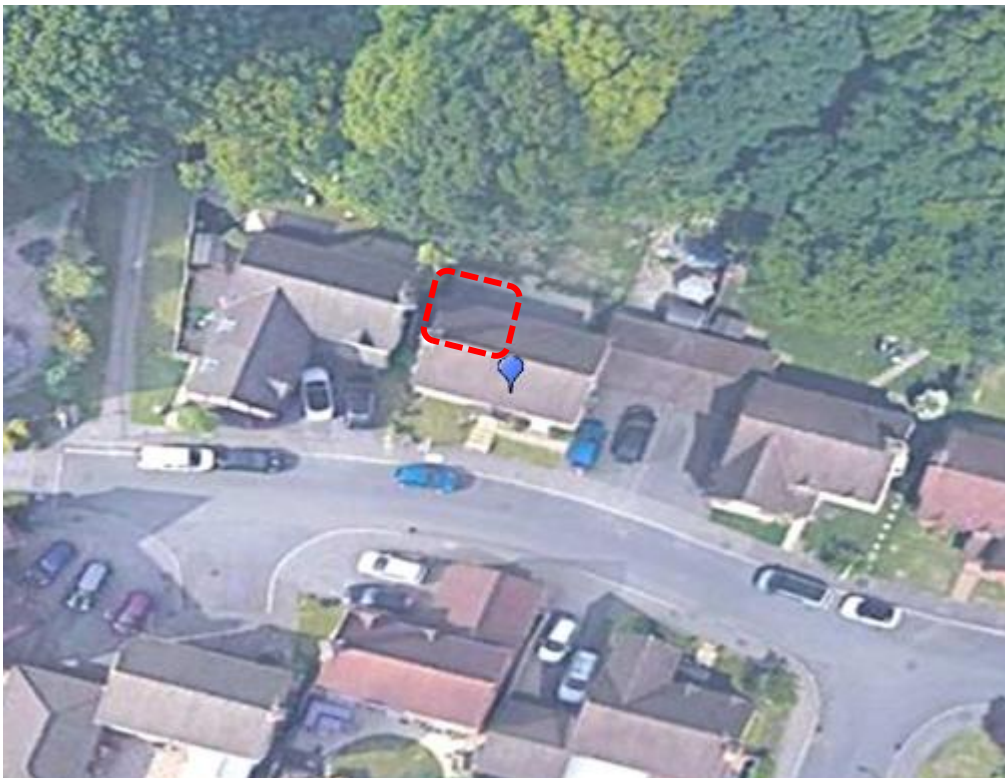
The cracking and evidence of movement is focused on the rear left hand side of the property. On the ground and first floors there are cracks that tend to suggest subsidence of the rear left hand corner of the property. The patio paving slabs also appear to have dropped and dip towards the rear left corner.
