0309046/CW/LC  
26 September 2024

## **EASTLEIGH – SUPPLEMENTARY GROUND INVESTIGATION**

Colliers PBC (Colliers) has been commissioned by Athora UK RE Log Property 24 Limited, to undertake an intrusive investigation on the newly redeveloped units at Unit 1 – 5 Woodside Road, Eastleigh, SO50 4DP. The works were completed to support the discharge of conditions 4-7 under Planning Application Reference: F/21/91183. These works were undertaken in connection with the previous works undertaken at the site and the requirements listed by the Local Authority for investigation within areas previously inaccessible at the time of investigation focused around identified potential sources. It is understood that the site, once development is completed, is to be leased by tenants for commercial use as newly developed units

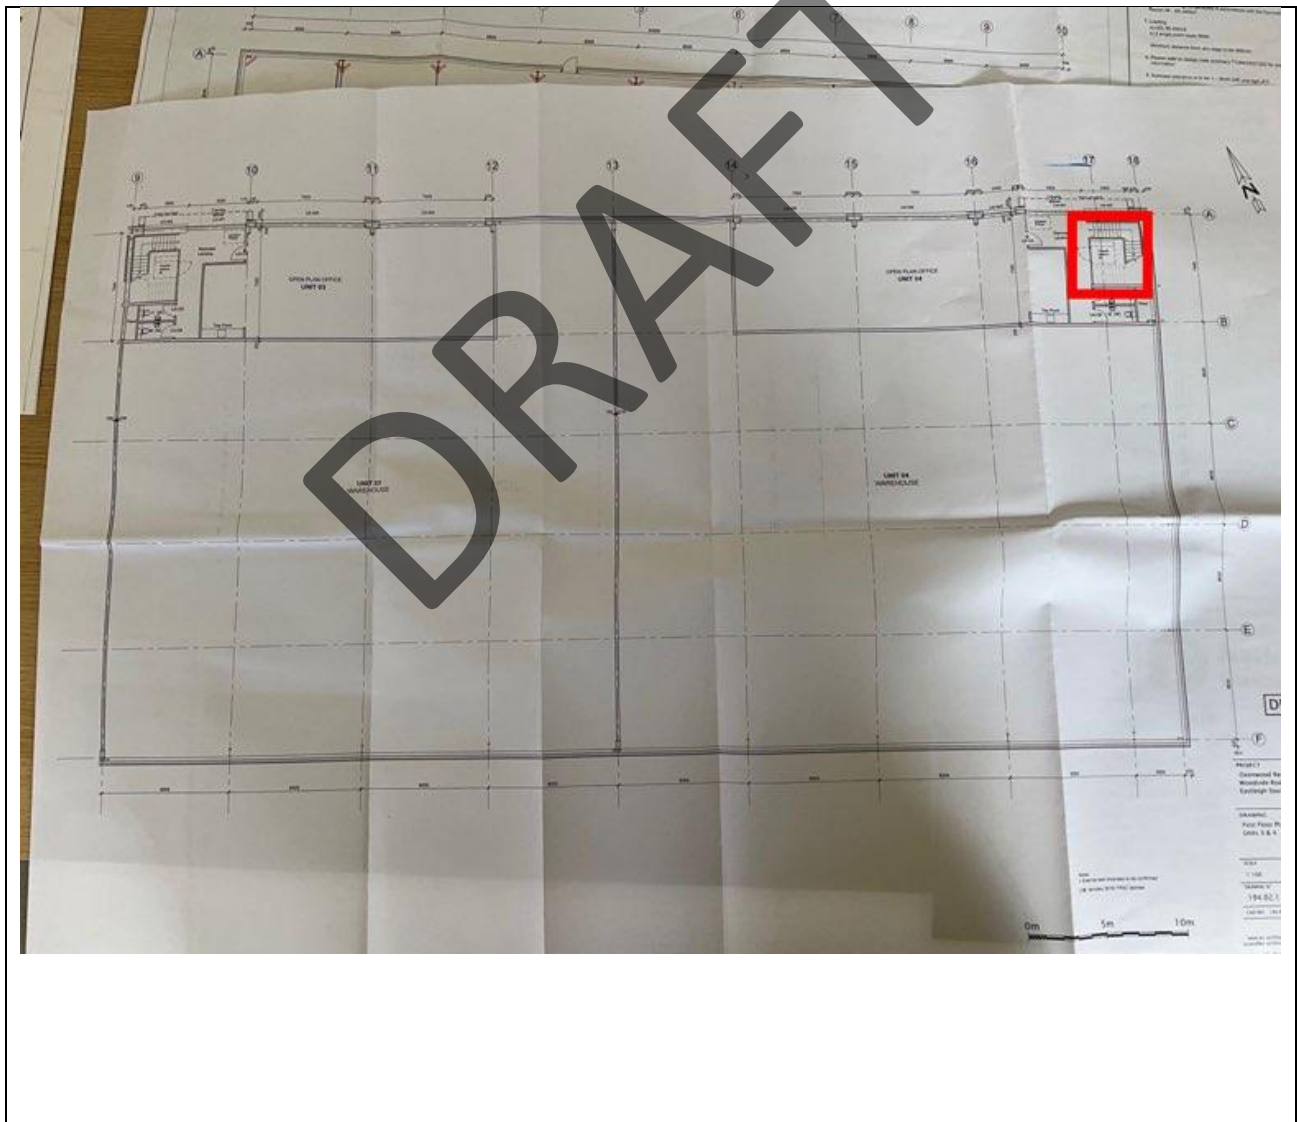
Area Inspected

| <p><b><u>(List any defects to detailing work and joints):</u></b></p> <p>During our inspection the following defects and repairs were carried out: N/A</p> <p>Have any defects identified above been satisfactorily rectified <input type="checkbox"/> Yes <input type="checkbox"/> No <input checked="" type="checkbox"/> N/A</p> <p>The Area has passed inspection <input checked="" type="checkbox"/></p> <p>The Area has failed inspection and a corrective action sheet has been left with the contractor <input type="checkbox"/></p> <p>The Area is incomplete as detailed above <input type="checkbox"/></p> <p>Signed: <b>James Hall</b> Date: <b>17/10/2022</b></p> | | | |

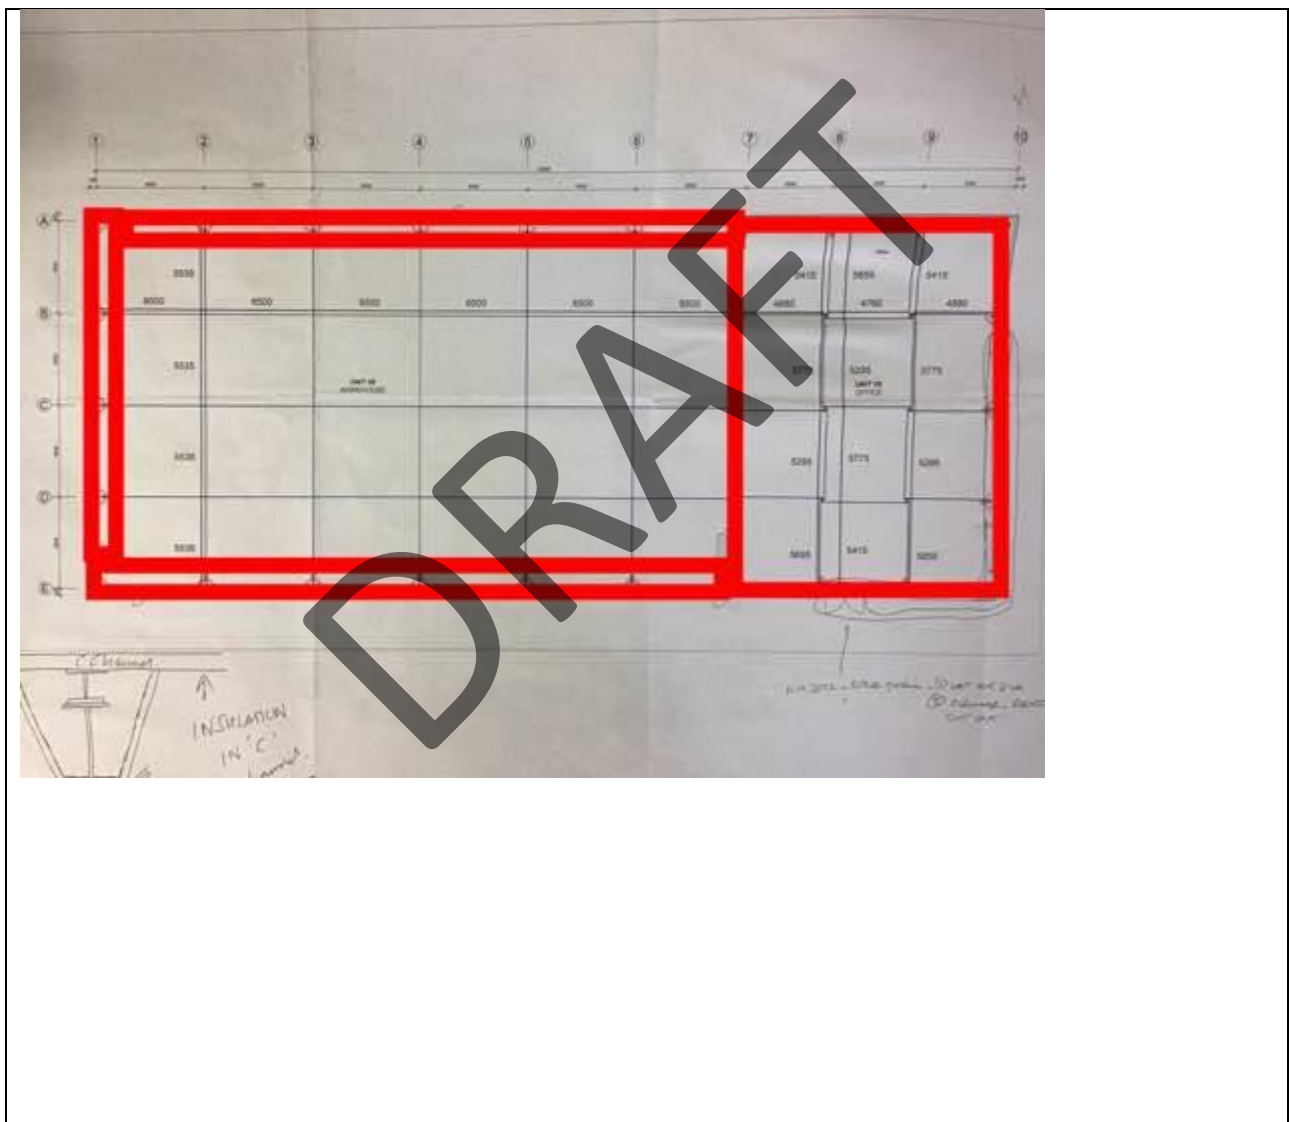
Area Inspected

| | <p><b><u>(List any defects to detailing work and joints):</u></b></p> <p>During our inspection the following defects and repairs were carried out: N/A.</p> <p>Have any defects identified above been satisfactorily rectified <input type="checkbox"/> Yes <input type="checkbox"/> No <input checked="" type="checkbox"/> N/A</p> <p>The Area has passed inspection <input checked="" type="checkbox"/></p> <p>The Area has failed inspection and a corrective action sheet has been left with the contractor <input type="checkbox"/></p> <p>The Area is incomplete as detailed above <input type="checkbox"/></p> <p>Signed: <b>Adam Mcdermott</b> Date: <b>08/11/2022</b></p> |

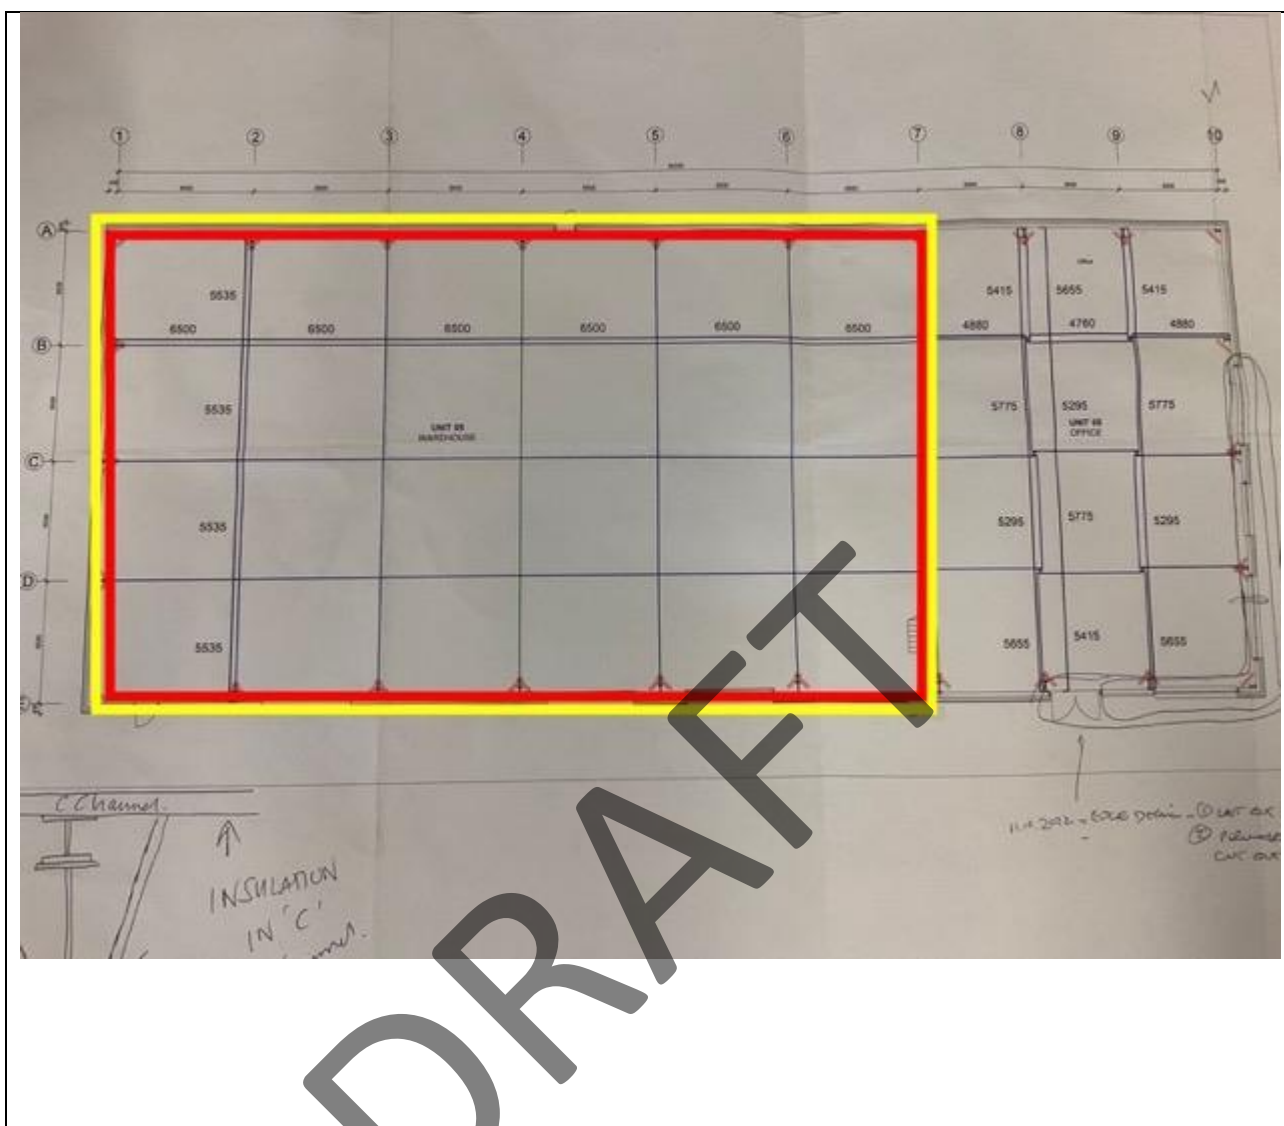
Area Inspected

| | <p><b><u>(List any defects to detailing work and joints):</u></b></p> <p>During our inspection the following defects and repairs were carried out: N/A</p> <p>Have any defects identified above been satisfactorily rectified <input type="checkbox"/> Yes <input type="checkbox"/> No <input checked="" type="checkbox"/> N/A</p> <p>The Area has passed inspection <input checked="" type="checkbox"/></p> <p>The Area has failed inspection and a corrective action sheet has been left with the contractor <input type="checkbox"/></p> <p>The Area is incomplete as detailed above <input type="checkbox"/></p> <p>Signed: <b>James Hall</b> Date: <b>11/11/2022</b></p> | | | |
