# Arboricultural Method Statement

## Rebuild of failed retaining wall

Site Address:  
43-66, Runnymede Court, West End  
Southampton, SO30 3DP

Ref: KTML42124-AMS

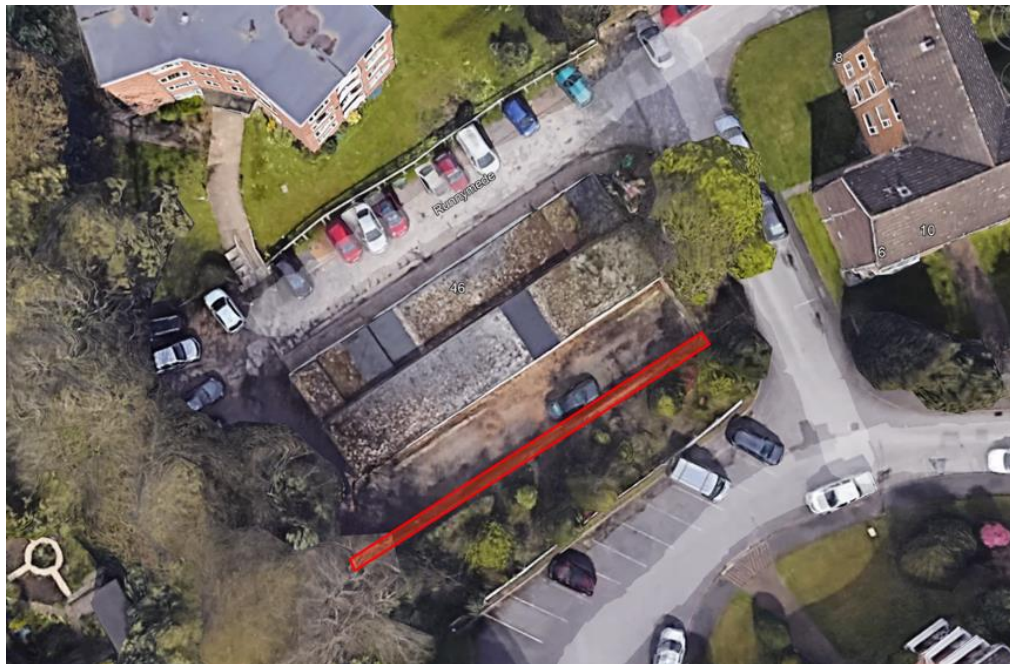
The wall is the southeastern and eastern boundary to the set of garages associated with the block of flats that are the applicant address to the north northwest. The wall is highlighted red below:
