## **Assessment of Significance and Heritage Statement Incorporating the Design Access Statement**

Site: The Old Cottage, High Street, Bursledon, Hampshire, SO31 8DJ

Client: Mr & Mrs Kyd

Date: 25<sup>th</sup> January 2025

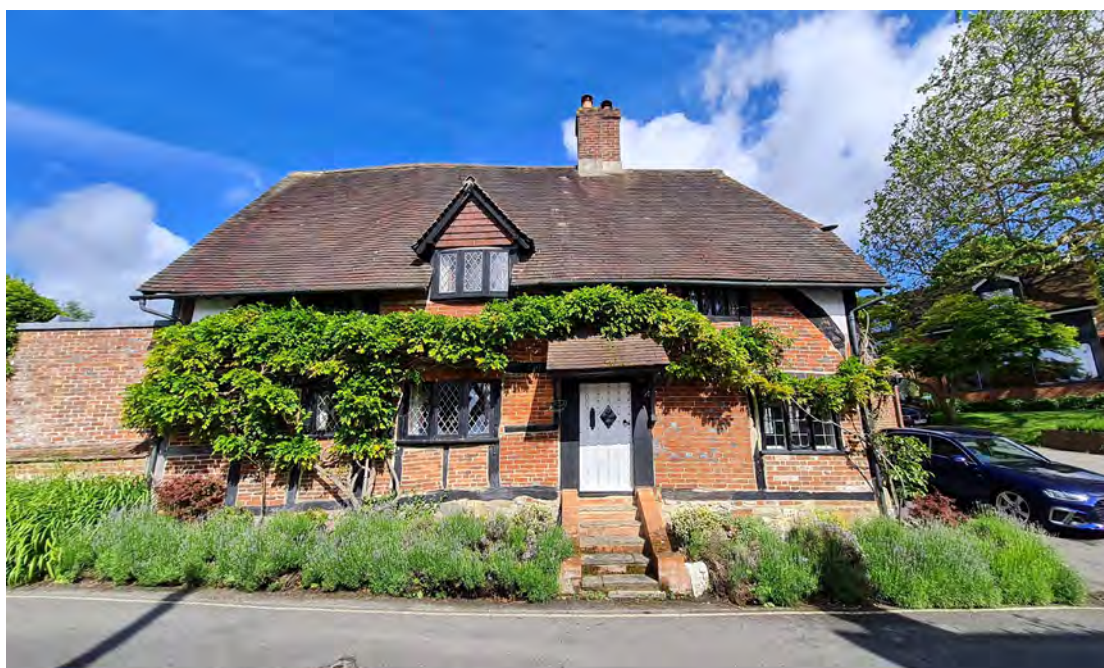
Figure 10; View of the front (South-East) elevation, facing onto High Street.

The masonry infill panels to the frame replace earlier wattle and daub infill, which now only remain in the sections above the braces to each end. The panel sizes vary between very large panels on the right-hand side of the door, and more regular sized ones in the bays to the bays on the left of the door. The curved nature of the braces is helpful in that Hampshire timber framing typically employed curved braces up to the mid-16<sup>th</sup> century, after which they are typically straight.

The timber frame shows signs of decay and earlier resin repairs in addition to some good quality timber repairs toward the South-Western end. There are a number of areas where the frame has been covered by bedded tiles, together with examples of face-fixed iron straps, which suggest significant decay or loss of members behind these coverings and failure of the original joints. The earlier resin repairs are also a potential cause for concern in that the remaining timber around these will be unable to breathe and may suffer as a result in the longer term.

To the frame repairs are illustrated on the proposed elevations as included above. Whilst the exact extent of repairs cannot be understood until work on them begins, this would include the removal of the earlier resin repairs and scarfing in of new sections of oak to re-form the traditional joints of the frame. It would also include the removal of the tiled-over sections to allow the repair of the underlying timber frame so that it can be visible again.

These repairs would be undertaken by a skilled specialist, experienced in work to historic timber frames. In all cases the working assumption would be to retain the maximum amount of historic timber and repair, rather than replace, members where possible. All repairs would be undertaken in oak of matching section and grain to the existing.

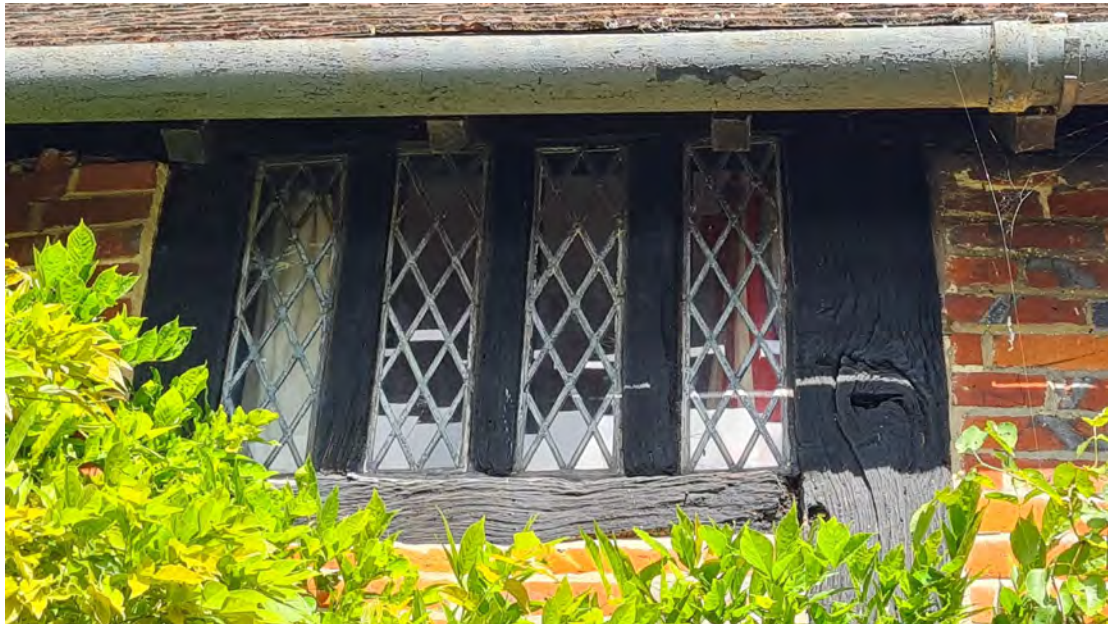
Figure 18; Close-up view of the interesting, mullioned window to the first floor, which serves the North-Eastern bedroom. This retains something of a late medieval or early modern window, and is significantly more pleasing to the eye than the others to this elevation.

- The like-for-like repair of the two older traditionally styled diamond-lead windows to the first floor. Repairs will use match material, section size, and details, retaining as much historic fabric as possible.

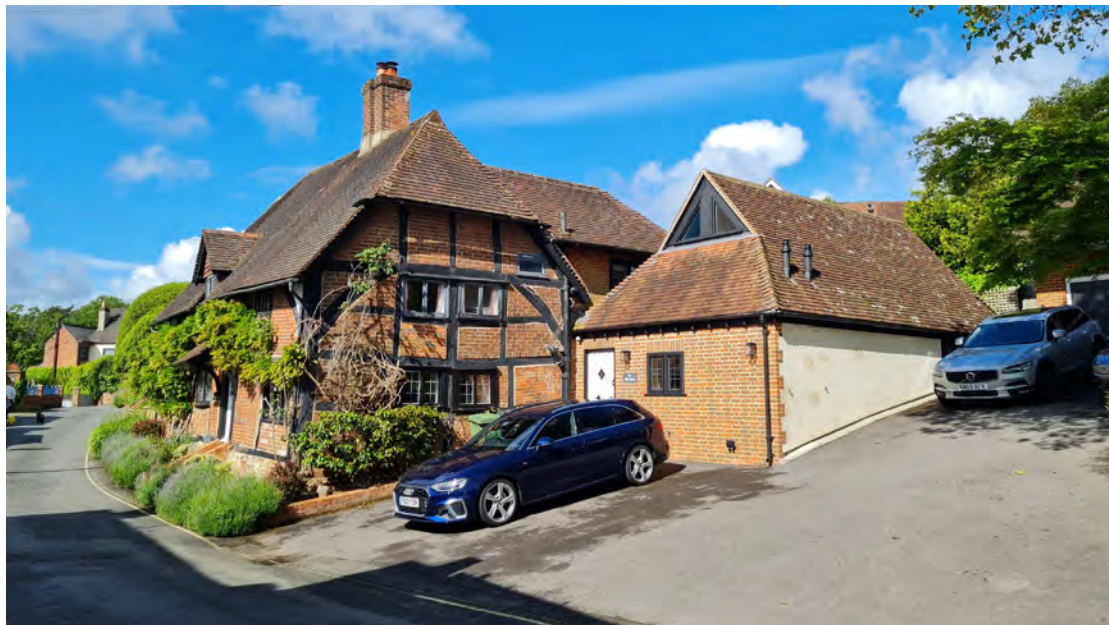
The windows to this elevation include a pair of two-light leaded casement windows of very basic construction to the ground floor, one of which incorporates a single steel frame to one side, whilst the other is a large top-hung casement with a substantial central mullion/glazing bar to give something of the appearance of a double casement. Both of these are C20 in date. Their frames include wide outer cover strips to address the issue of the junctions with the timber frame or masonry, and a hood to the top.

The first-floor windows are of a poorer quality still, being late C20 double casements to the bedroom and a top-hung single window to the bathroom. None of these have any glazing bars, and project a paucity of quality which spoils the elevation.

Figure 21; View of the North-East elevation as seen when coming along High Street. The set-back of the converted garage allows the observer to appreciate the age and character of the building.

- The replacement of the poor-quality windows on the North-East elevation with more appropriate diamond lead-lighted hardwood casement windows.
- The replacement of the larger windows (the first and ground floor bow windows and the mixed window to the Dining Room) with new hardwood face-planted windows.

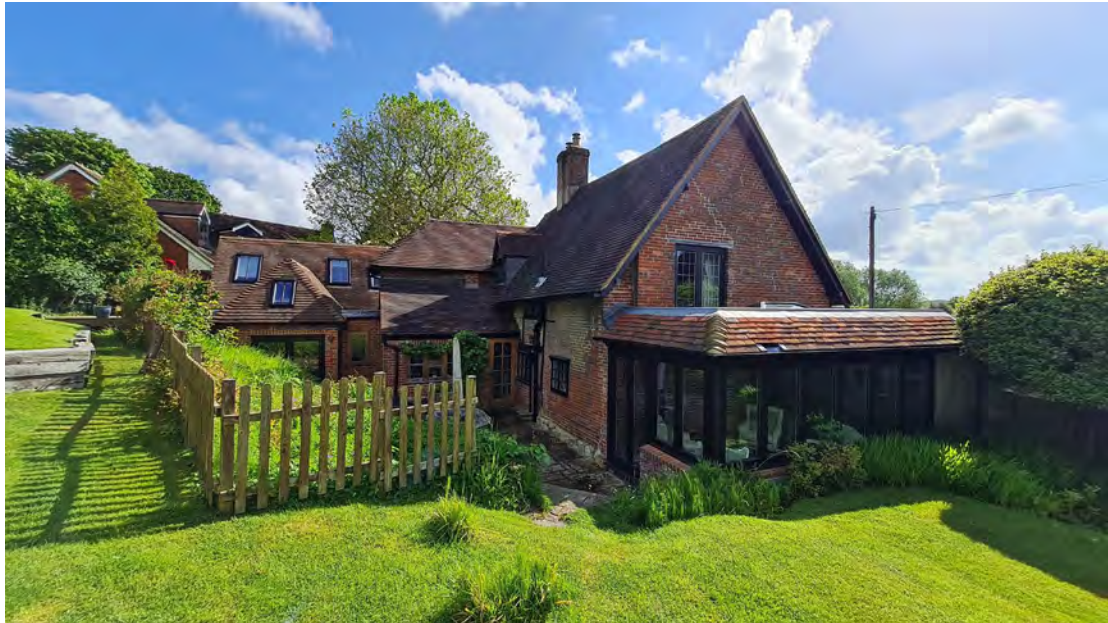
The gable which is visible from the road is entirely of brickwork, with a  $\frac{1}{2}$  brick thick skin in stretcher bond having been wrapped around the outside of the timber frame. This is most likely because of moisture penetration and/or more advanced decay to the timber frame on this elevation which faces directly into the prevailing weather. This projecting skin steps back into the original building line toward the garden side, where the frame was presumably lost, as no corner post is visible. Although relatively plain, the elevation and its window are well proportioned and attractive. The conservatory is also well detailed, using high-quality materials, and sits well with the building and garden.

Figure 27; The South-West elevation, with the two-storey element of the original cottage and modern conservatory in the foreground, and the mixture of extensions to the original house set back behind.

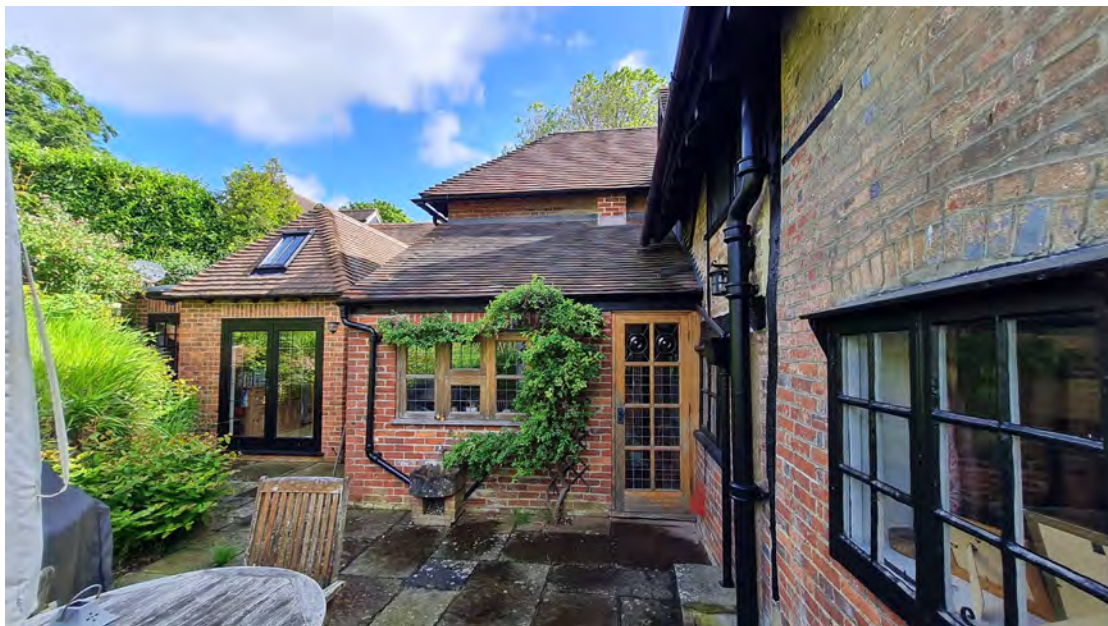
The extensions to the second part of this elevation are all of relatively modern construction, apparently replacing older structures on approximately the same footprint. Their mixed forms and diminutive nature as individual components of the whole mean that they do not compete with the original dwelling. Whilst generally nicely detailed and in comfortable materials, the oak windows and door have unduly heavy sections, making them stand out as less attractive than the others.

Figure 28; Closer view of the South-West elevation of the extension elements.

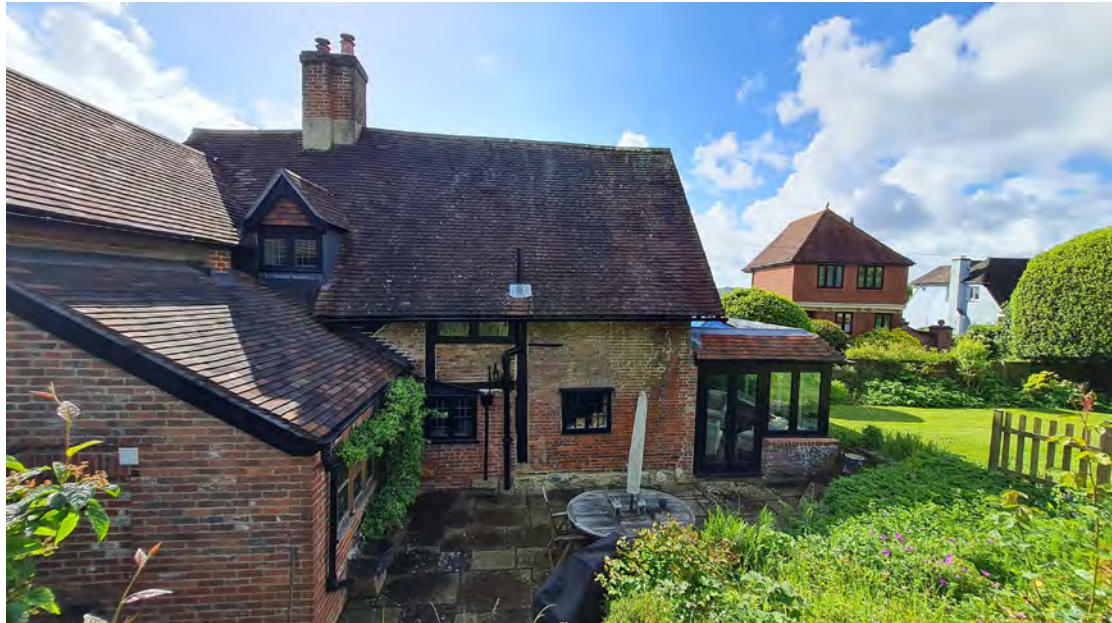
This elevation is largely formed by the rear of the main body of the original cottage. It is generally of brickwork, as the majority of the original timber frame has been lost externally, especially towards the Western corner where the weather would have taken the greatest toll. The stone plinth still remains to much of the elevation, and several individual timbers, including one primary frame post, a section of floor girt, a stud, and small section of brace remain visible.

The masonry is of a mixed character, with elements of Flemish bond and some more random work to the first floor. It seems likely to date from the C19, with some later work into the C20 in individual locations. The frame post is in need of some repair work to its lower section, as it sounds hollow.

Figure 29; View of the North-West (rear) elevation of the main body of the house.

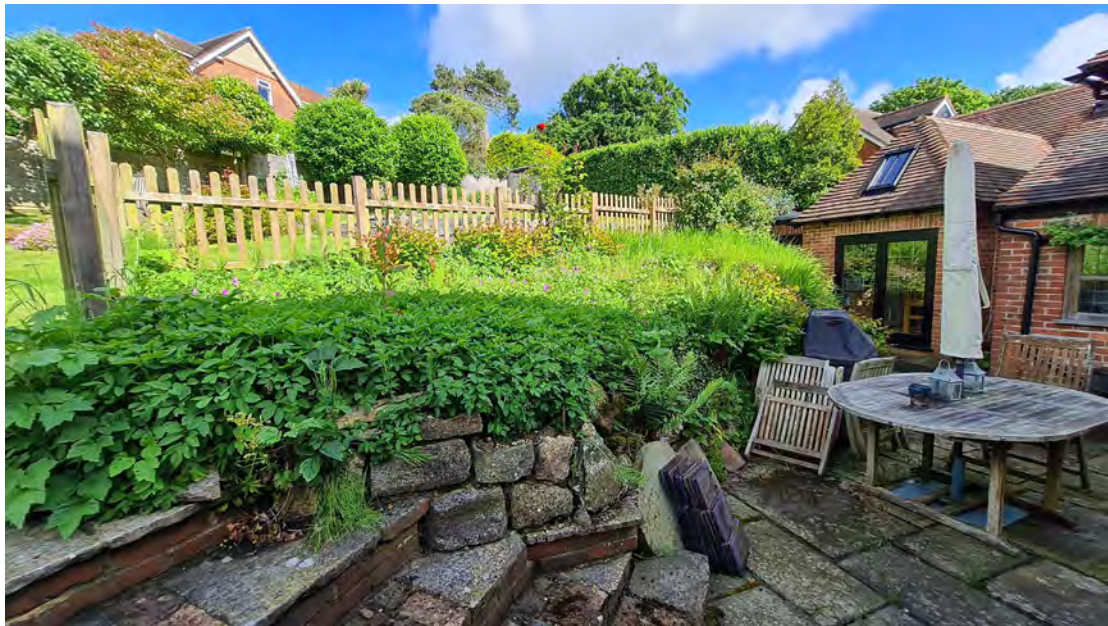
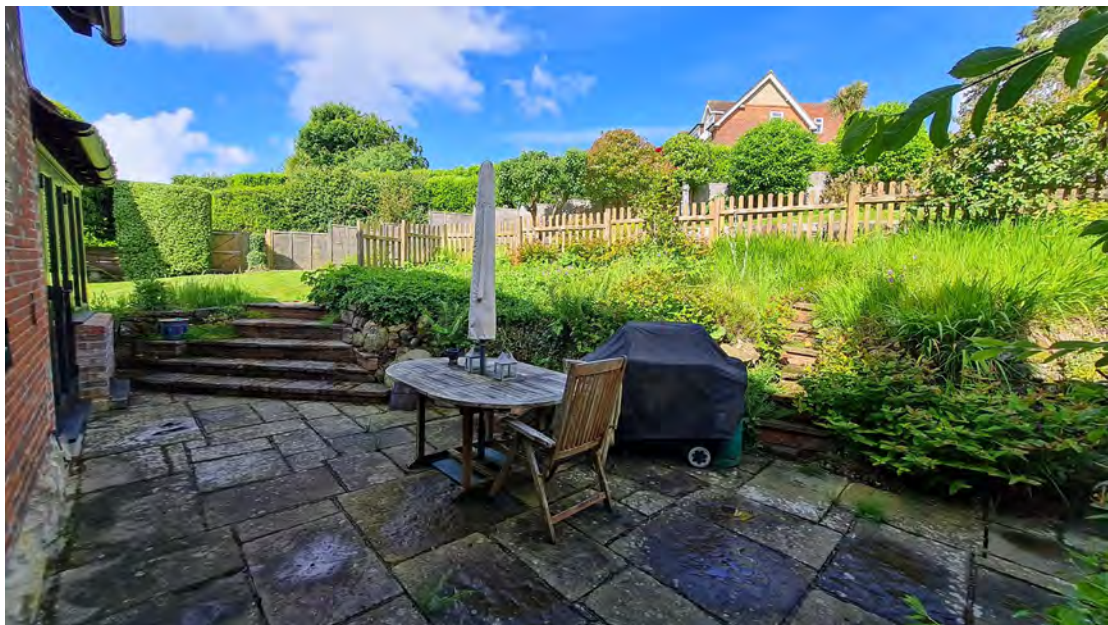
Externally the ground rises steeply to the North and West, and is generally laid to lawn. In the internal corner of the 'L' shaped plan of the building is a small terrace at ground floor level, although this suffers from being too compact to allow sunlight to reach it for much of the time. A retaining structure and bank form the boundary between this lower terrace and the wider garden, with a low picket fence to the top.

Landscaped steps run up from the terrace to the garden at an incongruous angle to the South-Western end, adjacent to the conservatory.

Figure 32; Image to show the current retaining structure and bank.
