# Tree Inspection and Risk Assessment

58 Brownhill Road

February 2025

# T1 – Lawson Cypress - *Chamaecyparis lawsoniana*

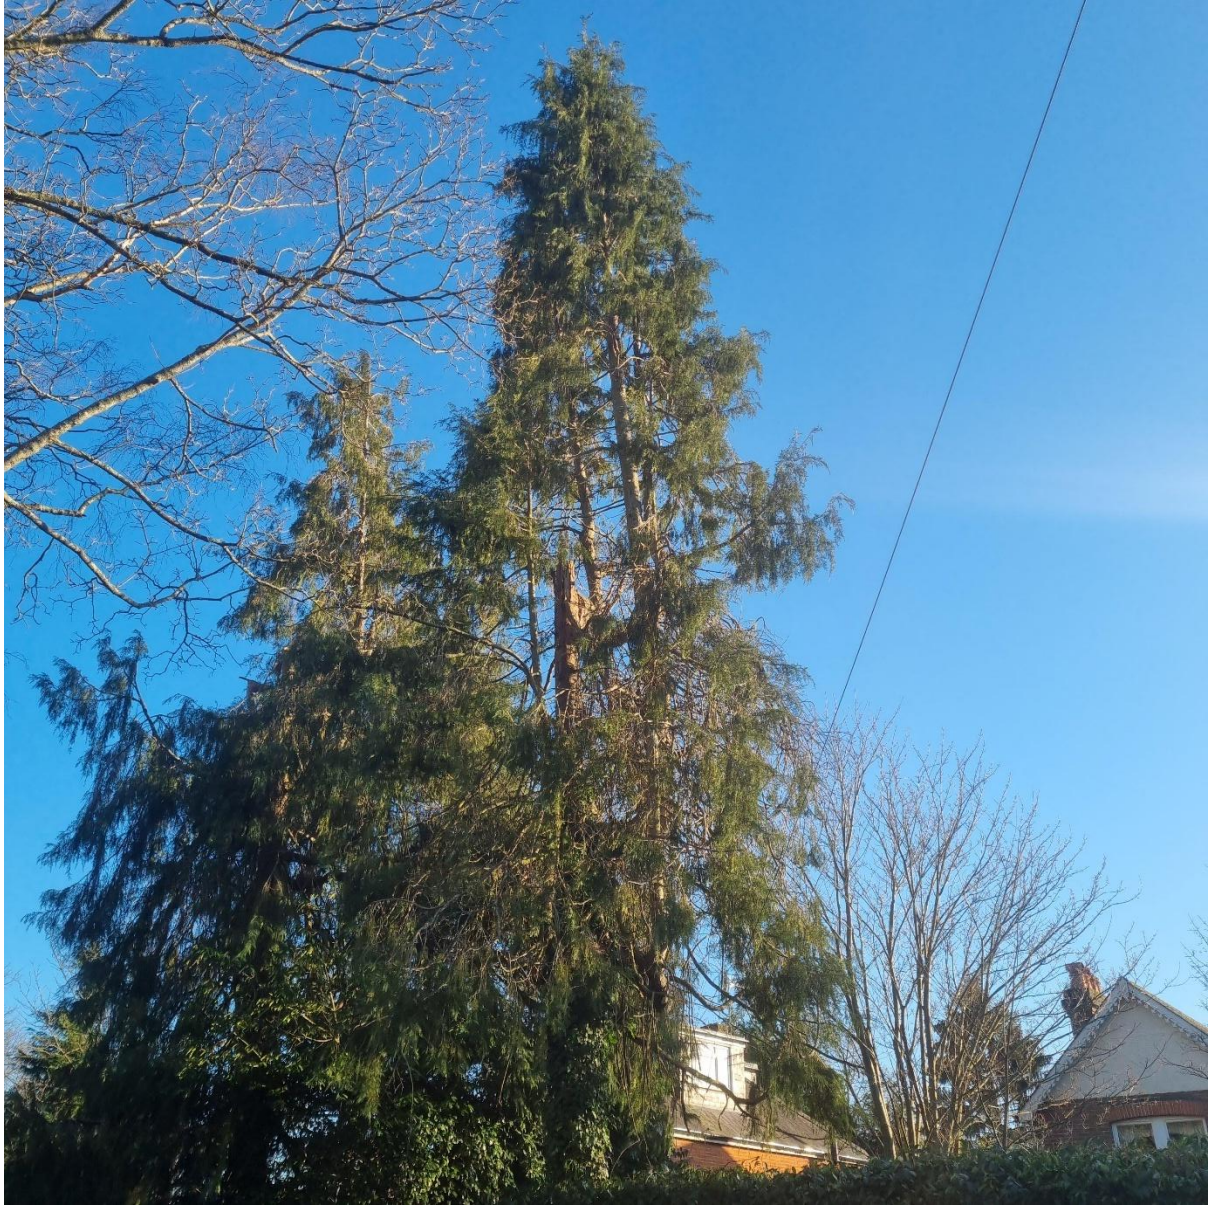
T1 is a mature tree located on the northern boundary of the site, adjacent the driveway and highway.

The tree has historically been truncated or reduced at approximately 12m from ground level, which has resulted in regrowth from the pruning wounds to form the upper canopy.

A recent stem failure has originated at this historic pruning wound. It was associated with high winds and decay at the point of attachment.

The canopy has a low leaf and small twig density in comparison to similar adjacent trees.

Given all the issues identified and evidenced with the tree and its location in relation to adjacent targets it is considered reasonable management to remove the tree and replant with a suitable species.
