**VERIFICATION REPORT**

**BOORLEY GARDENS, WINCHESTER ROAD**

**HEDGE END, SOUTHAMPTON, SO32 2UA**

**BELLWAY HOMES**

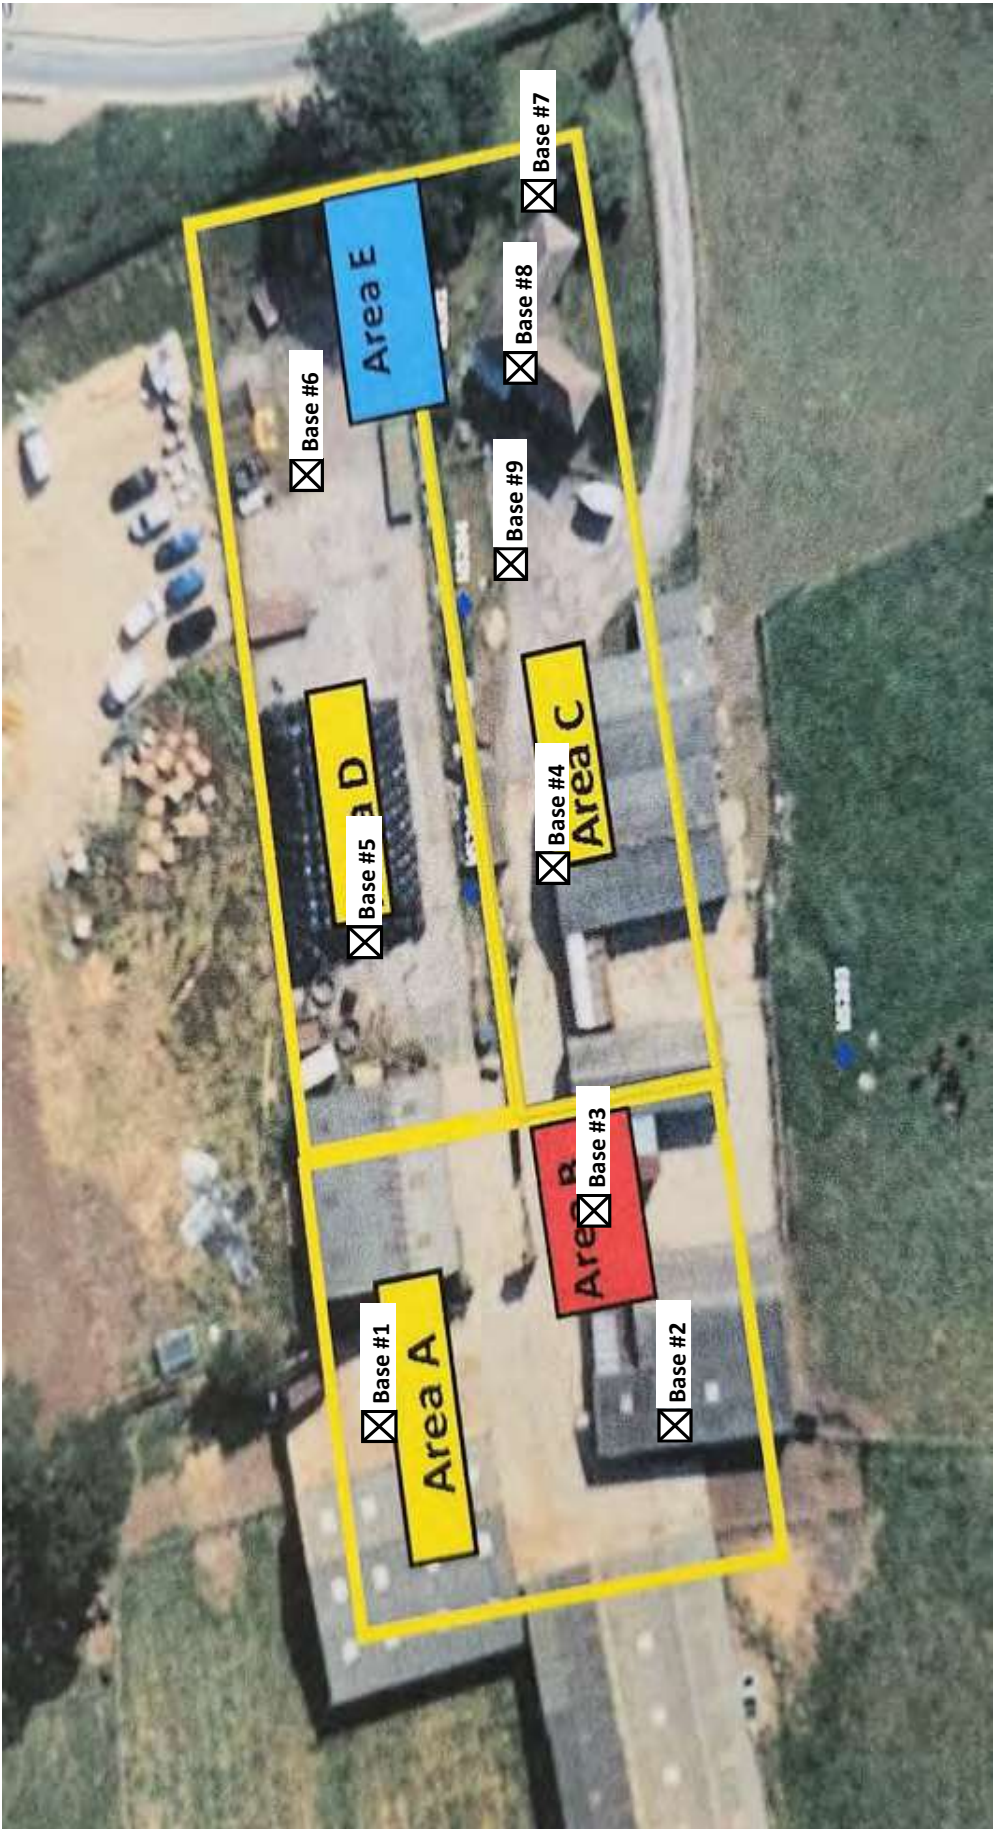
| <b>Project:</b> | Boorley Gardens, Park Farm Area | | <b>Title</b> | Location of Validation Samples | <div></div> <div>Geo-Environmental</div> |

Validation samples of the exposed formation were also obtained and were submitted to a UKAS accredited laboratory for testing for a suite of commonly occurring brownfield contaminants including asbestos to confirm the chemical suitability of the exposed natural soils. Nine samples were obtained (referenced Base #1 to Base #9) in locations providing a broad coverage of the site. The locations of these samples are shown in Figure 3. The laboratory test results are presented within Appendix C.

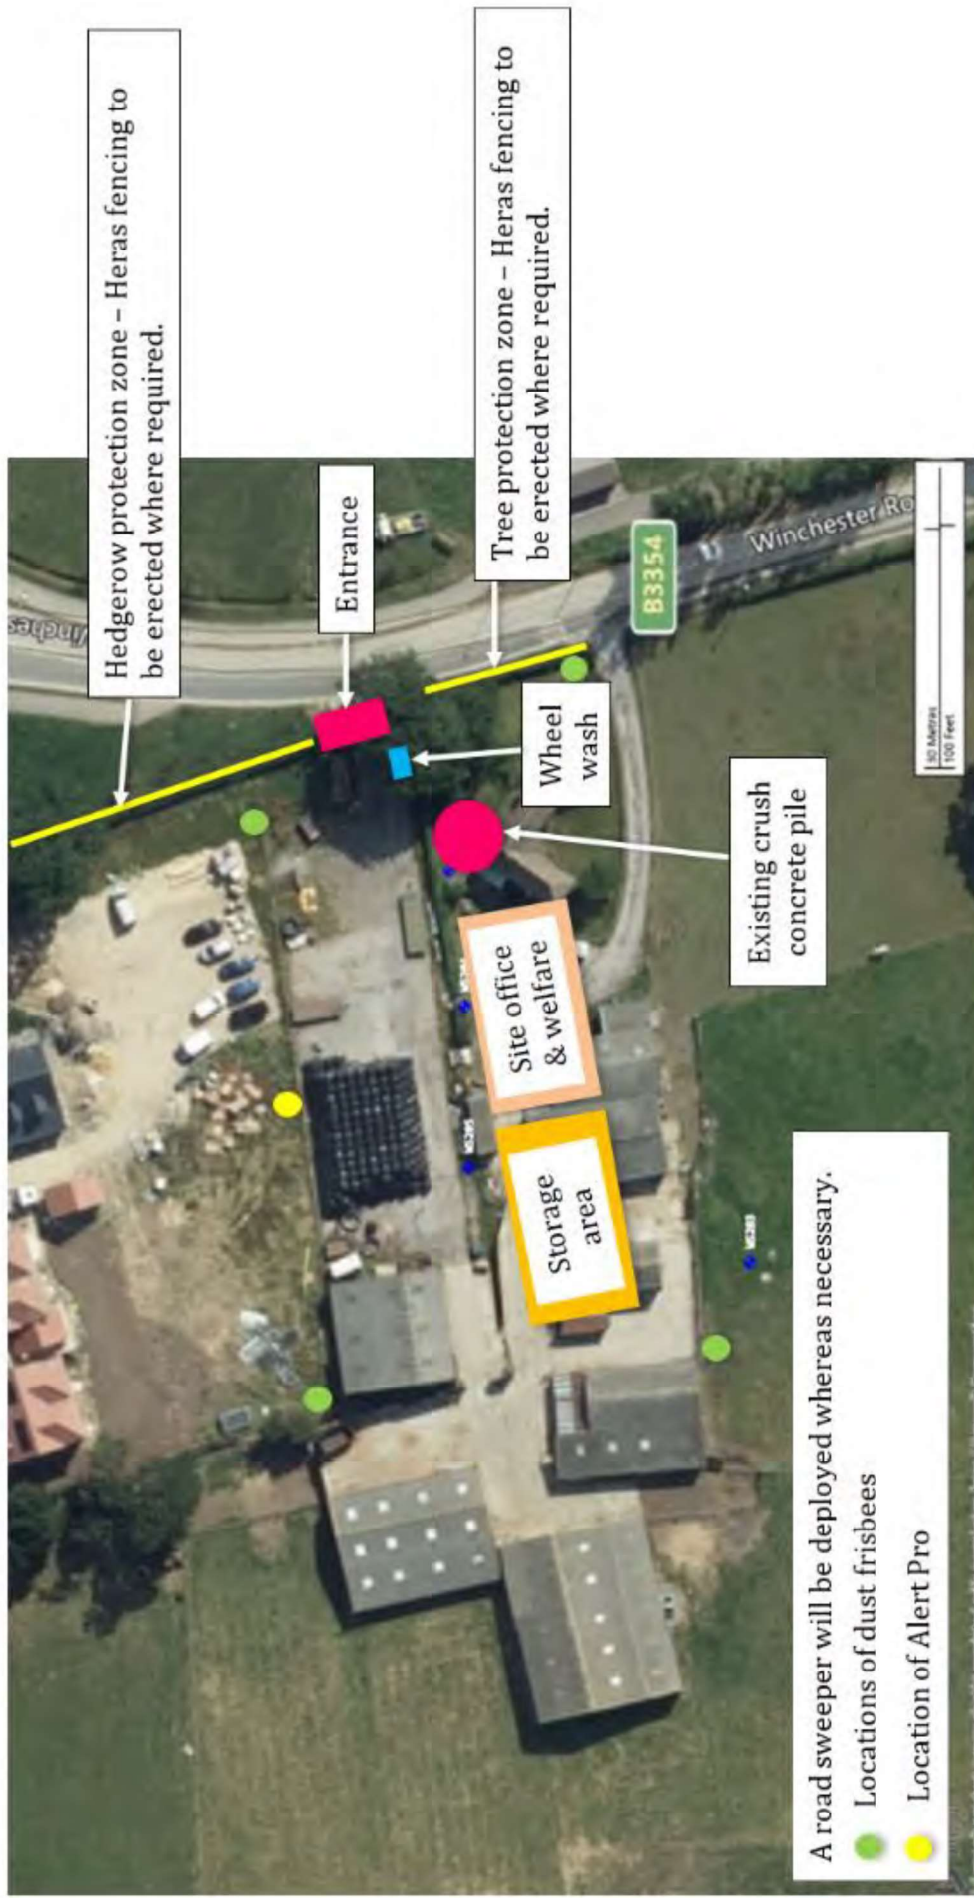
Figure 2: Location of different installations within the site plan

- Site set up was completed (boundary fencing & signage, welfare & storage areas etc.) as shown in Appendix A Figure 2.
- Remedial works were carried out in 5 Areas/phases within Parcel 1D as illustrated in Appendix A Figure 3.

- Dust monitoring was carried out using dust frisbee gauges throughout the duration of the project with reports being produced by a laboratory on a weekly basis from 4 dust frisbee locations along the site boundary as shown in Appendix A Figure 2. Dust frisbee bottle samples were tested for both dust analysis and asbestos ID.

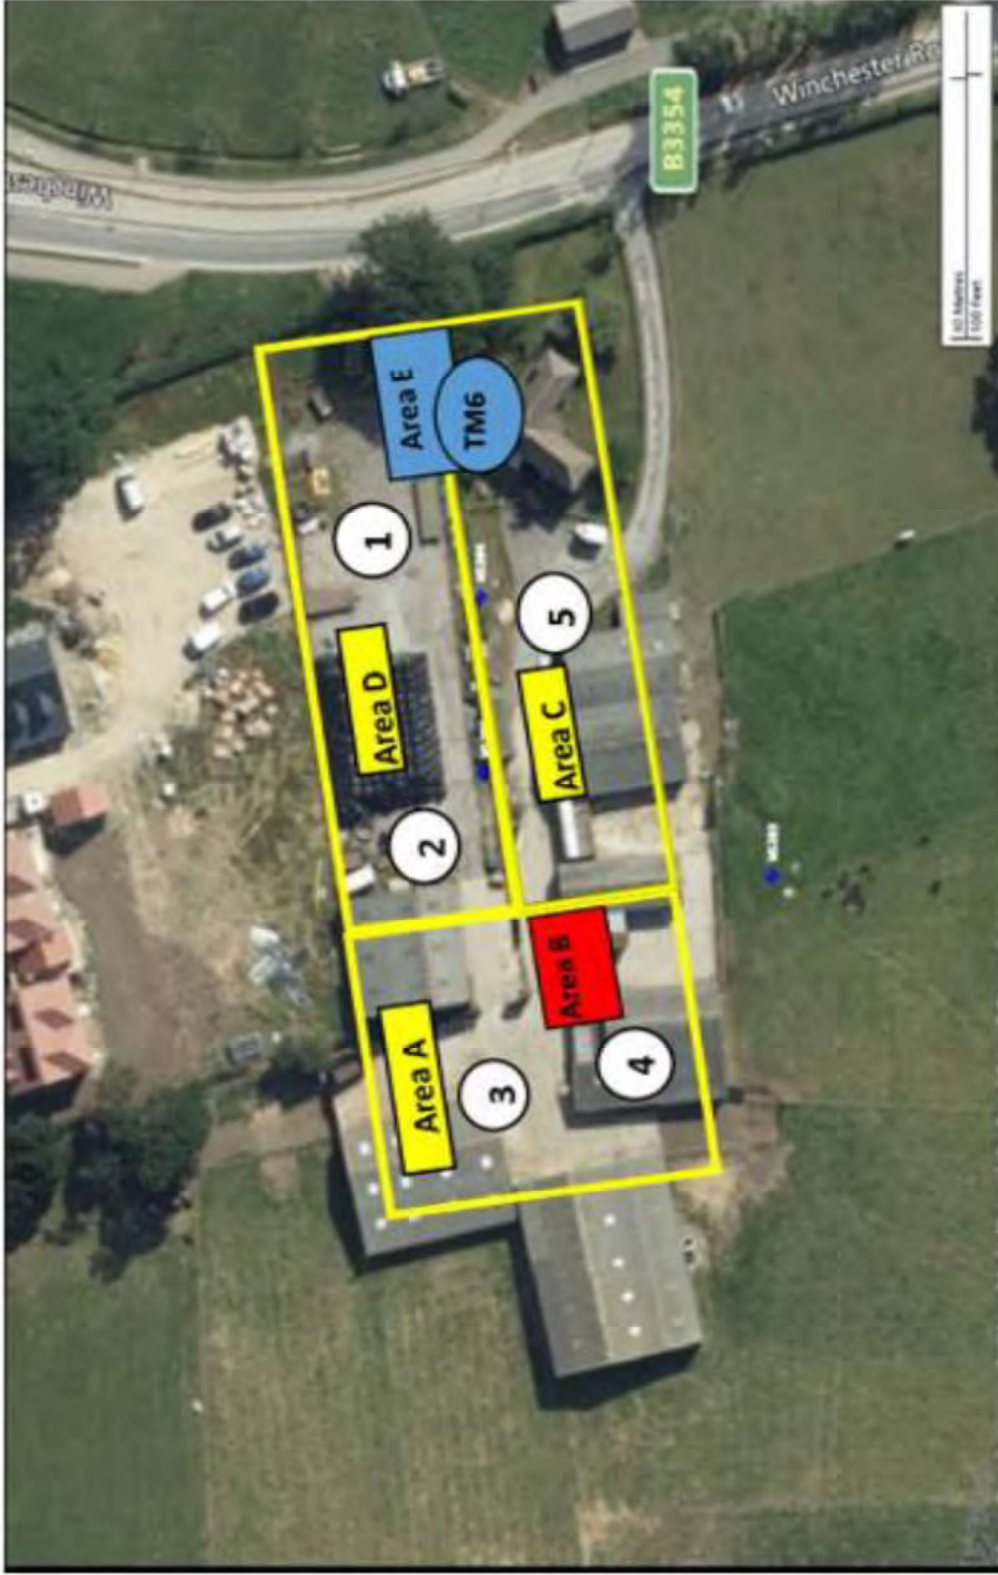
**Figure 3:** Soil and tarmac sampling locations within different areas

- Made ground in each area was scraped to the virgin ground which was between 150 mm and 400 mm.
- Excavated soil of each area was then stockpiled within the same phase to prevent any potential cross contaminations as shown in Appendix A Figure 3.
