# Arboricultural Report

## SUBSIDENCE INVESTIGATION AT:

5 Clausentum Close  
Chandlers Ford,  
Hampshire SO53  
2AQ

| Report Date: | 12 <sup>th</sup> of May 2023 |

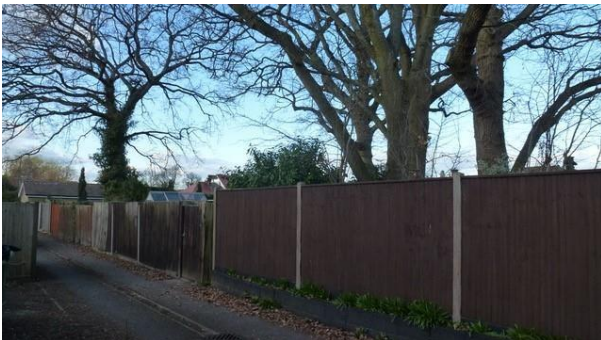
**Rear lane. T1, T3 & T4**

Trees T1, and T2 are both within influencing distance of the property (the radius of the zone of influence is taken from “Tree Roots & Buildings” Cutler, D.F. and I.B.K. Richardson, (1989) or determined in accordance with NHBC Standards Chapter 4 (2021)). English Oak are well recognised as having a high-water demand (NHBC Standards Chapter 4 (2021)) and are capable of causing subsidence damage during drought conditions.

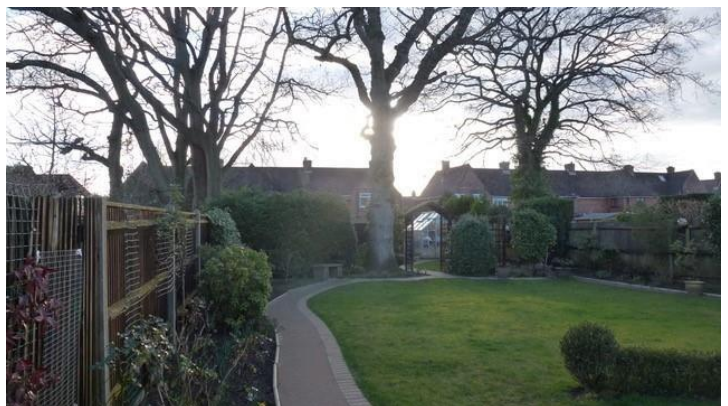
**T3 & T4 on left T2 middle & T1 right**

Trees (T3), and (T4) both also Oak are close to, but outside of the zone of influence but they are high water demand species capable of causing subsidence damage during drought conditions.
