**Workdry Ltd**  
**New Headquarters Office Building**  
**Bournemouth Road, Chandlers Ford**

**Drainage Design Statement**

**Date: November 2025**  
**Project No. 304846**  
**Report Reference: 304846-SWH-ZZ-ZZ-T-C-0002**  
**Revision: 01**

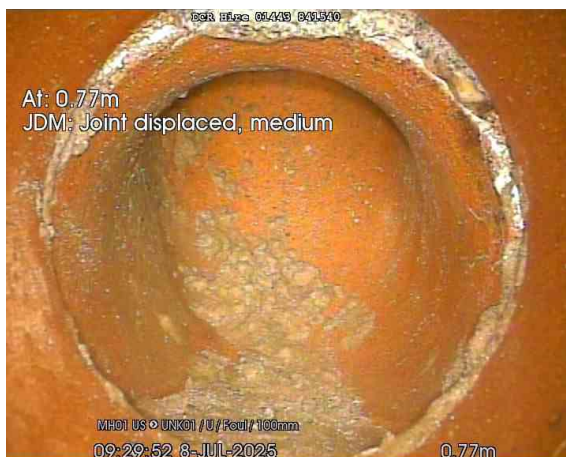
MH01 US\_0-77m\_092952.jpg, 00:00:10, 0.77 m  
Joint displaced, medium

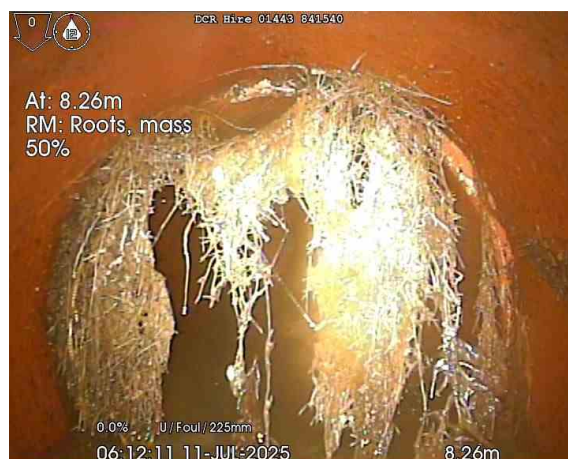
FW2301 US\_8-26m\_061211.jpg, 00:00:56, 8.26 m  
Roots, mass, 50% cross-sectional area loss

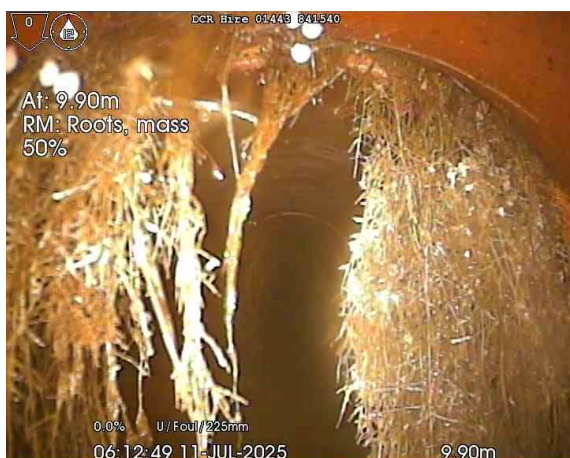
FW2301 US\_9-90m\_061249.jpg, 00:01:13, 9.90 m  
Roots, mass, 50% cross-sectional area loss

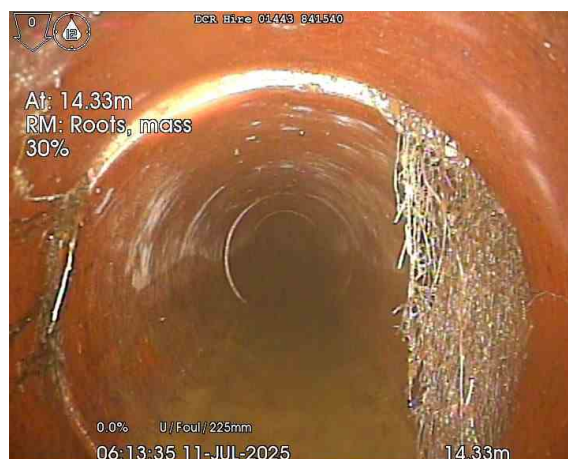
FW2301 US\_14-33m\_061335.jpg, 00:01:39, 14.33 m  
Roots, mass, 30% cross-sectional area loss

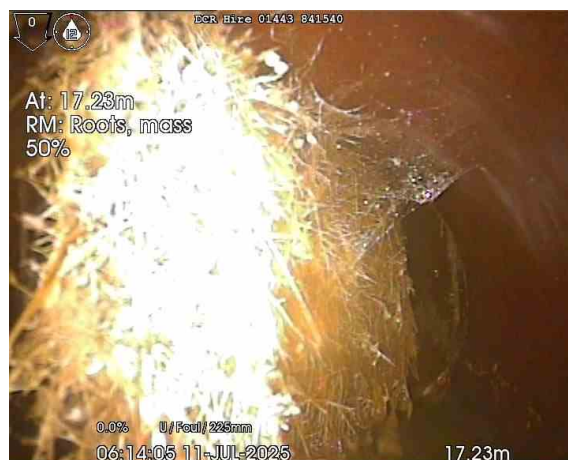
FW2301 US\_17-23m\_061405.jpg, 00:01:55, 17.23 m  
Roots, mass, 50% cross-sectional area loss

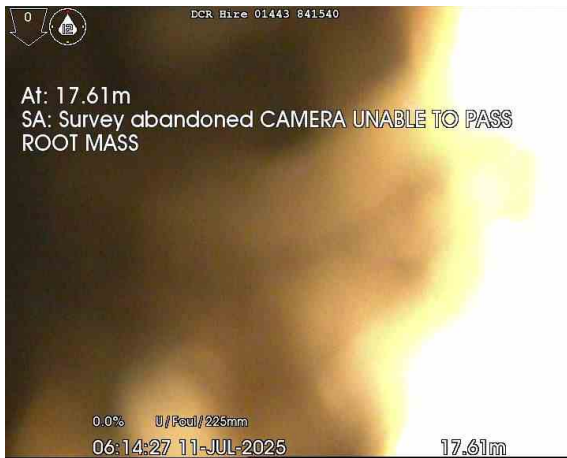
FW2301 US\_17-61m\_061427.jpg, 00:02:00, 17.61 m  
Survey abandoned, CAMERA UNABLE TO PASS ROOT  
MASS

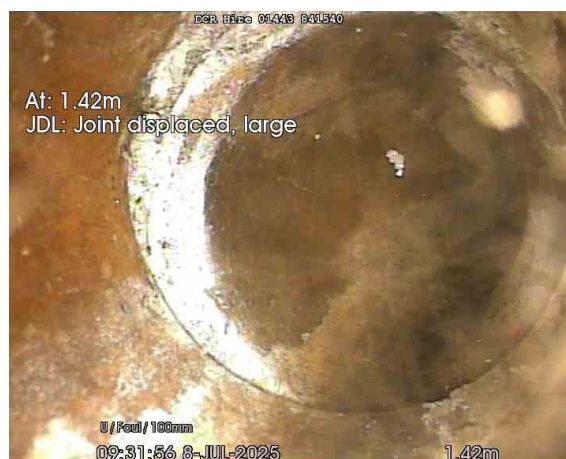
MH01 BR1\_1-42m\_093156.jpg, 00:00:11, 1.42 m  
Joint displaced, large

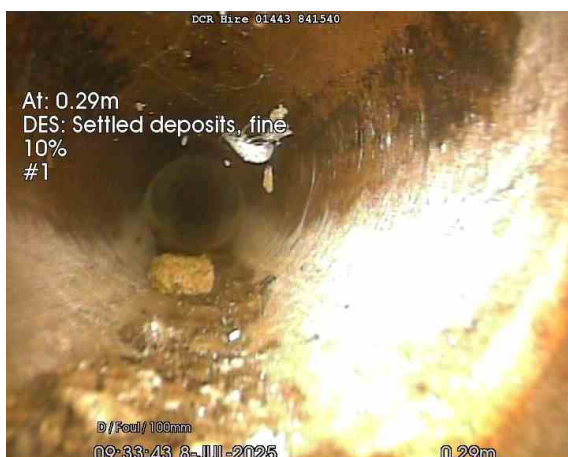
MH01 DS\_0-29m\_093343.jpg, 00:00:04, 0.29 m  
Settled deposits, fine, 10% cross-sectional area loss, start

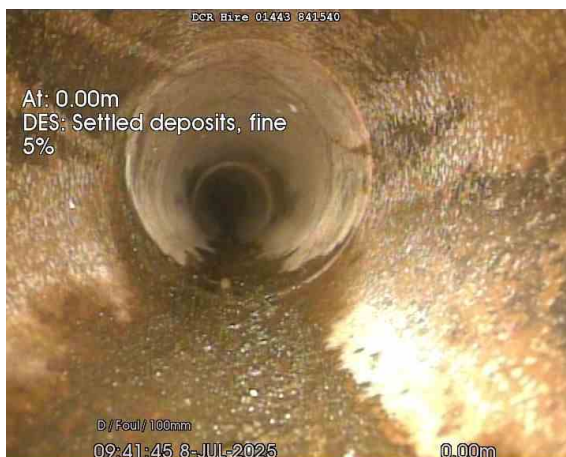
MH02 DS\_0-00m\_094145.jpg, 00:00:04, 0.00 m  
Settled deposits, fine, 5% cross-sectional area loss

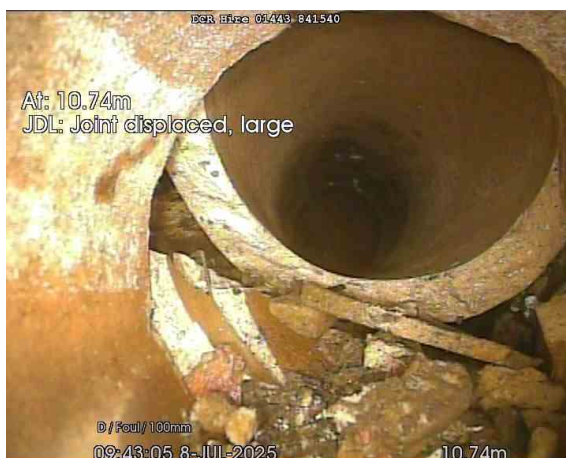
MH02 DS\_10-74m\_094305.jpg, 00:00:46, 10.74 m  
Joint displaced, large

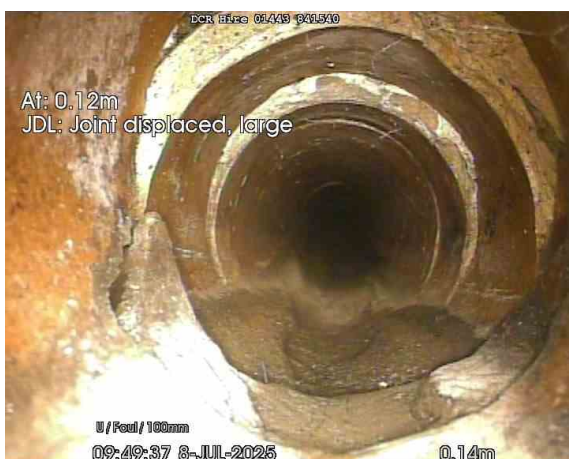
MH03 US\_0-14m\_094937.jpg, 00:00:08, 0.14 m  
Joint displaced, large

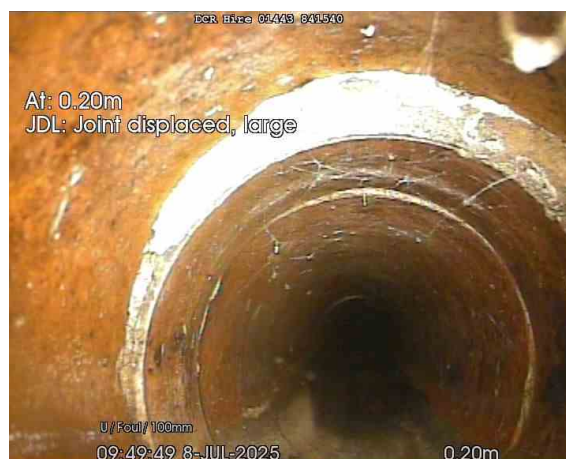
MH03 US\_0-20m\_094949.jpg, 00:00:13, 0.20 m  
Joint displaced, large

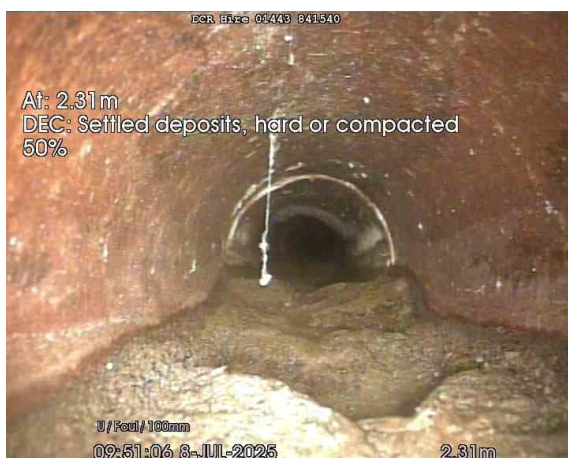
MH03 US\_2-31m\_095106.jpg, 00:00:47, 2.31 m  
Settled deposits, hard or compacted, 50% cross-sectional area loss

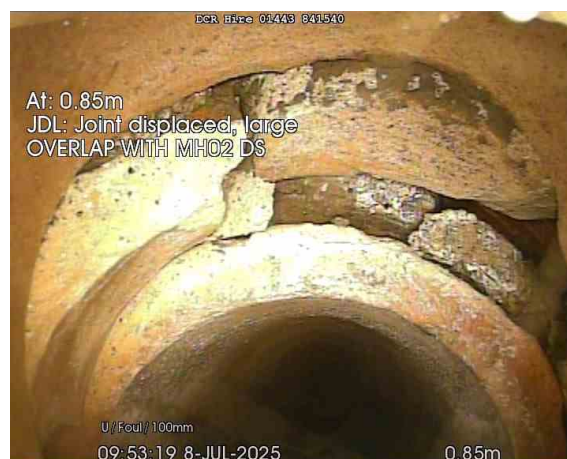
MH03 BR1\_0-85m\_095319.jpg, 00:00:11, 0.85 m  
Joint displaced, large, OVERLAP WITH MH02 DS

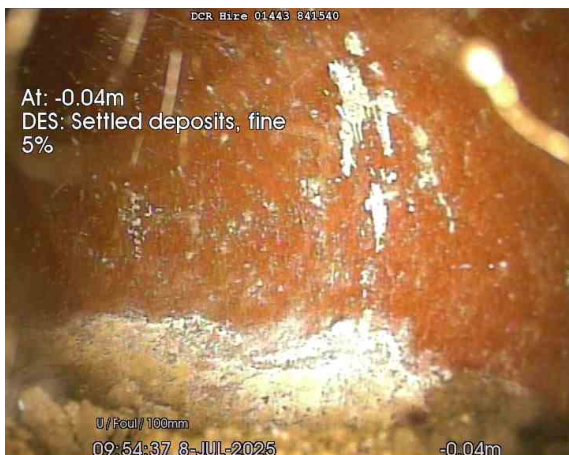
| Scale: 1:50 | Position [m] | Code | Observation | MPEG | Photo | Grade |
|---|---|---|---|---|---|---|
| | -0.04 | DES | Settled deposits, fine, 5% cross-sectional area loss | 00:00:05 | | 3 |

MH03 BR2\_-0-04m\_095437.jpg, 00:00:05, -0.04 m  
Settled deposits, fine, 5% cross-sectional area loss

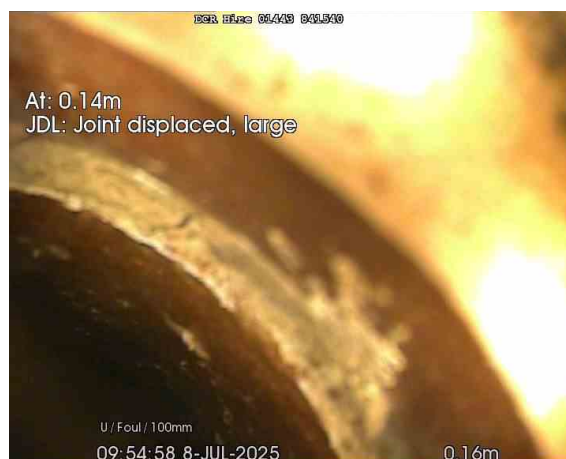
MH03 BR2\_0-16m\_095458.jpg, 00:00:16, 0.16 m  
Joint displaced, large

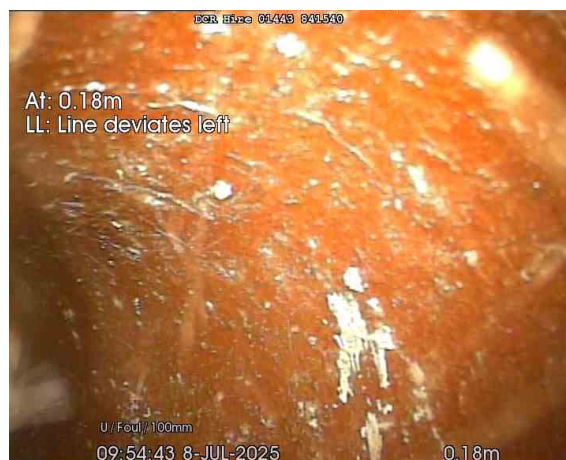
MH03 BR2\_0-18m\_095443.jpg, 00:00:07, 0.18 m  
Line deviates left

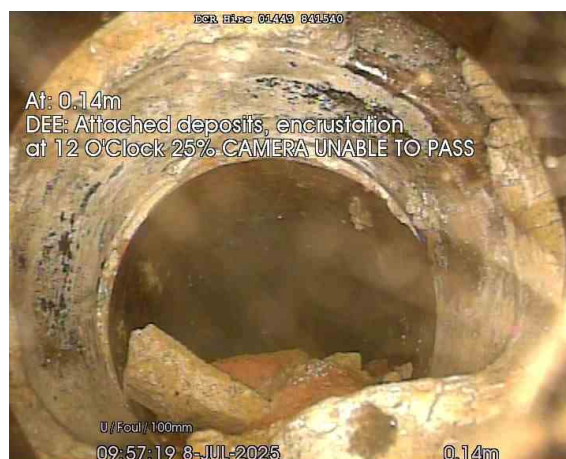
MH03 BR3\_0-14m\_095719.jpg, 00:00:33, 0.14 m  
Attached deposits, encrustation at 12 o'clock, 25% cross-sectional area loss, CAMERA UNABLE TO PASS

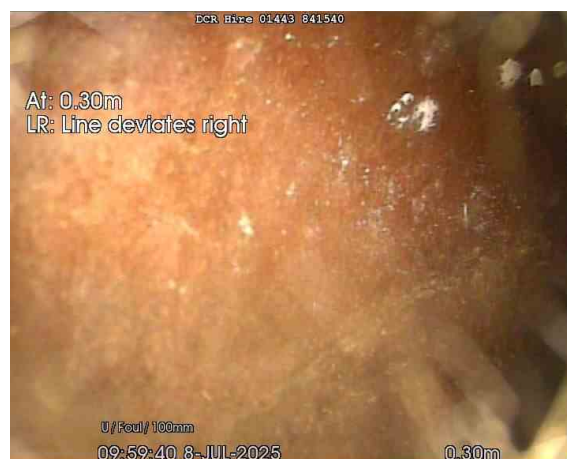
MH03 BR4\_0-30m\_095940.jpg, 00:00:13, 0.30 m  
Line deviates right

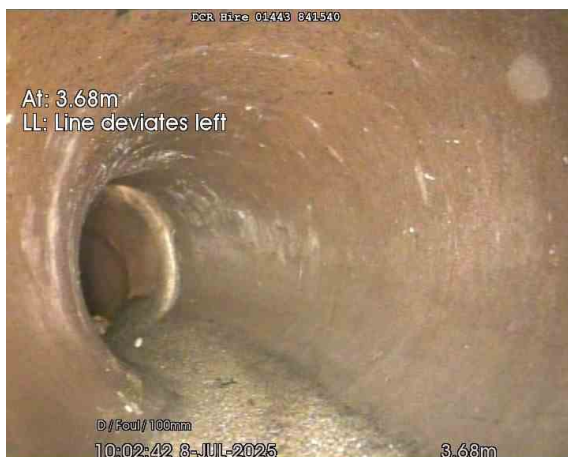
MH03 DS\_3-68m\_100242.jpg, 00:00:26, 3.68 m  
Line deviates left

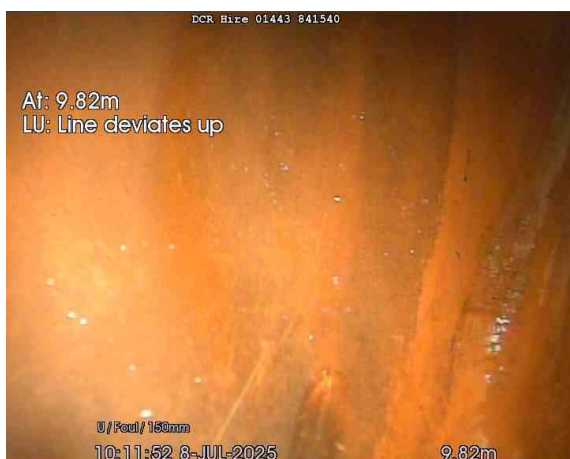
MH04 BR1\_9-82m\_101152.jpg, 00:00:50, 9.82 m  
Line deviates up

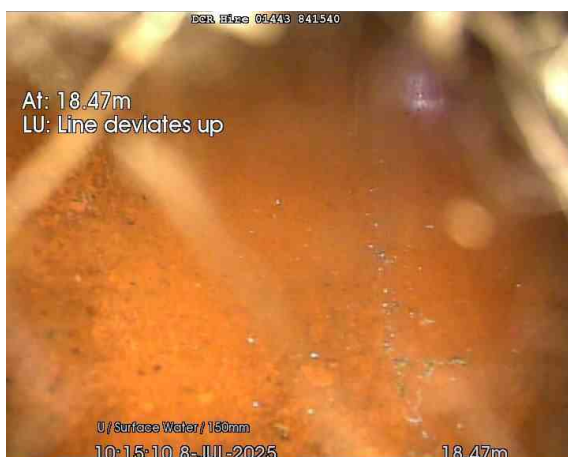
MH04 US\_18-47m\_101510.jpg, 00:01:07, 18.47 m  
Line deviates up

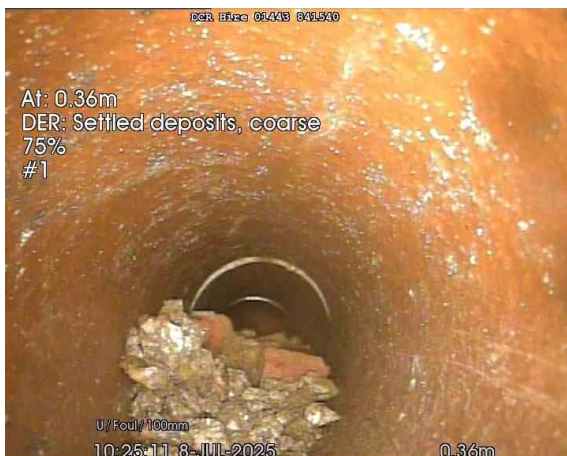
MH05 BR3\_0-36m\_102511.jpg, 00:00:10, 0.36 m  
Settled deposits, coarse, 75% cross-sectional area loss, start

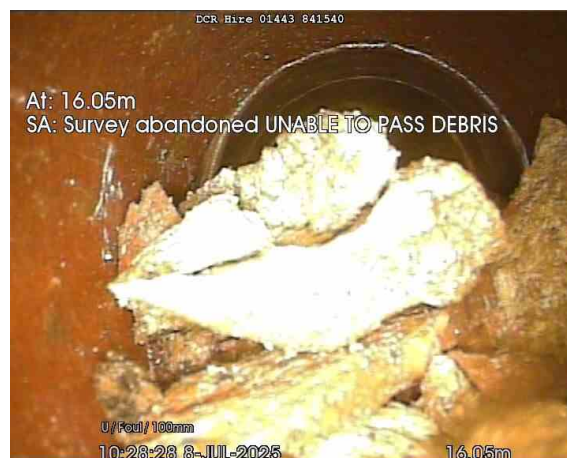
MH05 US\_16-05m\_102828.jpg, 00:01:01, 16.05 m  
Survey abandoned, UNABLE TO PASS DEBRIS

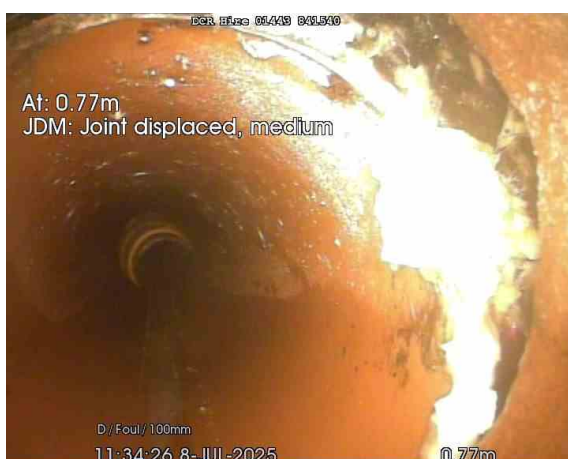
MH06 DS\_0-77m\_113426.jpg, 00:00:12, 0.77 m  
Joint displaced, medium

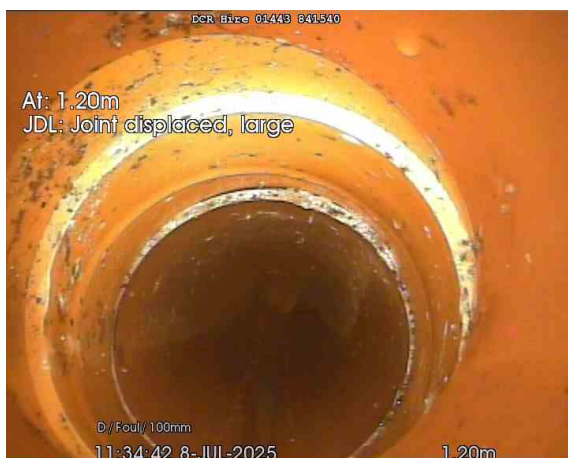
MH06 DS\_1-20m\_113442.jpg, 00:00:18, 1.20 m  
Joint displaced, large

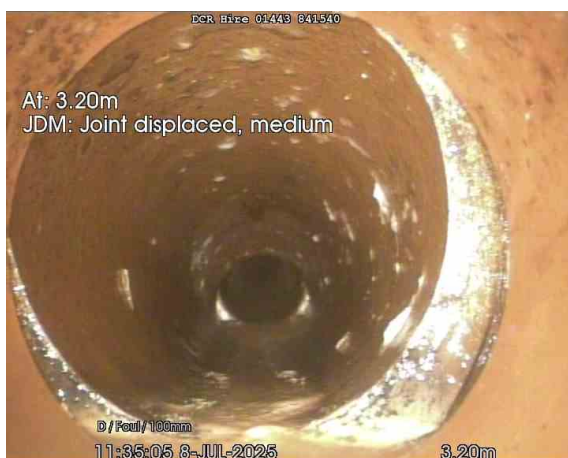
MH06 DS\_3-20m\_113505.jpg, 00:00:32, 3.20 m  
Joint displaced, medium

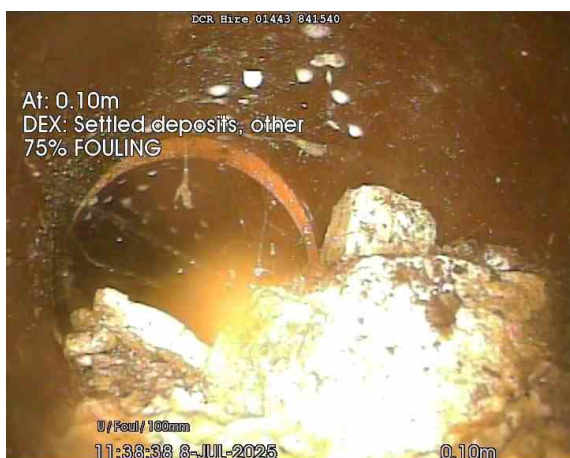
| Scale: | 1:50 | Position [m] | Code | Observation | MPEG | Photo | Grade |
|---|---|---|---|---|---|---|---|
| | | 0.10 | DEX | Settled deposits, other, 75% cross-sectional area loss: FOULING | 00:00:06 | | 4 |

MH06 US\_0-10m\_113838.jpg, 00:00:06, 0.10 m  
Settled deposits, other, 75% cross-sectional area loss,  
FOULING

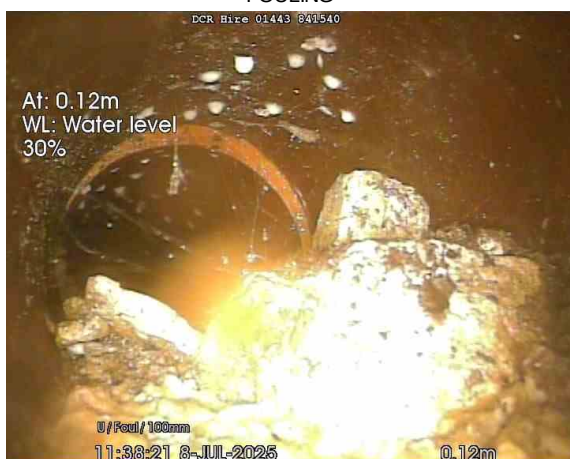
MH06 US\_0-12m\_113821.jpg, 00:00:04, 0.12 m  
Water level, 30% of the vertical dimension

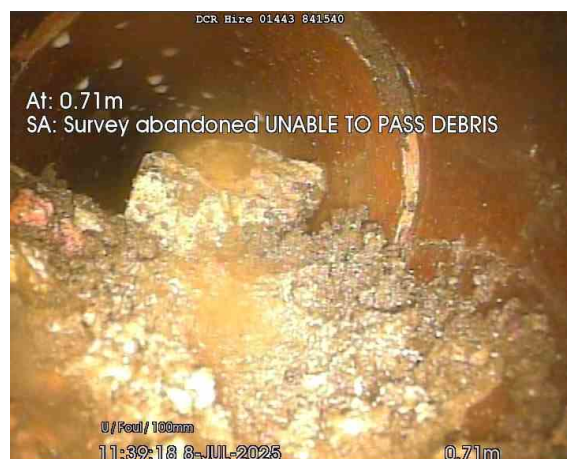
MH06 US\_0-71m\_113918.jpg, 00:00:16, 0.71 m  
Survey abandoned, UNABLE TO PASS DEBRIS

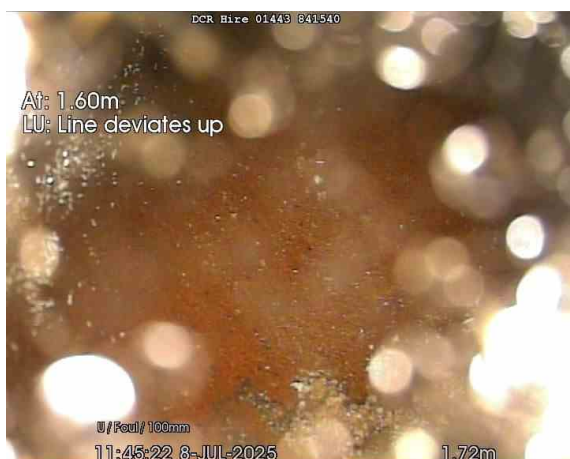
MH06 BR3\_1-74m\_114522.jpg, 00:00:12, 1.74 m  
Line deviates up

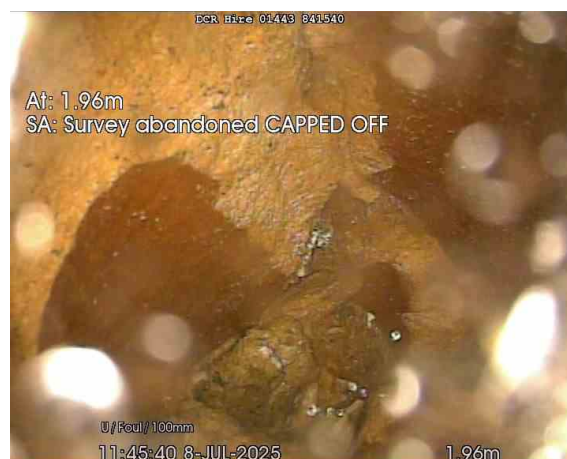
MH06 BR3\_1-96m\_114540.jpg, 00:00:18, 1.96 m  
Survey abandoned, CAPPED OFF

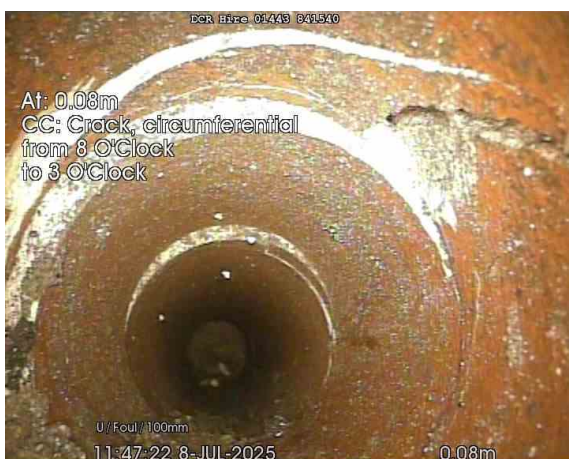
| Scale: | 1:50 | Position [m] | Code | Observation | MPEG | Photo | Grade |
|---|---|---|---|---|---|---|---|
| | | 0.08 | CC | Crack, circumferential from 8 o'clock to 3 o'clock | 00:00:05 | | 2 / 2 |

MH06 BR4\_0-08m\_114722.jpg, 00:00:05, 0.08 m  
Crack, circumferential from 8 o'clock to 3 o'clock
