# Site Investigation Report

192760.1.USI

Auger were commissioned by Questgates to undertake a site investigation and CCTV inspection of the underground drainage within the area of concern (AOC) at the property.

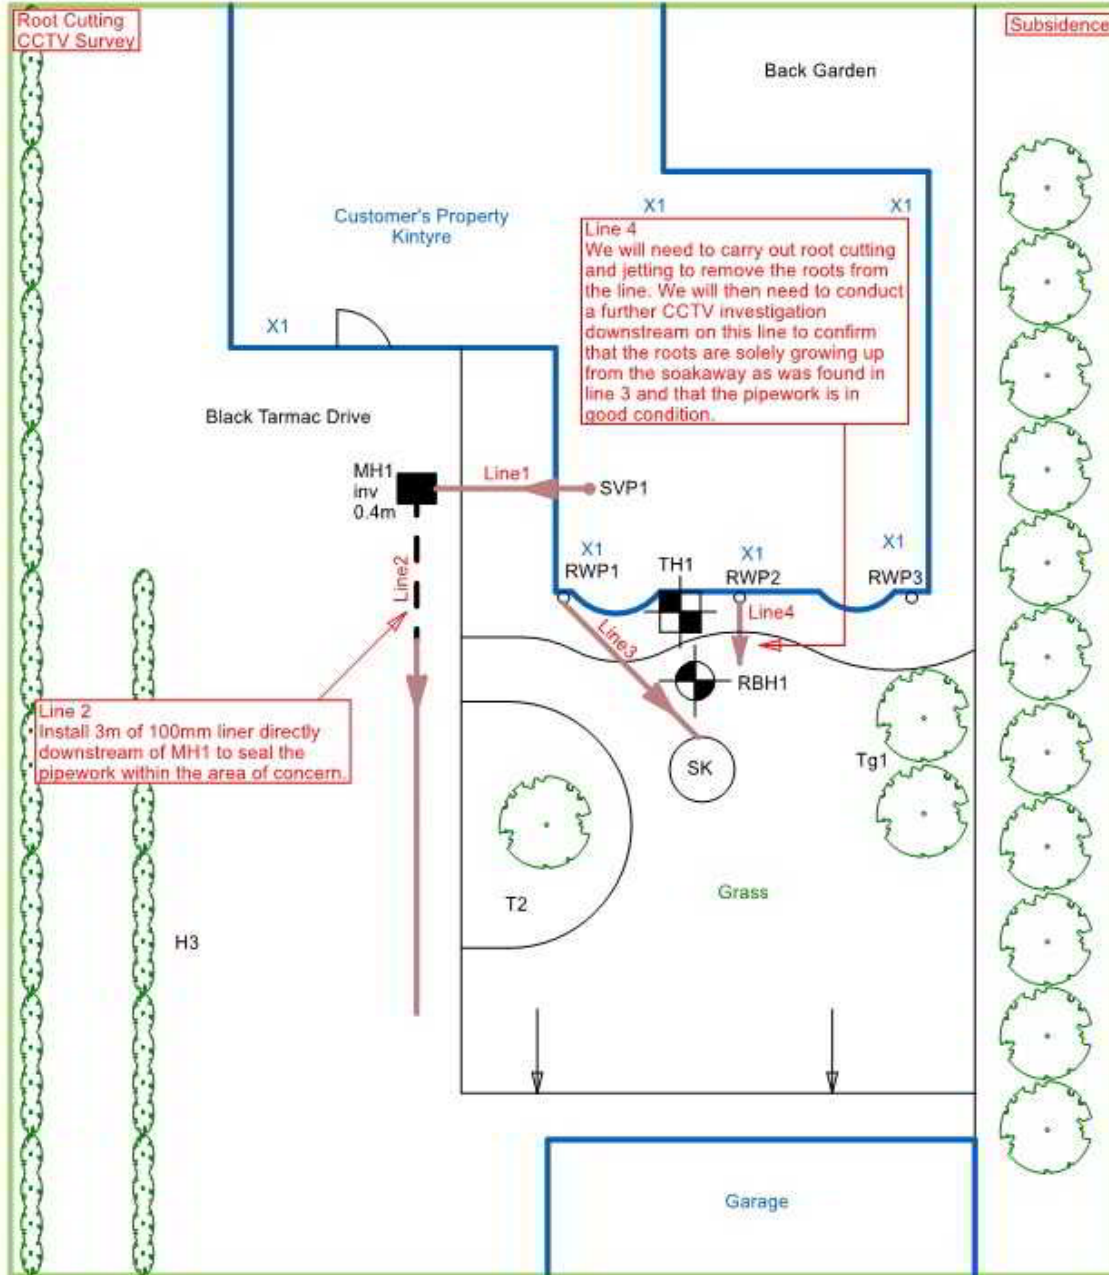
Our survey of line 2 revealed minor joint displacements and cracking within the 3m of 100mm pipework downstream of the manhole, within the area of concern.

Our survey of line 4 revealed root ingress within the plastic pipework. We suspect that this line, like line 3, runs to a soakaway located within the front garden and that the roots have grown up from the soakaway. However, we had run out of time of site to attempt to root cut this line to confirm this. We therefore propose that this line is further investigated to confirm that the roots have not penetrated the plastic pipework and that they are solely growing up from the soakaway.

| Refer Back to Client | <p>It is recommended that the following repairs are carried out to prevent an escape of water from the system:</p> <p><b>Line 2</b><br/>Install 3m of 100mm liner directly downstream of MH1 to seal the pipework within the area of concern.</p> <p><b>Line 4</b><br/>We will need to carry out root cutting and jetting to remove the roots from the line. We will then need to conduct a further CCTV investigation downstream on this line to confirm that the roots are solely growing up from the soakaway as was found in line 3 and that the pipework is in good condition.</p> <p>Please note that the further CCTV investigation may reveal additional defects to the drainage system. This will be reported whilst on-site and could potentially cause an increase in repair costs and provide further inconvenience to the customer/occupants.</p> <p>We will now refer the claim back to the client in order to progress the claim.</p> |

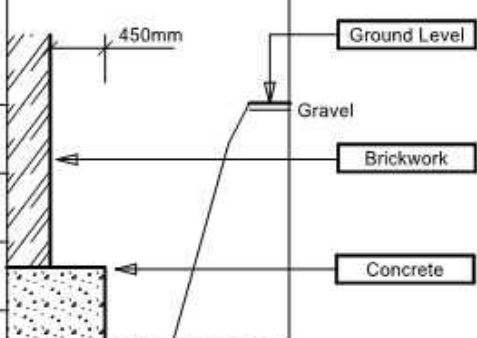
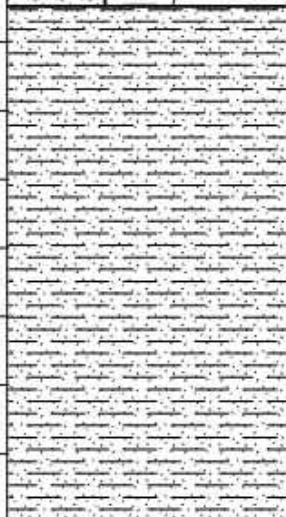
TH1 was undertaken in the desired location, we were able to expose the footings but we were unable to reach the required depth in TH1 because we encountered impenetrable ground consisting of fill material which our engineer could not auger through at 0.7m below ground level. Due to this we then carried out a borehole, stepped back from the trial hole, which our engineer was able to reach a depth of 1.1m within and we collected the requested soil and root samples from the borehole.

| Depth<br>(m) | Symbolic Log | Strata Description | Insitu Tests | | Soil<br>Sample | Root<br>Sample |
|---|---|---|---|--|---|---|
| 0.5 | | Very dry hard brown grey fine<br>to medium gravelly silty CLAY | 150kpa | | Soil<br>@ 0.6m | Root<br>@ 0.6m |
| 1.0 | | TRIAL HOLE TERMINATED | 150kpa | | | |
