## **Arboriculture Single Tree Report**

174 Hiltingbury Road  
Chandlers Ford  
Eastleigh,  
Southampton,  
SO53 3NS

Prepared by: Bradley Street, Dip Arb I4 (ABC)  
Consultant Arborist

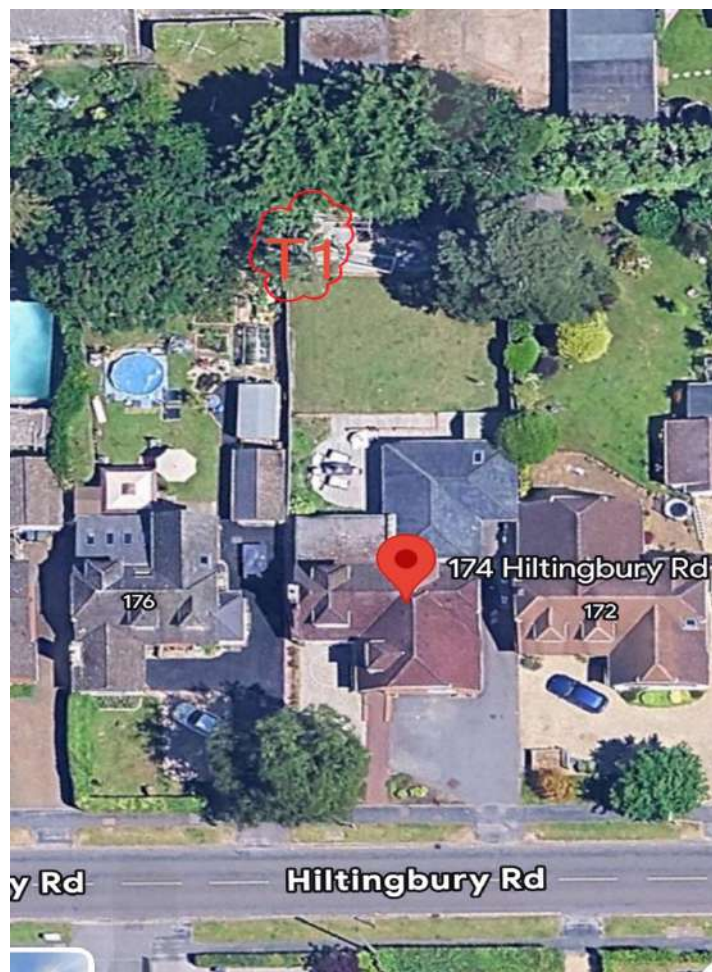
The subject tree (T1) is a Silver birch tree.

| Health | Tree is in a state of deep decline, with the majority of the canopy consisting of deadwood. |
| Structure | The tree is in severe decline, and the structure may be compromised due to the extent of dead and dying timber. |
| Target | If it were to fail, it could damage the seating area and the garden room. |
| Risk rating | High |

| Comment | Tree is in very poor condition and should be felled on safety grounds. |
| Recommendation | Given its location within a garden used by a person with special needs, the tree presents an increased safety risk. Recommend urgent consideration of removal. |
