## Arboricultural Appraisal Report

### Subsidence Damage Investigation at:

38 Fircroft Drive  
Chandler's Ford  
Eastleigh  
SO53 2HE

| MWA REF: | SUB251029-17086 |

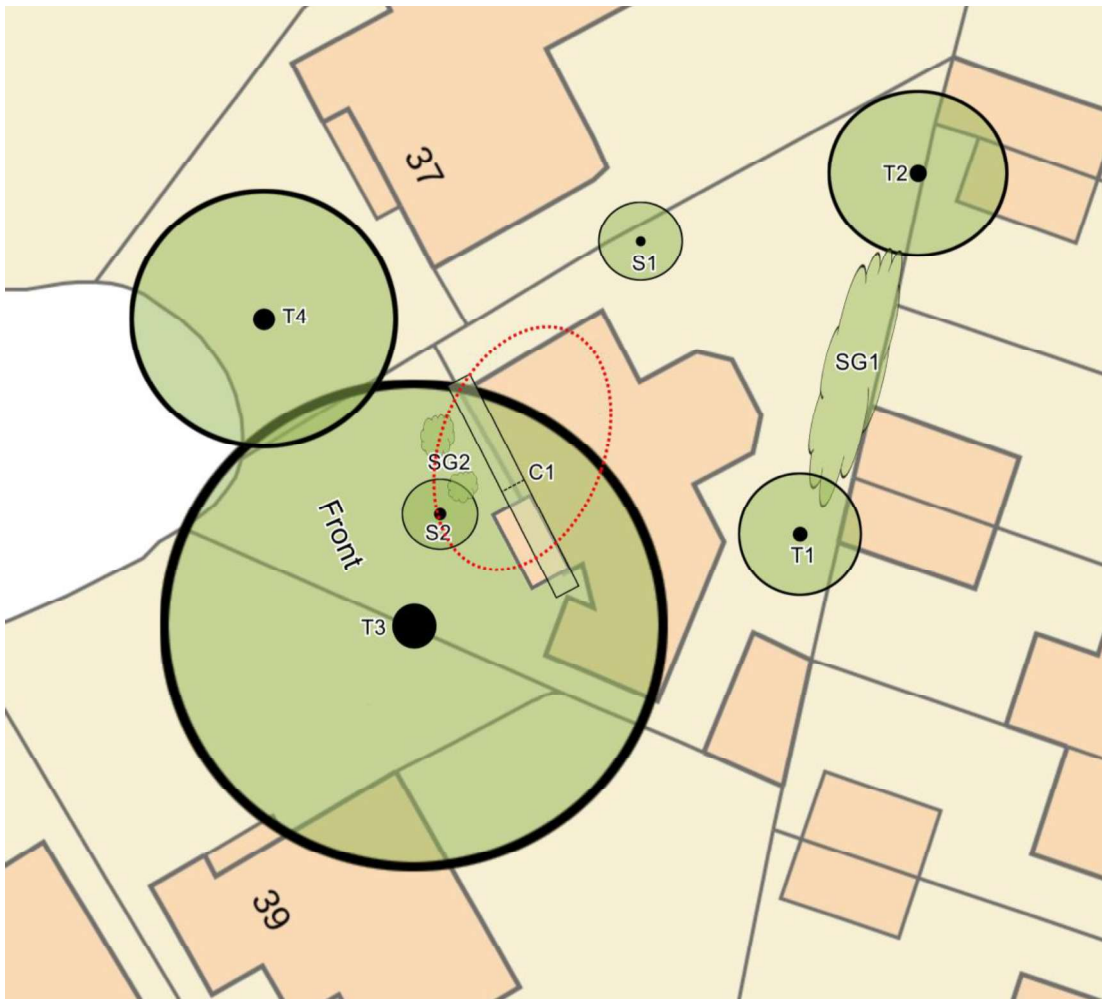
Damage relates to the front left-hand corner, the left-hand flank and the rear elevation. Further details of the damage can be obtained from Trinity Claims.

Approximate areas of damage
