# **Piling risk assessment**

## **Land east of Knowle Lane**

### **Fair Oak**

**April 2018**

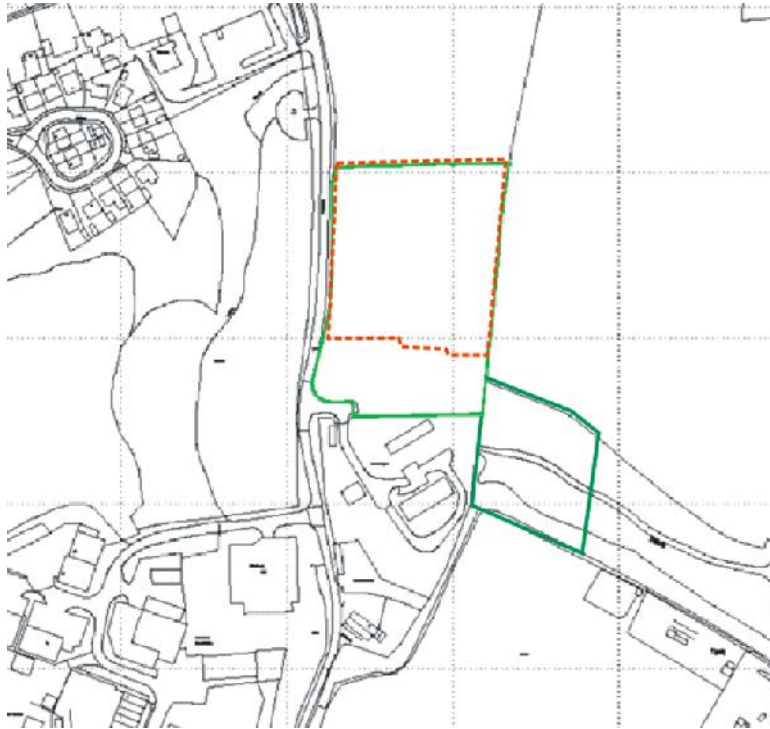
**Figure 1: Site location**

The site is located in Fair Oak, approximately four miles to the east of Eastleigh. The location of the site is shown in Figure 1, with the area covered by this report and the planning permission bounded in green. The area intended for residential development is bounded in red.

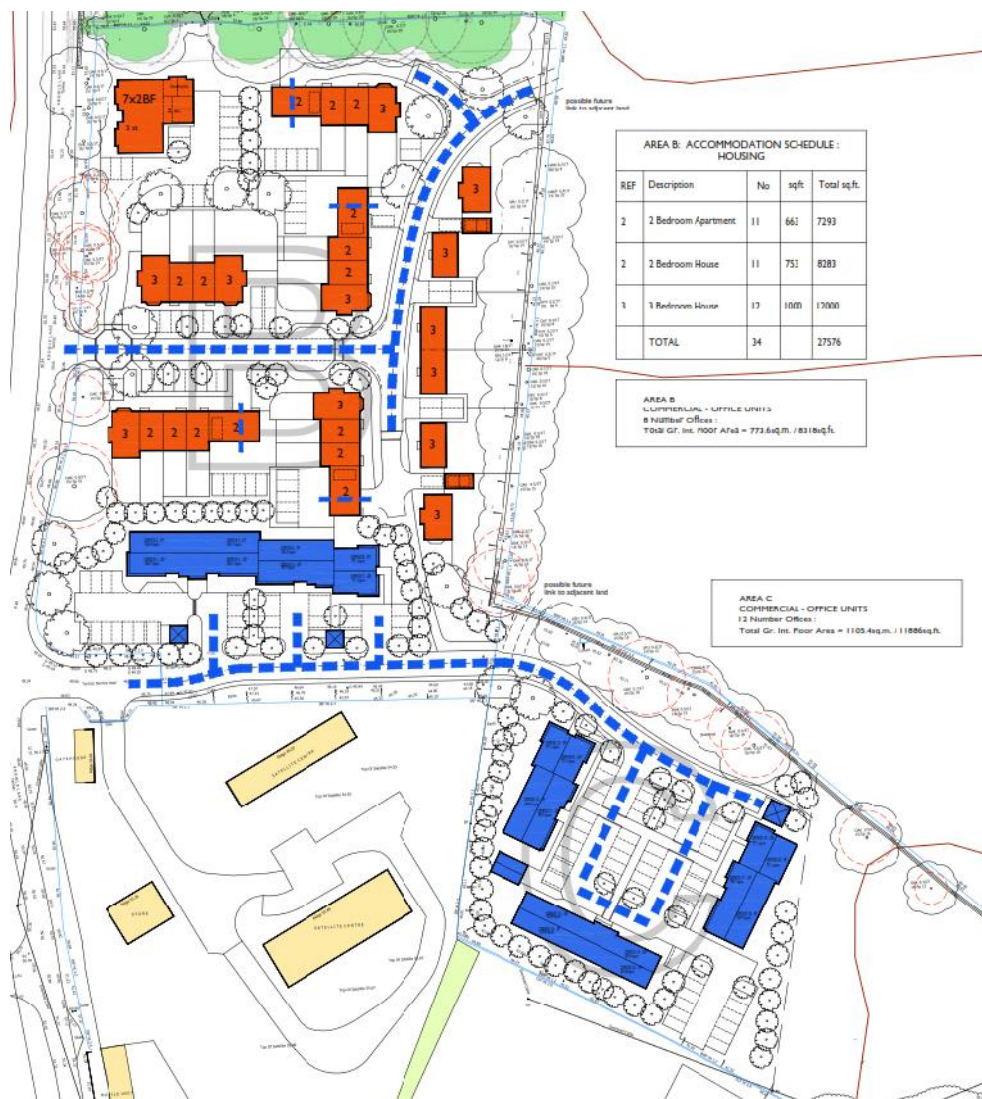
Figure 2: Proposed hybrid development layout

The site extends to approximately 2 Hectares and is approximately centered at National Grid Reference 450600 118520. The proposed hybrid development layout is illustrated in Figure 2, with the residential units represented in orange, and the commercial units in blue.
