# Arboricultural Method Statement

Highwood Homes Limited

Moorhill

Moorhill, Moorhill Road, West End,  
Eastleigh, SO30 3AZ

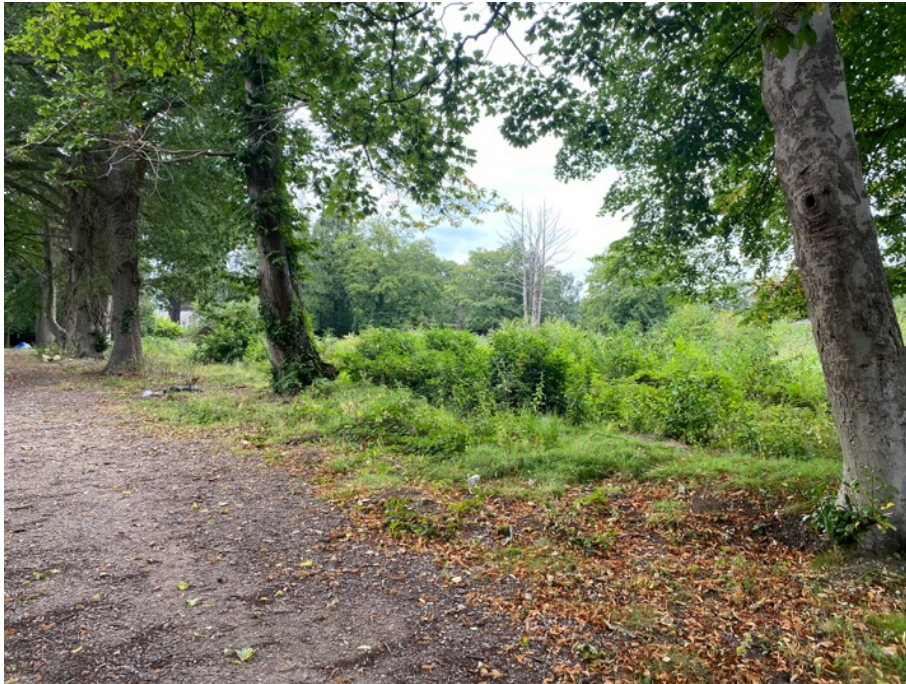
- 3.2 **Photograph 1:** A view of the site from the southeast

- 3.1 The site is located on the eastern side of Moorhill Road (A27) just to the south of the junction with Telegraph Road. The site is a previously developed site, that has since been demolished and is now unused. The site attracts fly tipping and anti-social behaviour.

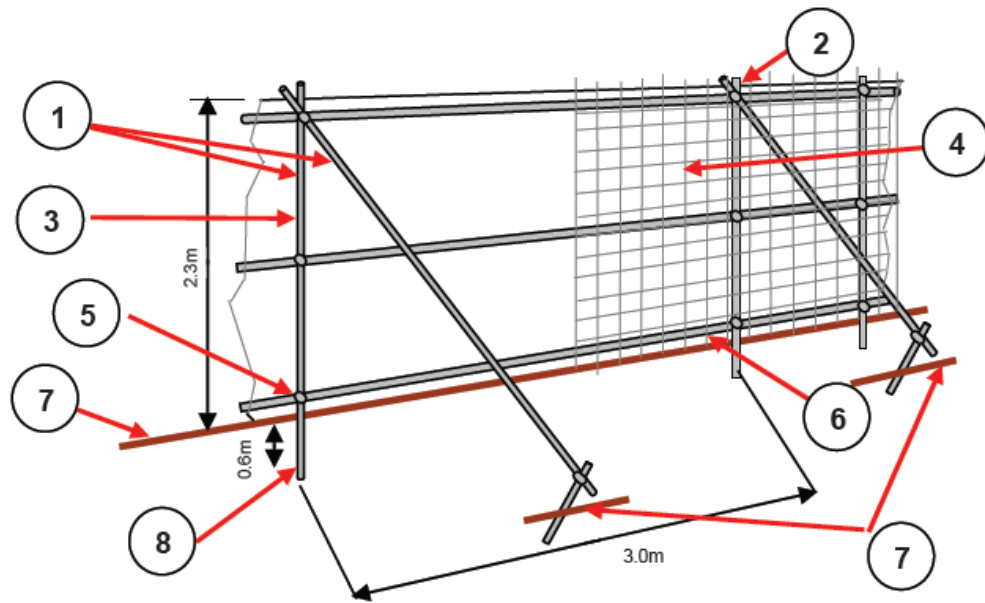
**Figure 1:** Protective Barrier

The barrier is to comprise of a vertical and horizontal framework, well braced to resist impacts, with vertical tubes spaced at a maximum interval of 3m. Onto this, weldmesh panels should be securely fixed with wire or scaffold clamps.

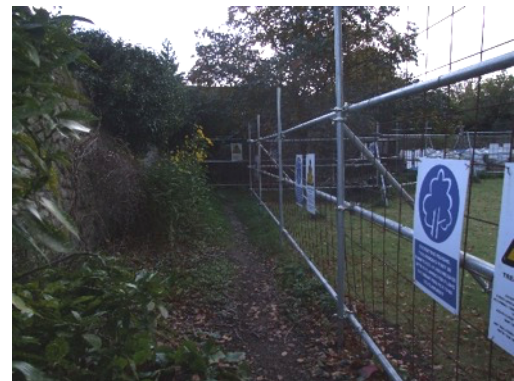
Example of protective barrier:

1. Standard scaffold poles
2. Uprights to be driven into the ground
3. Panels secured to uprights with wire ties and where necessary standard scaffold clamps
4. Weldmesh wired to the uprights and horizontals
5. Standard clamps
6. Wire twisted and secured on inside face of barriers to avoid easy dismantling
7. Ground level
8. Approximately 0.6m driven into the ground

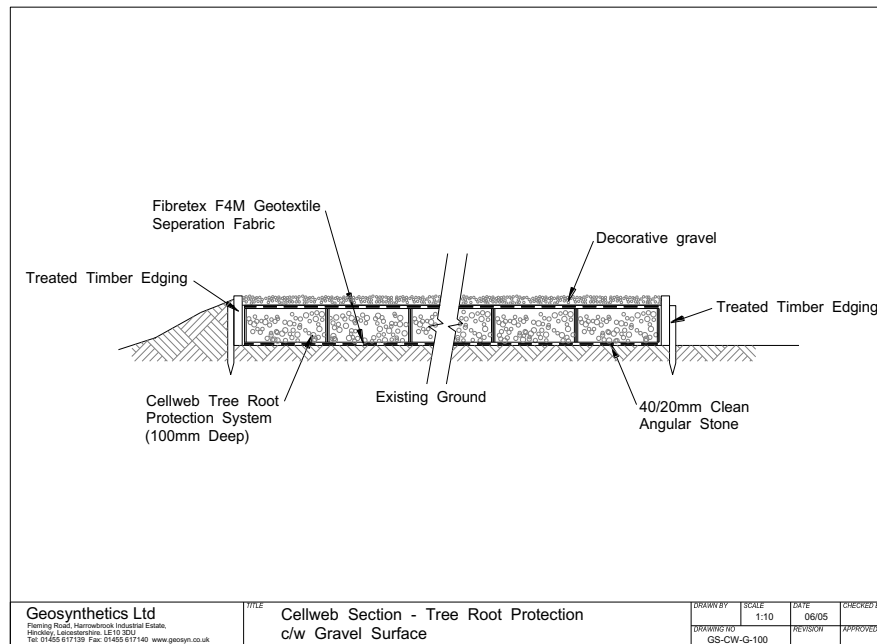
15.4 **Figure 2:** Cross section of 'No Dig' hard surface

- 15.1 Plan JFA0289.03 TPP appended at JF3 indicates where no-dig hard surfaces are to be installed within the RPA's of retained trees. The 'No Dig' hard surface shall be created from Geosynthetics Cellular Confinement system, Cellweb or similar product.
- 15.2 The 'No Dig' hard surface shall be installed in accordance with the manufacturers method statement. New surfacing is proposed within the RPA's of existing retained trees, which has the potential to cause harm if not specified and implemented with care.
- 15.3 I am confident that the proposed 'No Dig' hard surface can be installed without causing significant harm to the existing trees. This surface solution is within the recommendations set out in BS5837:2012 and would be appropriate in this situation.

This guidance describes the procedure required to undertake the installation of hard surfacing, i.e. footpath, whilst exerting no adverse effects on the roots of trees to be retained. It is essential to maintain adequate supplies of water and oxygen for trees through the soil. Porosity is important, particularly where the new hard surface covers an area of previously unmade ground, under which tree roots may have developed. Where hard surfacing passes beneath the tree's canopy, or where it encroaches upon the Construction Exclusion Zone (CEZ) of retained trees, a porous 'no dig' method of construction will be required. The construction has been engineer designed and consists of a non-clogging gas and water permeable surface and sub-base. This will incorporate a three-dimensional cellular confinement system to prevent future rutting and underlying ground compaction.

- PPE as required by the Site Supervisor
- Cellular confinement system
- Stapler and staples
- Staking pins
- Separation geotextile membrane
- Edge restraints
- **Infill aggregate (angular granular 40-20mm no fines)**
- Wearing course - Hard core for duration of use and then removed.

The soil surface will not be skimmed to establish new surfaces at the former ground level, as this has the potential to cause root damage. Therefore, loose organic matter and/or turf will be removed carefully using hand tools, and the new surface established above the former ground level, using a granular fill where required.

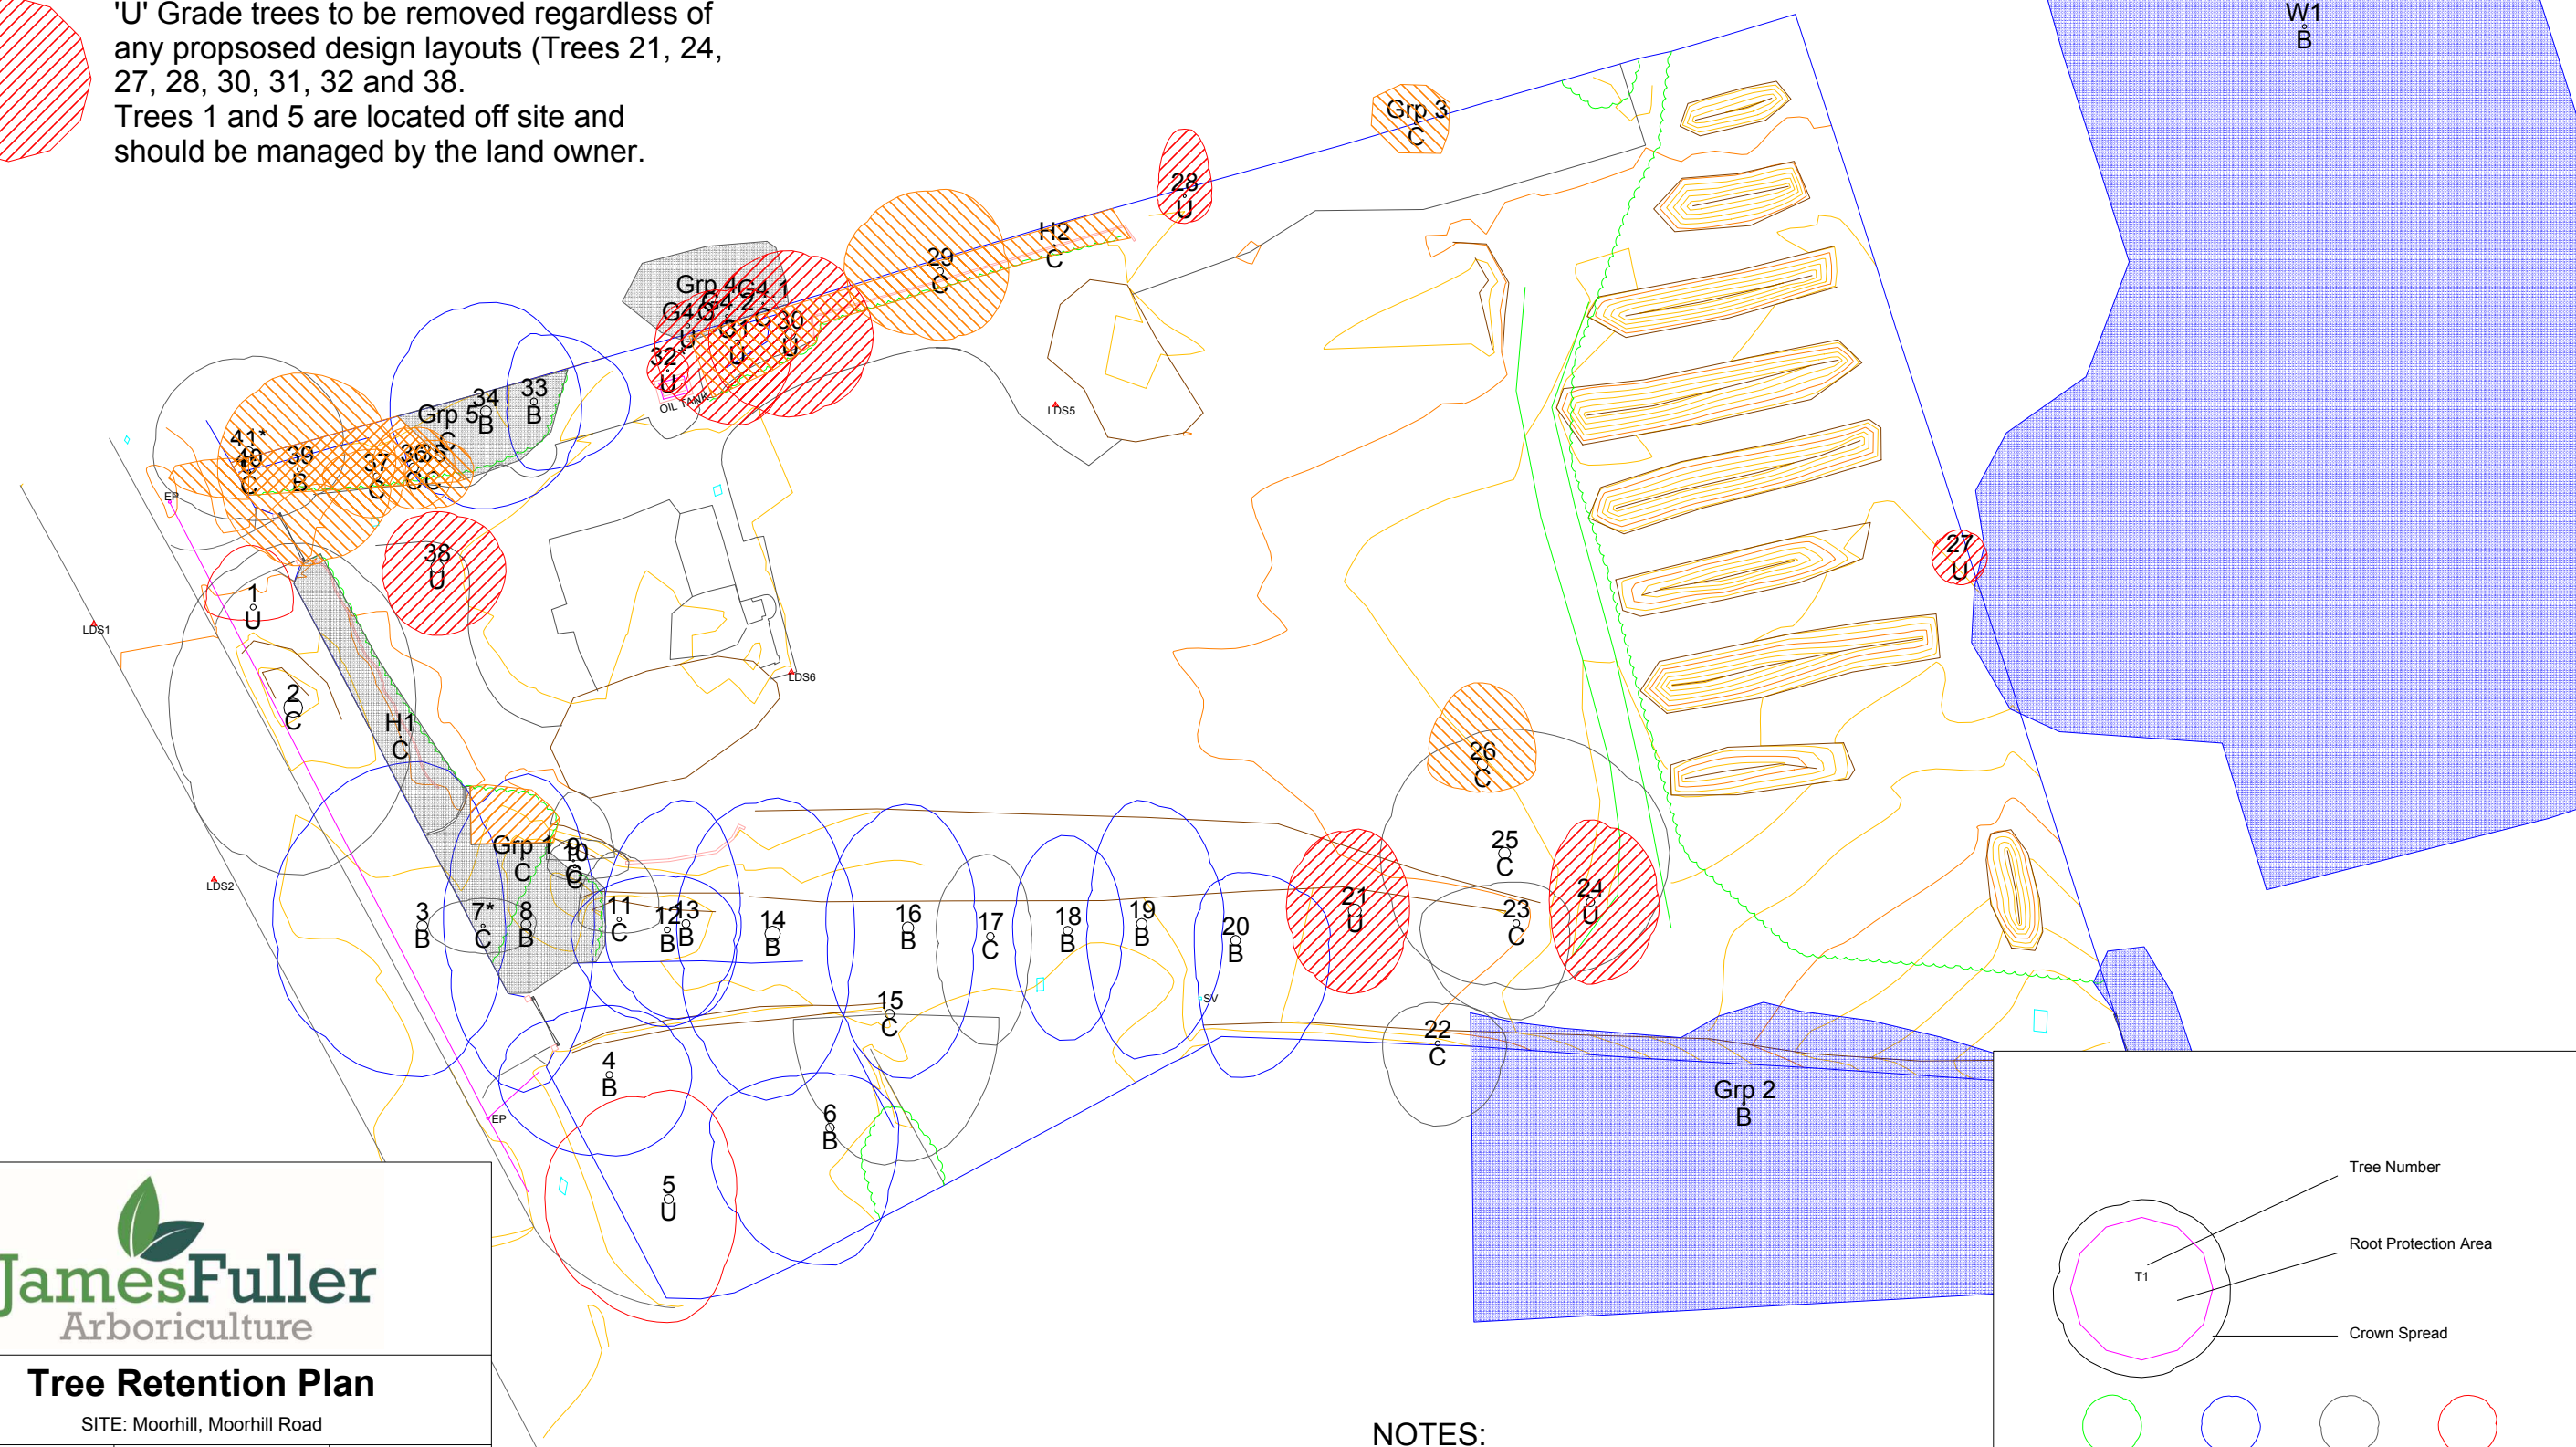
## Tree Retention Plan

Trees 26, 29, 35, 36, 37, 39 and 40, Group 3, Sections of Groups 1 and 5 and Hedge 2

'U' Grade trees to be removed regardless of any proposed design layouts (Trees 21, 24, 27, 28, 30, 31, 32 and 38).

Trees 1 and 5 are located off site and should be managed by the land owner.

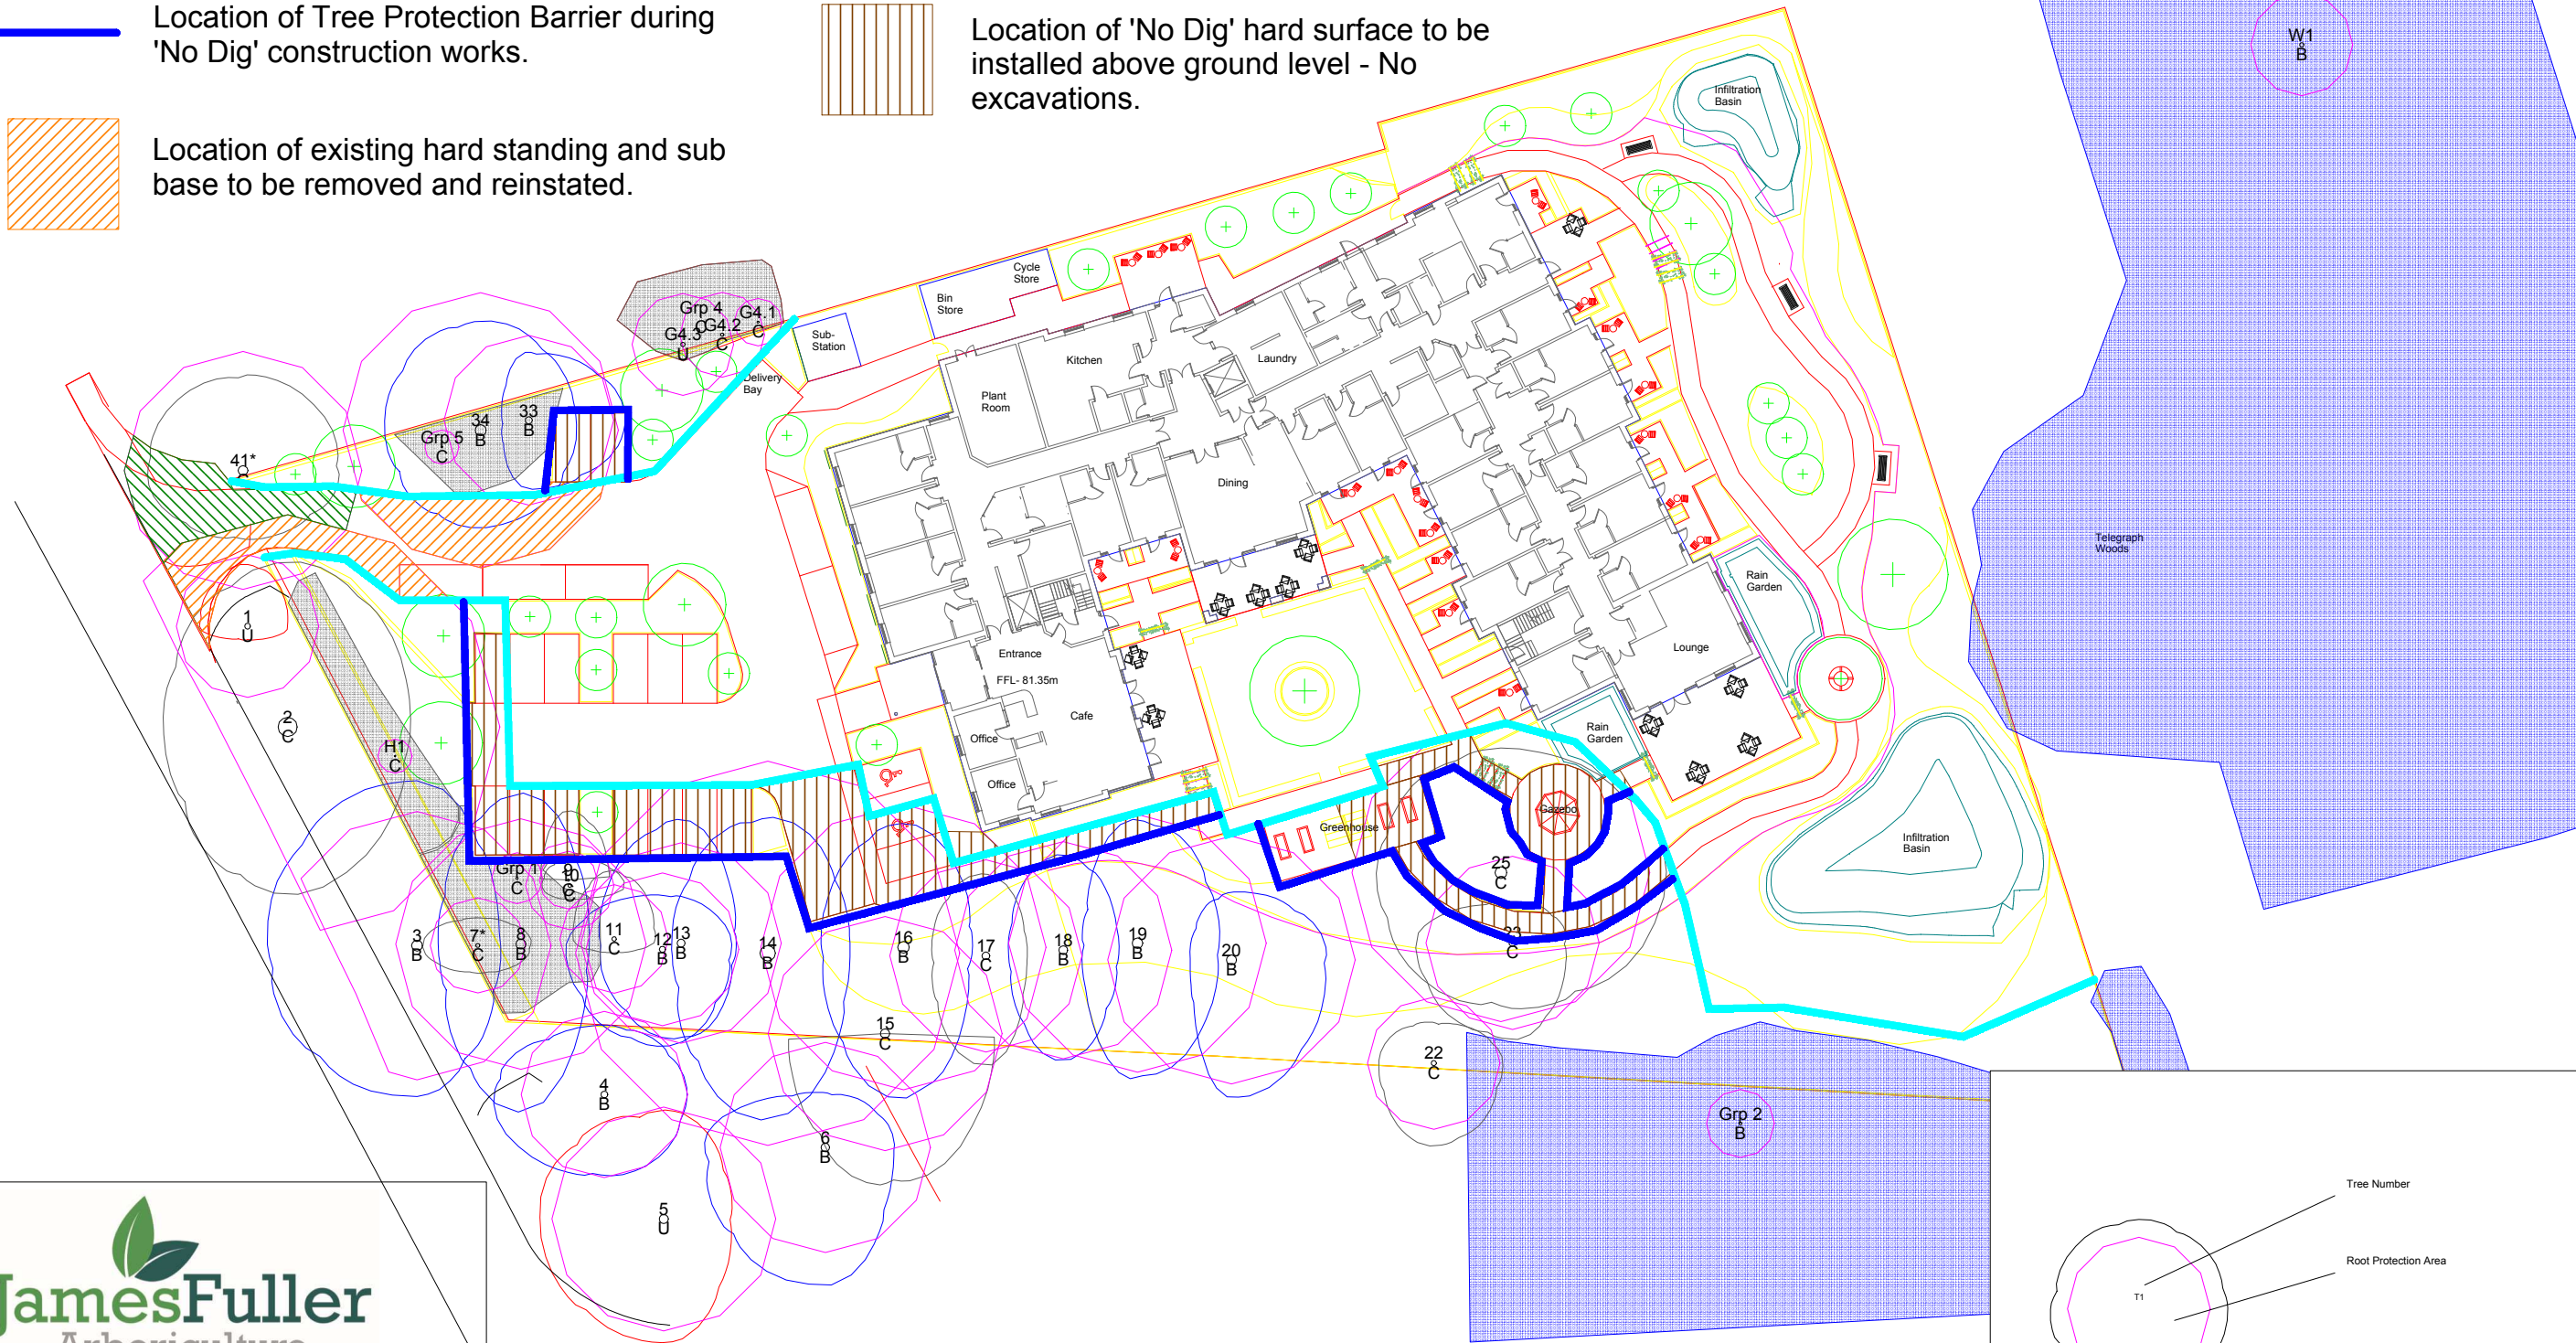
## Tree Protection Plan

- Location of Tree Protection Barrier for main site works, to be constructed as detailed within section 11 of the AMS
- Location of Tree Protection Barrier during 'No Dig' construction works.
- Location of existing hard standing and sub base to be removed and reinstated.

- Location of excavations for new access road and services, to be supervised by retained arboricultural consultant.
- Location of 'No Dig' hard surface to be installed above ground level - No excavations.

This Arboricultural Method Statement (AMS) demonstrates the protection measures for the retained trees and should be read in association with the Tree Protection Plan JFA0289.03 TPP appended at JF3. This report follows the initial tree survey, implications assessment and on-going discussions to minimise the impact upon the existing tree stock.

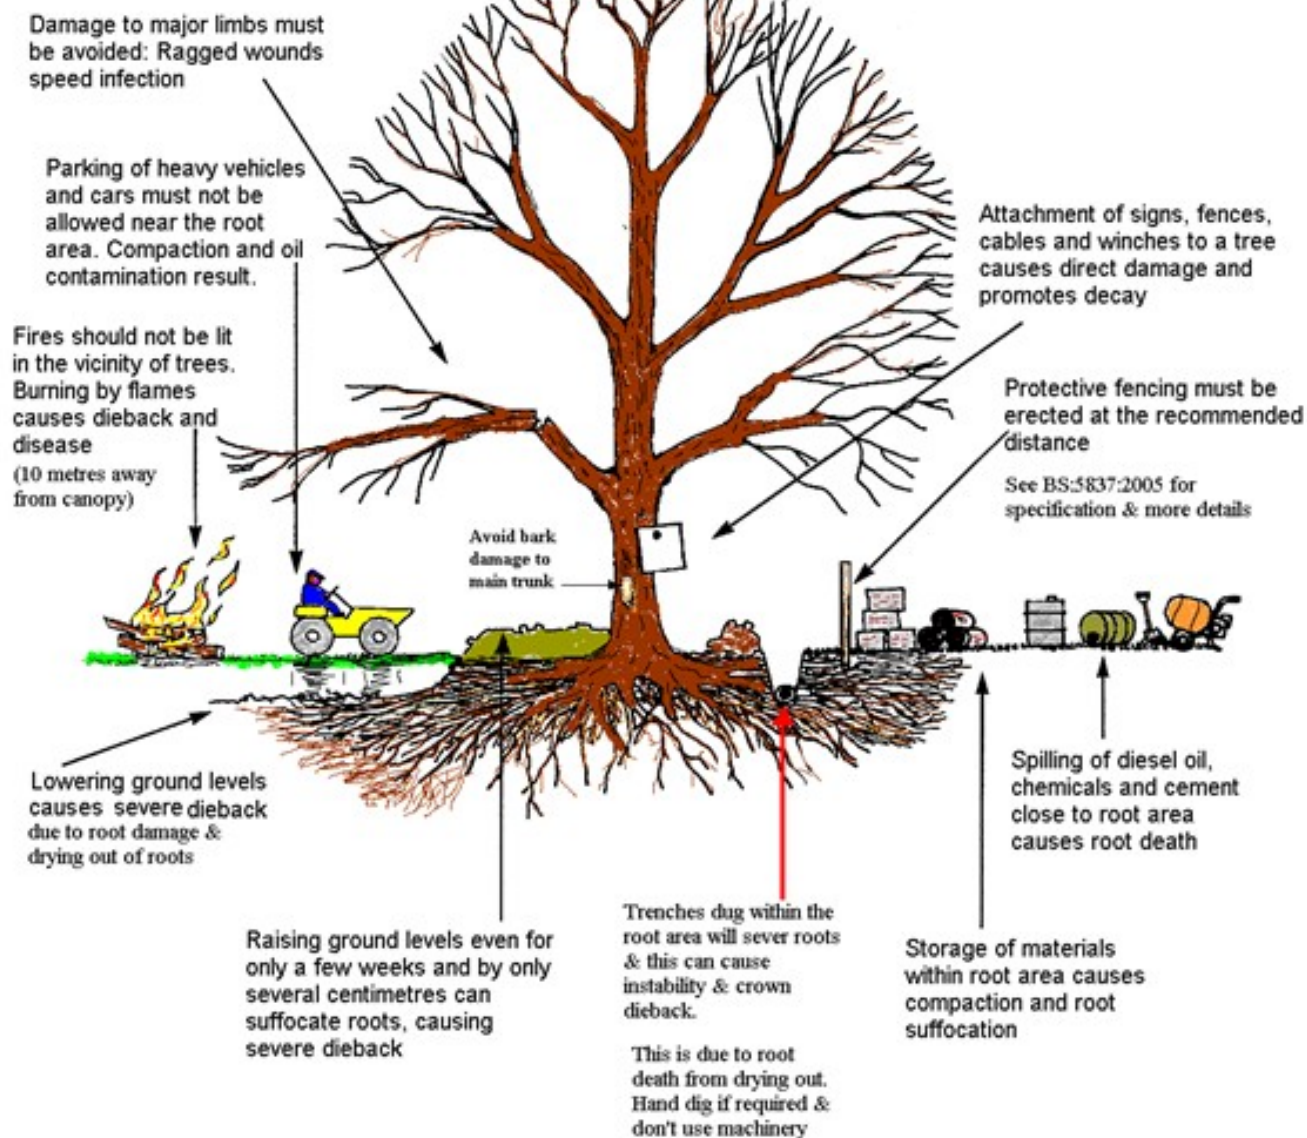
# Common causes of Tree Death

The use of properly positioned protective fencing can prevent tree deaths occurring.

*Please use copies of this as an on-site poster for personnel*

- 9.3 There is a Common causes of Tree Damage leaflet attached at JF5, it is recommended that leaflet is handed out to all contractors to make them aware of the potential actions carried out on site that could damage any retained trees. It is hoped that making all site operatives aware of how a tree can be damaged that this might help avoid retained trees being accidentally damaged.
