**HERITAGE STATEMENT**  
**Incorporating Design & Access Statement**  
Relating to  
**Extension and replacement outbuilding**  
at  
**Weymouth House, 148 Church Rd, Eastleigh**  
November 2022

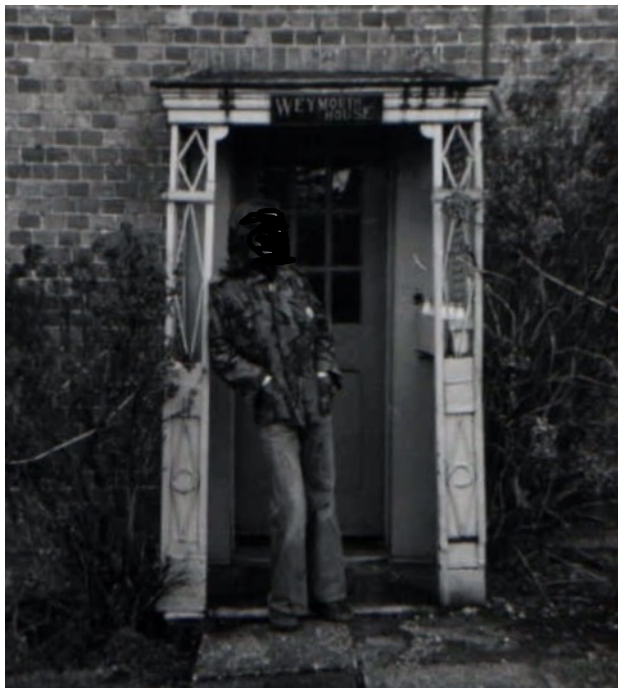
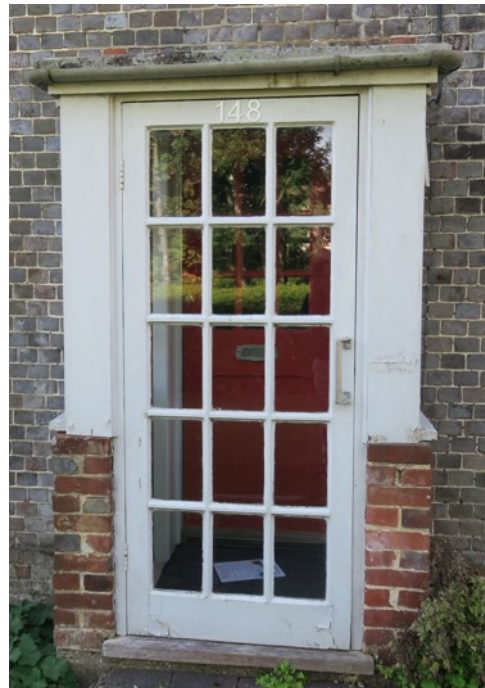
The trellis porch described in the listing is shown in the photograph below left, and has been replaced by the present inappropriate and poor-quality flat roofed timber porch, shown below right.

The inappropriate porch on the front elevation is to be removed and replaced with as close a copy as possible of the original trellis porch referred to in the listing, and shown in the only known photograph, on page 2. This will be purpose-made and detailed drawings can be provided under condition.

The current inappropriate porch is detrimental to the appearance of the front elevation from which most of the significance is derived. The reinstatement of the earlier porch, based on available evidence, is therefore entirely positive.

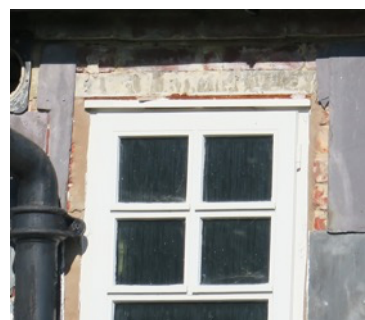
The slate hanging conceals the execution of the alterations to the openings, but where slates are missing it is clear that the work was not sensitively executed – see bathroom window, right.

In 1986, three years after listing, LBC was granted for “alterations to windows” but the associated documents are not available on line, so the scope of approved work is unclear. However, by inspection it is clear that the south first floor bathroom window opening, and the south and west kitchen window openings have been altered, and new windows fitted. The back door opening relates to the first of the C20 extensions, and the large patio door opening in the later C20 extension appears also to be an alteration. These latter openings are fitted with modern aluminium double glazed doors. The first floor south sash windows are very obvious modern replacements and do not follow historic detailing.

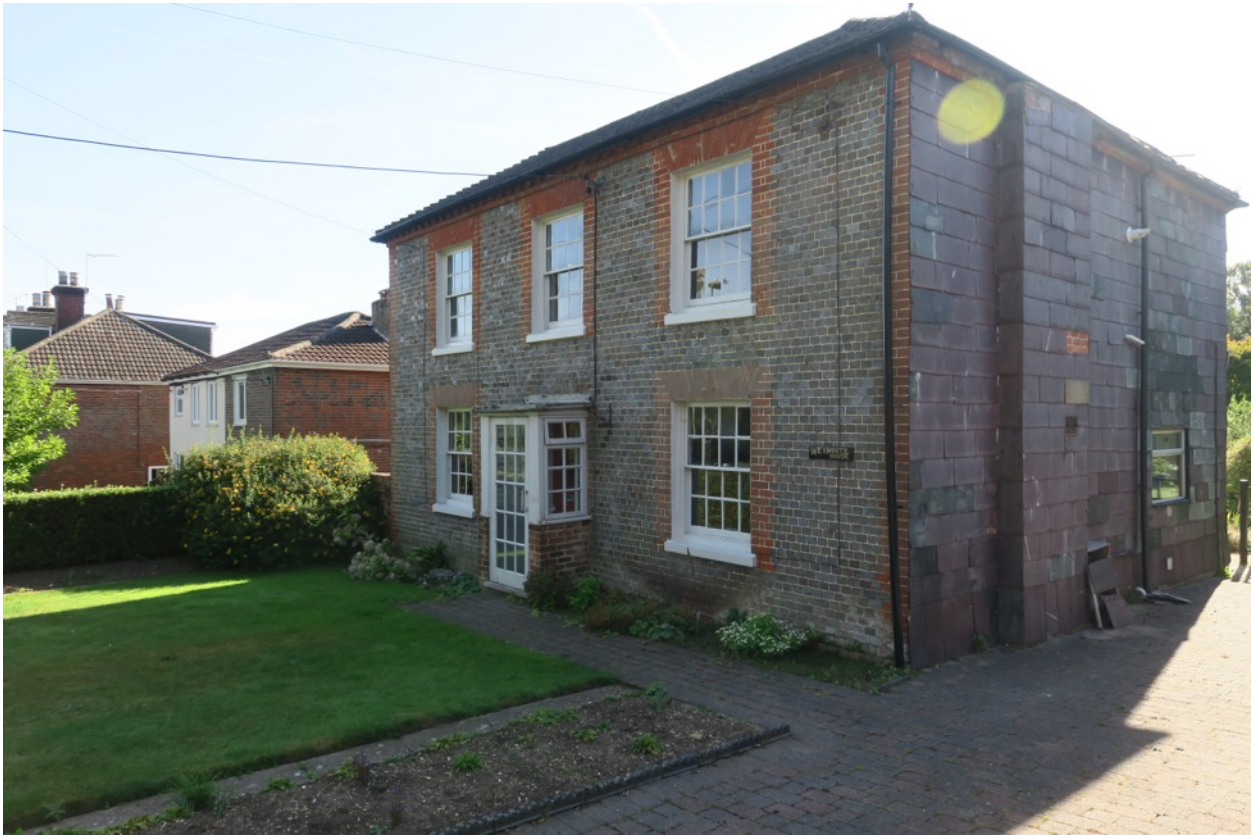
Front and side (west) elevations

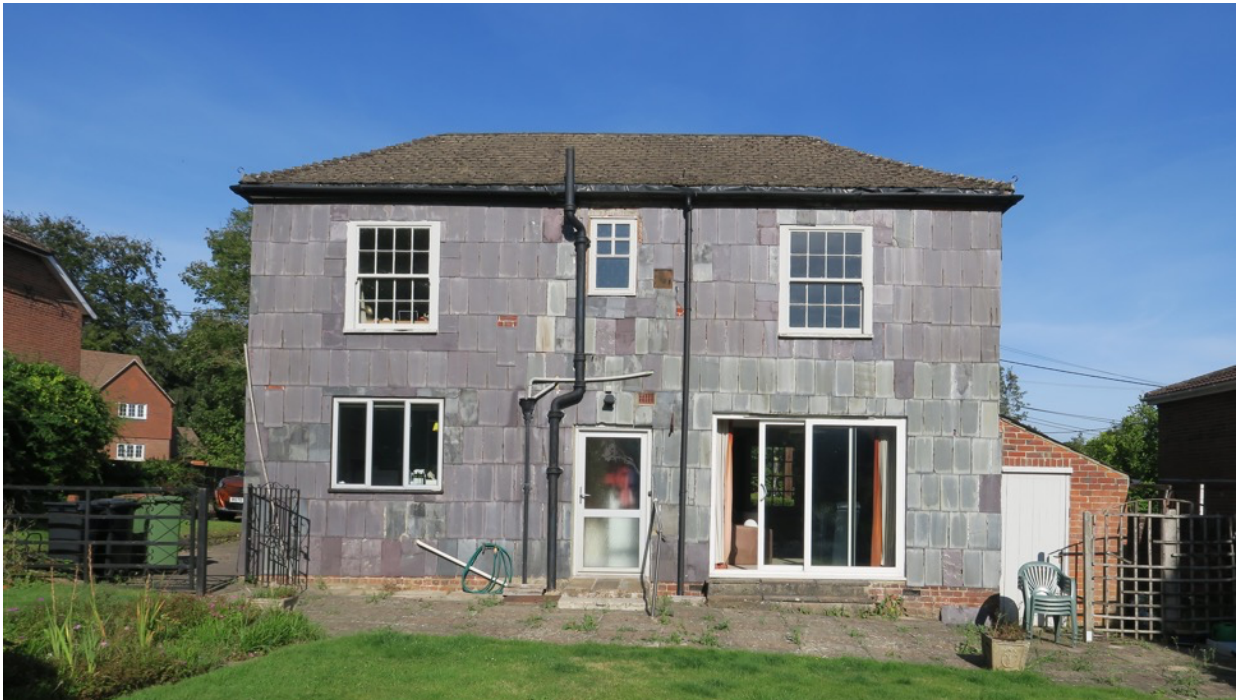
Rear elevation

The rear elevation of the property has been much altered over the building's history, including window and door opening alterations which may have had consent. The proposed extension requires minimal alteration to the ground floor external wall only, and the building fabric concerned dates from the C20 and is not original.

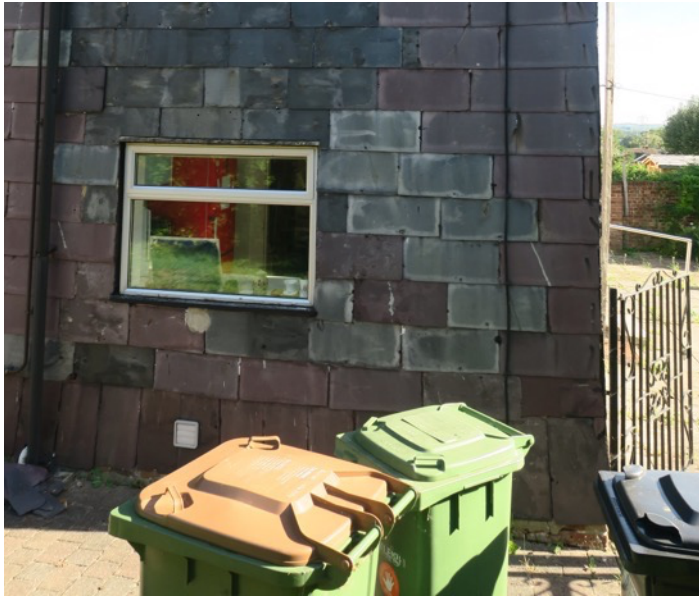
west elevation kitchen window

property rather than the original building fabric. On the west elevation the already altered window openings will be further adjusted to create a new side entrance, and side windows to bring additional light into the existing spaces. A further window will be added on the east elevation to bring light into the existing reception room.

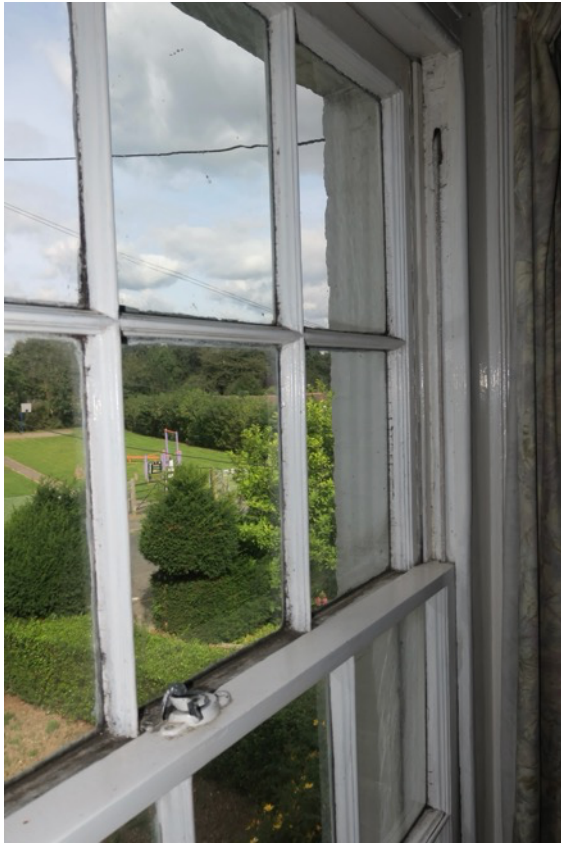
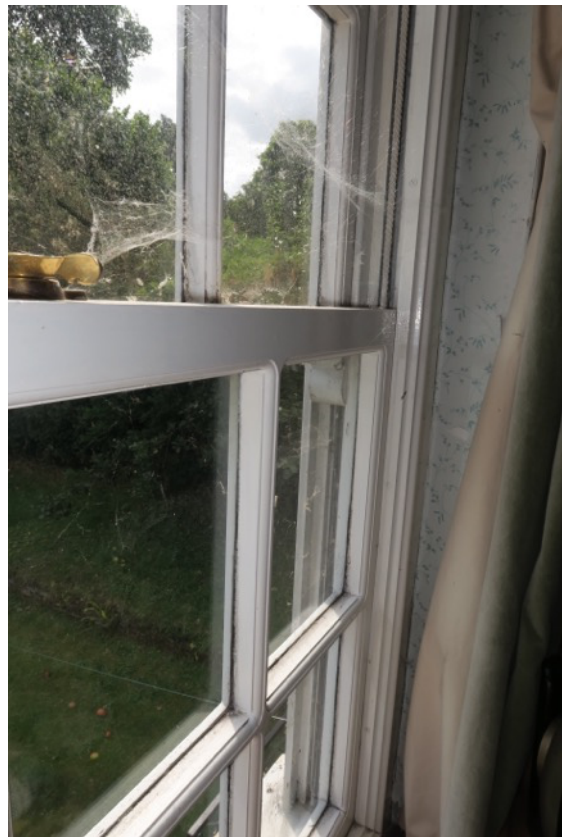
Front (left) and rear (right) sash windows; original front windows and remaining original glass contribute to significance.

Fortunately the original front elevation sash windows remain, some with original glass, and the brick detailing around the window openings is in good condition and original.

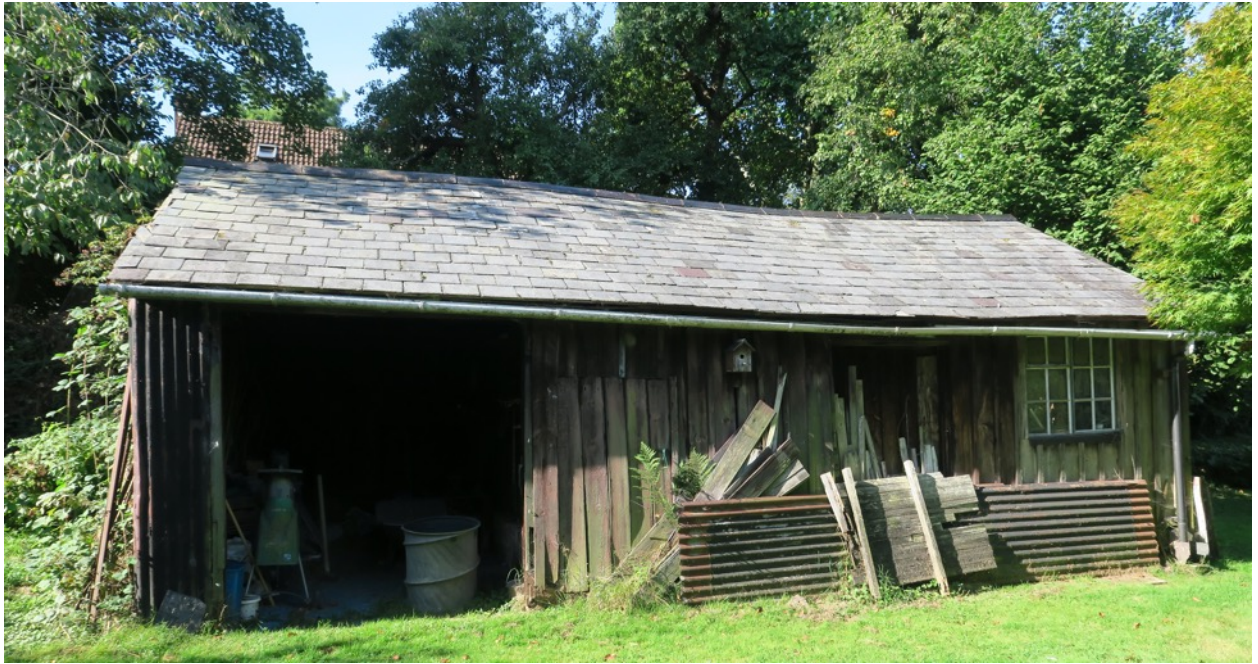
Outbuilding – see structural report for more photographs

In the rear garden sits a simple wooden building with slate roof and vertical timber board cladding. A building is shown here on old maps, and anecdotal evidence suggests it was once a cart shed. However, it has fallen into disrepair and been subject to inappropriate repairs. Today it is in very poor structural condition, and little original structure remains. A separate report has been prepared regarding its condition and is included in this application.

The applicants wish to bring the outbuilding into use but its condition preclude this as it is beyond structural repair. It is therefore proposed to construct a new building of the same size and footprint and to clad it with the same vertical sawn lapped boards and natural slate roof as the current building. The door and window arrangement is to be broadly similar.
