## Optera Structural Solutions

### SOW 7343 Desktop quote for the provision of a tree root barrier

April 28, 2023

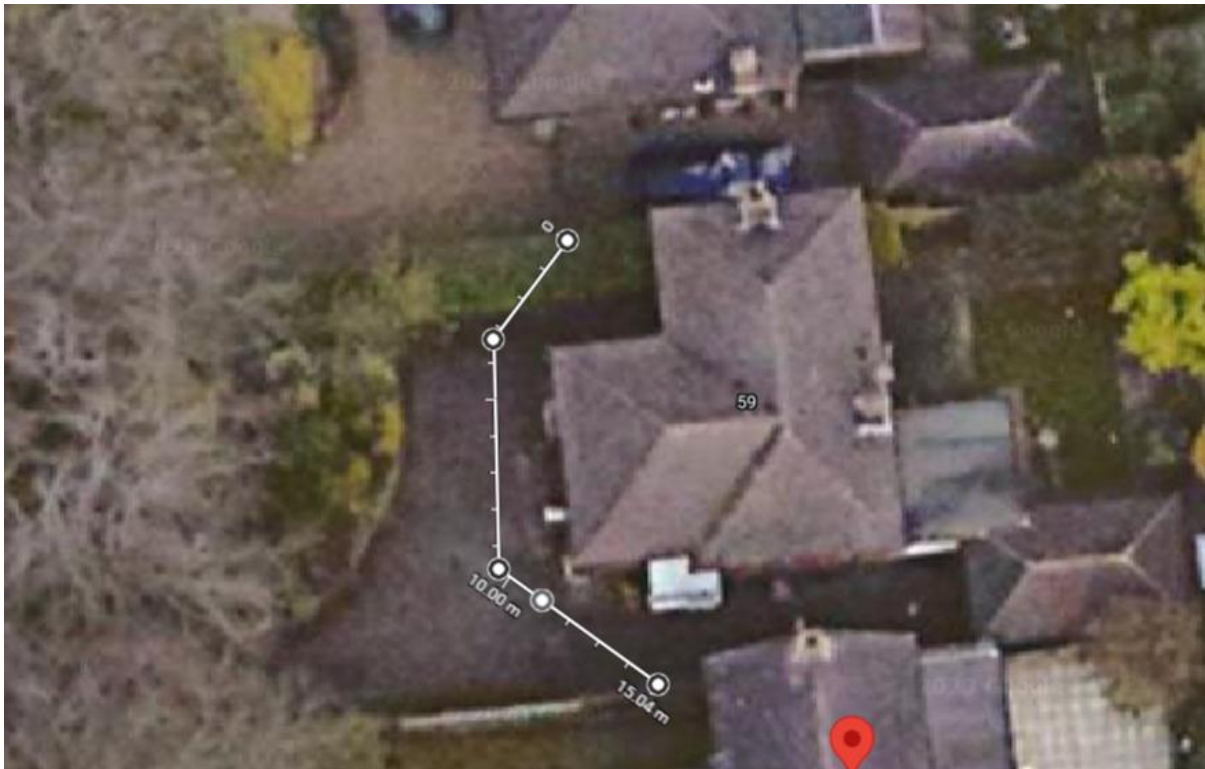
Aerial plan indicating proposed 15m length and alignment of barrier.

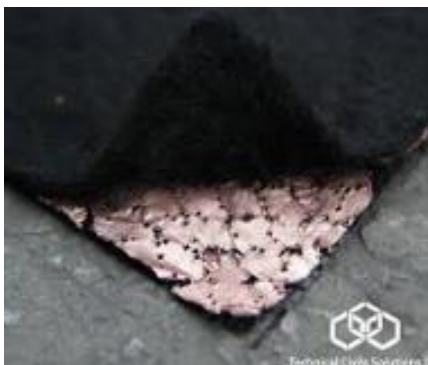
The Copper signal barrier details a copper foil securely bonded between porous geotextile, releasing copper ions and forming copper carbonate (verdigris) that signals an adverse reaction to roots deflecting them away from the barrier. The presence of copper does not constitute an eco-system burden or impact on groundwater

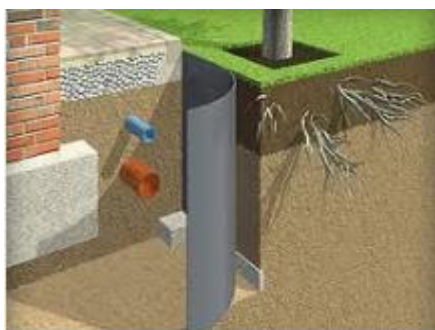
The benefits of such a shield are its dual protection both physical and biological. The multi layered sheets can be welded together whilst retaining its flexible qualities, i.e. can be cut and effectively resealed to fit round services and foundations, inert with a 60 year service life expectancy. Equally the solution inhibits root growth on the barrier face which is often problematic with conventional barriers where increased moisture levels can cause root growth to become more prolific on the face of a traditional barrier. Research has shown that the use of the recommended style of copper based screening has greatly reduced the effects of root growth when compared to other traditional physical barrier installations
