## **Remediation method statement**

**Land east of Knowle Lane**

**Fair Oak**

**Version 1.0**

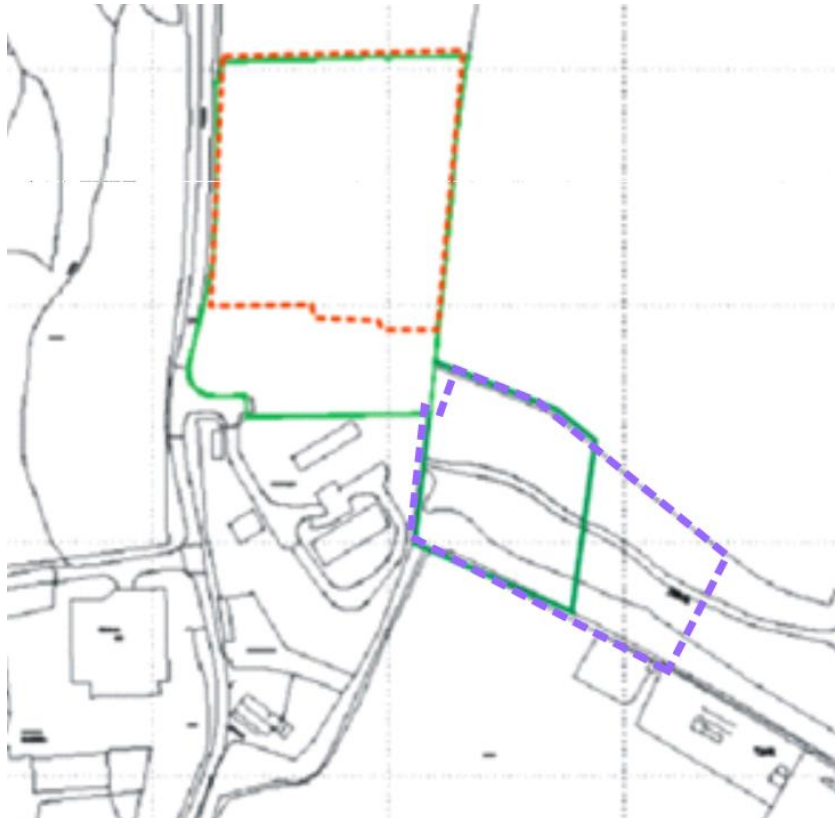
**Figure 1: Site location**

The site is located in Fair Oak, approximately four miles to the east of Eastleigh. The location of the larger original site is shown in Figure 1, bounded in green. The area covered by the current application is bounded in purple.

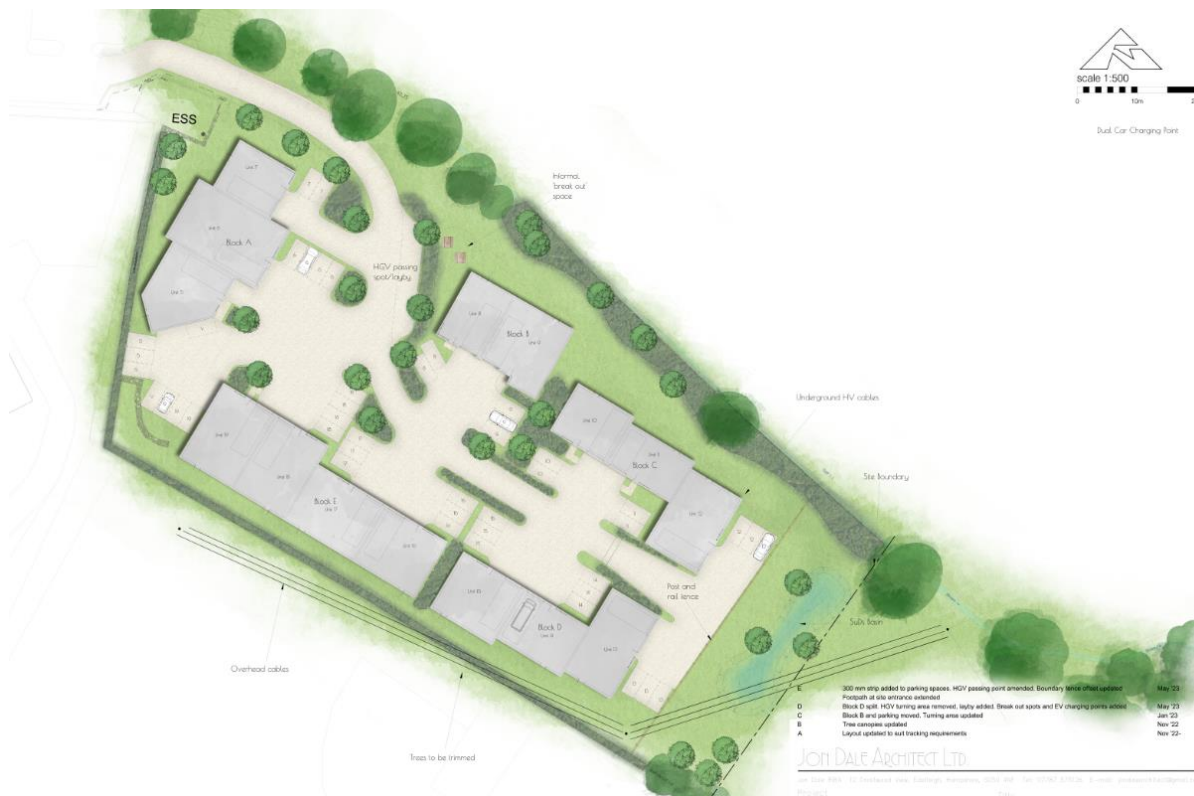
**Figure 2: Proposed development layout**

The proposed development comprises construction of five general industrial buildings (Use Class B2) containing 15 separate units, including landscaping, parking and associated works, as illustrated in Figure 2 below.

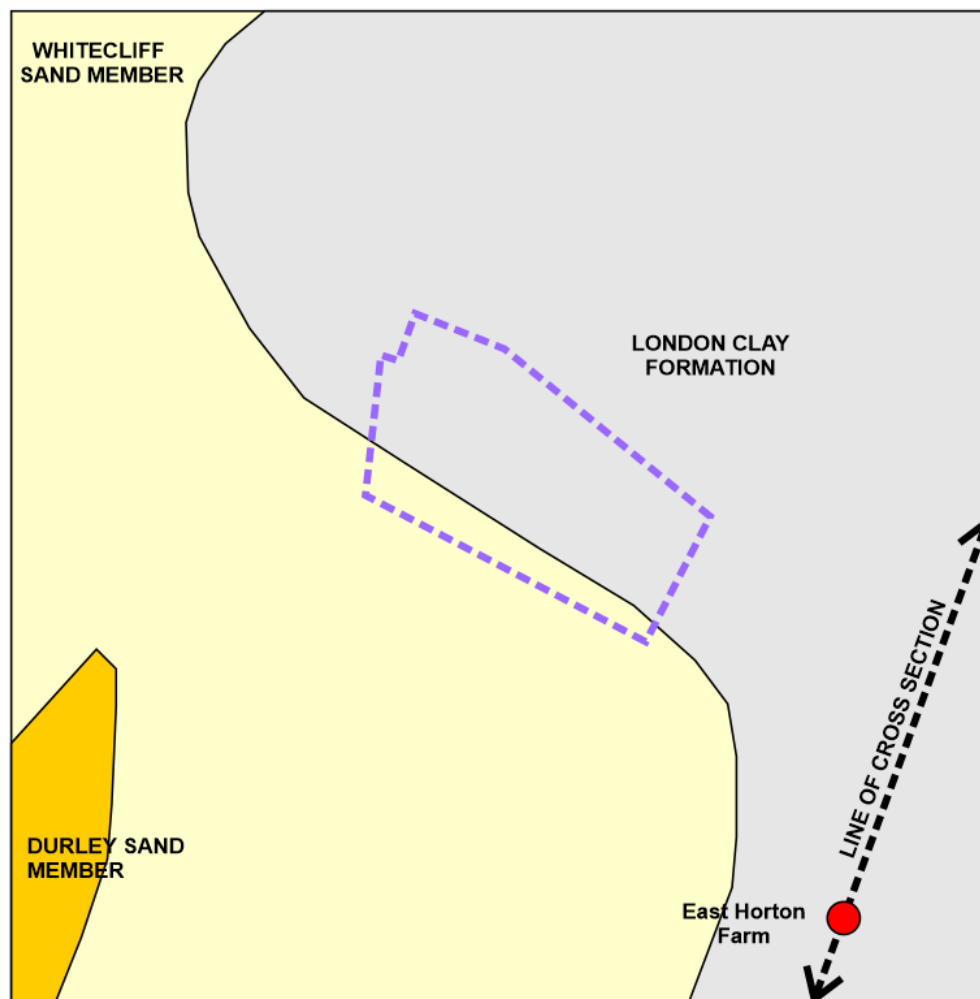
Figure 3: Geology local to the site, after BGS Sheet 315 solid and drift edition

The 1:50,000 British Geological Survey geological map for Southampton (*England and Wales Sheet 315 solid and drift edition*, 1987) identifies bedrock comprising the London Clay Formation (LCF) across the site. No superficial deposits are shown in the area, however an element of the LCF in the form of the Whitecliff Sand Member is indicated to be present across the extreme southwestern part of the site. A cross section presented on the map sheet identifies that the overall dip of strata across the site is to the southwest. The general distribution of the LCF elements and the cross section local to the site are presented in Figures 3 and 4 below.

The natural soils in all exploratory holes were described as sandy CLAY, with the exception of WS16 (2017), where clayey SAND was recorded between 1.9mBGL (the base of the Made Ground) and 3.9mBGL. This is suggestive of the Whitecliff Sand Member and ties in with the anticipated geology on the southwestern boundary as presented in Figure 3 above.

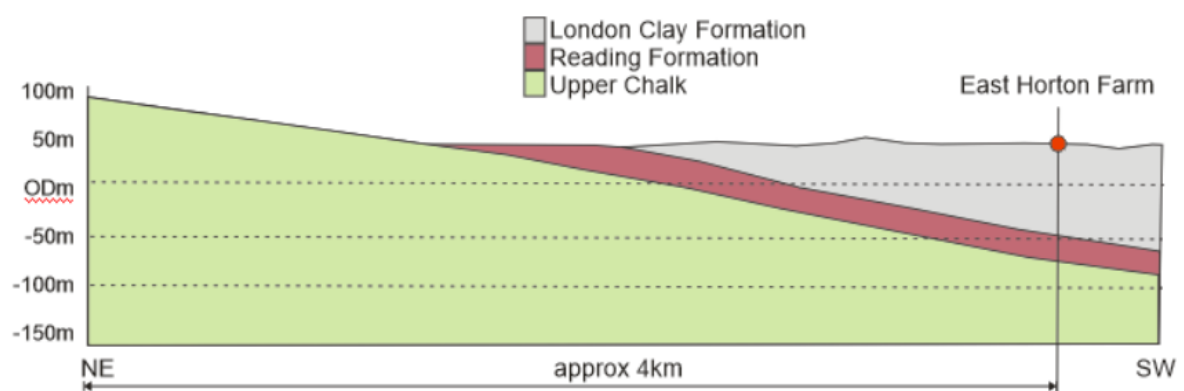
Figure 4: Geological section local to the site, after BGS Sheet 315 solid and drift edition (vertical exaggeration x4)

The Whitecliff Sand Member (WSM) is described as fine-grained sand occurring as lenticular bodies within the upper parts of the London Clay Formation (LCF) as thin discontinuous beds and channels. Within the Southampton area, the LCF consists predominantly of interbedded silty sandy clay. Underlying the LCF at depth is the Reading Formation (clay, sand and pebbles) over the Upper Chalk. In the direct vicinity of the site, the Upper Chalk lies at >100m BGL.

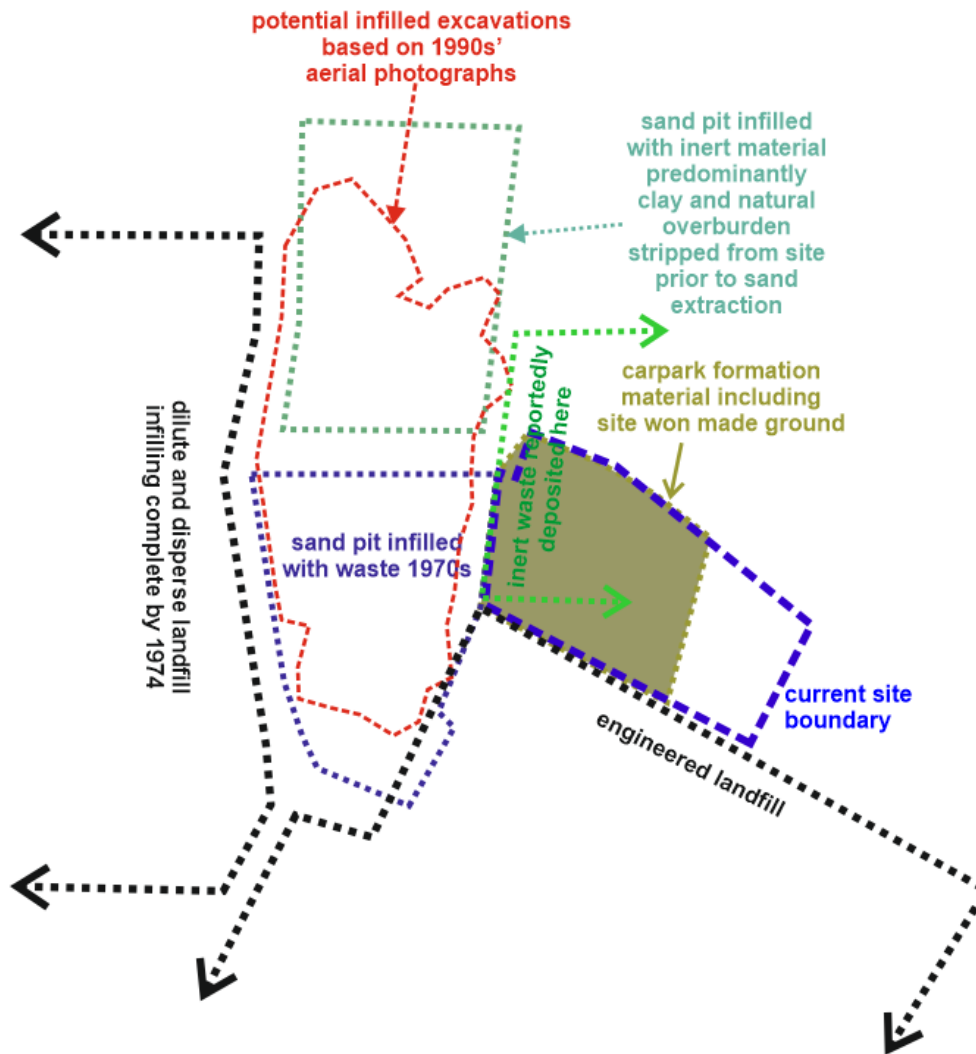
**Figure 5: Approximate extent and location of landfilling as identified by historic records**

Historic records in the form of maps, plans, aerial photographs and regulatory records indicate that the site is located in an area of intensive historic sand extraction and landfilling as illustrated in Figure 5 below.

Two separate areas of dilute and disperse landfilling outside the site boundary represent potential sources of historic gas/leachate in a position to impact the site via lateral migration. These are in the form of an aged dilute and disperse landfill and an infilled sand pit to the northwest, developed for commercial use c.2000. A more recent engineered landfill located on the southern boundary of the site can be discounted as a potential source of gas/leachate due to its integrated gas extraction system and basal liner.

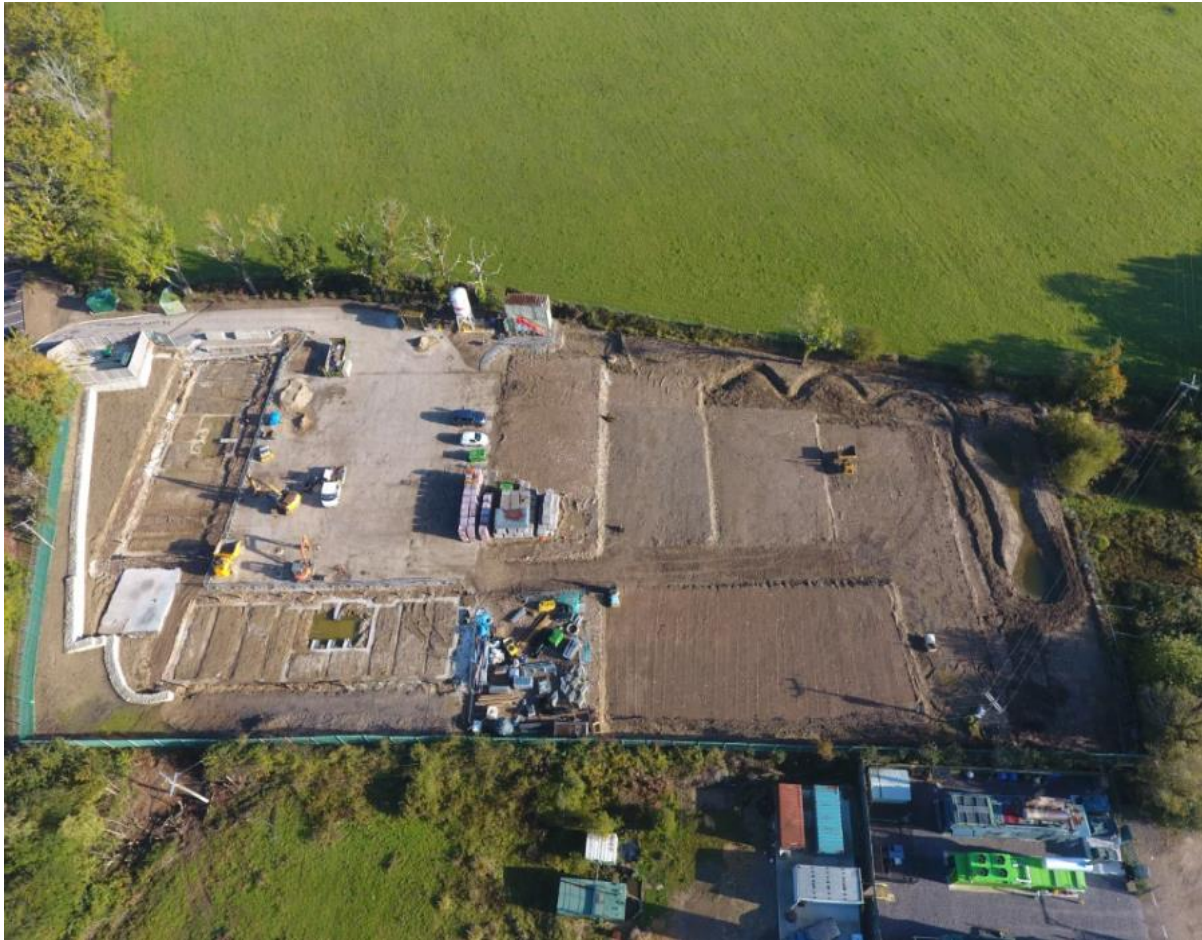
**Figure 6: 2021 aerial photograph of site**

Between purchase by the Client in 2008 and surrender of the Environmental Permit in 2018, the site was consistently used as a site compound, following removal of any made ground and the placement of inert carpark formation materials. Between 2018 and 2019 when Covid stopped works, the original carpark formation material was removed, and the levels reinstated using imported predominantly clay material. The piles and ring beams to Buildings B and C permitted under the previous planning permission were installed, together with the drainage and surface water attenuation tanks beneath the car park area in the northern part of the site. The lower area (Buildings D and E) was reduced to the formation levels determined for the previous application and covered with crushed concrete. A recent aerial photograph is presented as Figure 6 below, and the Client confirms that no further works have been undertaken since 2019.

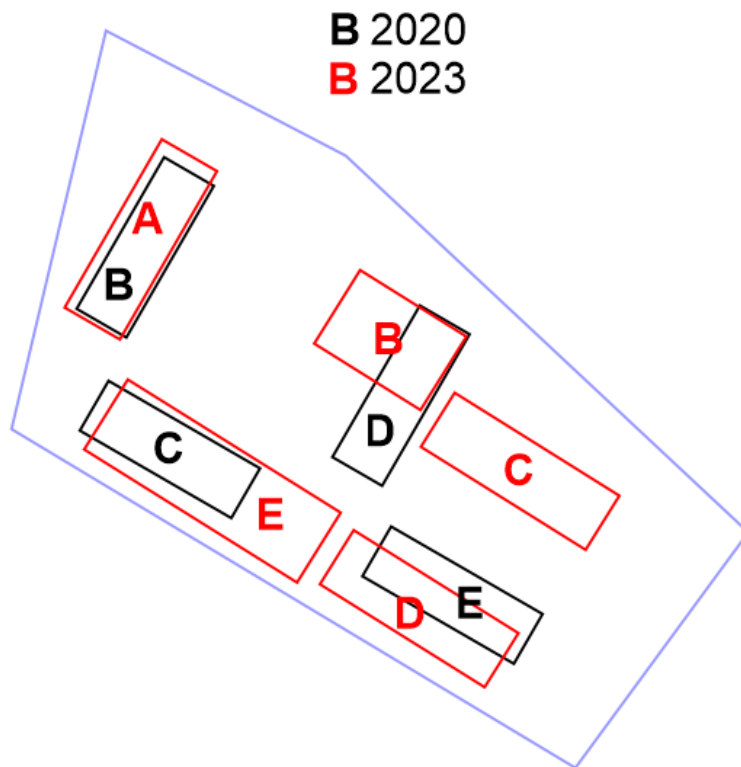
Figure 7: Current and previous proposed block locations

To contextualise the construction works undertaken prior to the site shutting down, the approximate block locations from 2020 and the current development are presented in Figure 7.

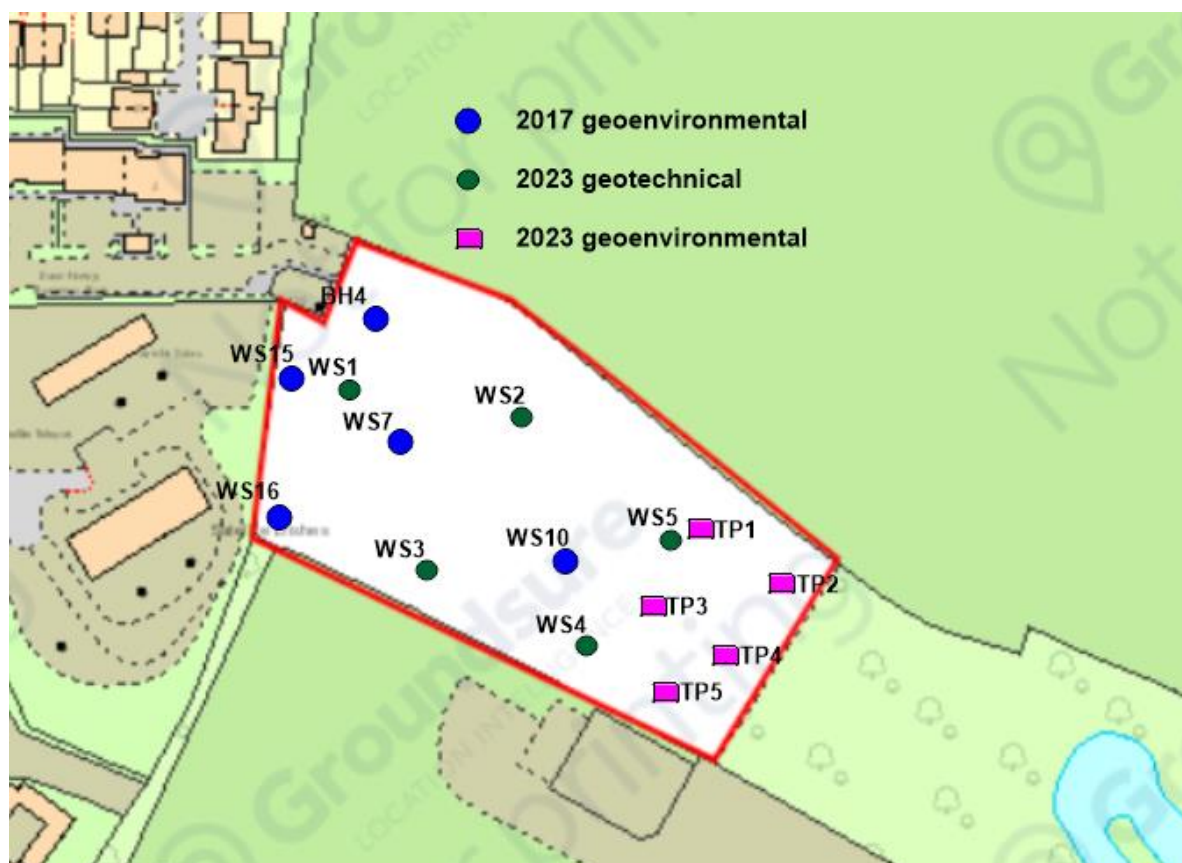
Figure 8: Exploratory hole locations

The original reports should be referred to for additional information. The approximate locations of exploratory holes from all three site investigations are illustrated in Figure 8 below.

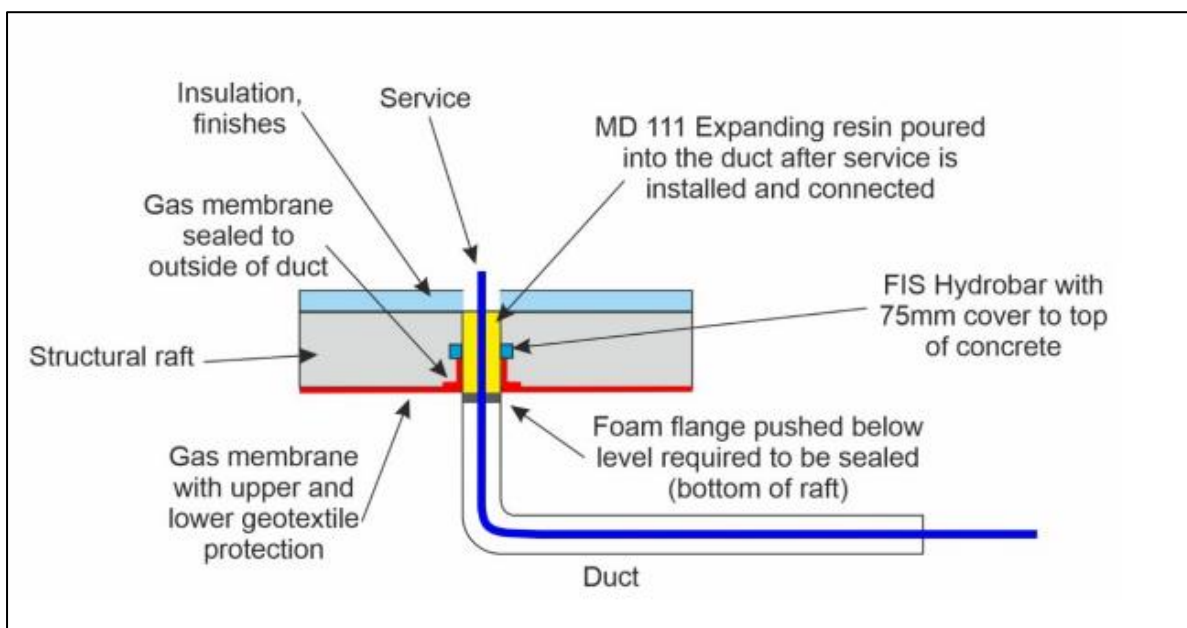
Figure 9: Duct sealing diagram

Ducts for service entry through the cast-in-situ slab must have their annulus sealed using closed cell expanding foam or expanding resin (e.g. Filoform MD3 duct sealing system), down to the depth of the sub-slab membrane. As shown in Figure 9.
