# HAMBLE POINT MARINA

Hamble-le-Rice, Southampton

## FLOOD RISK ASSESSMENT

| Project No | 24-409-60c |

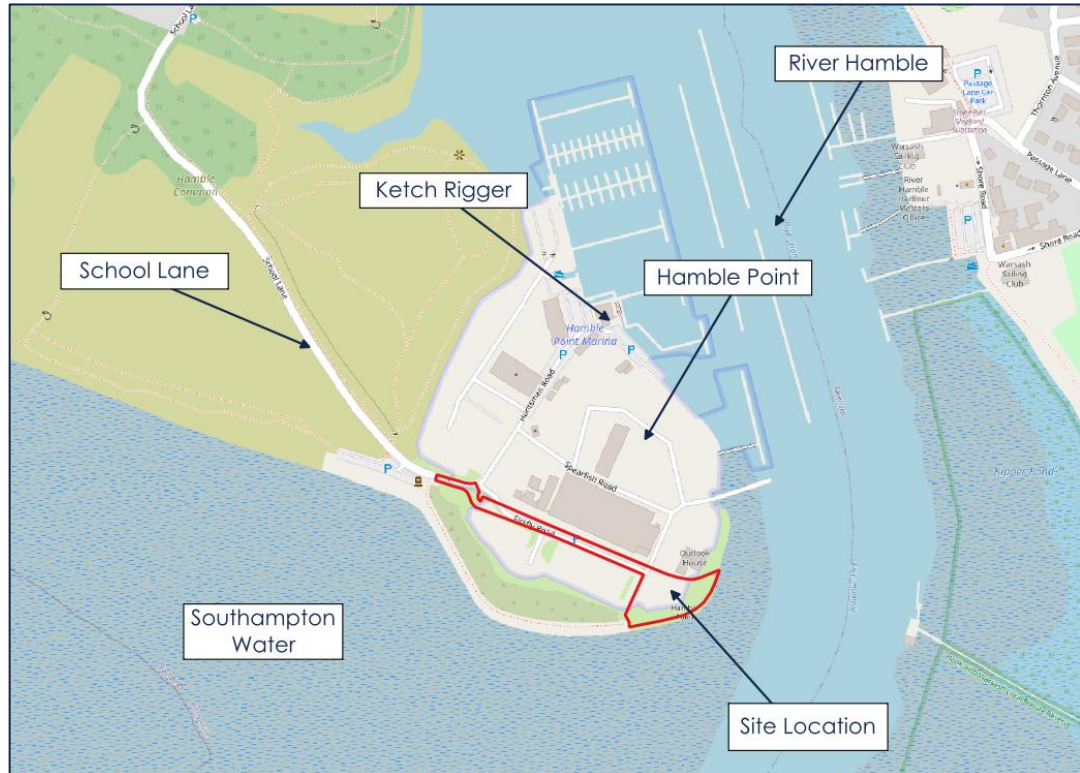
Figure 3-1 Site Location

- 3.1.1 The site is located in the Hamble Point Marnia, to the southeast of Hamble Point, Hamble-le-Rice, Southampton. The approximate coordinates for the site are 448622, 105738 and the closest postcode is SO31 4NB. Figure 3-1 shows the site location.

- 3.2.1 The nearest watercourse to the site is the tidal River Hamble, a designated Main River. This flows in a southerly direction to Southampton Water and surrounds the site to the east and south. The location of this watercourse is shown on Figure 3-1.

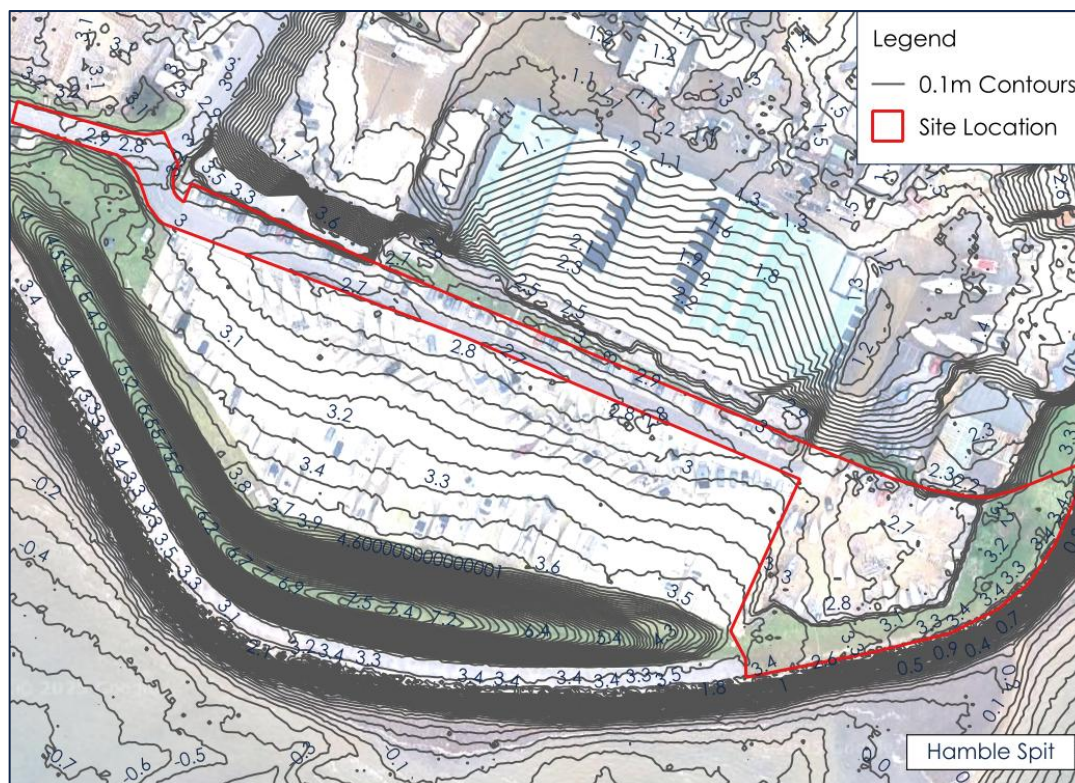
Figure 3-2 Topography of the site

- 3.2.4 As shown in Figure 3-2 and the topographic survey, the topography at the location of the proposed restaurant (in the east of the site) is relatively flat, with an average elevation of approximately 2.75mAOD. Immediately to the south of the location of the proposed restaurant, the elevations rise to a maximum elevation of 3.46mAOD in the southern corner of the site.

- 3.2.5 The elevation of the proposed parking bays immediately to the north and west of the proposed restaurant location have an elevation of between 2.86mAOD and 3.18mAOD. The existing access road and car parking spaces in the western section of the site has an elevation of approximately 3.0mAOD.

- 3.2.6 To the north of the location of the proposed restaurant, the levels drop steeply to an elevation of 2.2mAOD. The levels immediately to the east and south of the proposed restaurant sharply drop off to Hamble Spit, at an elevation of approximately -0.1mAOD.

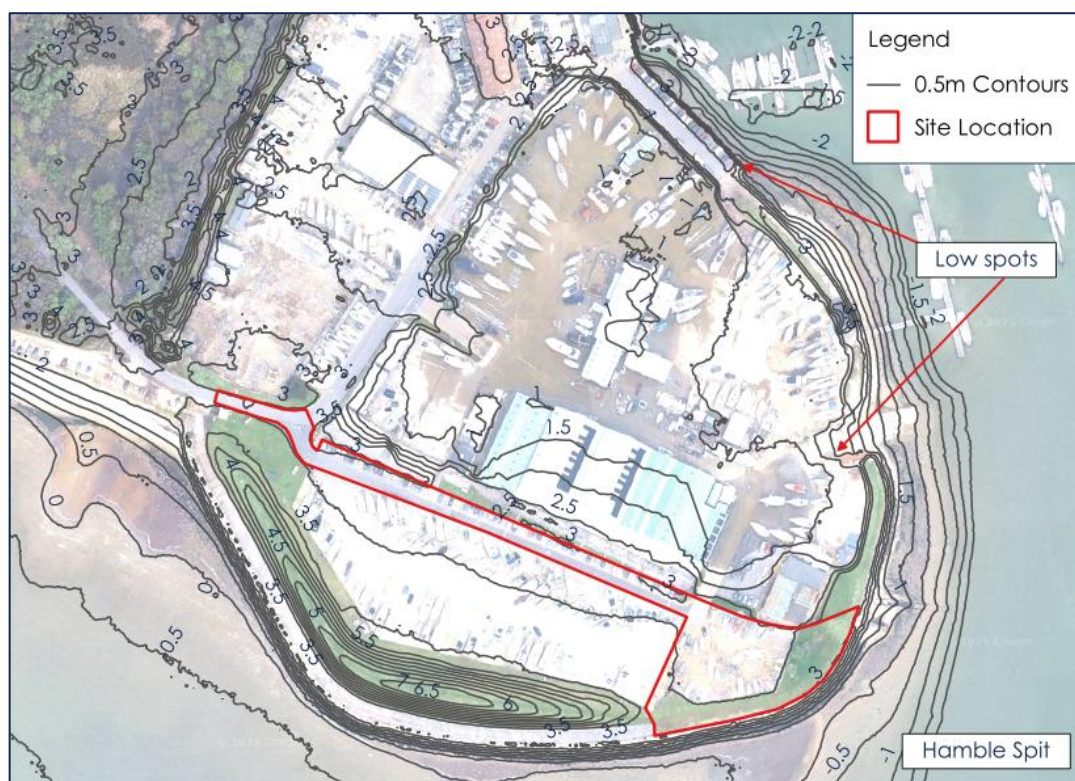
Figure 3-3 Topography of the wider marina

- 3.2.7 There is a topographic high spot (an embankment) to the south of the site, which rises up to 7.9mAOD. There are also low banks which run around the edge of the Hamble Marina to the north of the site. These banks have an approximate elevation of 3.1mAOD, although they are non-continuous, with low spots 95m and 190m to the north of the site. These low spots have elevations of 2.1mAOD and 1.8mAOD respectively, and the locations of the low spots is shown in Figure 3-3.

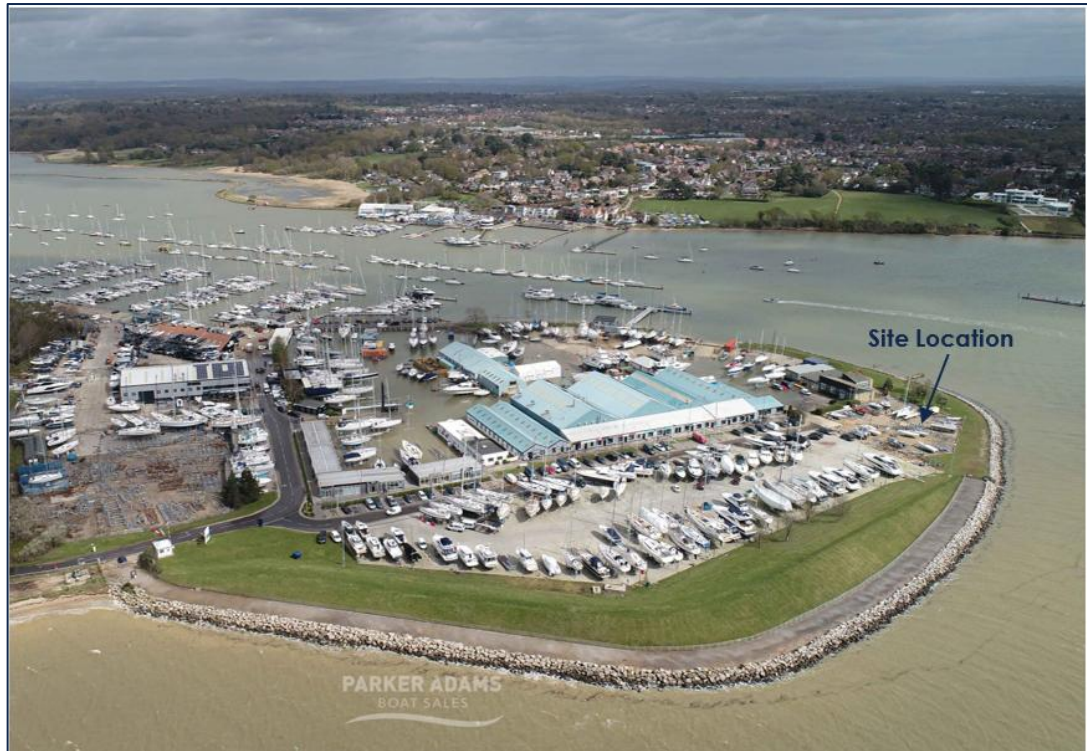
Figure 3-4 Image of the flooding of Hamble Point Marina, 9<sup>th</sup> April 2024

- 3.4.3 Although both these records show there to be no recorded flooding of the site, an internet search for '*Hamble Point Marina Flooding*' provided images of flooding from 9<sup>th</sup> April 2024, when Storm Pierrick generated strong winds which coincided with a high tide (equating to a 1 in 55 year event<sup>1</sup>). As shown in Figure 3-4, this event caused flooding to the marina. The site itself is shown to be flood free, although it is not known when the photo was taken. If the photo was taken after high tide, flood waters would have receded.

- 5.3.4 As discussed in Section 3.4, a flood event impacted Hamble Point Marina, equating to a 1 in 55 year event<sup>1</sup>. The photos from this event do not show the site to be impacted, whereas the model shows an impact at the site from the 1 in 20 year event. The difference between the two is likely due to temporary defences being put into place before the April 2024 event, which are not present in the model. Therefore, the model represents a conservative approach.

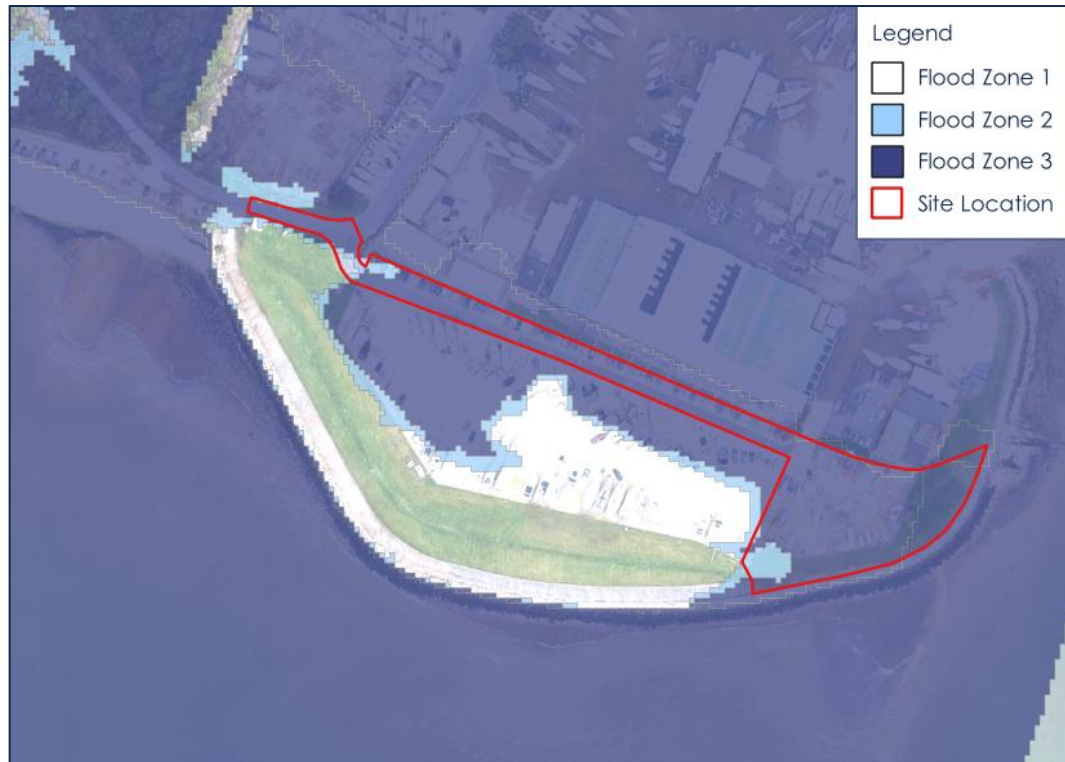
Figure 5-1 Flood Map for Planning

5.2.2 The 2025 iteration of the Environment Agency (EA) Flood Map for Planning defines the site as falling entirely within Flood Zone 3, meaning the site is at High risk of fluvial or tidal flooding.

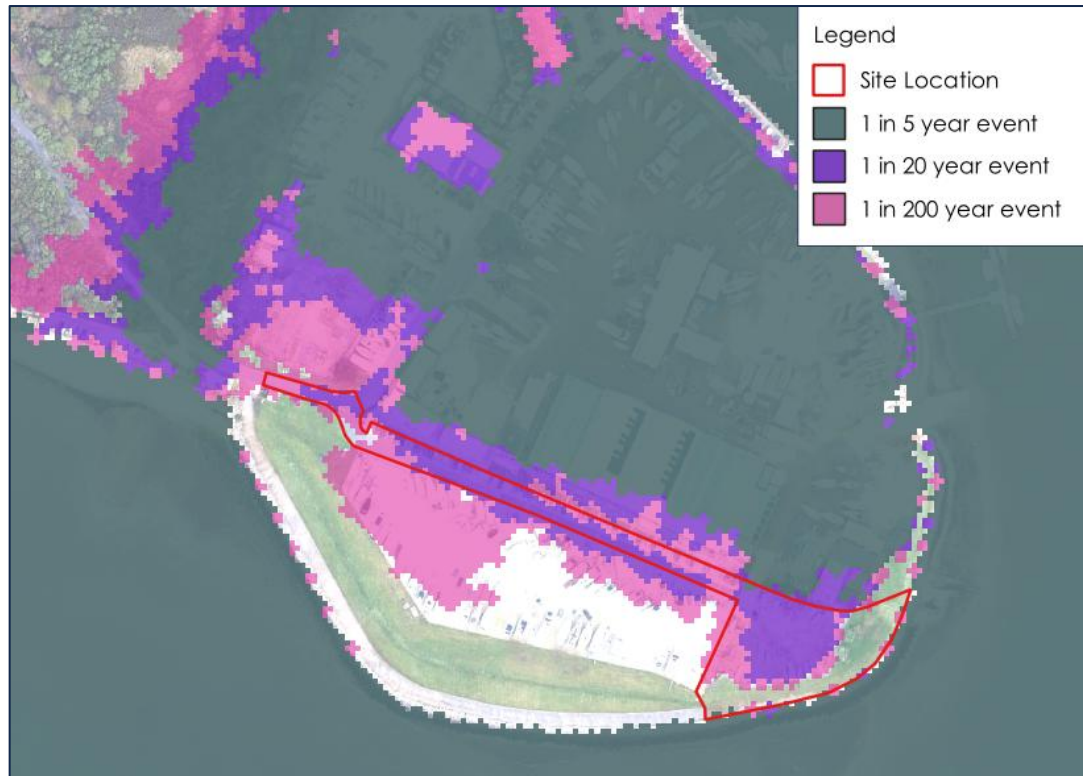
Figure 5-2 Modelled Flood Extents from the Southampton Water model

- 5.3.3 The model shows that for the present day (2012), the site is flood free in the 1 in 5 year event. It becomes flooded in the 1 in 20 year event and higher events, including the design event, as shown in Figure 5-2.

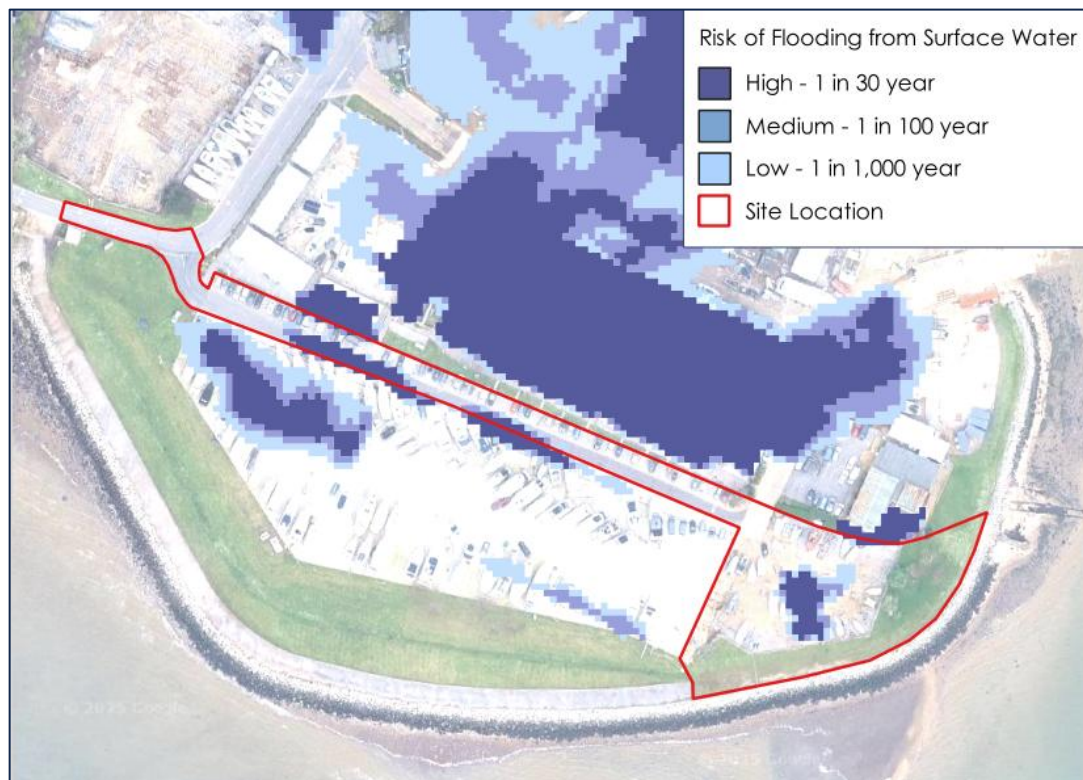
Figure 5-3 RoFSW with Climate Change Extents

- 5.5.2 The mapping is derived by the simulation of the above rainfall events over a digital terrain model (DTM). The DTM is defined on a 2m square grid and as a result, local topographic features are often poorly defined.
- 5.5.3 The RoFSW mapping (including an uplift for climate change) predicts that the site is at High risk of flooding from surface water, as shown in Figure 5-3. In addition, there are two areas of High risk of surface water flooding immediately to the north of the site.

- 5.7.1 In the event of sewer flooding occurring upstream of the site, water would behave in a similar manner to the surface water flood mapping shown above. The extent of surface water flooding on the site itself, shown in the RoFSW mapping (Figure 5-3), is from water falling on the site rather than flowing from elsewhere. There are no known sewers on the site to generate flooding.
- 5.7.2 The risk of sewer flooding is therefore considered to be **Negligible**.

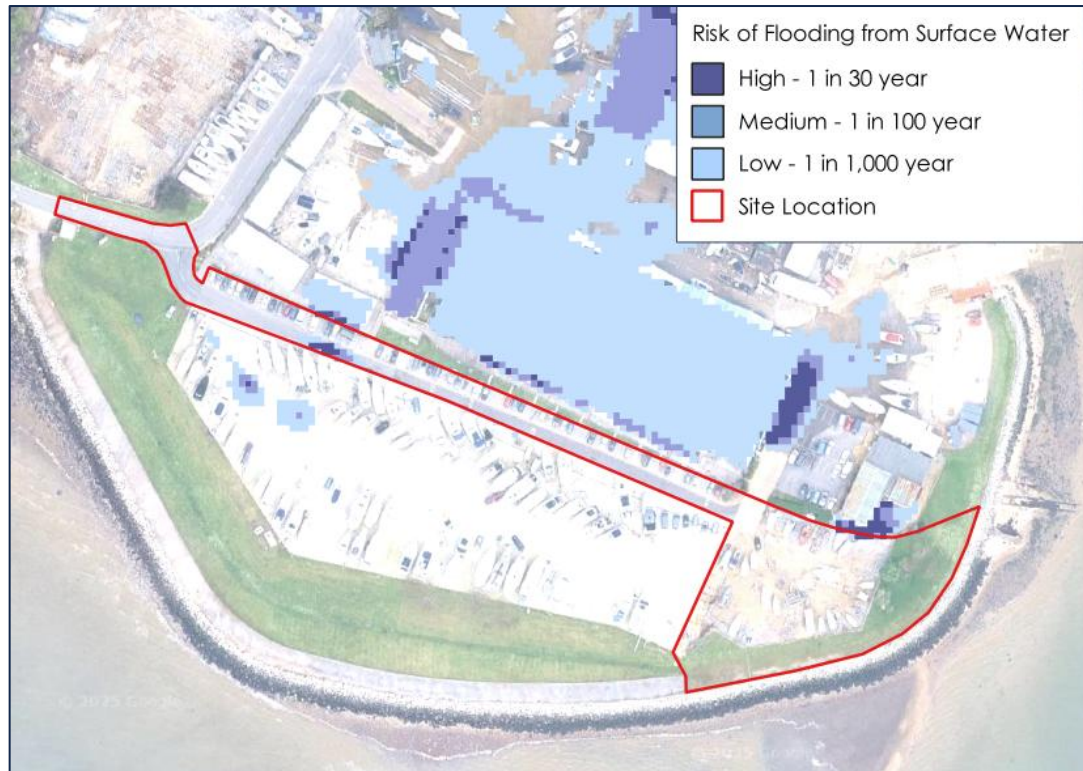
Figure 5-4 RoFSW with Climate Change Extents 0.2 Depth Band

- 5.5.4 The RoFSW dataset also indicates the predicted flood depths which would occur during the extreme rainfall events. The flood risk is categorised into depth bands including 0.2m, 0.3m, 0.6m, 0.9m and 1.2m. It should be noted that depths below 0.075m are removed from the dataset as most land is covered by some water as rain falls across the area in surface water flood modelling.
- 5.5.5 The dataset indicates the risk of surface water flooding present across the eastern portion of the site is not included in the shallowest depth band, the 0.2m depth band, as shown in Figure 5-4. Therefore, the surface water flooding predicted to impact the site in all three rainfall events has depths of between 0.075m and 0.2m.

- 5.5.6 In the west of the site, there is topographic low spot which is showing to still be at High risk of flooding for the 0.2m depth band. This is not present in the 0.3m depth band, indicating this surface water flooding is between 0.2m and 0.3m deep.

- 5.5.7 The area of High risk flooding in the western portion of the site immediately to the north of the site is also not present in the 0.3m depth band, and therefore this surface water flooding is also between 0.2m and 0.3m deep.

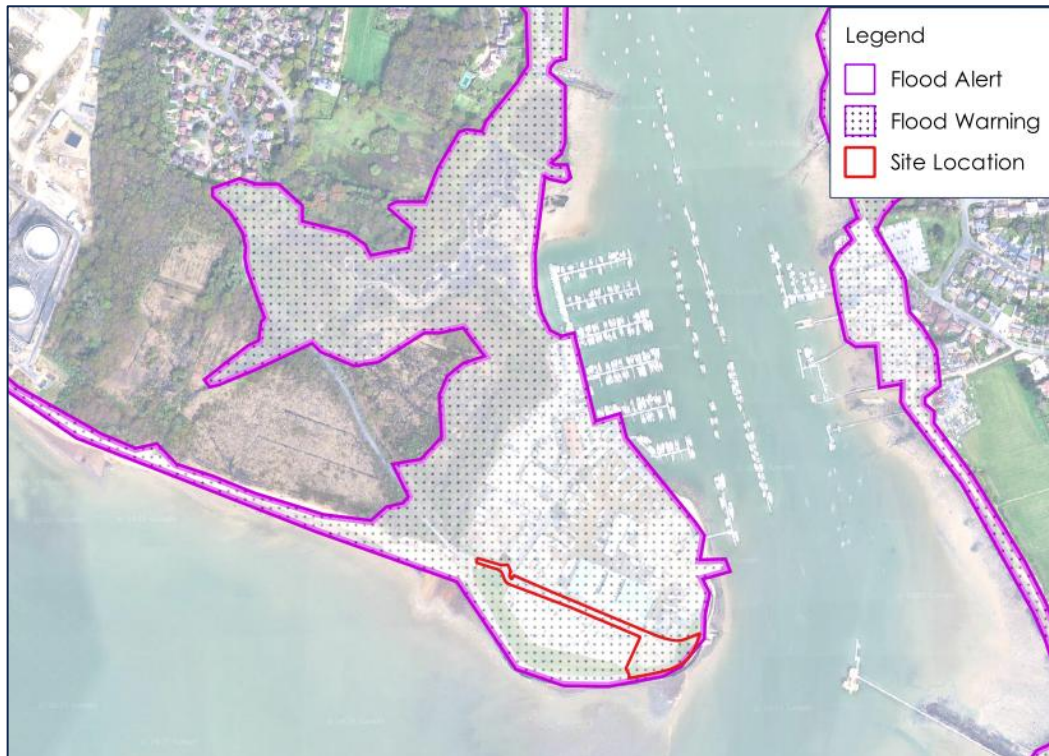
Figure 6-1 Flood Alert and Warning Areas

- 6.2.1 Floodline Warnings is a free service provided by the Environment Agency that provides flood warnings direct by phone, email or text message.
- 6.2.2 The site is located within the Environment Agency Flood Warning and Alert areas for the Hamble Estuary, as shown in Figure 6-1. It is therefore recommended the restaurant appoint an FEP Manager, and they contact the Environment Agency on 0345 988 1188 and signs up to the flood warning service. The FEP Manager or

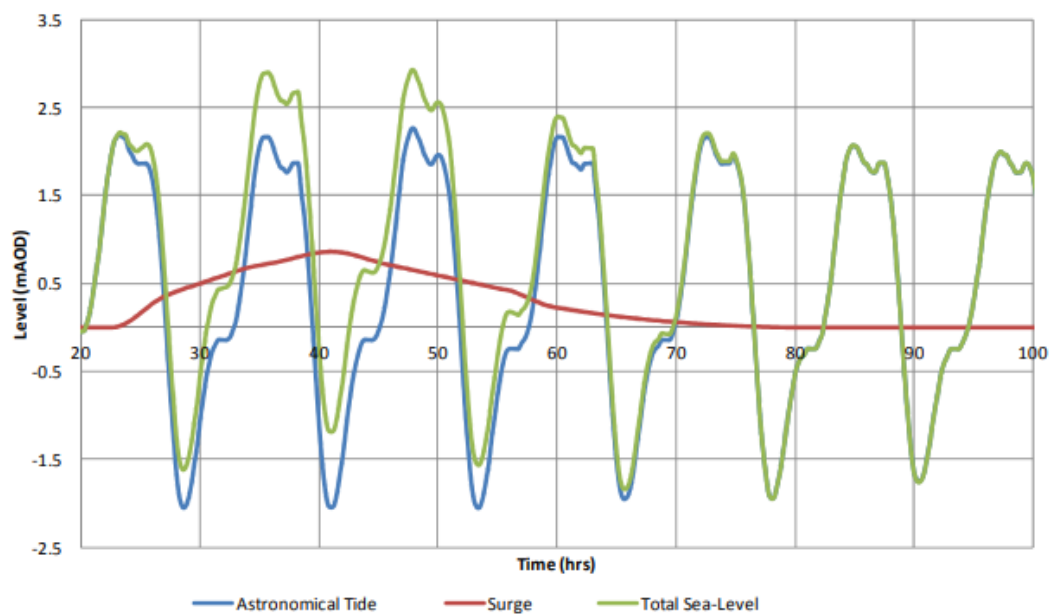
Figure 6-2 1 in 200 year design tidal graph for the mouth of Southampton Water

- 6.3.3 The duration of the flood event has been estimated based on the peak of the design event tidal curve. This has been extracted from the Southampton Water coastal modelling study final inception report and is shown below in Figure 6-2.
- 6.3.4 The peak of the event is approximately 45 hours, with water levels reaching a level where there would be flooding present for approximately one hour either side of the peak of the event in the present day.
- 6.3.5 Therefore, the duration of flooding at the site has been estimated to be approximately two hours.

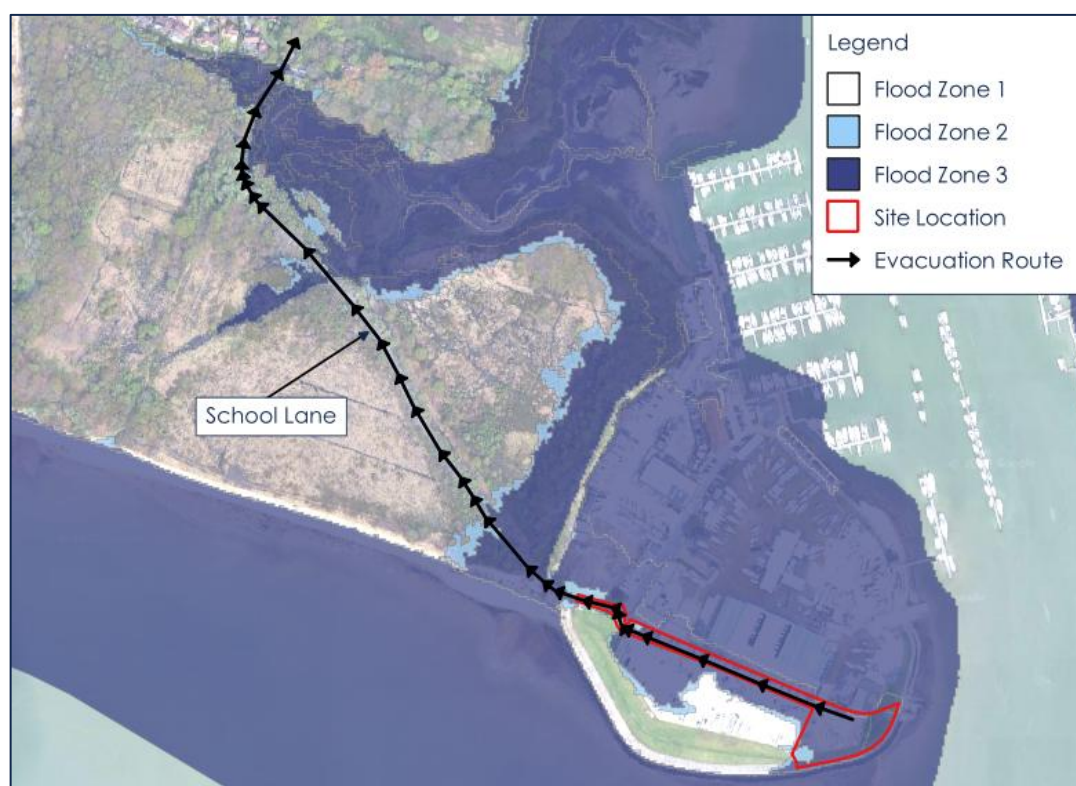
Figure 6-3 Evacuation Route

6.5.2 If evacuation were required, this should be undertaken in advance of the flood event where possible. There is one evacuation route to high ground in Flood Zone 1. It should be noted that there is some high ground in Flood Zone 1 to the west of the site, but this would leave occupiers of the site stranded.

- 6.5.7 The routes, shown in Figure 6-3 are adopted highways with dedicated footways adequate for all mobility needs. The FEP Manager may wish to nominate a dedicated evacuation muster point.

6.5.4 It should be noted that there are areas of flooding along School Lane, which provides the access to and from the site. The first area is 375m from the western extent of the site and is due to the removal of a watercourse crossing structure from the model. Inspection of LiDAR data shows the deck level of the crossing is comfortably above the future 1 in 200 year flood level, meaning it would be unaffected by flooding in the design event.
