# Arboricultural Method Statement

56-64 Hamble Lane

Ref:  
May 2025  
JFA0335 V2

There is a planning application for the construction of 6 (six) no. bungalows with associated parking and landscaping, and vehicle access from Sydney Avenue at the site to the rear of 56-64 Hamble Lane, Hamble.

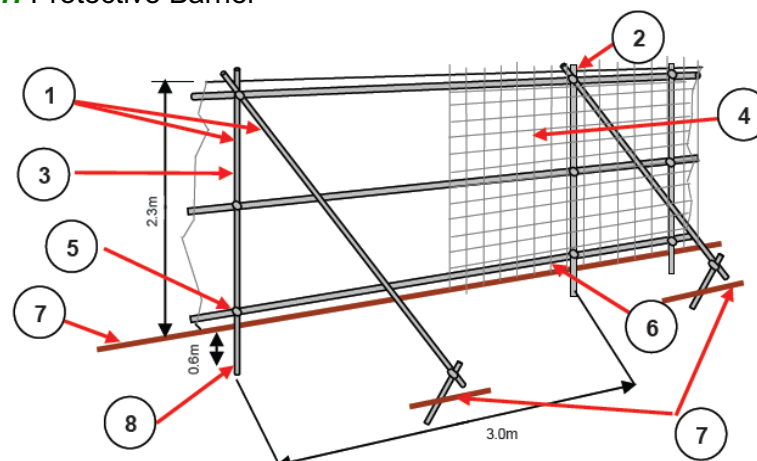
**Figure 1:** Protective Barrier

The barrier is to comprise of a vertical and horizontal framework, well braced to resist impacts, with vertical tubes spaced at a maximum interval of 3m. Onto this, weldmesh panels should be securely fixed with wire or scaffold clamps.

1. Standard scaffold poles
2. Uprights to be driven into the ground
3. Panels secured to uprights with wire ties and where necessary standard scaffold clamps
4. Weldmesh wired to the uprights and horizontals
5. Standard clamps
6. Wire twisted and secured on inside face of barriers to avoid easy dismantling
7. Ground level
8. Approximately 0.6m driven into the ground

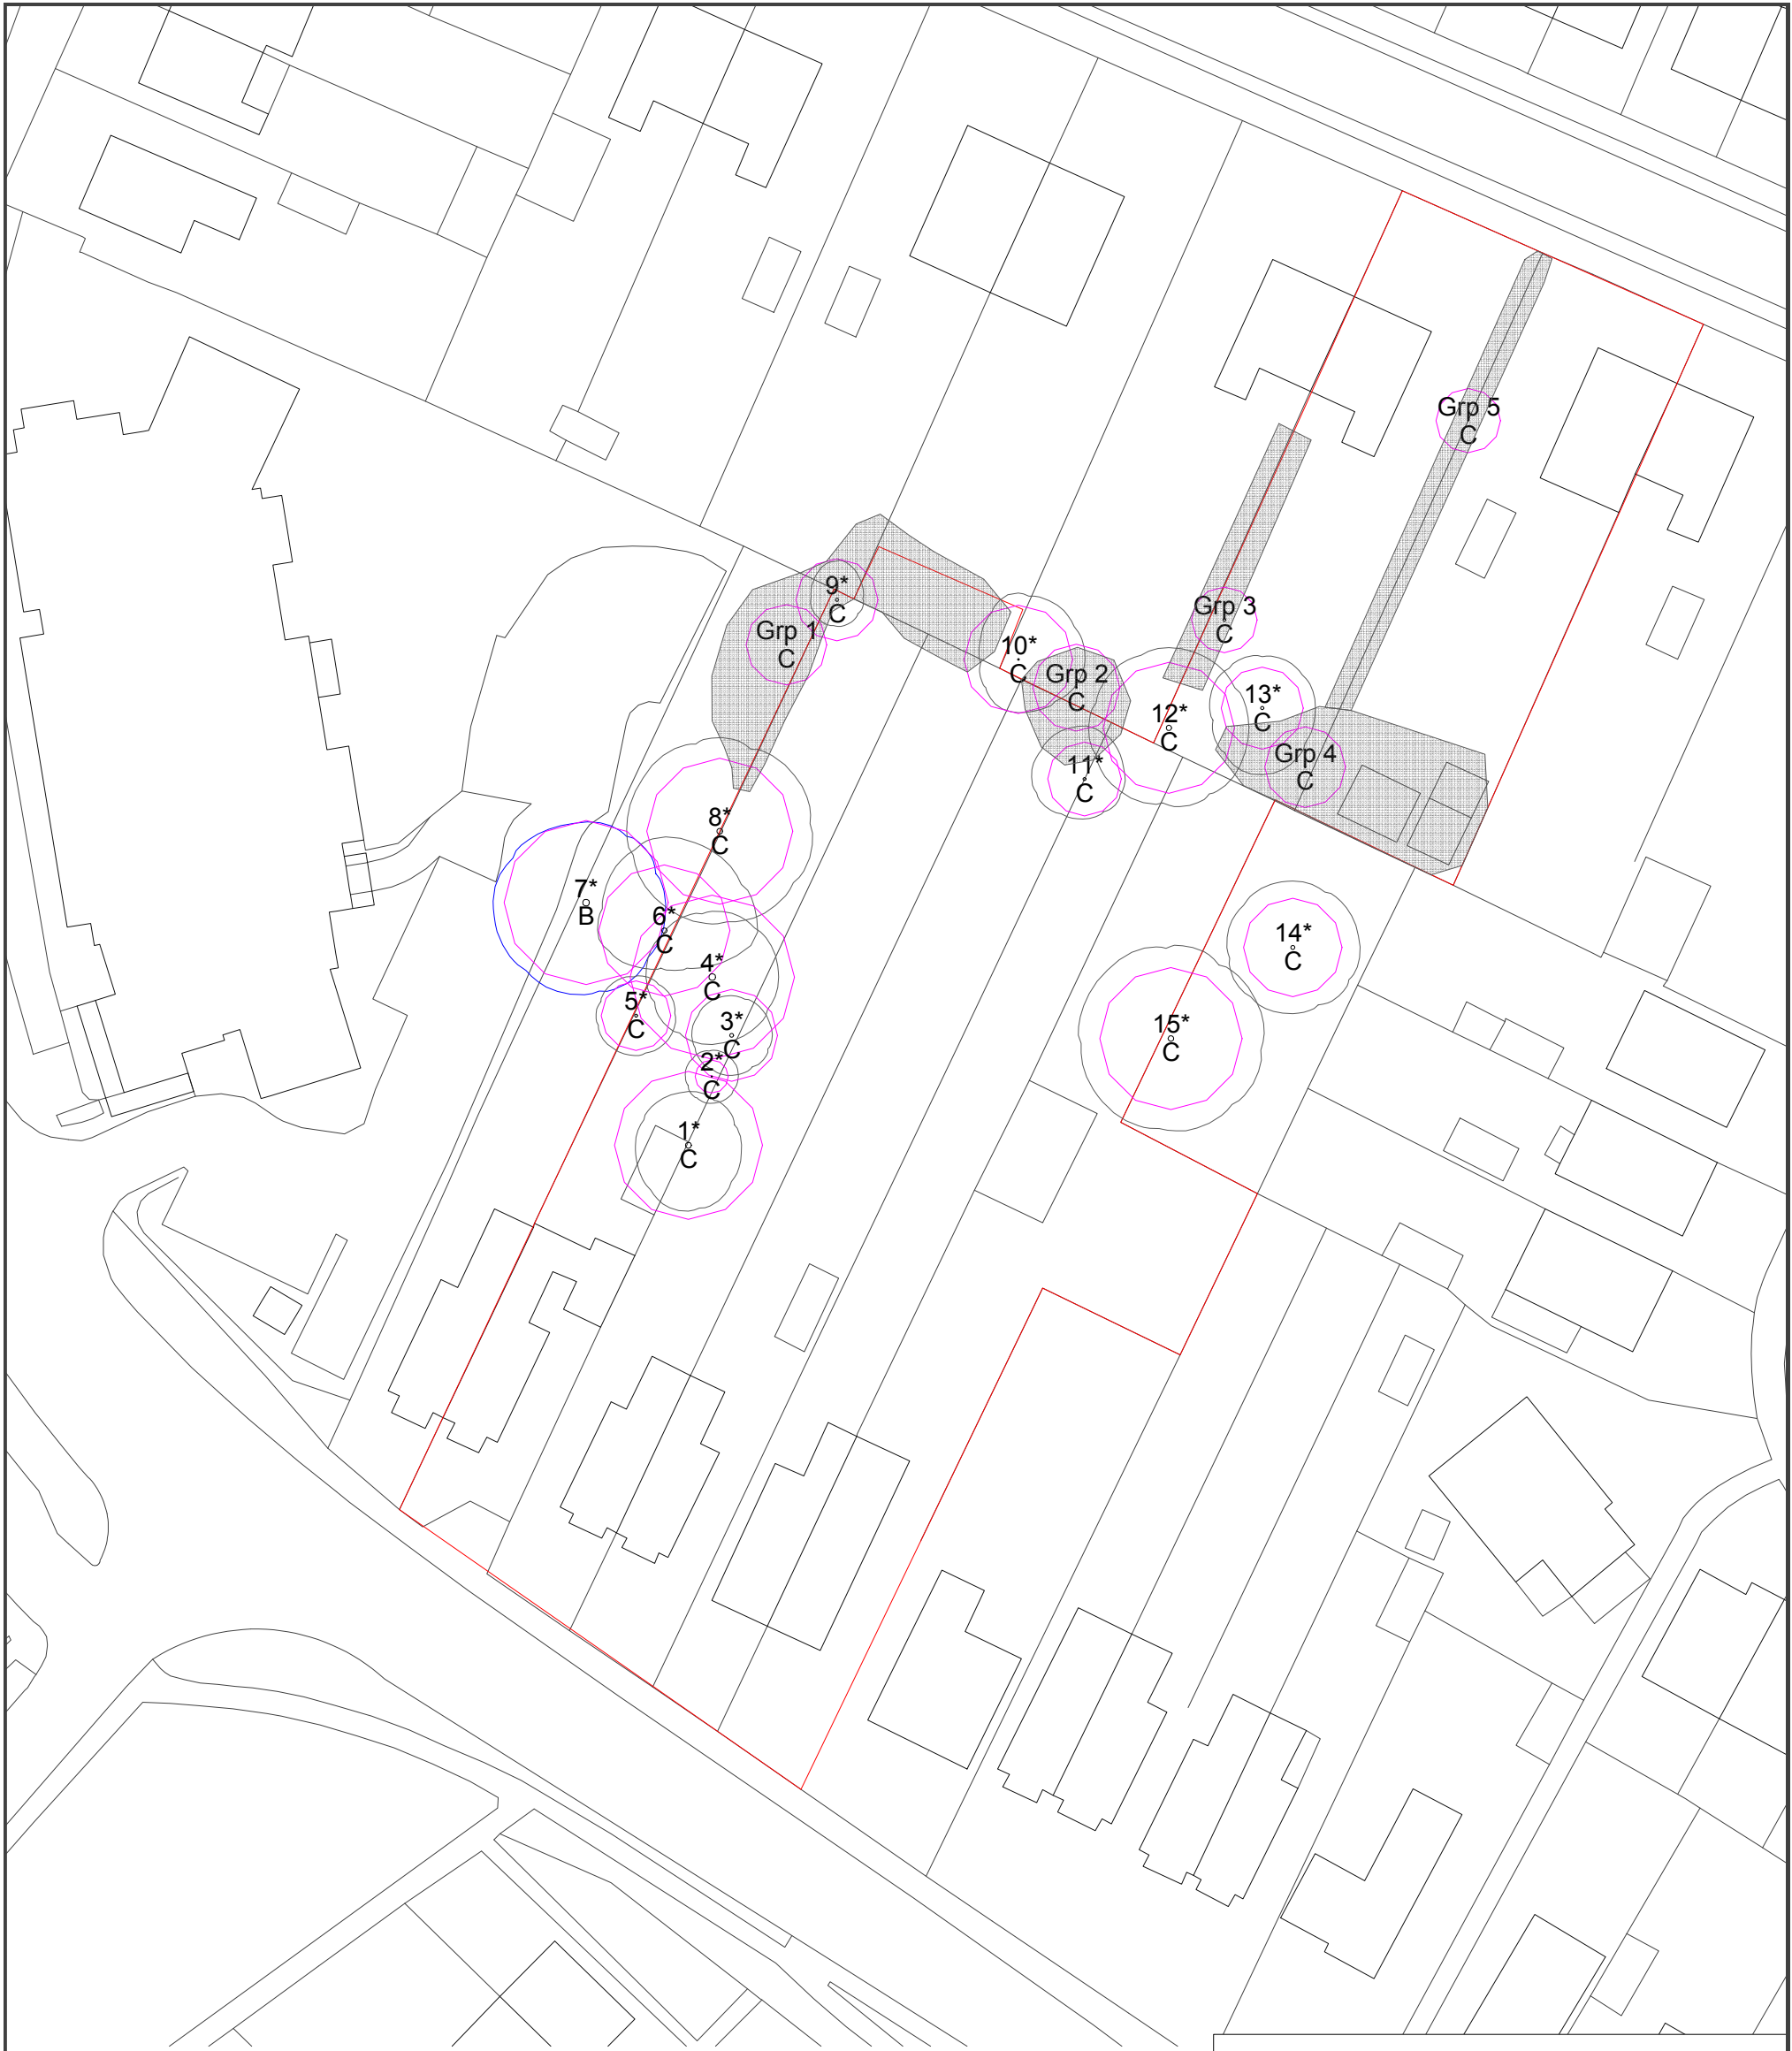
### Tree Survey Plan

- NOTES:**
- 1. The tree locations are indicatively plotted.
  - 2. The site is not located within a Conservation Area.
  - 3. None of the existing trees are protected by a Tree Preservation Order (TPO).

- 4.1 A tree survey was undertaken by James Fuller of James Fuller Arboriculture during February 2024 that identified 15 (fifteen) individual trees and 5 (five) groups of trees. The combined Tree Survey and Root Protection Area (RPA) Schedule is appended at JF1 and Tree Survey Plan JFA0335.01 TSP is appended at JF2.

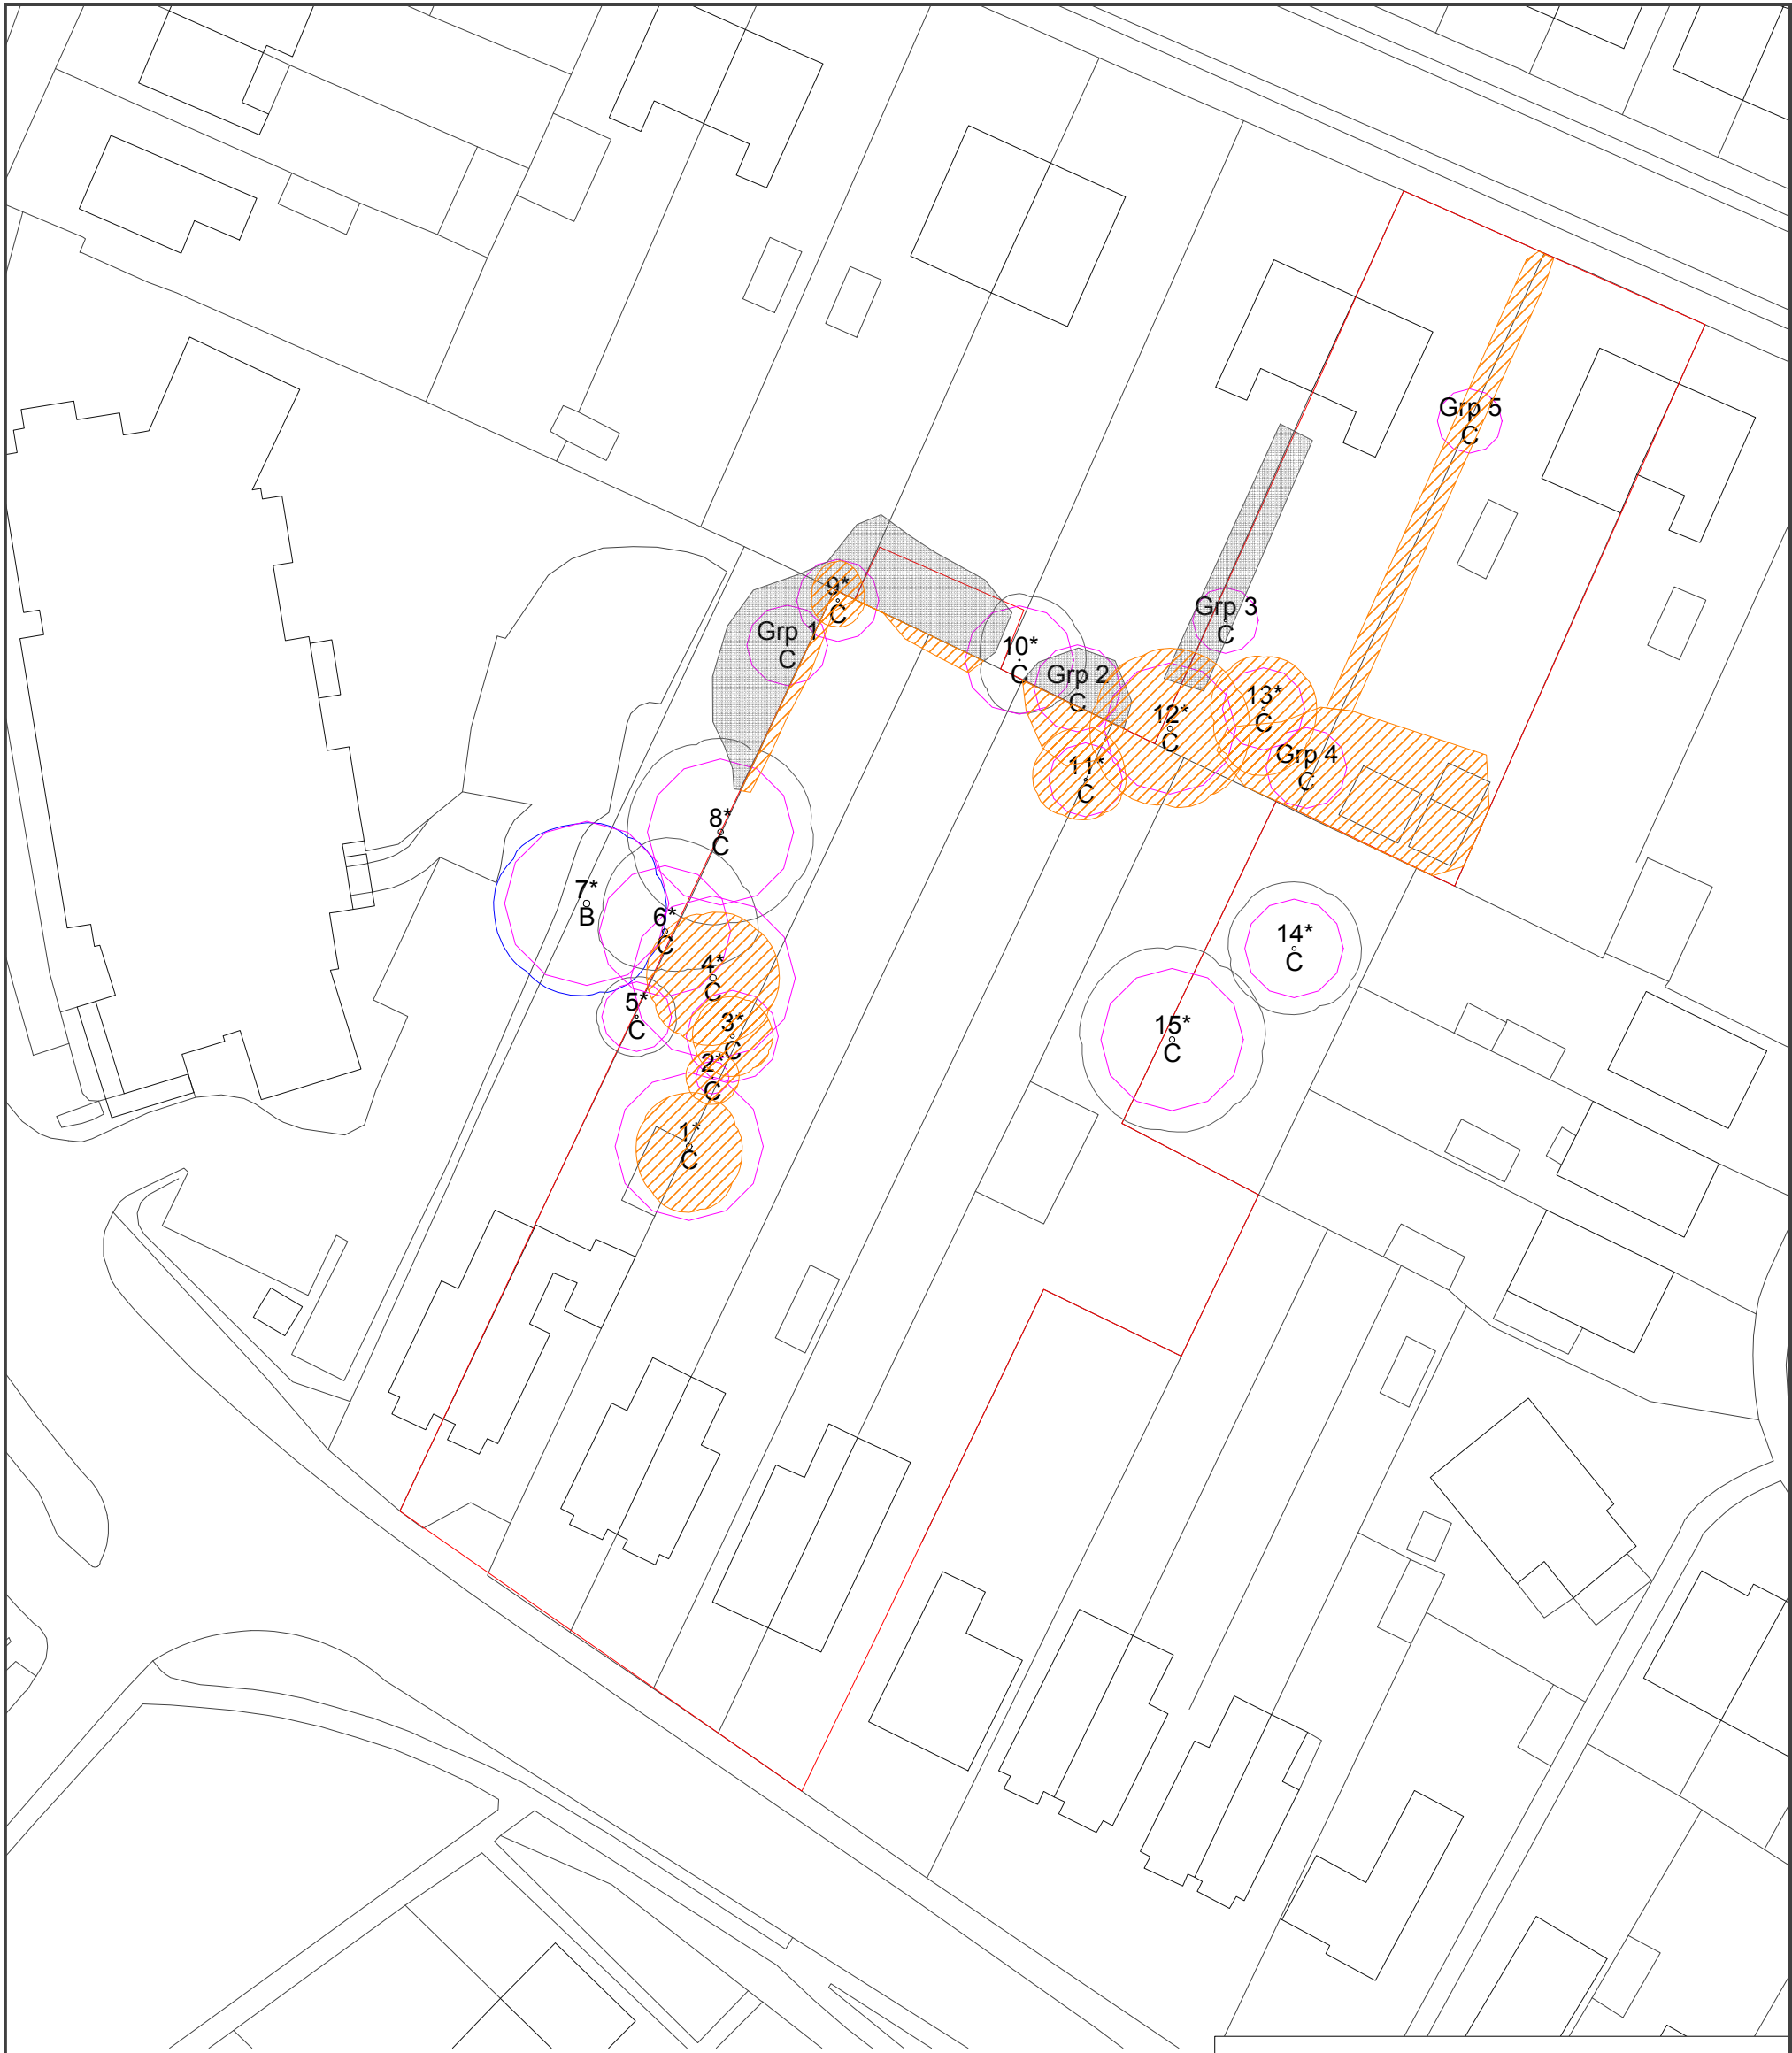
### Tree Retention Plan

Trees 1, 2, 3, 4, 9, 11, 12 and 13 and Groups 4 and 5 and sections of Groups 1 and 2 to be removed to facilitate the proposed design layout.

- NOTES:
1. The tree locations are indicatively plotted.
  2. The site is not located within a Conservation Area.
  3. None of the existing trees are protected by a Tree Preservation Order (TPO).

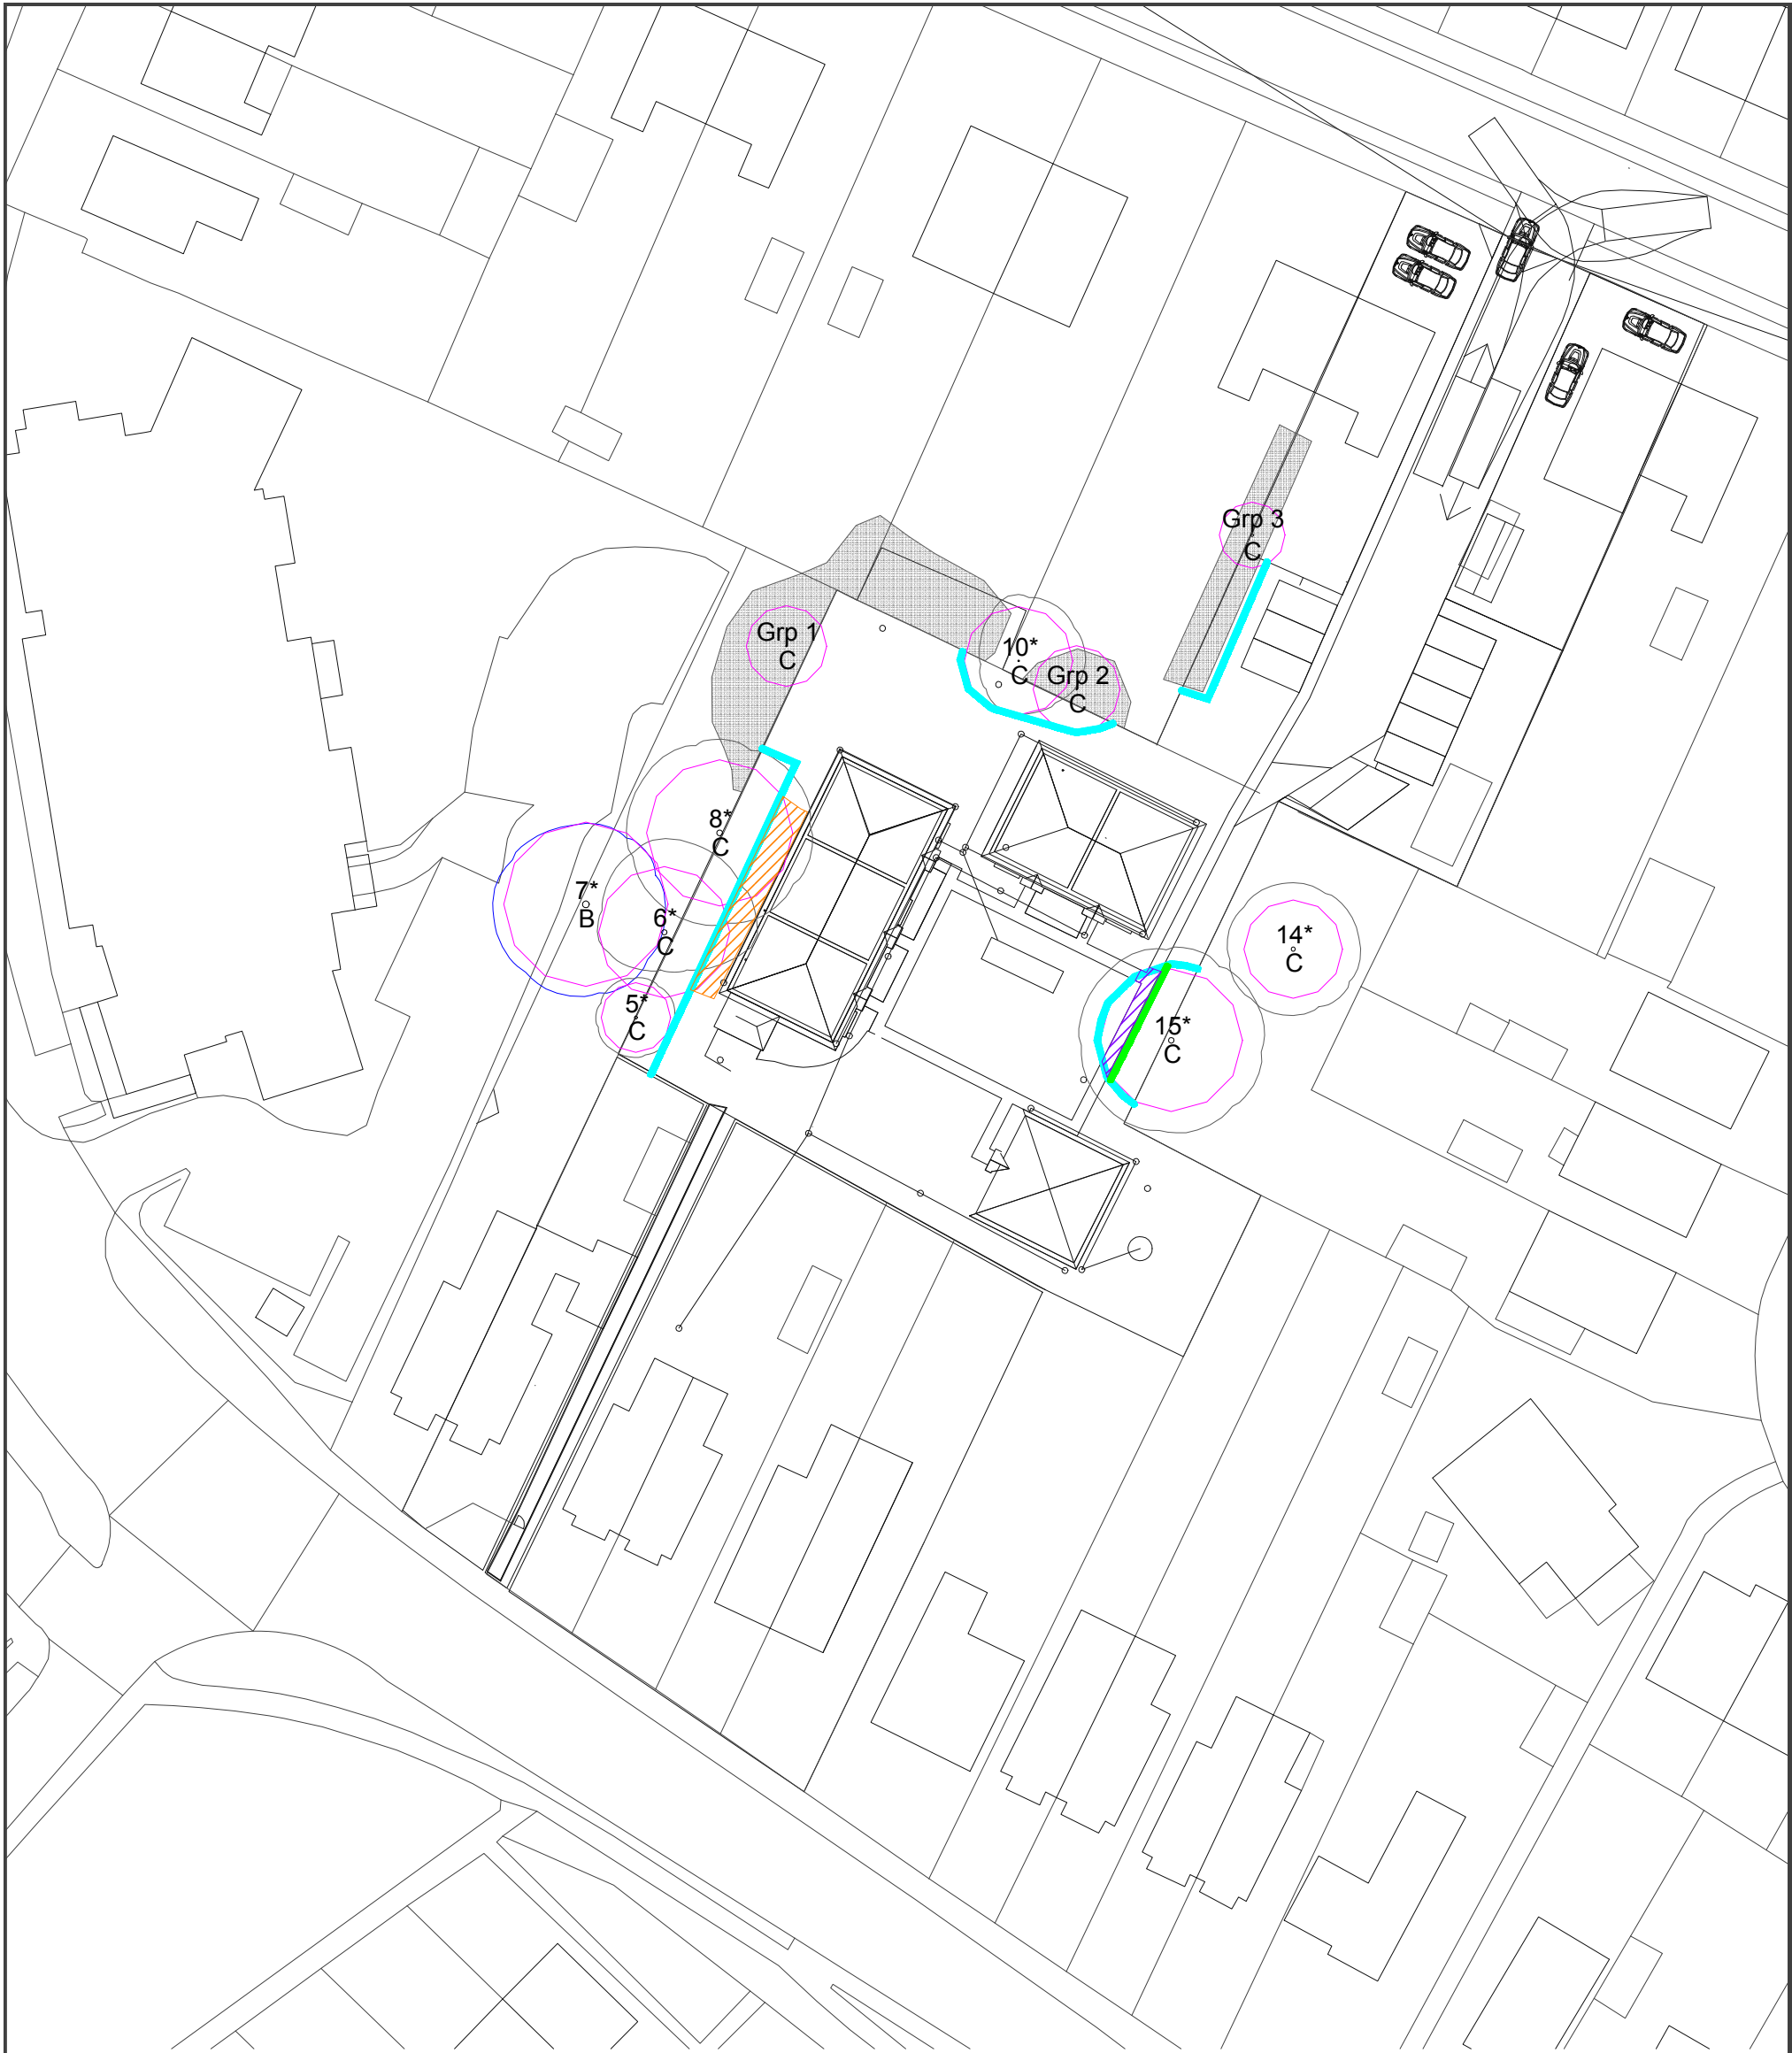
# Tree Protection Plan

Location of hand dig excavation for footpath within RPA of Tree 15 to be supervised.

This Arboricultural Method Statement (AMS) demonstrates the protection measures for the retained trees and should be read in association with the Tree Protection Plan appended at JF3. This report follows the initial tree survey, implications assessment and on-going discussions to minimise the impact upon the existing tree stock.

It is recommended that a copy of the Tree Protection Plan is made available to act as a point of reference for all contractors.
