# Boundary Lakes Golf Course

SuDS Maintenance Plan

On behalf of **Utilita Bowl**

Project Ref: 2306 | Report 4 | Date: June 2025

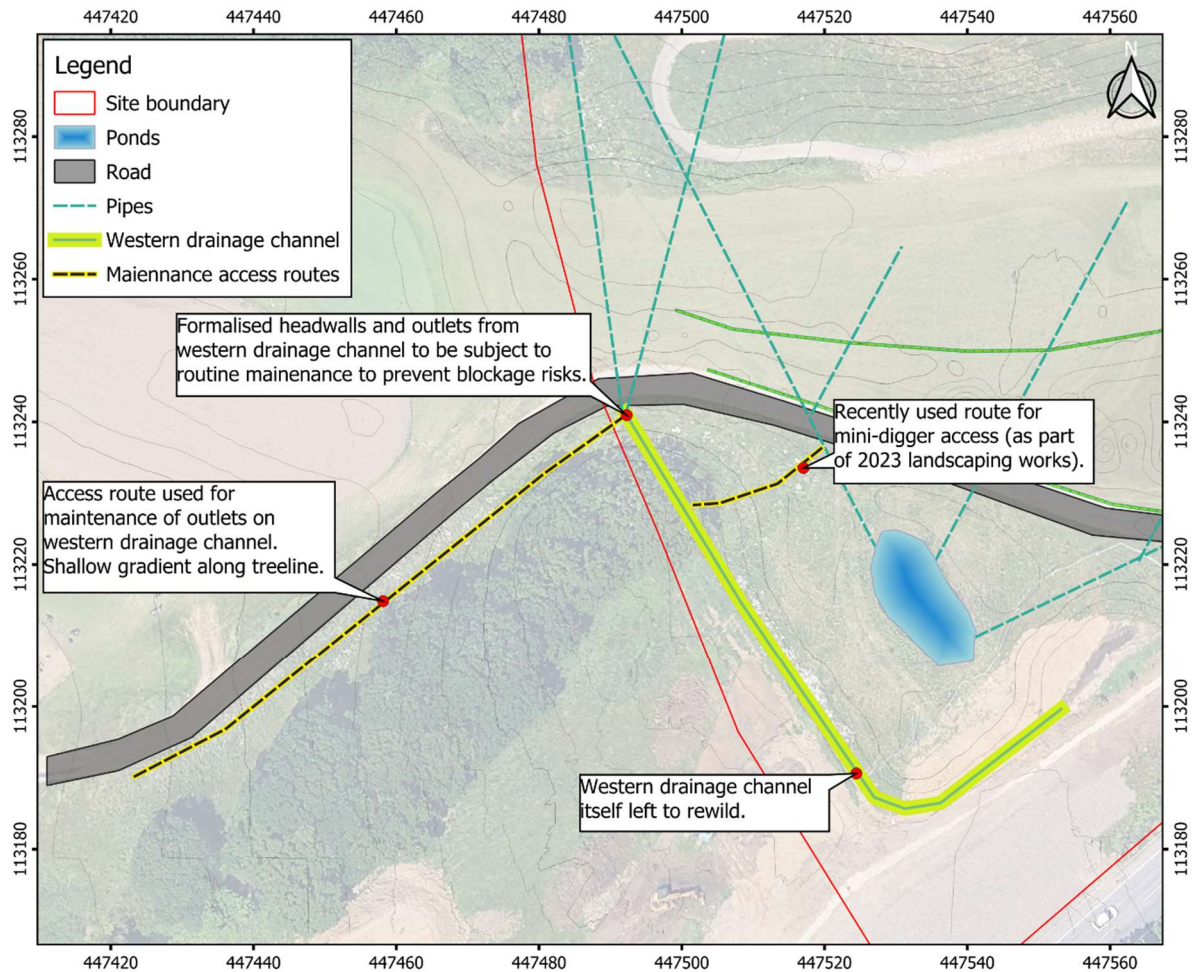
Figure 2.1 Maintenance arrangements in west of Site

This western part of the Site (i.e. the western drainage channel area) will be allowed to rewild over time, with minimal routine maintenance being undertaken on the western drainage channel itself. This will increase channel roughness, reducing the velocity of surface water conveyance along the channel and to the downstream network. This is not thought to pose a flood risk as the feature is at the top of the network (i.e. it has a small catchment area and relatively low inflows), has a large capacity and is not surrounded by flood risk receptors. A delayed concentration time to the downstream parts of the network may provide a net benefit overall with regards to on-site water management.

Occasional landscaping work can be undertaken on the feature (to re-profile or remove sediment for example) if required, with access to the channel being available via the southern bank. The base of the channel was accessed as part of the landscaping works (to reprofile the channel bed) in 2023. The access route is illustrated in Figure 2.1. Routine maintenance will be undertaken around the outlet orifices on the downstream (northern) end of the feature (as per the arrangements for the remainder of the drainage network). Maintenance personnel will access the outlets on-foot from the access road to the northwest (illustrated in Figure 2.1). This route provides a shallow gradient for safe access.
