# HAMBLE POINT MARINA

Hamble-le-Rice, Southampton

## FLOOD RISK ASSESSMENT & DRAINAGE STRATEGY

Project No 24-409-60c

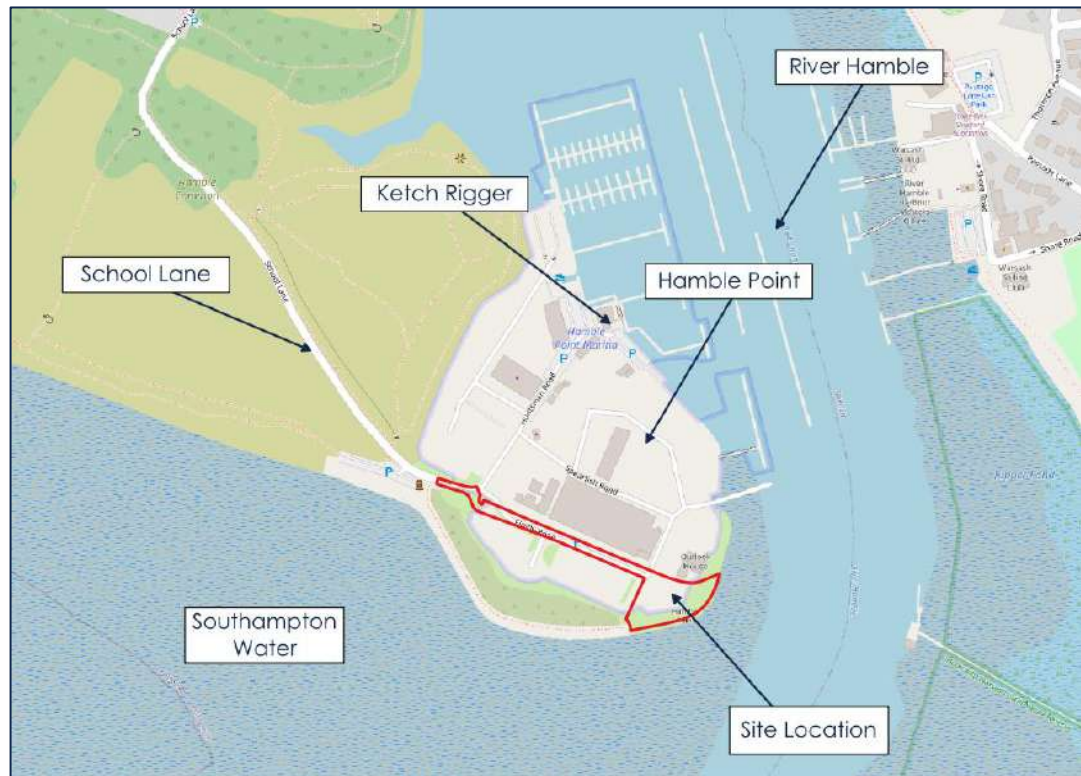
Figure 3-1 Site Location

- 3.1.1 The site is located in the Hamble Point Marina, to the southeast of Hamble Point, Hamble-le-Rice, Southampton. The approximate coordinates for the site are 448622, 105738 and the closest postcode is SO31 4NB. Figure 3-1 shows the site location.

- 3.2.1 The nearest watercourse to the site is the tidal River Hamble, a designated Main River. This flows in a southerly direction to Southampton Water and surrounds the site to the east and south. The location of this watercourse is shown on Figure 3-1.

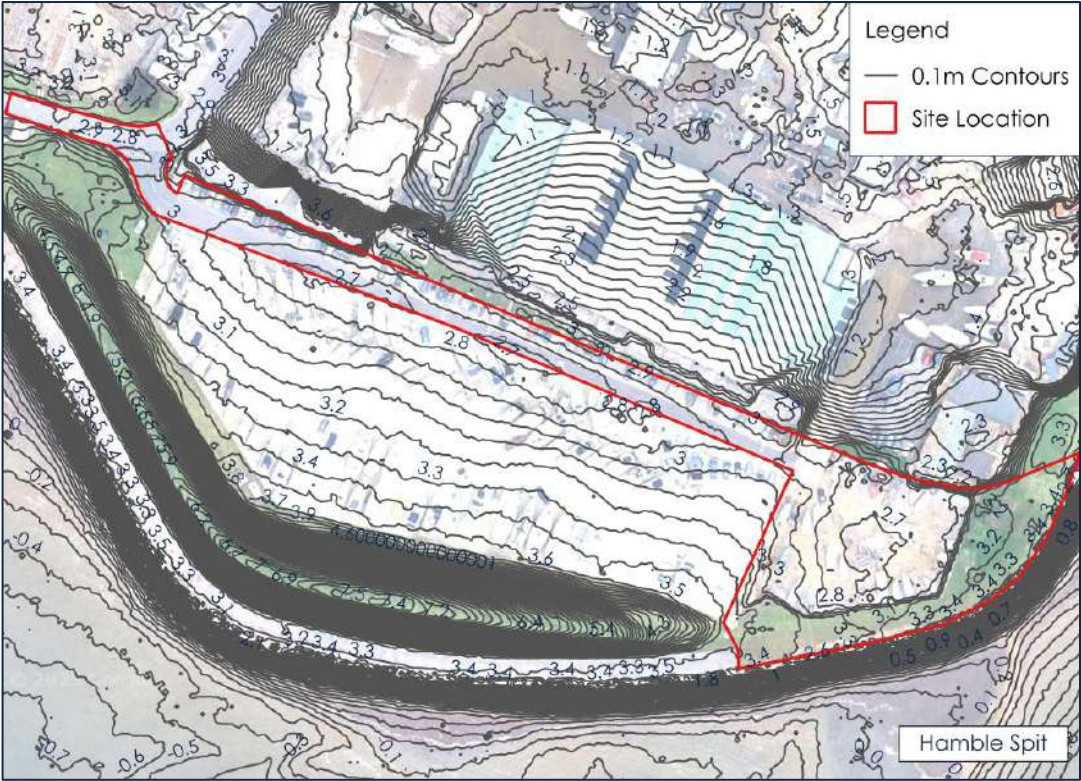
Figure 3-2 Topography of the site

- 3.2.4 As shown in Figure 3-2 and the topographic survey, the topography at the location of the proposed restaurant (in the east of the site) is relatively flat, with an average elevation of approximately 2.75mAOD. Immediately to the south of the location of the proposed restaurant, the elevations rise to a maximum elevation of 3.46mAOD in the southern corner of the site.

- 3.2.5 The elevation of the proposed parking bays immediately to the north and west of the proposed restaurant location have an elevation of between 2.86mAOD and 3.18mAOD. The existing access road and car parking spaces in the western section of the site has an elevation of approximately 3.0mAOD.

- 3.2.6 To the north of the location of the proposed restaurant, the levels drop steeply to an elevation of 2.2mAOD. The levels immediately to the east and south of the proposed restaurant sharply drop off to Hamble Spit, at an elevation of approximately -0.1mAOD.

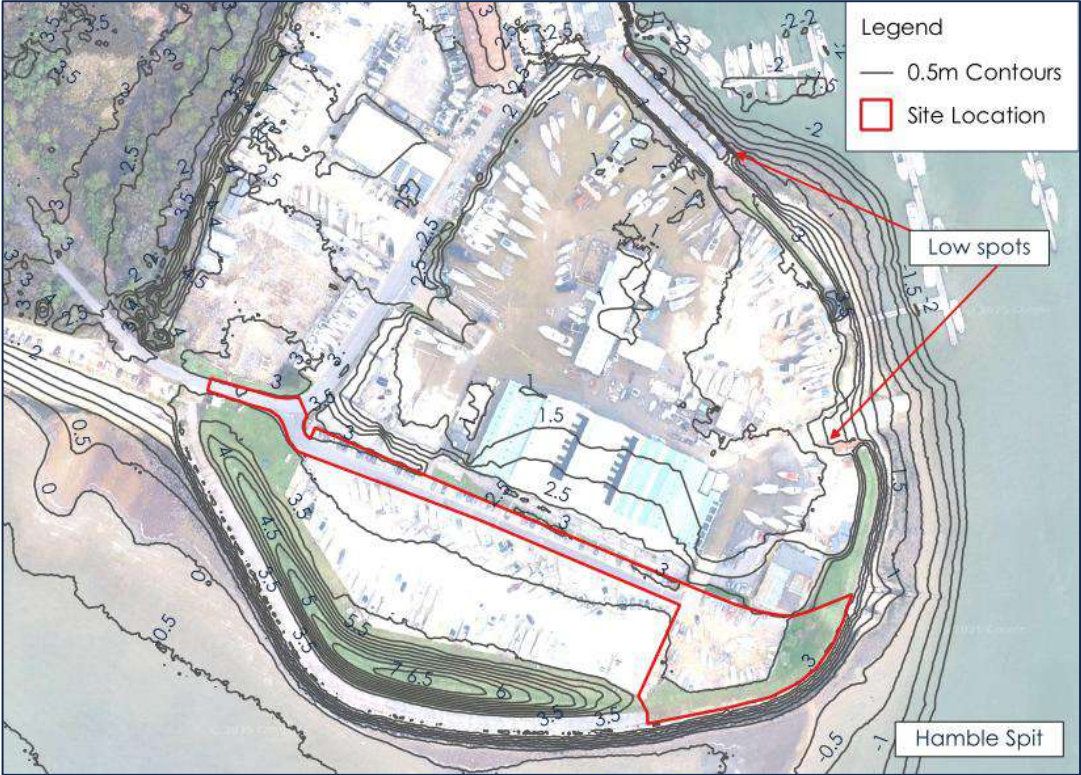
Figure 3-3 Topography of the wider marina

- 3.2.7 There is a topographic high spot (an embankment) to the south of the site, which rises up to 7.9mAOD. There are also low banks which run around the edge of the Hamble Marina to the north of the site. These banks have an approximate elevation of 3.1mAOD, although they are non-continuous, with low spots 95m and 190m to the north of the site. These low spots have elevations of 2.1mAOD and 1.8mAOD respectively, and the locations of the low spots is shown in Figure 3-3.

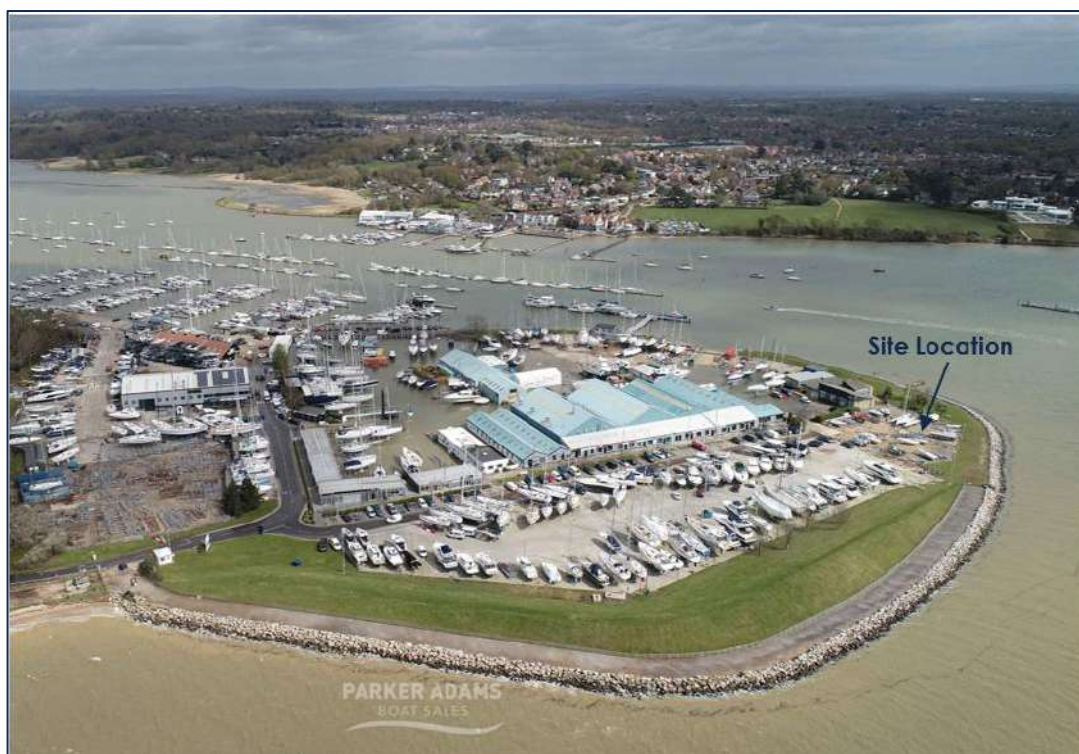
Figure 3-4 Image of the flooding of Hamble Point Marina, 9<sup>th</sup> April 2024

- 3.4.3 Although both these records show there to be no recorded flooding of the site, an internet search for '*Hamble Point Marina Flooding*' provided images of flooding from 9<sup>th</sup> April 2024, when Storm Pierrick generated strong winds which coincided with a high tide (equating to a 1 in 55 year event<sup>1</sup>). As shown in Figure 3-4, this event caused flooding to the marina. The site itself is shown to be flood free, although it is not known when the photo was taken. If the photo was taken after high tide, flood waters would have receded.

- 5.3.4 As discussed in Section 3.4, a flood event impacted Hamble Point Marina, equating to a 1 in 55 year event<sup>1</sup>. The photos from this event do not show the site to be impacted, whereas the model shows an impact at the site from the 1 in 20 year event. The difference between the two is likely due to temporary defences being put into place before the April 2024 event, which are not present in the model. Therefore, the model represents a conservative approach.

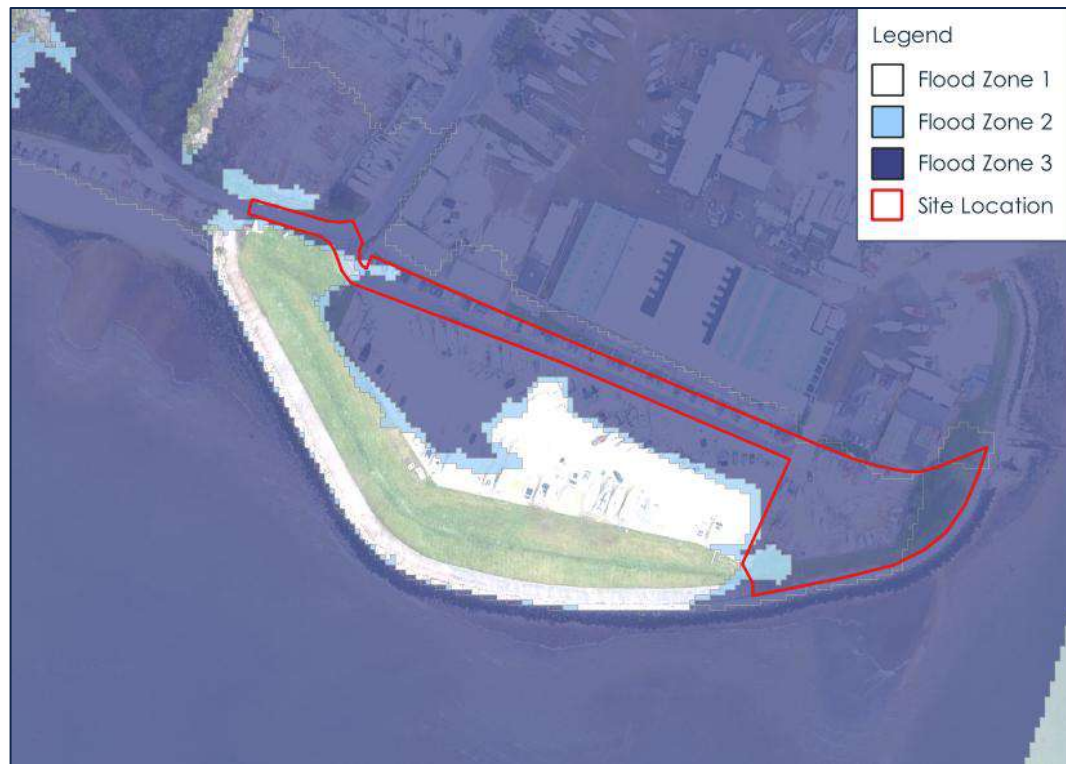
Figure 5-1 Flood Map for Planning

5.2.2 The 2025 iteration of the Environment Agency (EA) Flood Map for Planning defines the site as falling entirely within Flood Zone 3, meaning the site is at High risk of fluvial or tidal flooding.

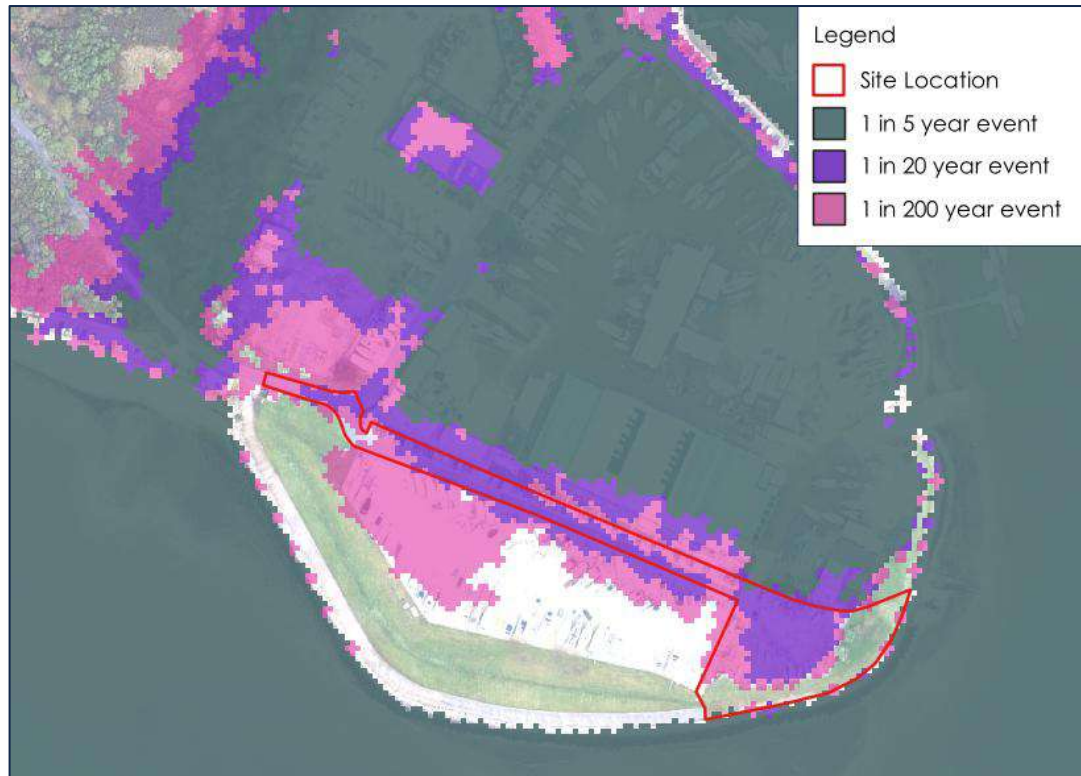
Figure 5-2 Modelled Flood Extents from the Southampton Water model

- 5.3.3 The model shows that for the present day (2012), the site is flood free in the 1 in 5 year event. It becomes flooded in the 1 in 20 year event and higher events, including the design event, as shown in Figure 5-2.

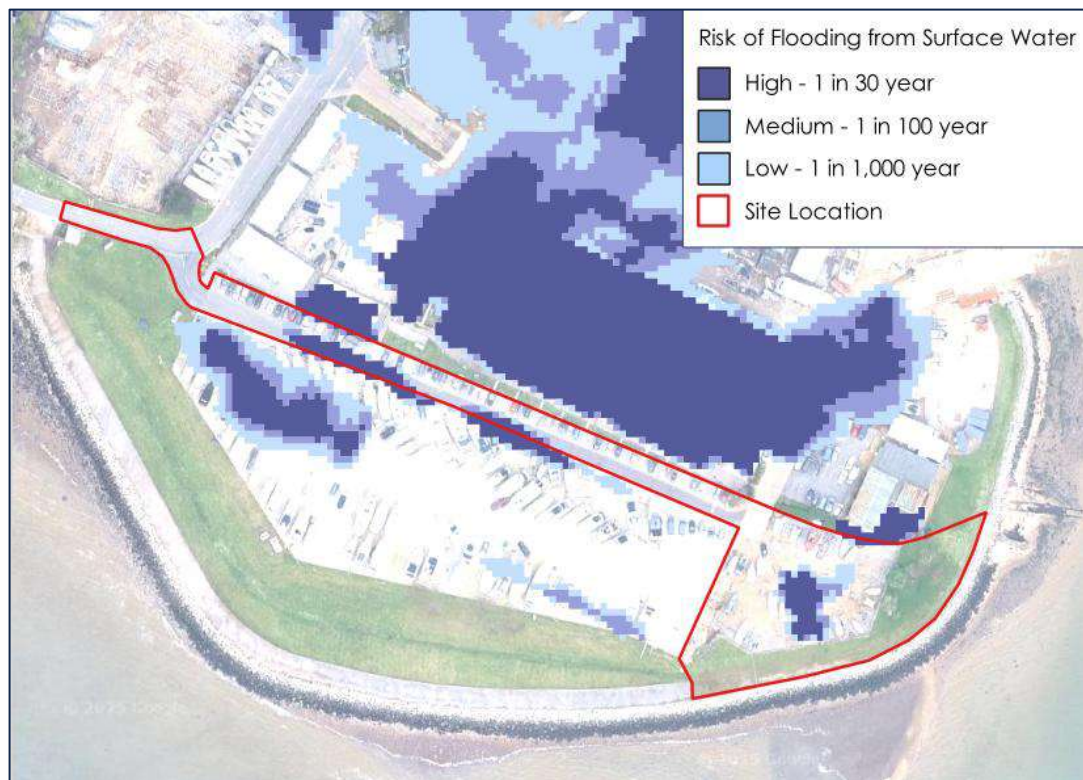
Figure 5-3 RoFSW with Climate Change Extents

- 5.5.2 The mapping is derived by the simulation of the above rainfall events over a digital terrain model (DTM). The DTM is defined on a 2m square grid and as a result, local topographic features are often poorly defined.
- 5.5.3 The RoFSW mapping (including an uplift for climate change) predicts that the site is at High risk of flooding from surface water, as shown in Figure 5-3. In addition, there are two areas of High risk of surface water flooding immediately to the north of the site.

- 5.7.1 In the event of sewer flooding occurring upstream of the site, water would behave in a similar manner to the surface water flood mapping shown above. The extent of surface water flooding on the site itself, shown in the RoFSW mapping (Figure 5-3), is from water falling on the site rather than flowing from elsewhere. There are no known sewers on the site to generate flooding.
- 5.7.2 The risk of sewer flooding is therefore considered to be **Negligible**.

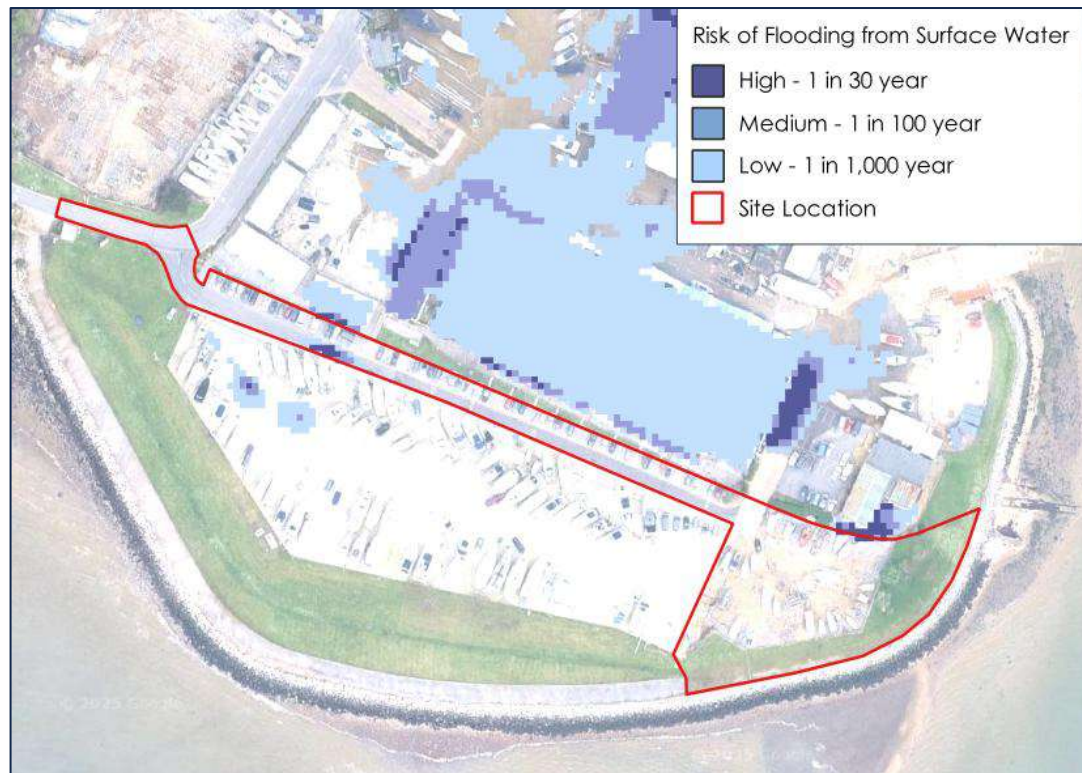
Figure 5-4 RoFSW with Climate Change Extents 0.2 Depth Band

- 5.5.4 The RoFSW dataset also indicates the predicted flood depths which would occur during the extreme rainfall events. The flood risk is categorised into depth bands including 0.2m, 0.3m, 0.6m, 0.9m and 1.2m. It should be noted that depths below 0.075m are removed from the dataset as most land is covered by some water as rain falls across the area in surface water flood modelling.
- 5.5.5 The dataset indicates the risk of surface water flooding present across the eastern portion of the site is not included in the shallowest depth band, the 0.2m depth band, as shown in Figure 5-4. Therefore, the surface water flooding predicted to impact the site in all three rainfall events has depths of between 0.075m and 0.2m.

- 5.5.6 In the west of the site, there is topographic low spot which is showing to still be at High risk of flooding for the 0.2m depth band. This is not present in the 0.3m depth band, indicating this surface water flooding is between 0.2m and 0.3m deep.

- 5.5.7 The area of High risk flooding in the western portion of the site immediately to the north of the site is also not present in the 0.3m depth band, and therefore this surface water flooding is also between 0.2m and 0.3m deep.

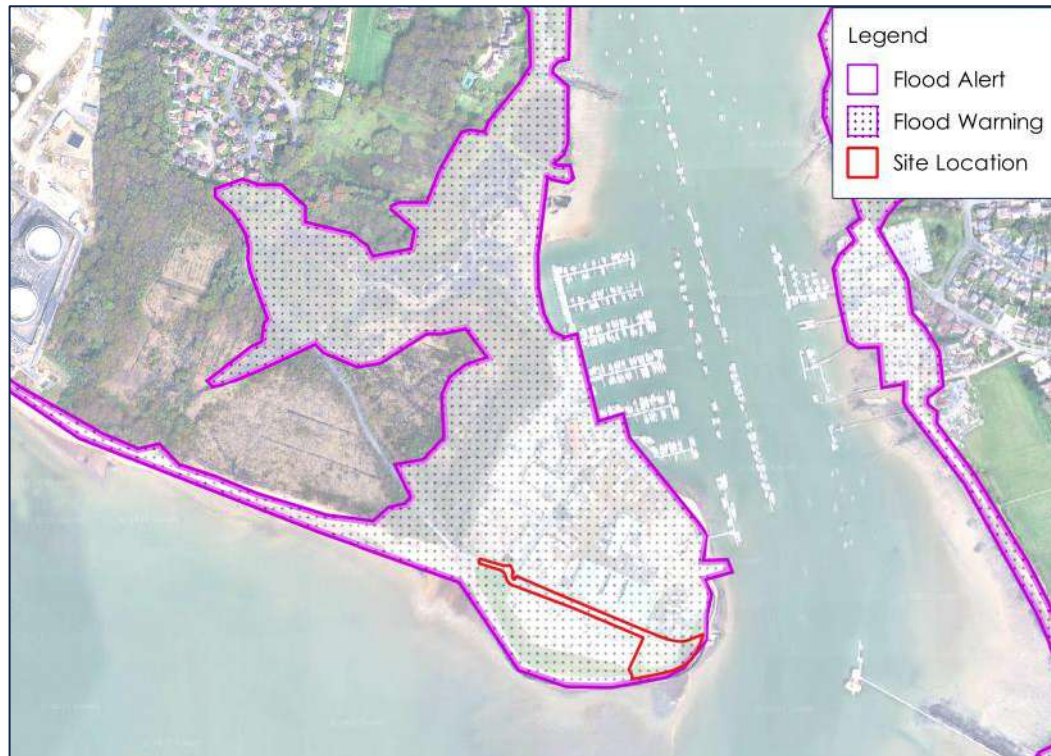
Figure 6-1 Flood Alert and Warning Areas

- 6.2.1 Floodline Warnings is a free service provided by the Environment Agency that provides flood warnings direct by phone, email or text message.
- 6.2.2 The site is located within the Environment Agency Flood Warning and Alert areas for the Hamble Estuary, as shown in Figure 6-1. It is therefore recommended the restaurant appoint an FEP Manager, and they contact the Environment Agency on 0345 988 1188 and signs up to the flood warning service. The FEP Manager or

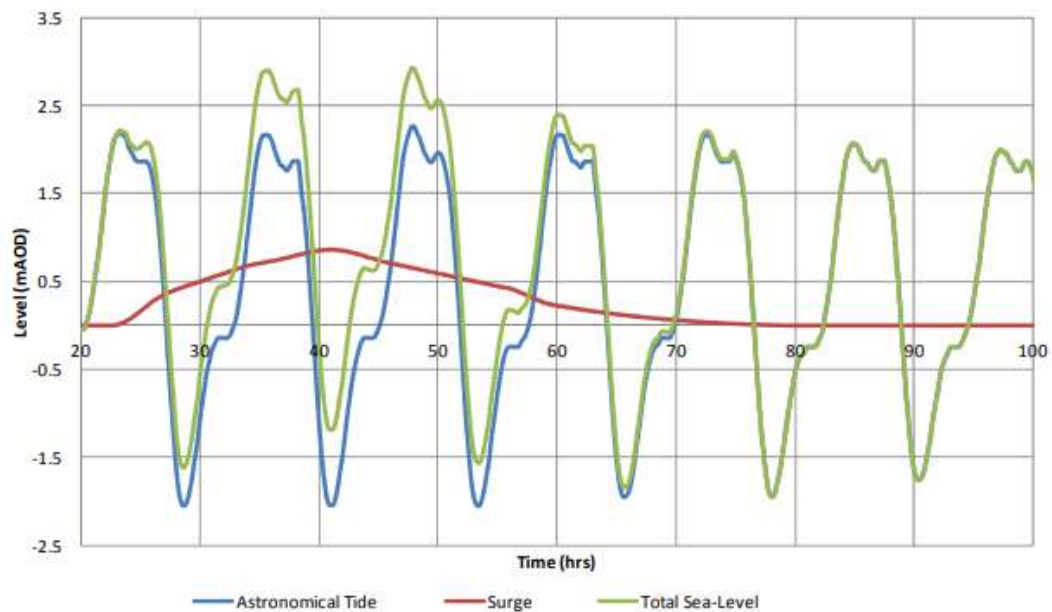
Figure 6-2 1 in 200 year design tidal graph for the mouth of Southampton Water

- 6.3.3 The duration of the flood event has been estimated based on the peak of the design event tidal curve. This has been extracted from the Southampton Water coastal modelling study final inception report and is shown below in Figure 6-2.
- 6.3.4 The peak of the event is approximately 45 hours, with water levels reaching a level where there would be flooding present for approximately one hour either side of the peak of the event in the present day.
- 6.3.5 Therefore, the duration of flooding at the site has been estimated to be approximately two hours.

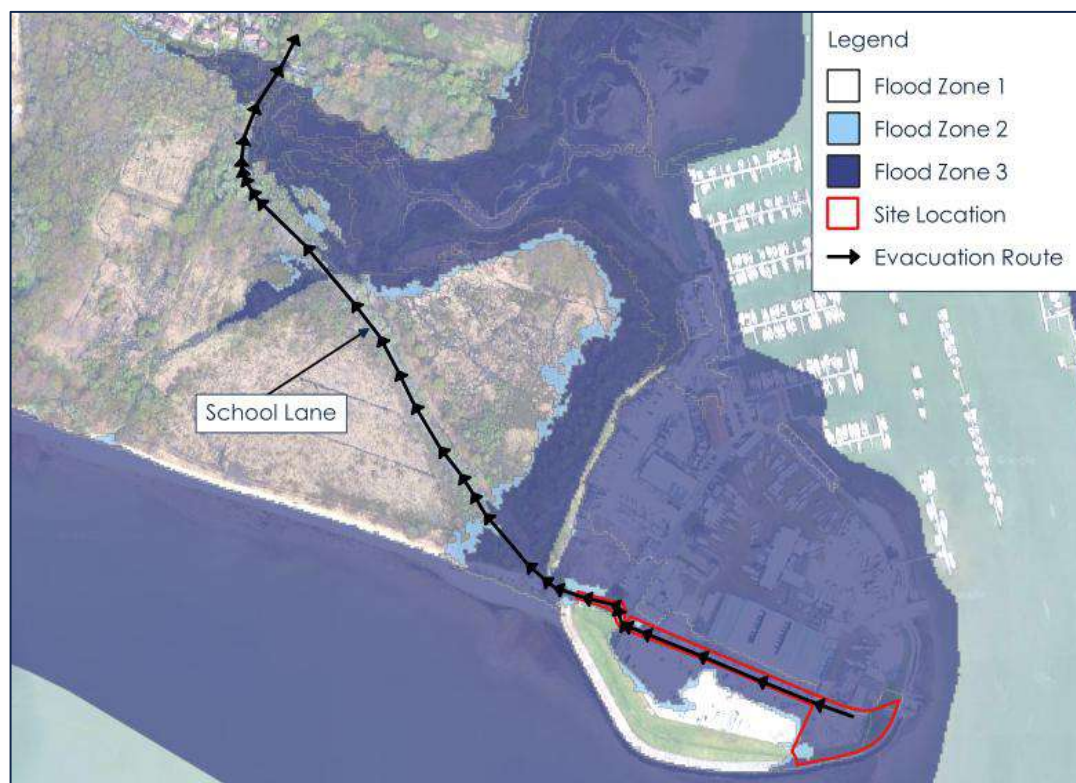
Figure 6-3 Evacuation Route

6.5.2 If evacuation were required, this should be undertaken in advance of the flood event where possible. There is one evacuation route to high ground in Flood Zone 1. It should be noted that there is some high ground in Flood Zone 1 to the west of the site, but this would leave occupiers of the site stranded.

- 6.5.7 The routes, shown in Figure 6-3 are adopted highways with dedicated footways adequate for all mobility needs. The FEP Manager may wish to nominate a dedicated evacuation muster point.
