**ADDRESS:** Stroudwood Farm, Winchester Road, Upham

**TITLE:** Plans and Section

**Ref.** 030301 P.03 A

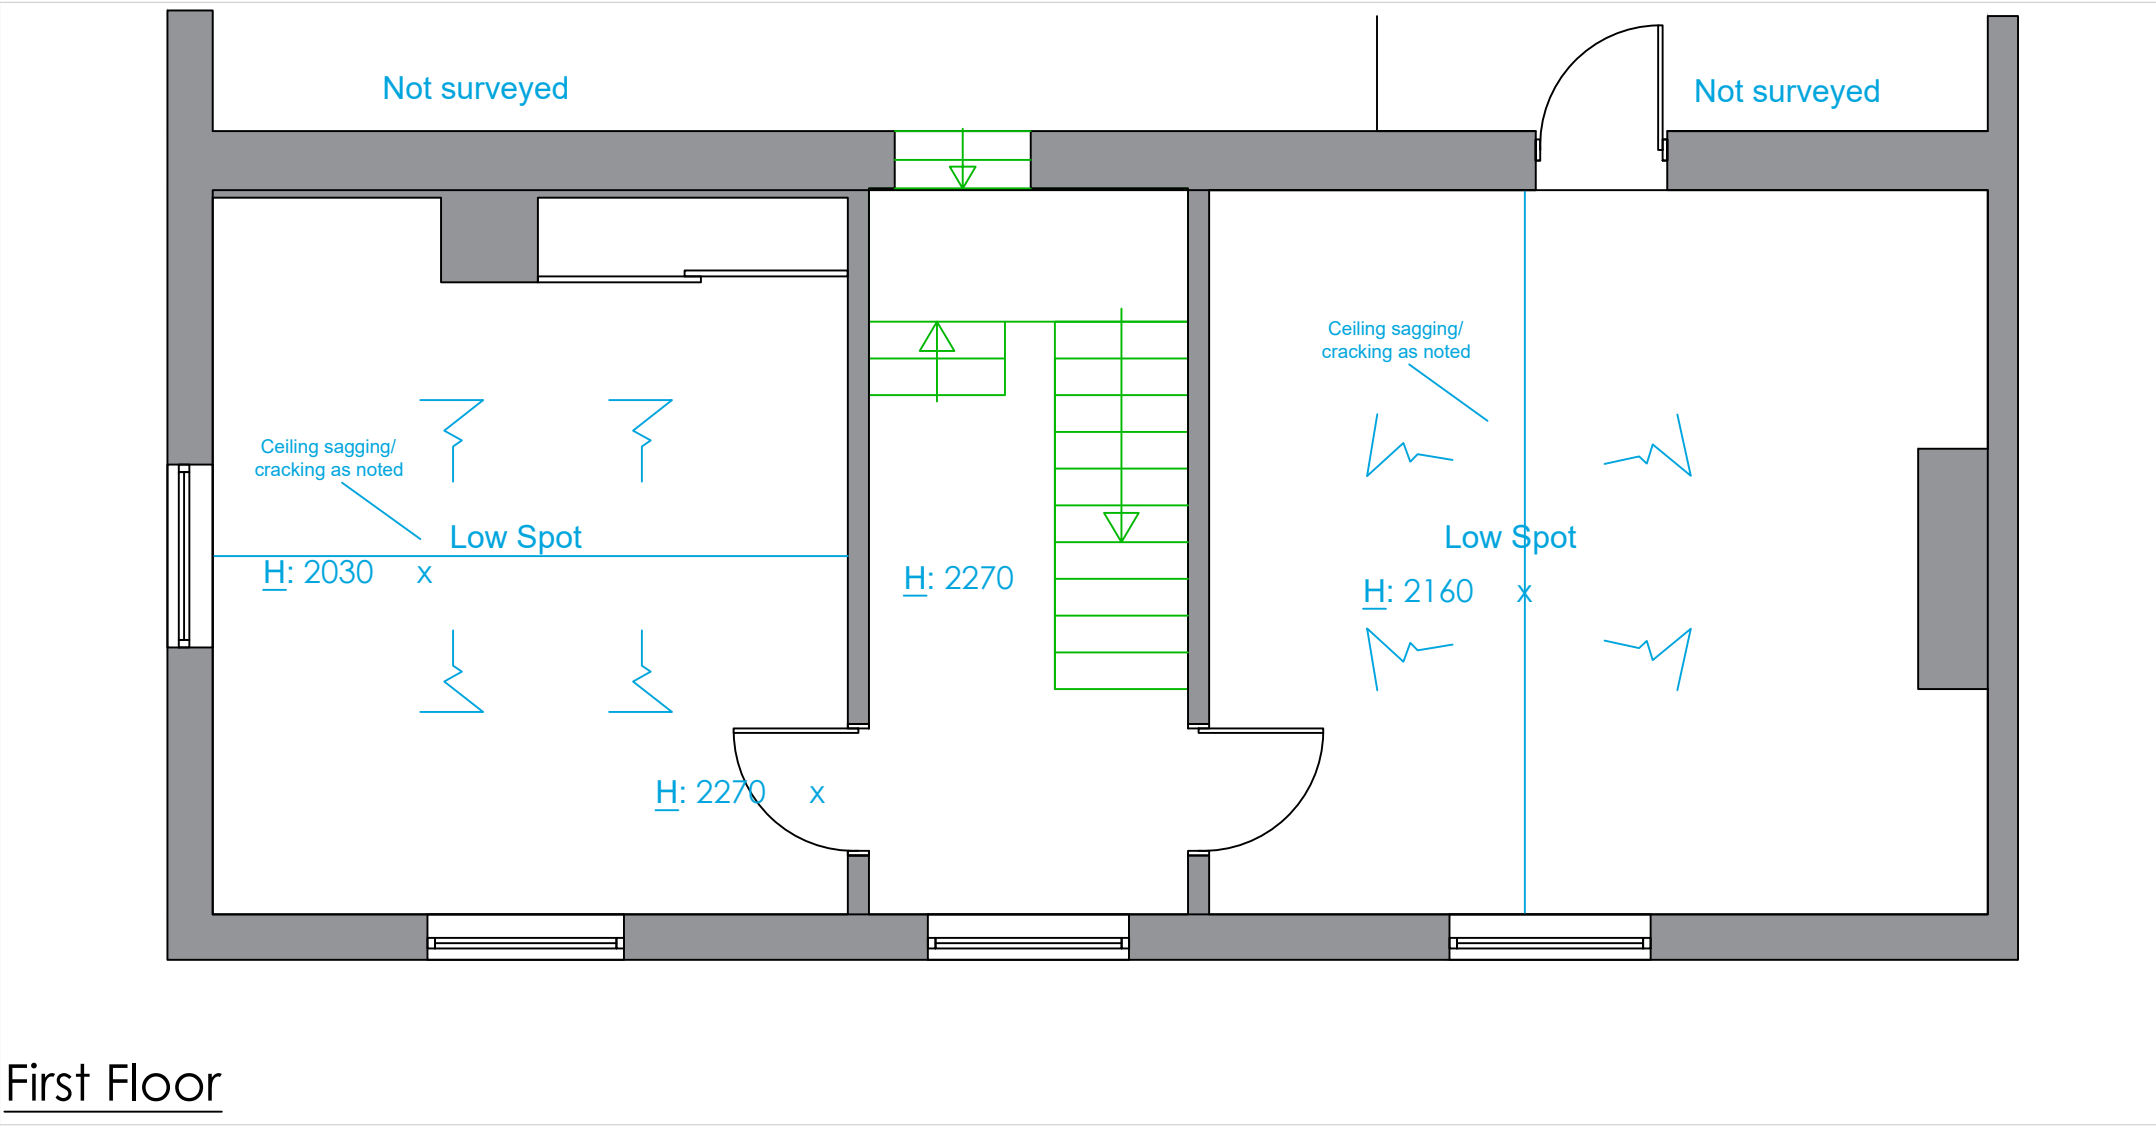
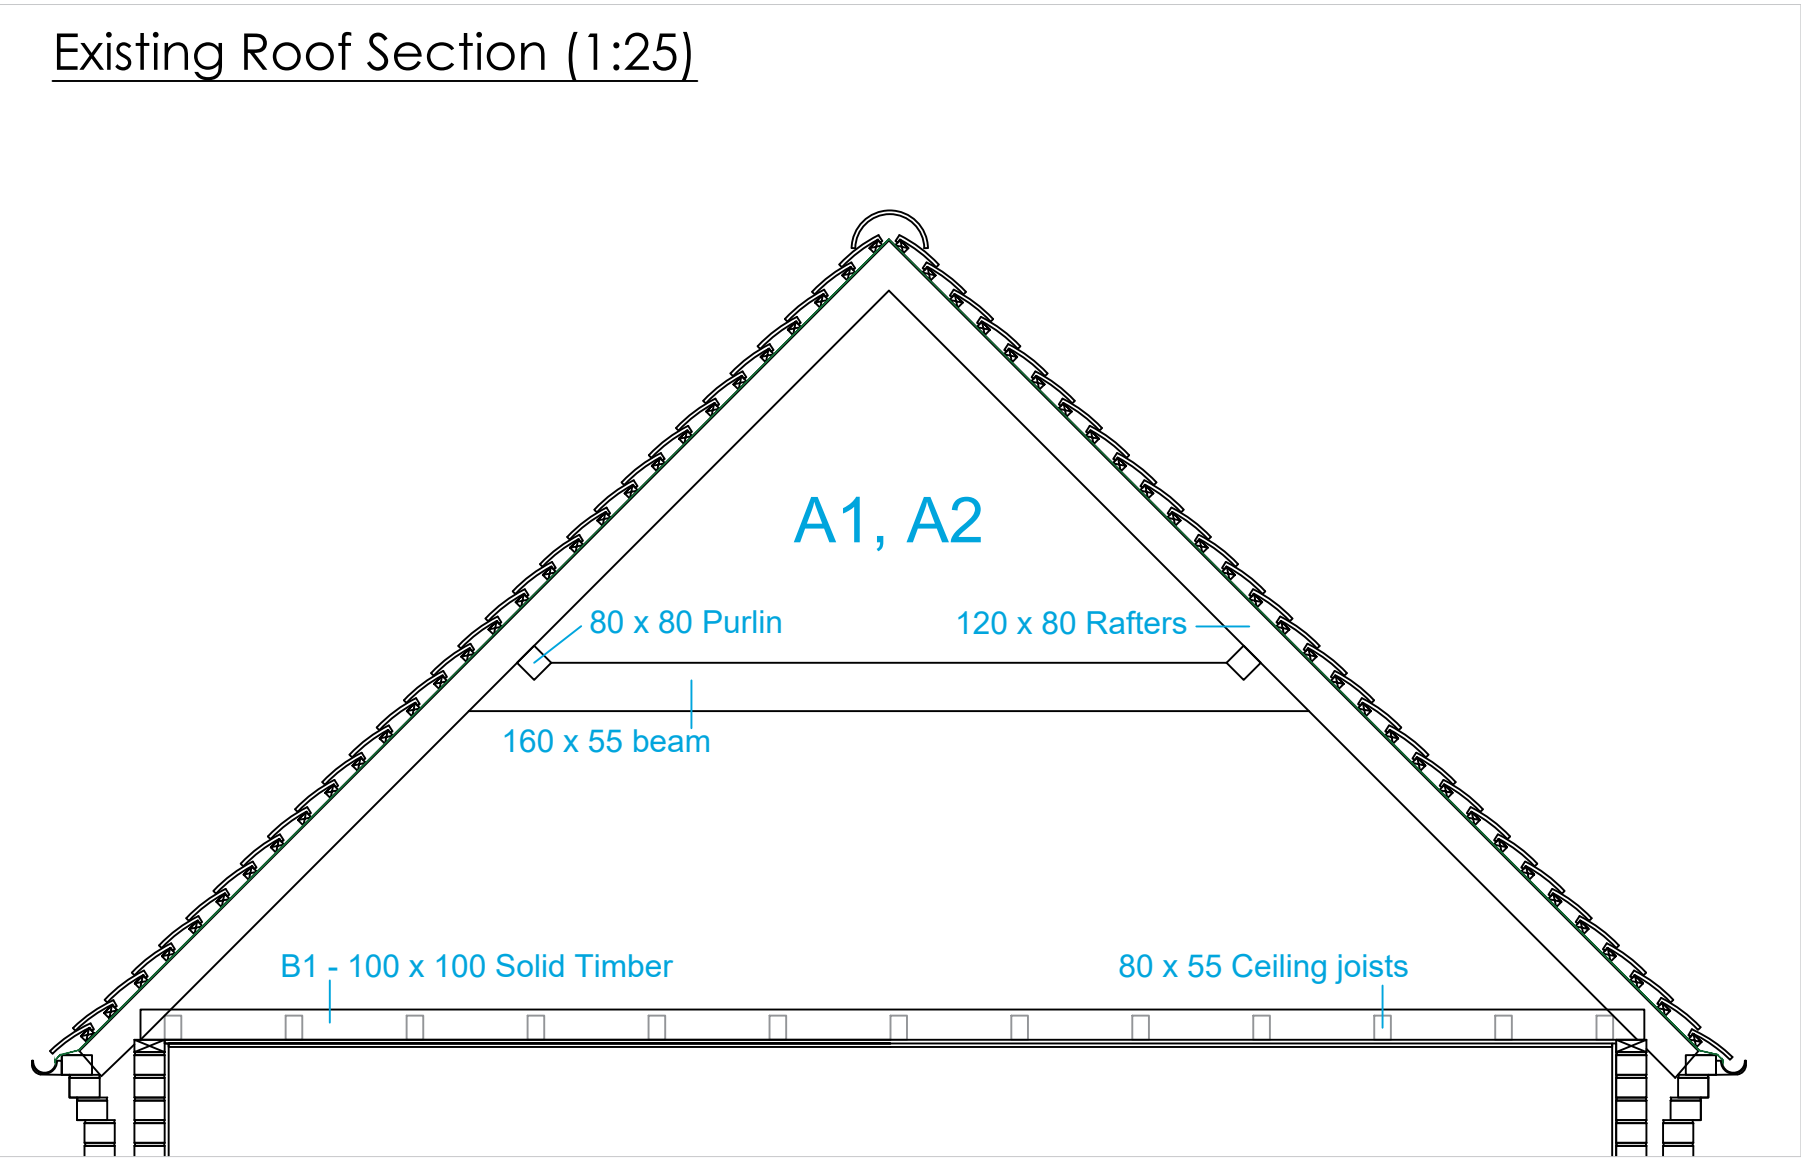
#### Ceiling Repairs - Lath and plaster

The Contractor is to carefully chip-off damaged plaster to expose laths. Where these are seen to be in a good condition, laths should be re-fixed to joists using stainless steel ring shank nails. Where laths are damaged or in poor condition these should be cut back to the next joist and replacement Oak laths affixed at every joist using stainless steel ring shank nails, ensuring a 6 to 10mm gap between laths.

Apply a 10 to 15mm scratch coat to damp laths, consisting of Lime putty mixed 1:3 with sand.

Once dried, apply a 1:2 Lime putty/ graded sand finish coat.

The plaster finish should be applied flush with the existing ceiling and patched in to avoid surface bumps or edges.

Ensure adequate heating and ventilation whilst plaster is drying.
