PROJECT  
The Linden Collection  
For Linden Group  
Boorley Green Phase 2 Parcel B5

DRAWING  
THE FLETCHER  
L1867/D5  
Front Elevation

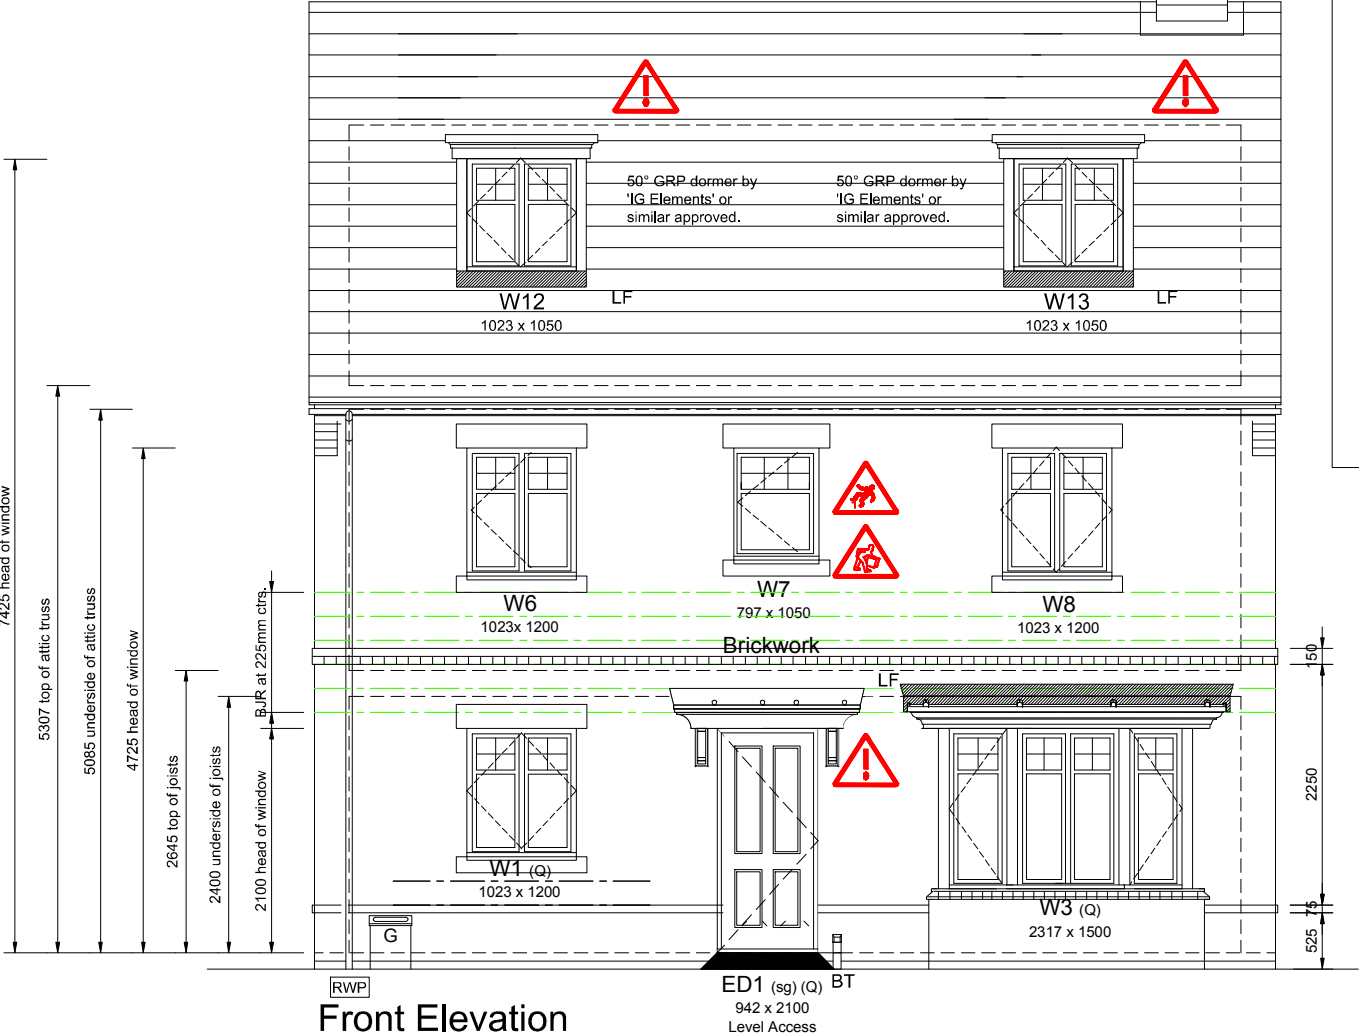
Front Elevation

NOTE: For bed joint reinforcement. Elevations shown as Brick, no bed joint reinforcement required. Setting out for Render/Recon Stone coursing heights may be adjusted depending on openings.

NOTE: For rainwater downpipe locations, refer to plot specific drawings.

NOTE: For recon stone units, ensure mortar is colour matched to the stone.
