The Linden Collection  
For Linden Group  
Boorley Green Phase 2 Parcel B5

THE FLETCHER  
L1867/D5  
Rear Elevation

| JOB NO. | DRAWING NO. | REV |
|---|---|---|
| LHS306 | FLE-602 | C9 |

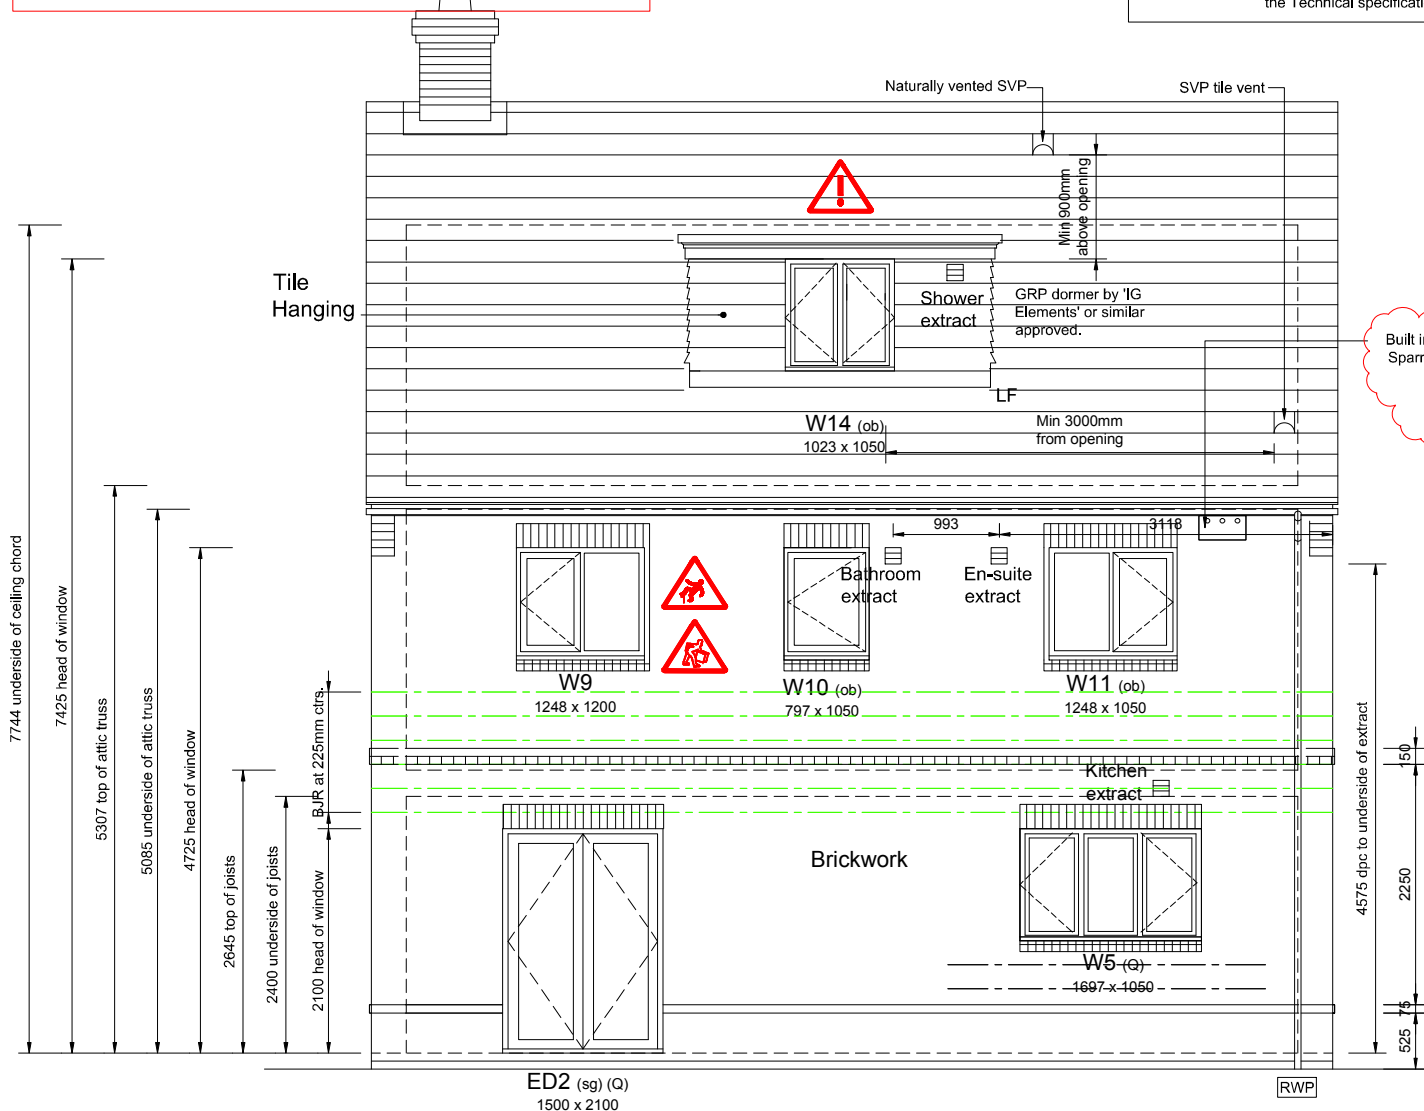
## Rear Elevation

NOTE: For bed joint reinforcement.  
Elevations shown as Brick, no bed joint reinforcement required. Setting out for Render/Recon Stone coursing heights may be adjusted depending on openings.

NOTE: For rainwater downpipe locations, refer to plot specific drawings.

NOTE: For recon stone units, ensure mortar is colour matched to the stone.
