## **Completion Report**

at  
**The Malthouse, Church Lane, Botley,  
Southampton, Hampshire SO30 2EJ**  
for  
**Orchard Homes**

**Reference: 19336/CR**  
**October 2022**

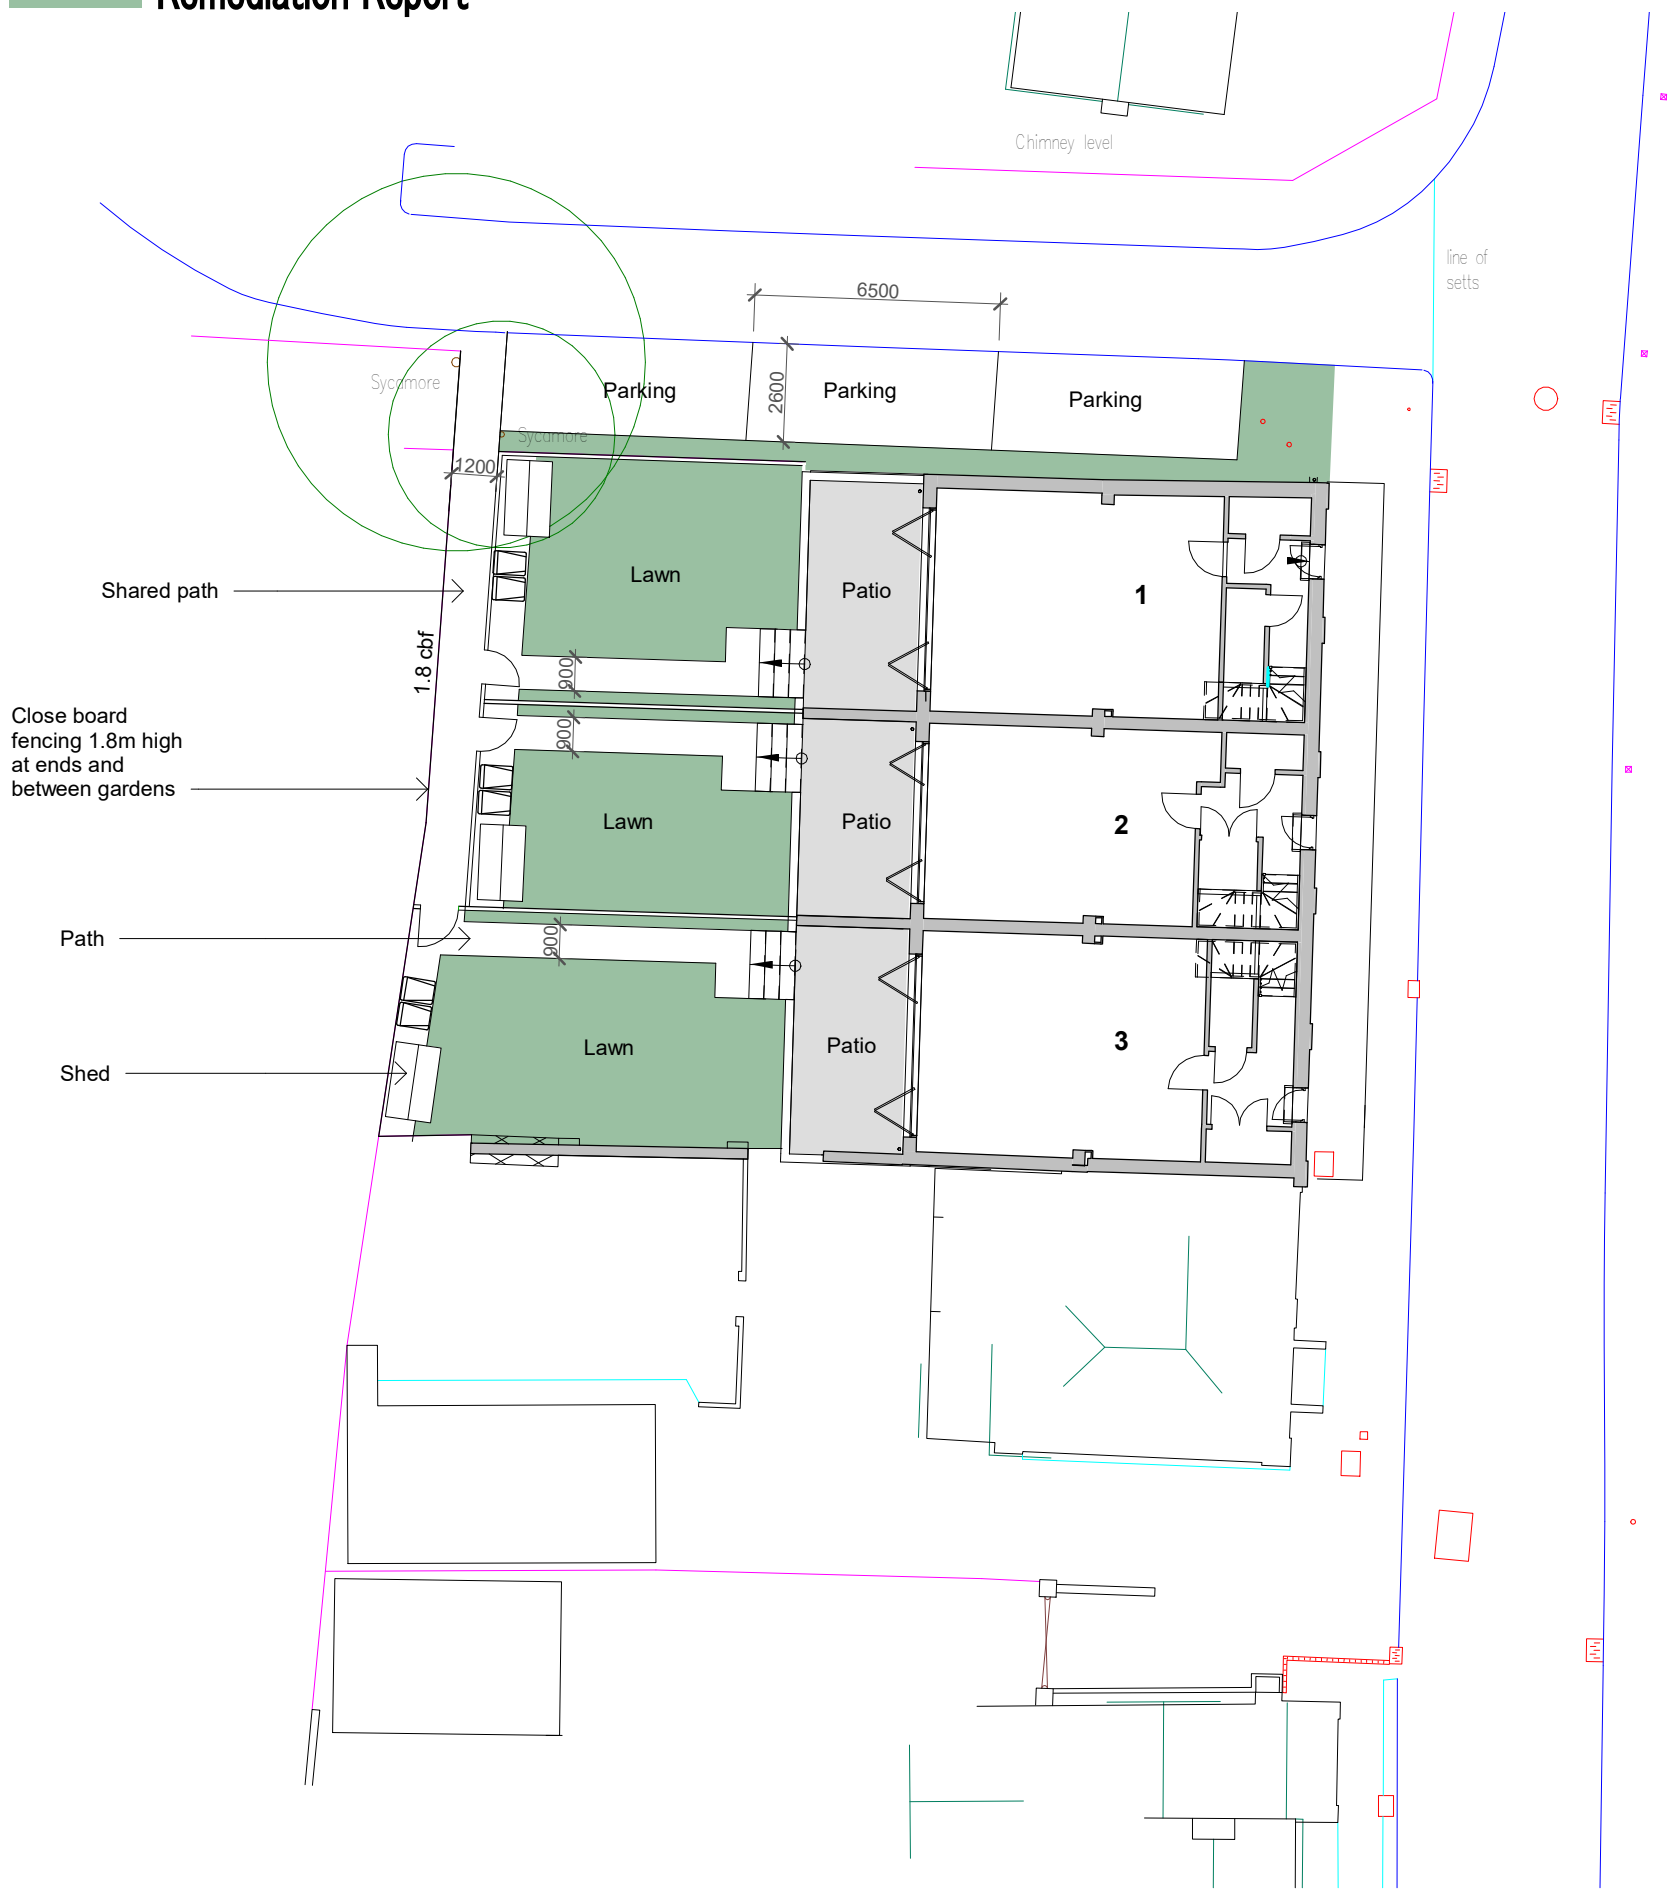
Works carried out and completed as per SOILS Remediation Report

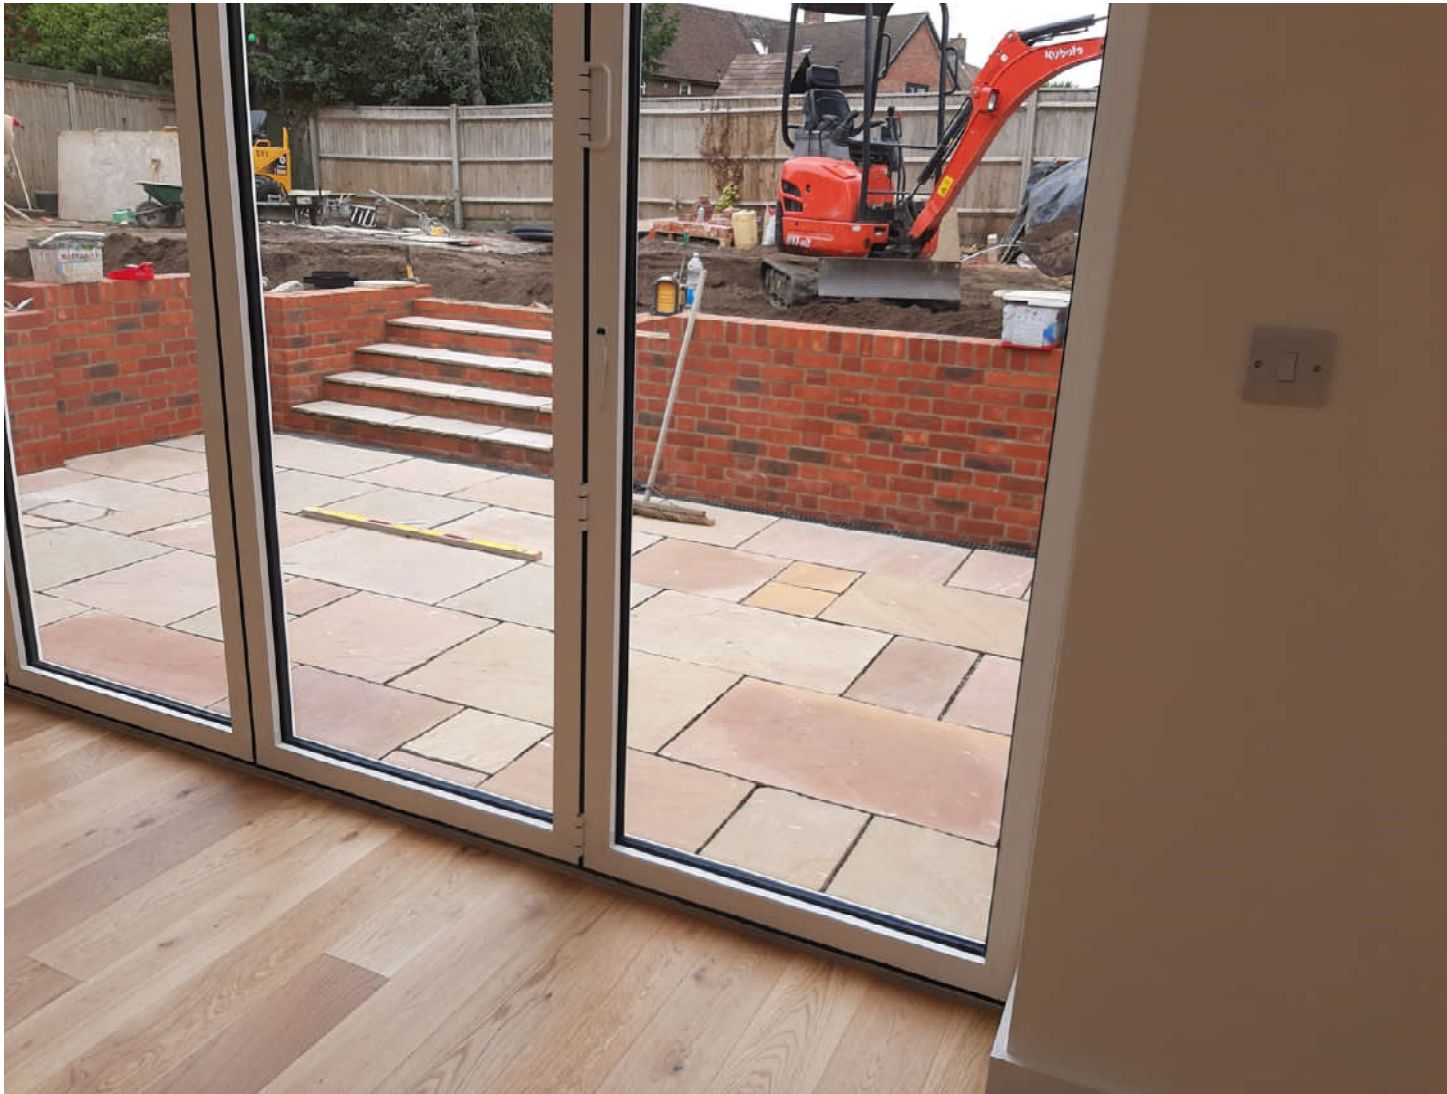
19336 The Malthouse: Site Works Photograph – View SW from House Interior
