**Arboricultural Implications Assessment  
and Method Statement  
for  
29 Valley Road, Chandlers Ford**

Report Ref: **231558 - AIA**

Report Date: **13 June 2023**

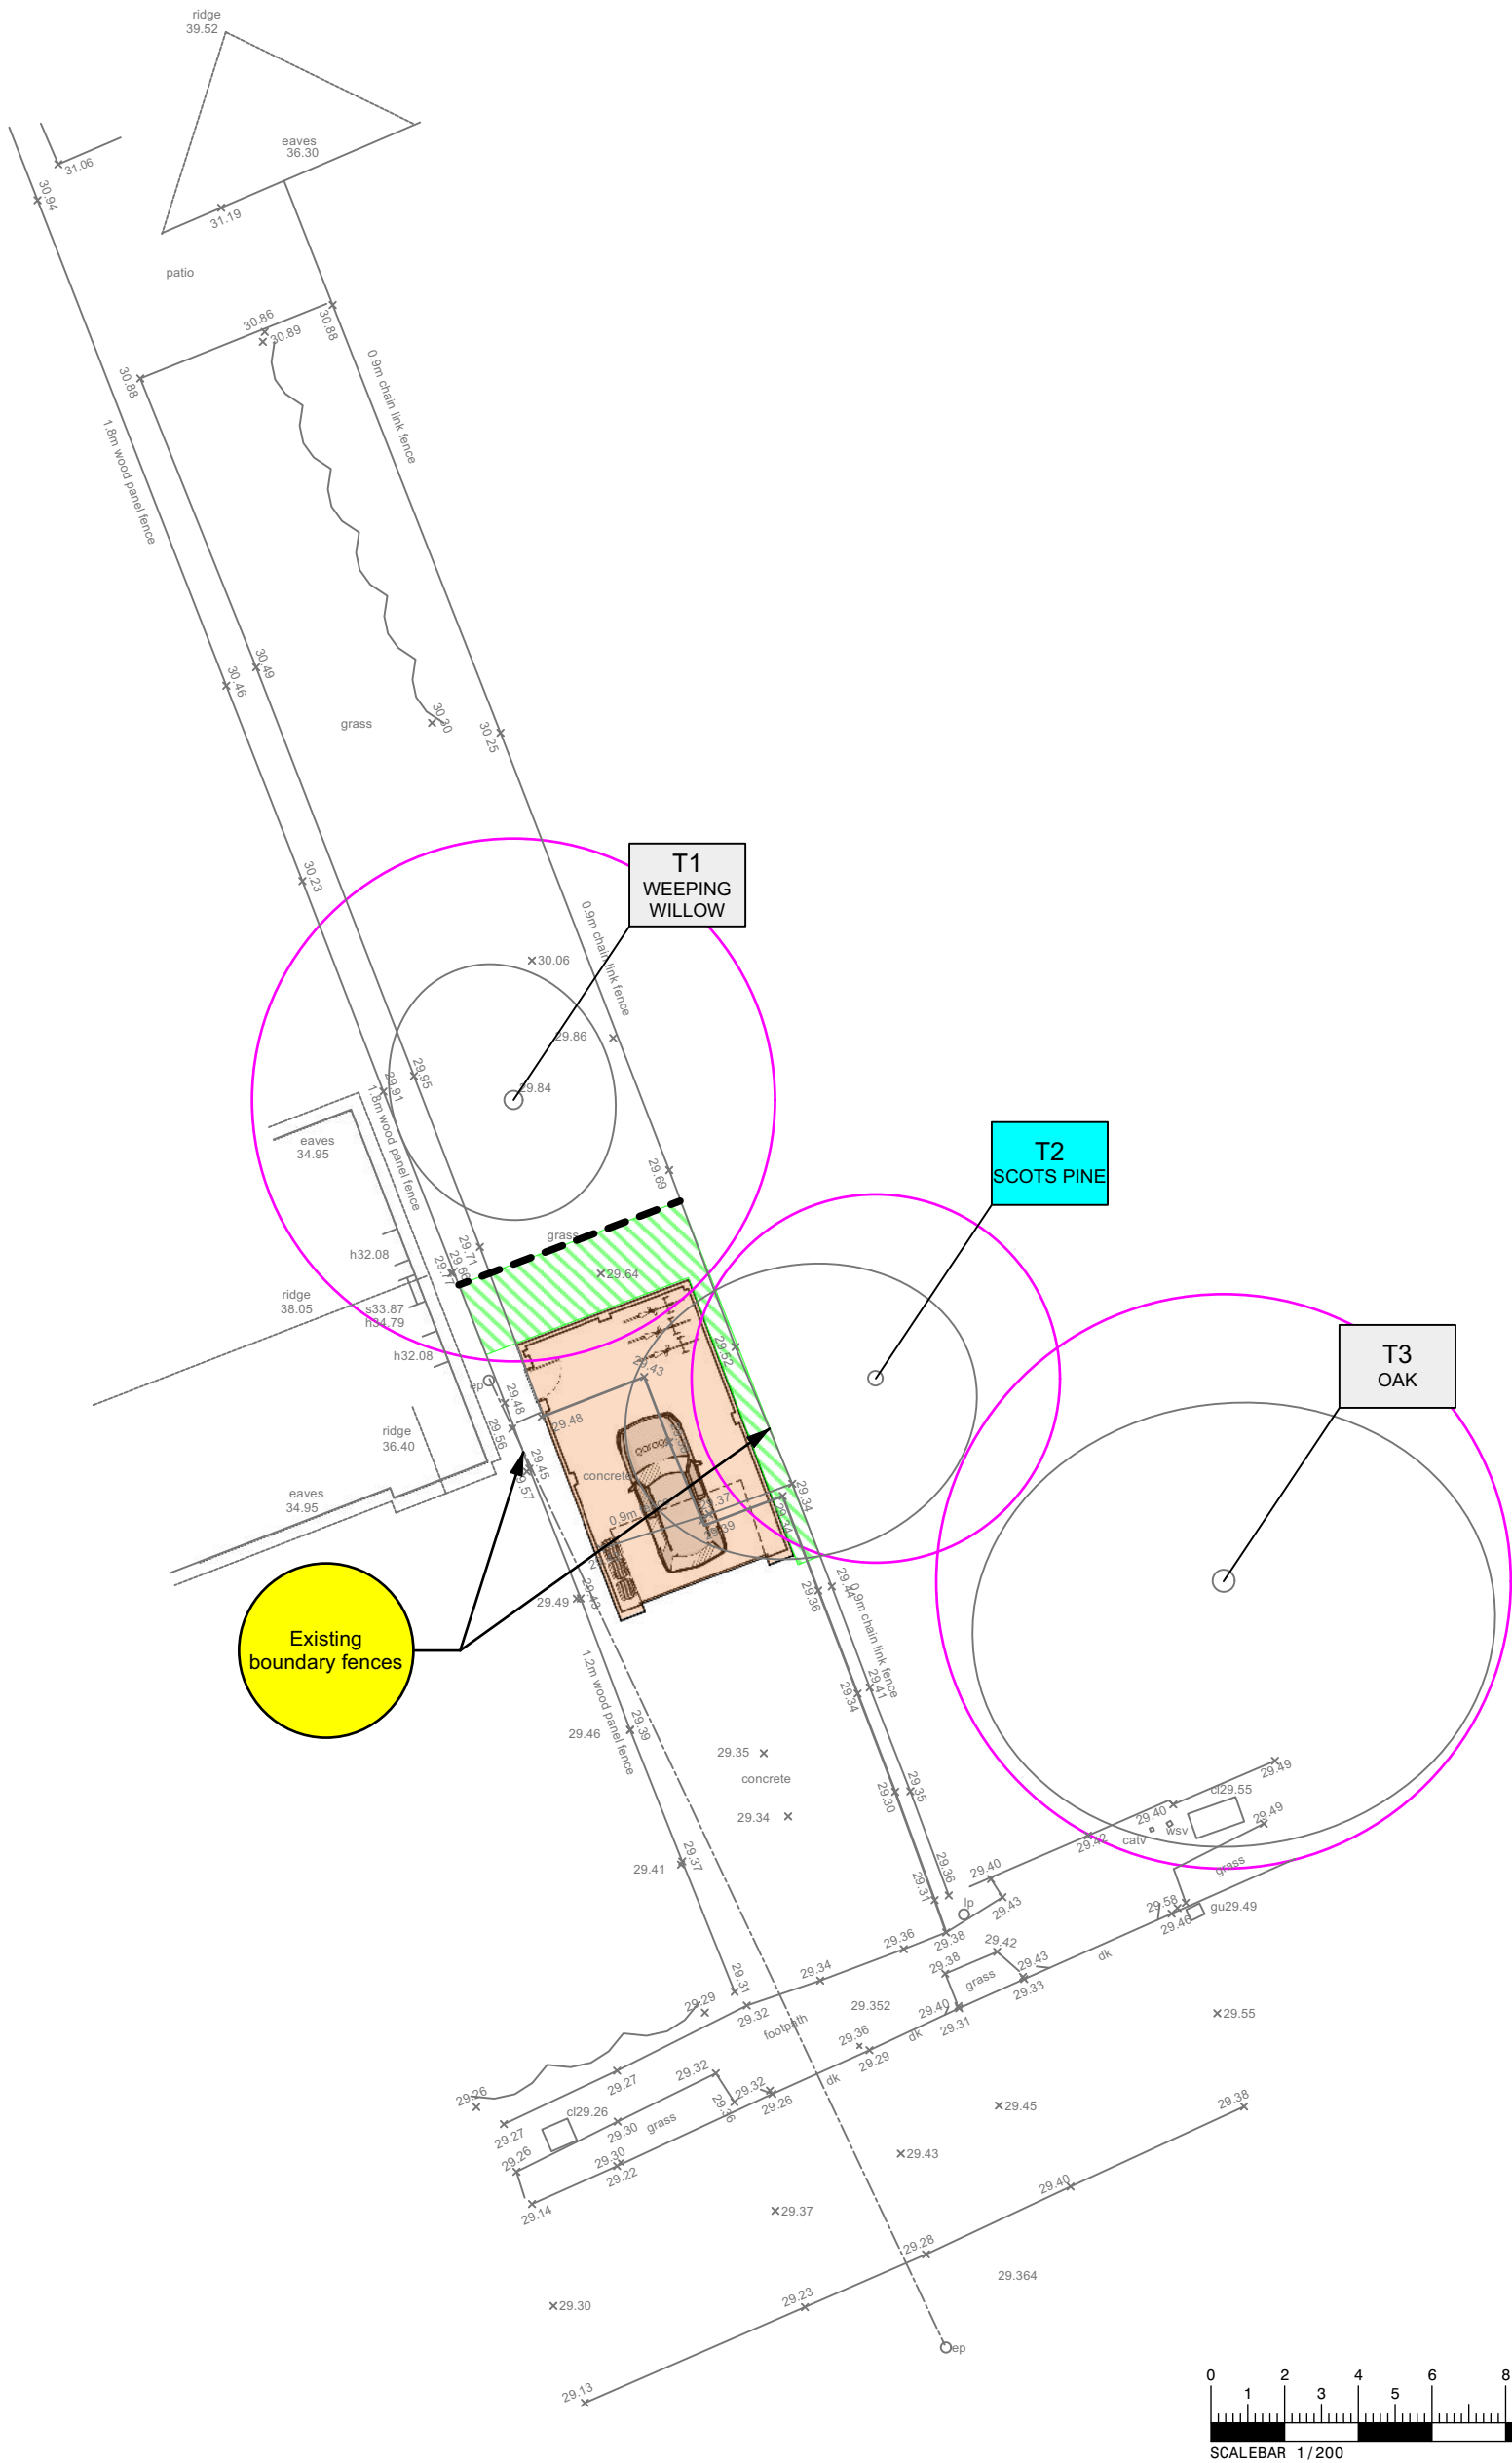
ECO 2 - TREE PROTECTION AT  
29 VALLEY ROAD, CHANDLERS FORD

COMPOSITE PLAN:  
LAND SURVEY IN GREY,  
PROPOSED GARAGE POSITION  
IN BLACK WITH ORANGE FILL

**Root Protection Areas (RPAs):**  
Below ground tree constraints for  
trees based on BS 5837 guidance

- 1.4 **The Tree Protection Plan:** This is included in Appendix 1 and is a composite drawing derived from the information provided. It shows the existing landscape features (from the land survey) in grey superimposed over the proposed site changes indicated in black outline with orange fill. This allows the relationship between the two to be clearly seen and an appropriate analysis of the implications of the proposed site changes to be undertaken. The Tree Protection Plan has also been annotated to show protection measures for any retained trees which could realistically be affected by the proposed development. It shows any activities in Root Protection Areas (RPAs) and if any trees are to be removed, they are shown with a red dashed outline.

5.1.1 **Tree Protection Plan (TPP):** The plan in Appendix 1 is illustrative, but is based on the layout drawings and topographical survey provided. Therefore, all scaled measurements should be checked against the original design documents. The attached plan and all other information in this report should only be used for dealing with the tree protection issues and all other uses are prohibited, unless authorised by ecourban ltd. All the existing trees will have been numbered, with any higher categories (A and B) highlighted in green and blue rectangles and any low categories (C and U) highlighted in grey and red respectively. The plan also shows the locations of the proposed protective measures, including areas where special care may be required. The TPP is an important document and a copy of it should be kept on site for reference during the construction phase of the project.

5.1.2 **Protective barriers:** The approximate location of the barriers is illustrated on the plan in Appendix 1 and information on barrier design based on BS 5837:2012 guidance is included in Appendix 3. The protective barriers will be erected before any materials or machinery are brought onto the site and before any clearance or construction activities occur. Once the protective barriers have been positioned, these will stay in situ for the duration of the construction phase, unless previously agreed with the project arboricultural consultant or council's tree officer. There will be no access into the protected areas and the storage of excavated debris and building materials will be prohibited in RPAs, unless authorised by the project arboricultural consultant, after discussion with the council's tree officer. No fires or fuel storage will be allowed within or near to protected areas under any circumstances.

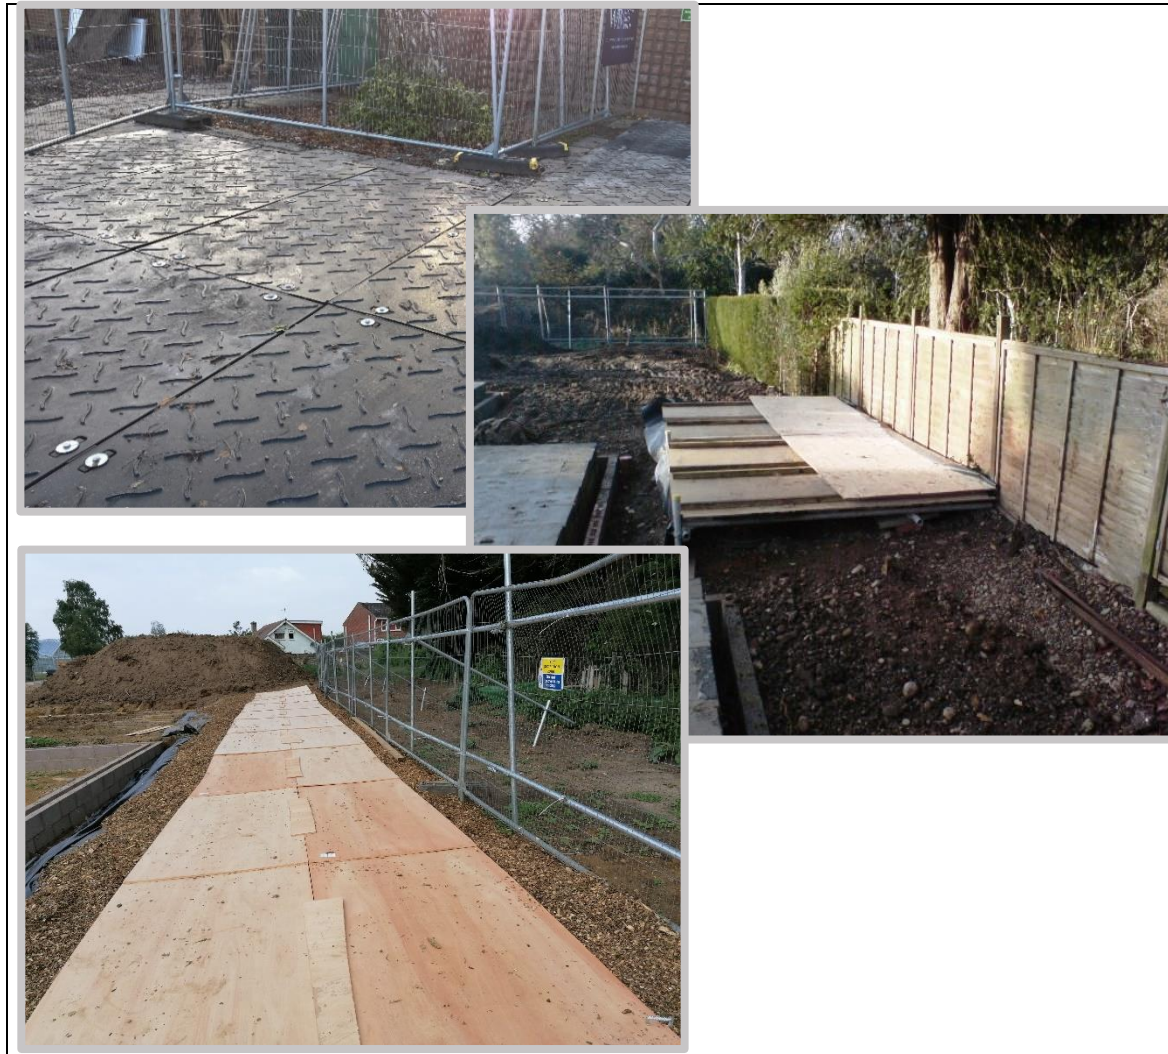
## Appendix 4: Illustrative Specification for Ground Protection within RPAs

New temporary ground protection should be capable of supporting any traffic entering or using the site without being distorted or causing compaction of underlying soil.

- a) for pedestrian movements only, a single thickness of scaffold boards placed either on top of a driven scaffold frame, so as to form a suspended walkway, or on top of a compression-resistant layer (e.g. 100 mm depth of woodchip), laid onto a geotextile membrane;*
- b) for pedestrian-operated plant up to a gross weight of 2 t, proprietary, inter-linked ground protection boards, placed on top of a compression-resistant layer (e.g. 150 mm depth of woodchip), laid onto a geotextile membrane;*
- c) for wheeled or tracked construction traffic exceeding 2 t gross weight, an alternative system (e.g. proprietary systems or pre-cast reinforced concrete slabs) to an engineering specification designed in conjunction with arboricultural advice, to accommodate the likely loading to which it will be subjected.*

5.1.3 **Ground protection measures:** Where the positioning of tree protection barriers is not feasible due to the need for construction access, then ground protection measures will be needed to safeguard RPAs. The position of ground protection is shown on the plan included in Appendix 1, with guidance for ground protection design included in Appendix 4 and an installation video for proprietary ground protection is available to view at <https://www.youtube.com/watch?v=QiaRgNUacKY>. The ground protection will also be installed before any materials or machinery are brought onto the site and prior to any clearance or construction activities occurring. Again, once the ground protection has been positioned, it will stay in situ for the duration of the construction phase, unless previously agreed with the project arboricultural consultant or council's tree officer.
