| Momentum Fitness Charity | | | | |
| Scout Hut,<br>Brickfield Lane, Chandlers Ford,<br>Eastleigh SO53 4DP. | | | | |
| Cross Sections | | | | |
| Drawing No: | 93386-500-003 | | Issue: | |

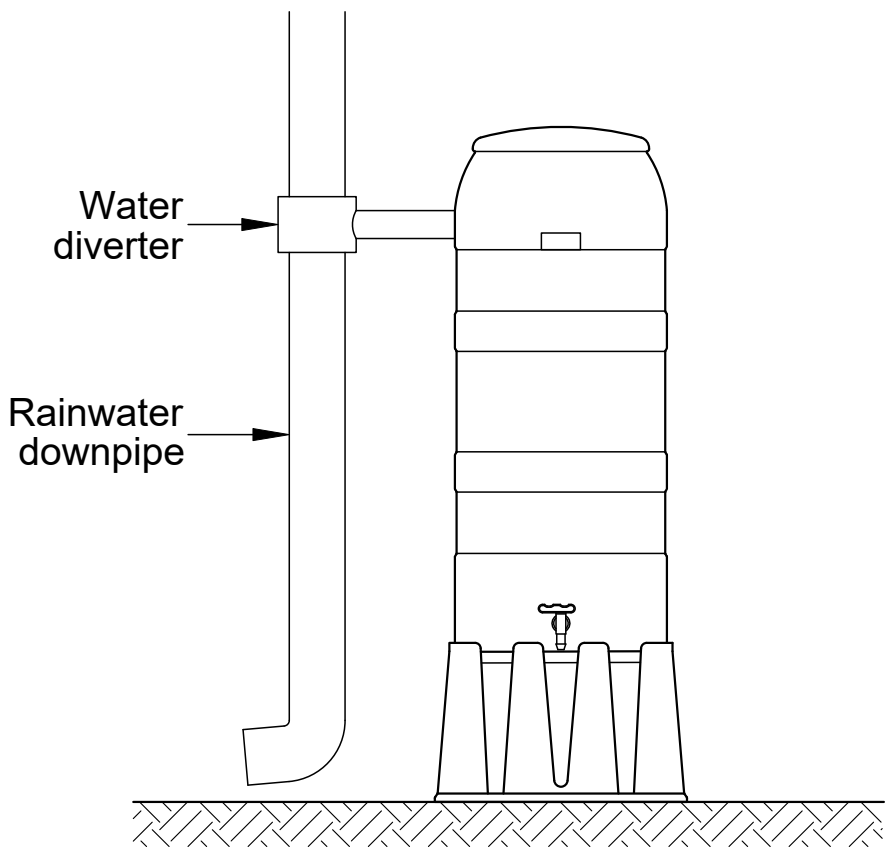
Typical Rain Water Harvest Butt

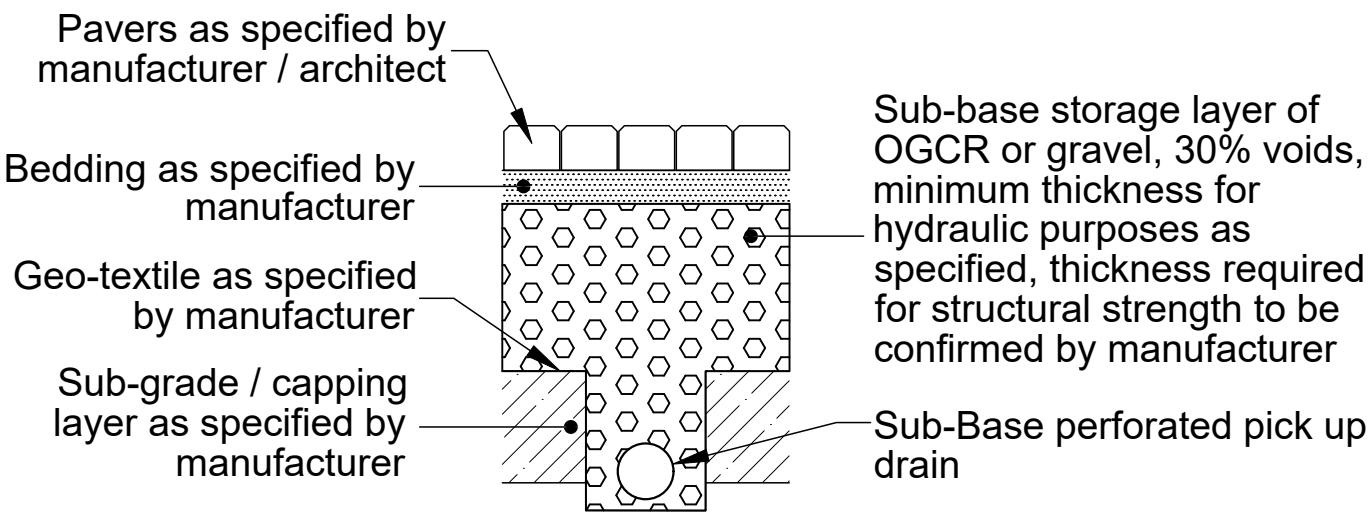
Typical Permeable Paving Detail with Perforated Pick Up  
Pipe within Trench

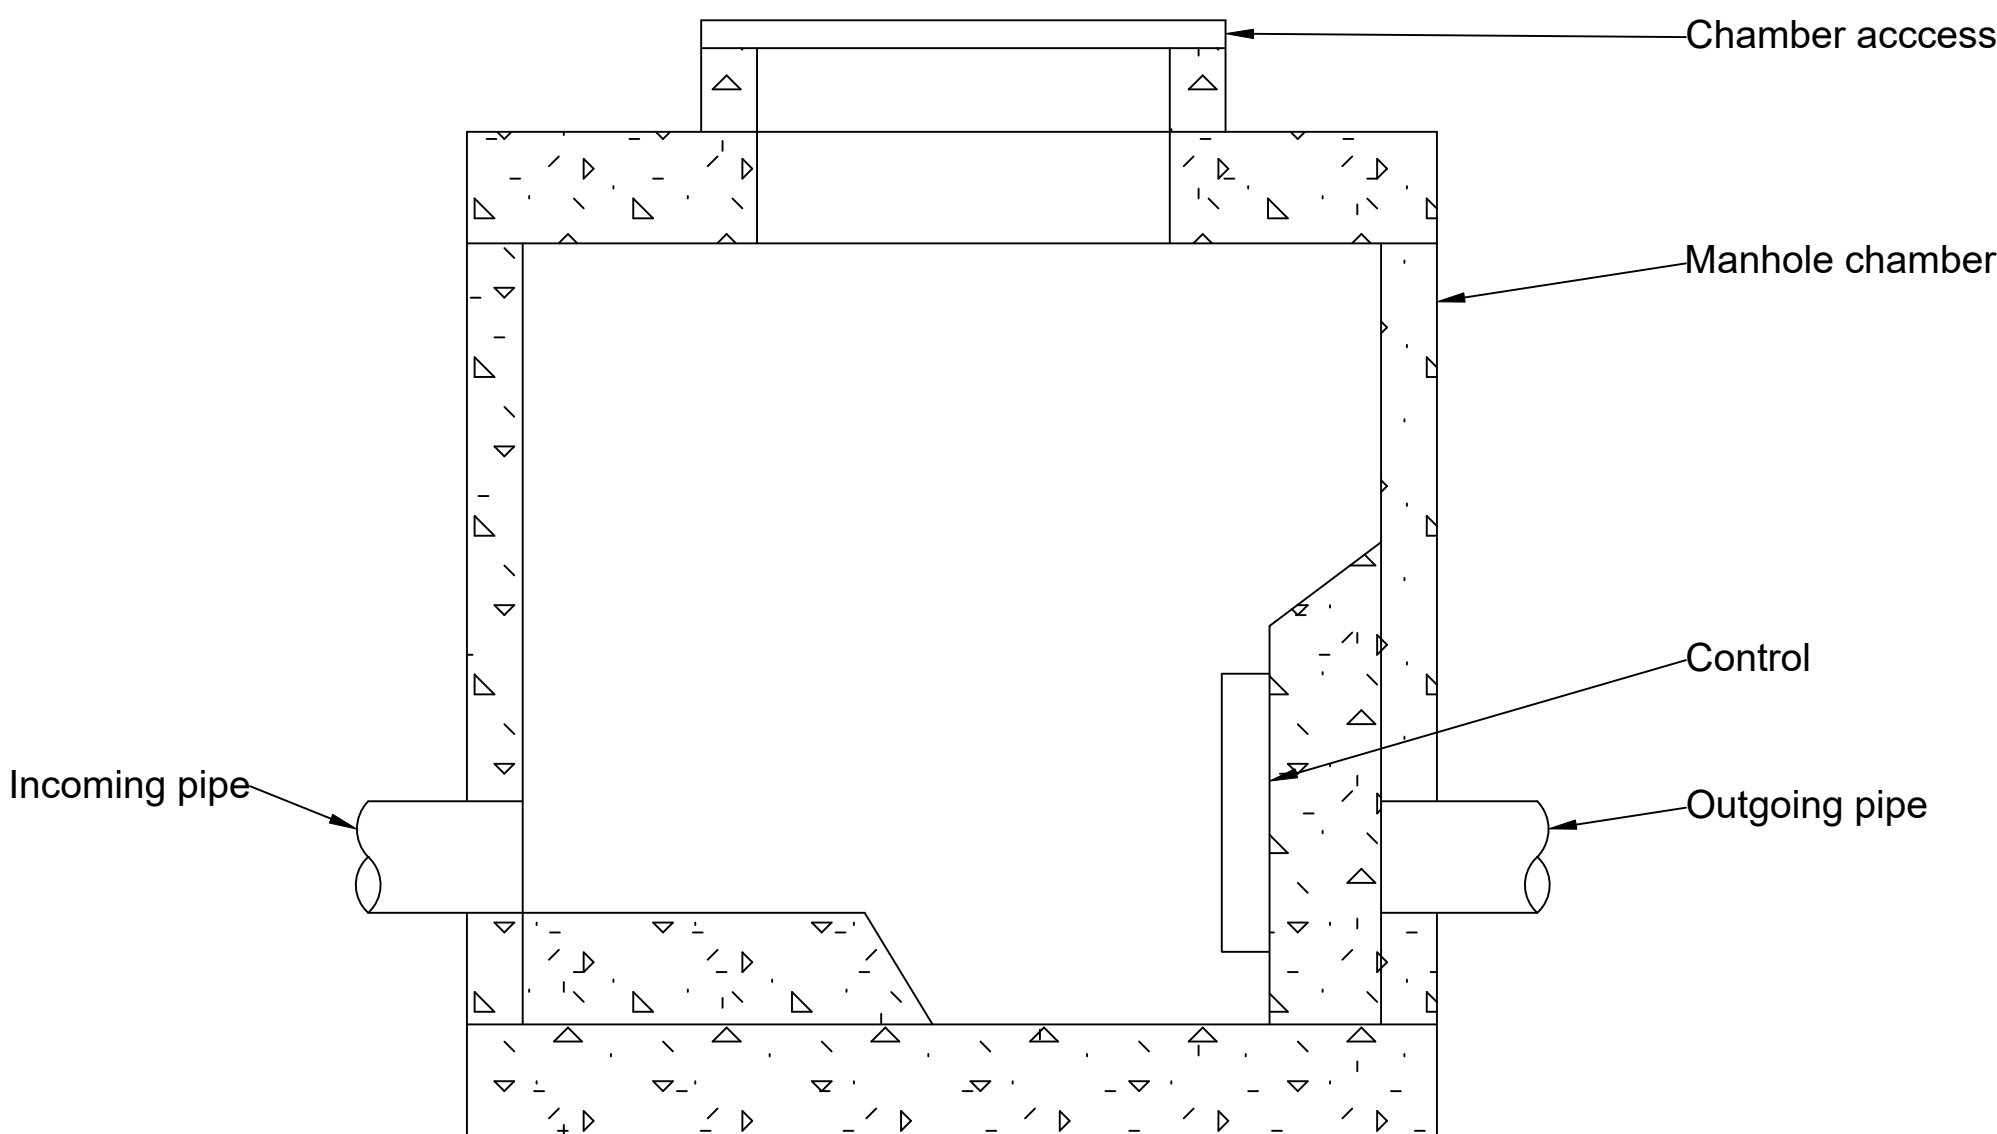
Typical control chamber  
(Design to be specified by manufacturer)

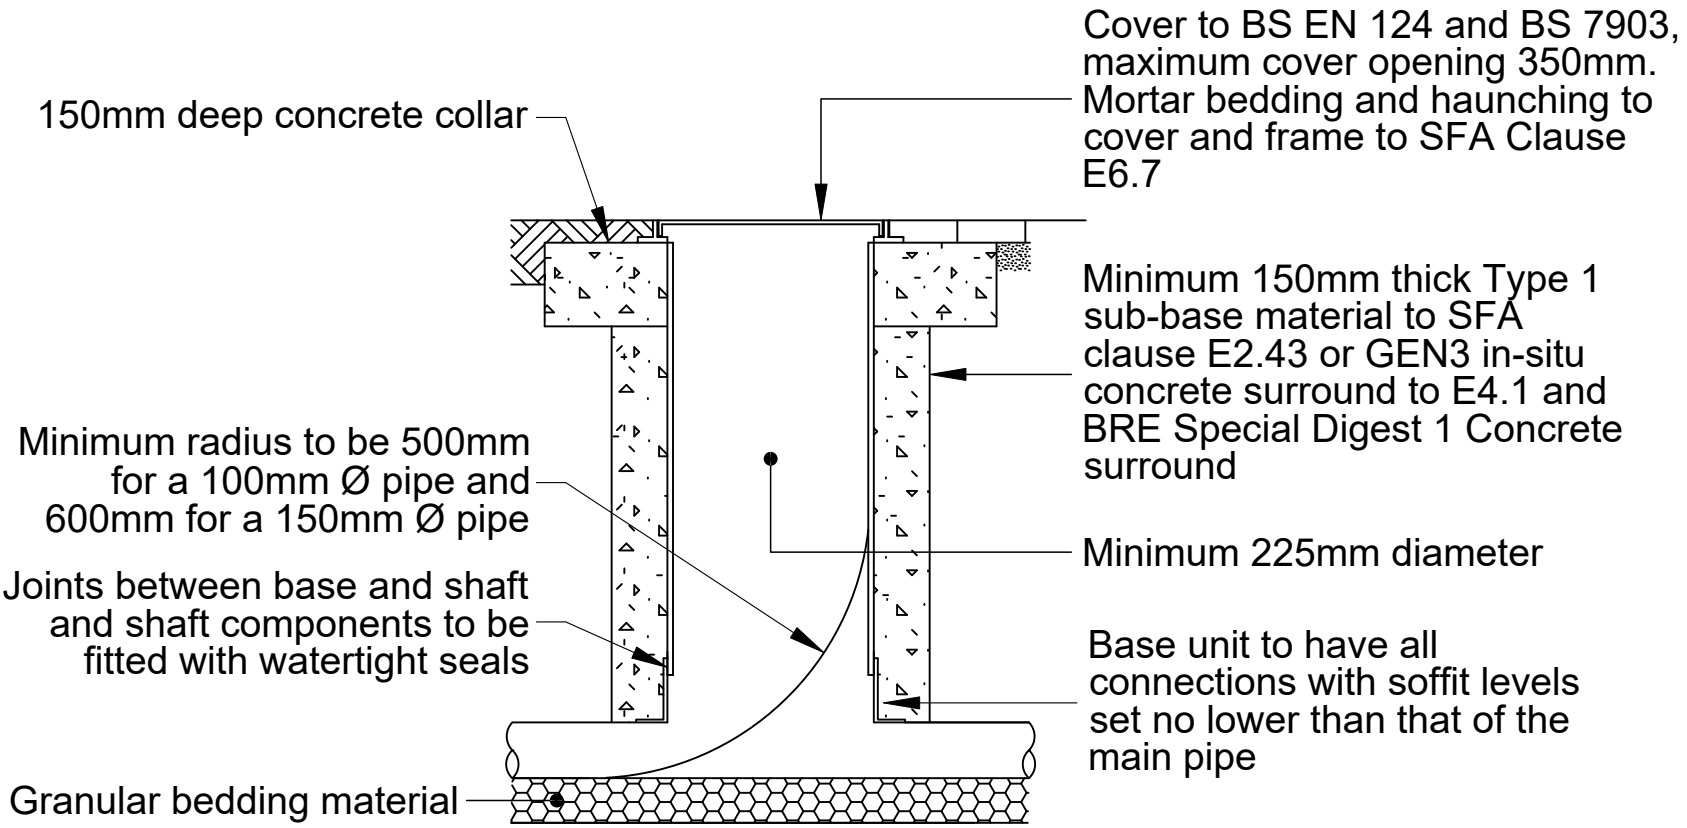
Typical Inspection Chamber  
(Driveways, paved areas)
