## Parcel C6

### Outline application

DC/22/94190

#### **Condition 8a – Lighting**

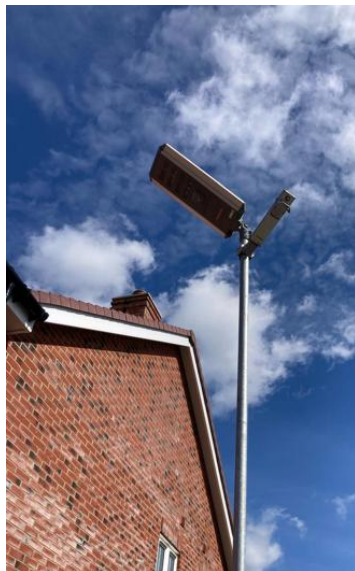
Please see the image below, which shows the lighting shield installed on the column within Parcel C6. This shield has been fitted to prevent light spill onto the adjacent open green space and was installed by Prolectric in accordance with the mitigation measures recommended in the lighting report prepared by SLR. Specifically, Section 2.3.1 of the report refers to:

*"The application of a front shield to the streetlight in AoS1E East to reduce the projection of light into the tree line at the boundary of the development."*

The lighting design for Parcel C6 has now been updated to reflect that Streetlight 4A and Bollard 21B have not been installed. Unfortunately, Prolectric's design software does not have the capability to model the effect of lighting shields. As a result, the submitted lux contour drawings continue to show the light levels without the benefit of the installed shield, including the area where the 1 lux contour extends beyond the development boundary.

exposure. However, the report shows that the installation of a lighting shield, identified as an appropriate mitigation measure to reduce light spill into this specific area, brings the lighting levels below the 1 lux threshold on the vertical plane representing the tree line.
