# MEMORANDUM

**LUMINOUS OAK SEMH SCHOOL,  
BOORLEY GARDENS  
REF; HCC/2024/0665**

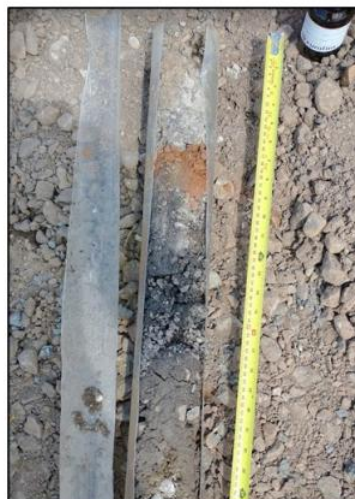
During the first phase of intrusive investigation at the school site, Terra Firma identified contamination at one of five locations investigated. This is reported in Terra Firma's GIR report, dated March 2024. In summary, determinant concentrations were compared against an end use of *public open space: residential* and elevated PAH compounds were recorded in WS102 within darker Made Ground, visually identifiable as seen in the below photograph.

Contamination was not found in the underlying soils at WS102 or in any other locations investigated during the first phase.

The source of the PAH contaminated material was attributed to crushing activities by the housing developer.

Jackson Rowe instructed the visual removal of the contaminated dark grey made ground prior to site handover to HCC in June 2024. Terra Firma undertook further investigations of the PAH hotspot.

The supplementary investigation involved Terra Firma drilling another hole (WS4) where the PAH hotspot (WS102) had previously been identified in 2023.

The 2024 investigations found no PAH compounds to be elevated above their respective screening value.

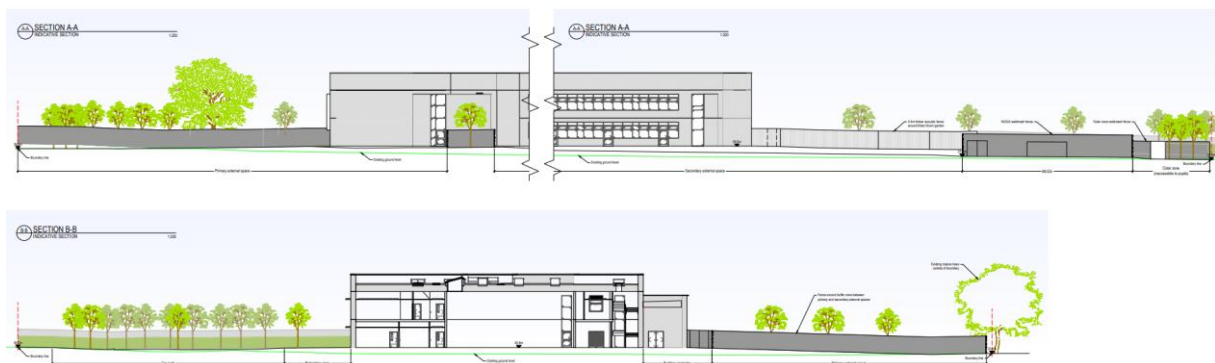
There is no intention to cut at the site but following a topsoil strip, the site levels will raise slightly as shown on the sections below to create the required formation level.

Certified fill will be imported and the groundworks contractor shall provide details of the provenance of any imported fill materials and evidence of compliance to HCC, prior to placement.
