## Surface water drainage water quality issue 5 2 24 for RM/24/98388 Land west of Allbrook Way

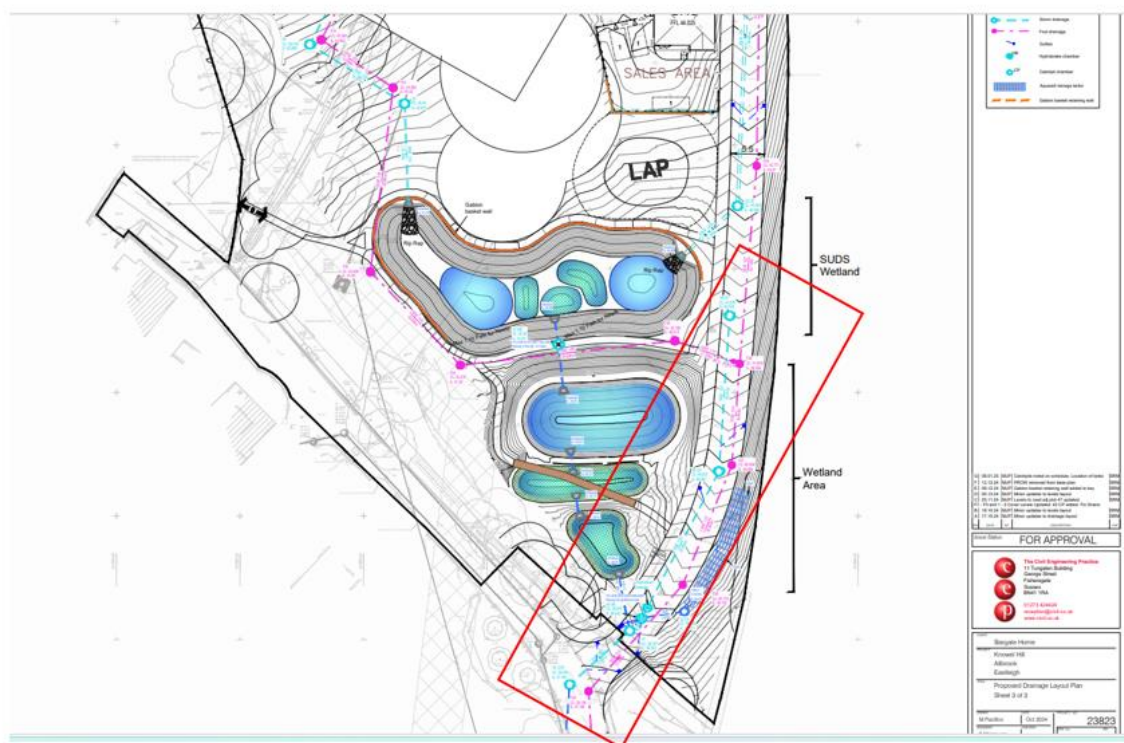
The area of concern for water quality (as discussed below) is marked with a red rectangle. This has not been addressed by the LLFA response (4 February 2025) which deals with the volume of water runoff nor by the response from Gillings Planning (14 January 2025) which deals with maintenance and monitoring for the wetland and the frequency of silt removal. EBC water quality policy (DM6) is more stringent than the LLFA's water quality remit (Ciria pollution mitigation indices).

The surface water runoff collected in this part of the system will have un-mitigated pollution hazards because it is washing down the main roadway where all vehicles enter and leave the site. As shown on this plan, it is only subject to one form of treatment, the downstream defender rather than the 3 forms of treatment required by DM6. It does not enter the wetland or pond system at any point.

In sheet 3 there is a surface water drainage pipe running along the road to the east of the pond system with several gullies and two catchpits and which only goes through a downstream defender before being discharged off site.

Any water that enters this small side catchment will only have one form of treatment rather than three. Pollutants that wash down the road surface in exceedance flows could also enter this catchment. I realise that due to the slope of the site it may not be possible to route the water from this catchment through the pond system, however it still needs to undergo sufficient treatment with water pollution hazards fully mitigated before being discharged off site.

A potential solution would be to camber the road and direct the runoff through a vegetated swale/filter strip along the side of the road rather than piping it to the end. Who will be adopting this road once the development has been completed?
