## Various Works to East Horton Golf Club

### Transport Statement

February 2025

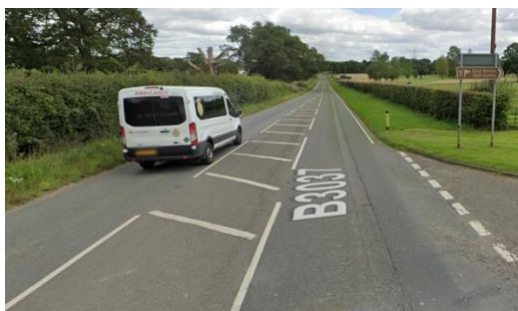
- 2.1. East Horton Golf Club is set in approximately 260 acres and is located between Lower Upham to the east and Fair Oak to the west. It is served by a Ghost Island Right Turn Lane junction with Mortimers Lane to the north of the site, which is demonstrated below.
- 2.2.

Golf Club Access Looking East

- 7.1. It is intended to utilise the existing access onto Mortimers Lane which takes the form of a ghost island right turn lane with a wide bell mouth junction and has previously been utilised for various earthwork operations including the extension to the Greenwood Course in 2009.

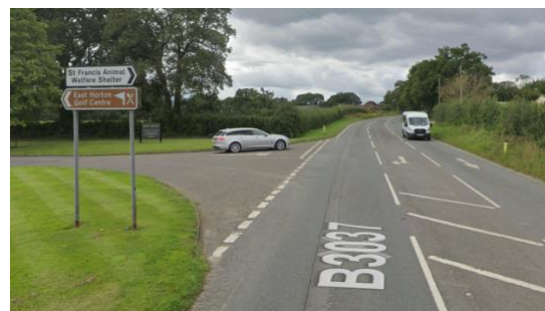
Golf Club Access Looking West

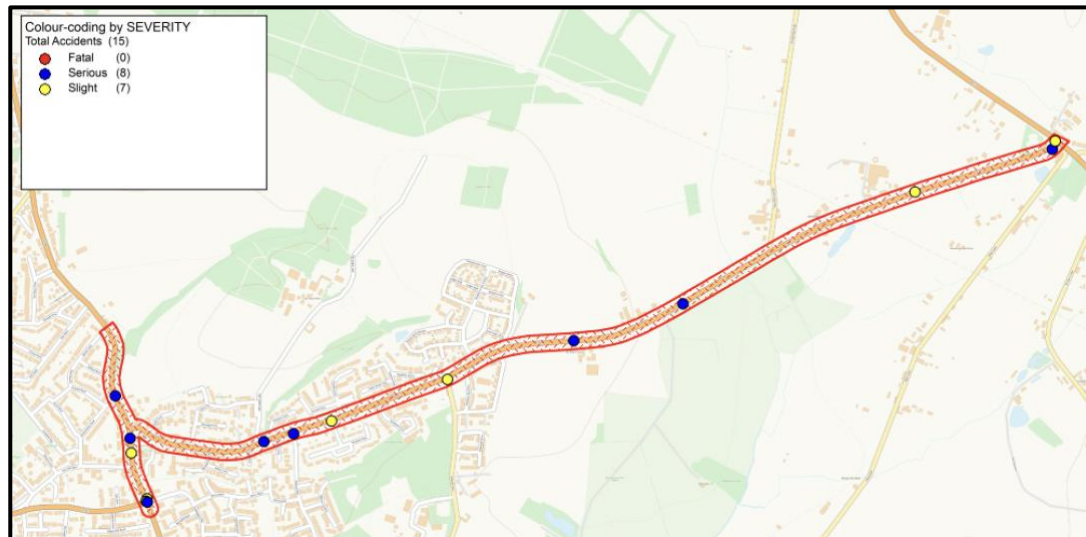
- 4.1. In order to assess the Personal Injury Accident (PIA) history for this area, Hampshire Constabulary have provided latest PIA data from 01/04/2019 until 30/04/2024. The extent of the search data is shown below and extends from the B3354 at Fair Oak to the B2177 Winchester Road.

4.2. It is evident that there have been a number of recorded accidents on Mortimers Lane as well as on the B3354 and details of these incidents are given below.

- 4.3. From the above accident data, it can be seen that for the latest 5-year period there have been a total of 7 incidents on Mortimers Lane, 2 of which involved single vehicles. Of all recoded incidents just 1 involved an HGV who when reversing struck a pedestrian crossing Mortimers Lane. The Police comment on this incident suggested that the Driver of the HGV failed to look properly whilst the pedestrian failed to judge the vehicles path and speed.
- 4.4. It is evident from the PIA Data that there is no common theme or reason for the recorded accidents and that most are related to driver error rather than any deficiency in the safety of the surrounding highway network. The PIA data is included as [Appendix 1](#) to this Statement.

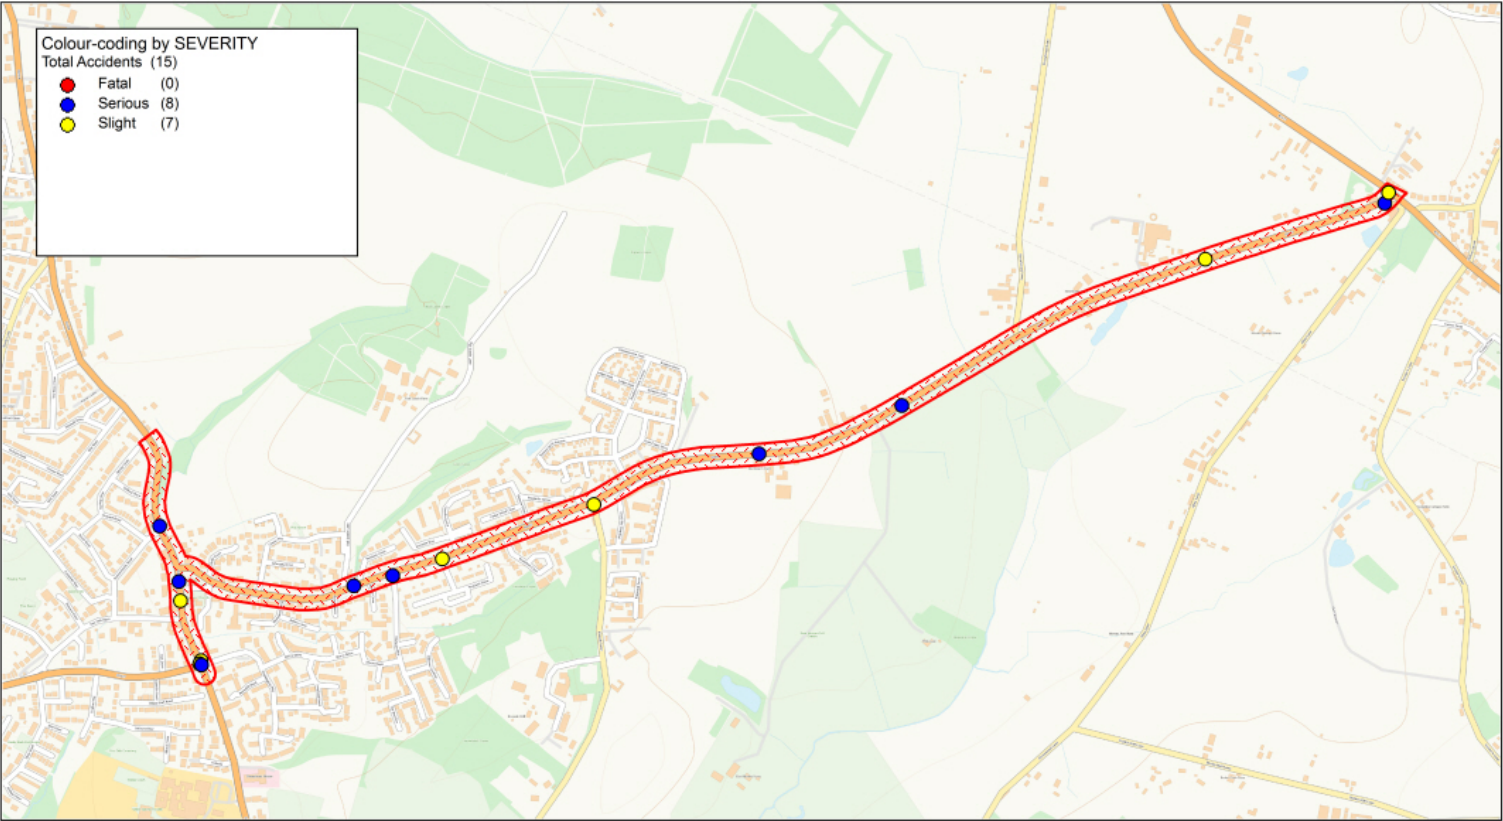
B3057 Mortimers Lane, Fair Oak

### Personal Injury Accident Data

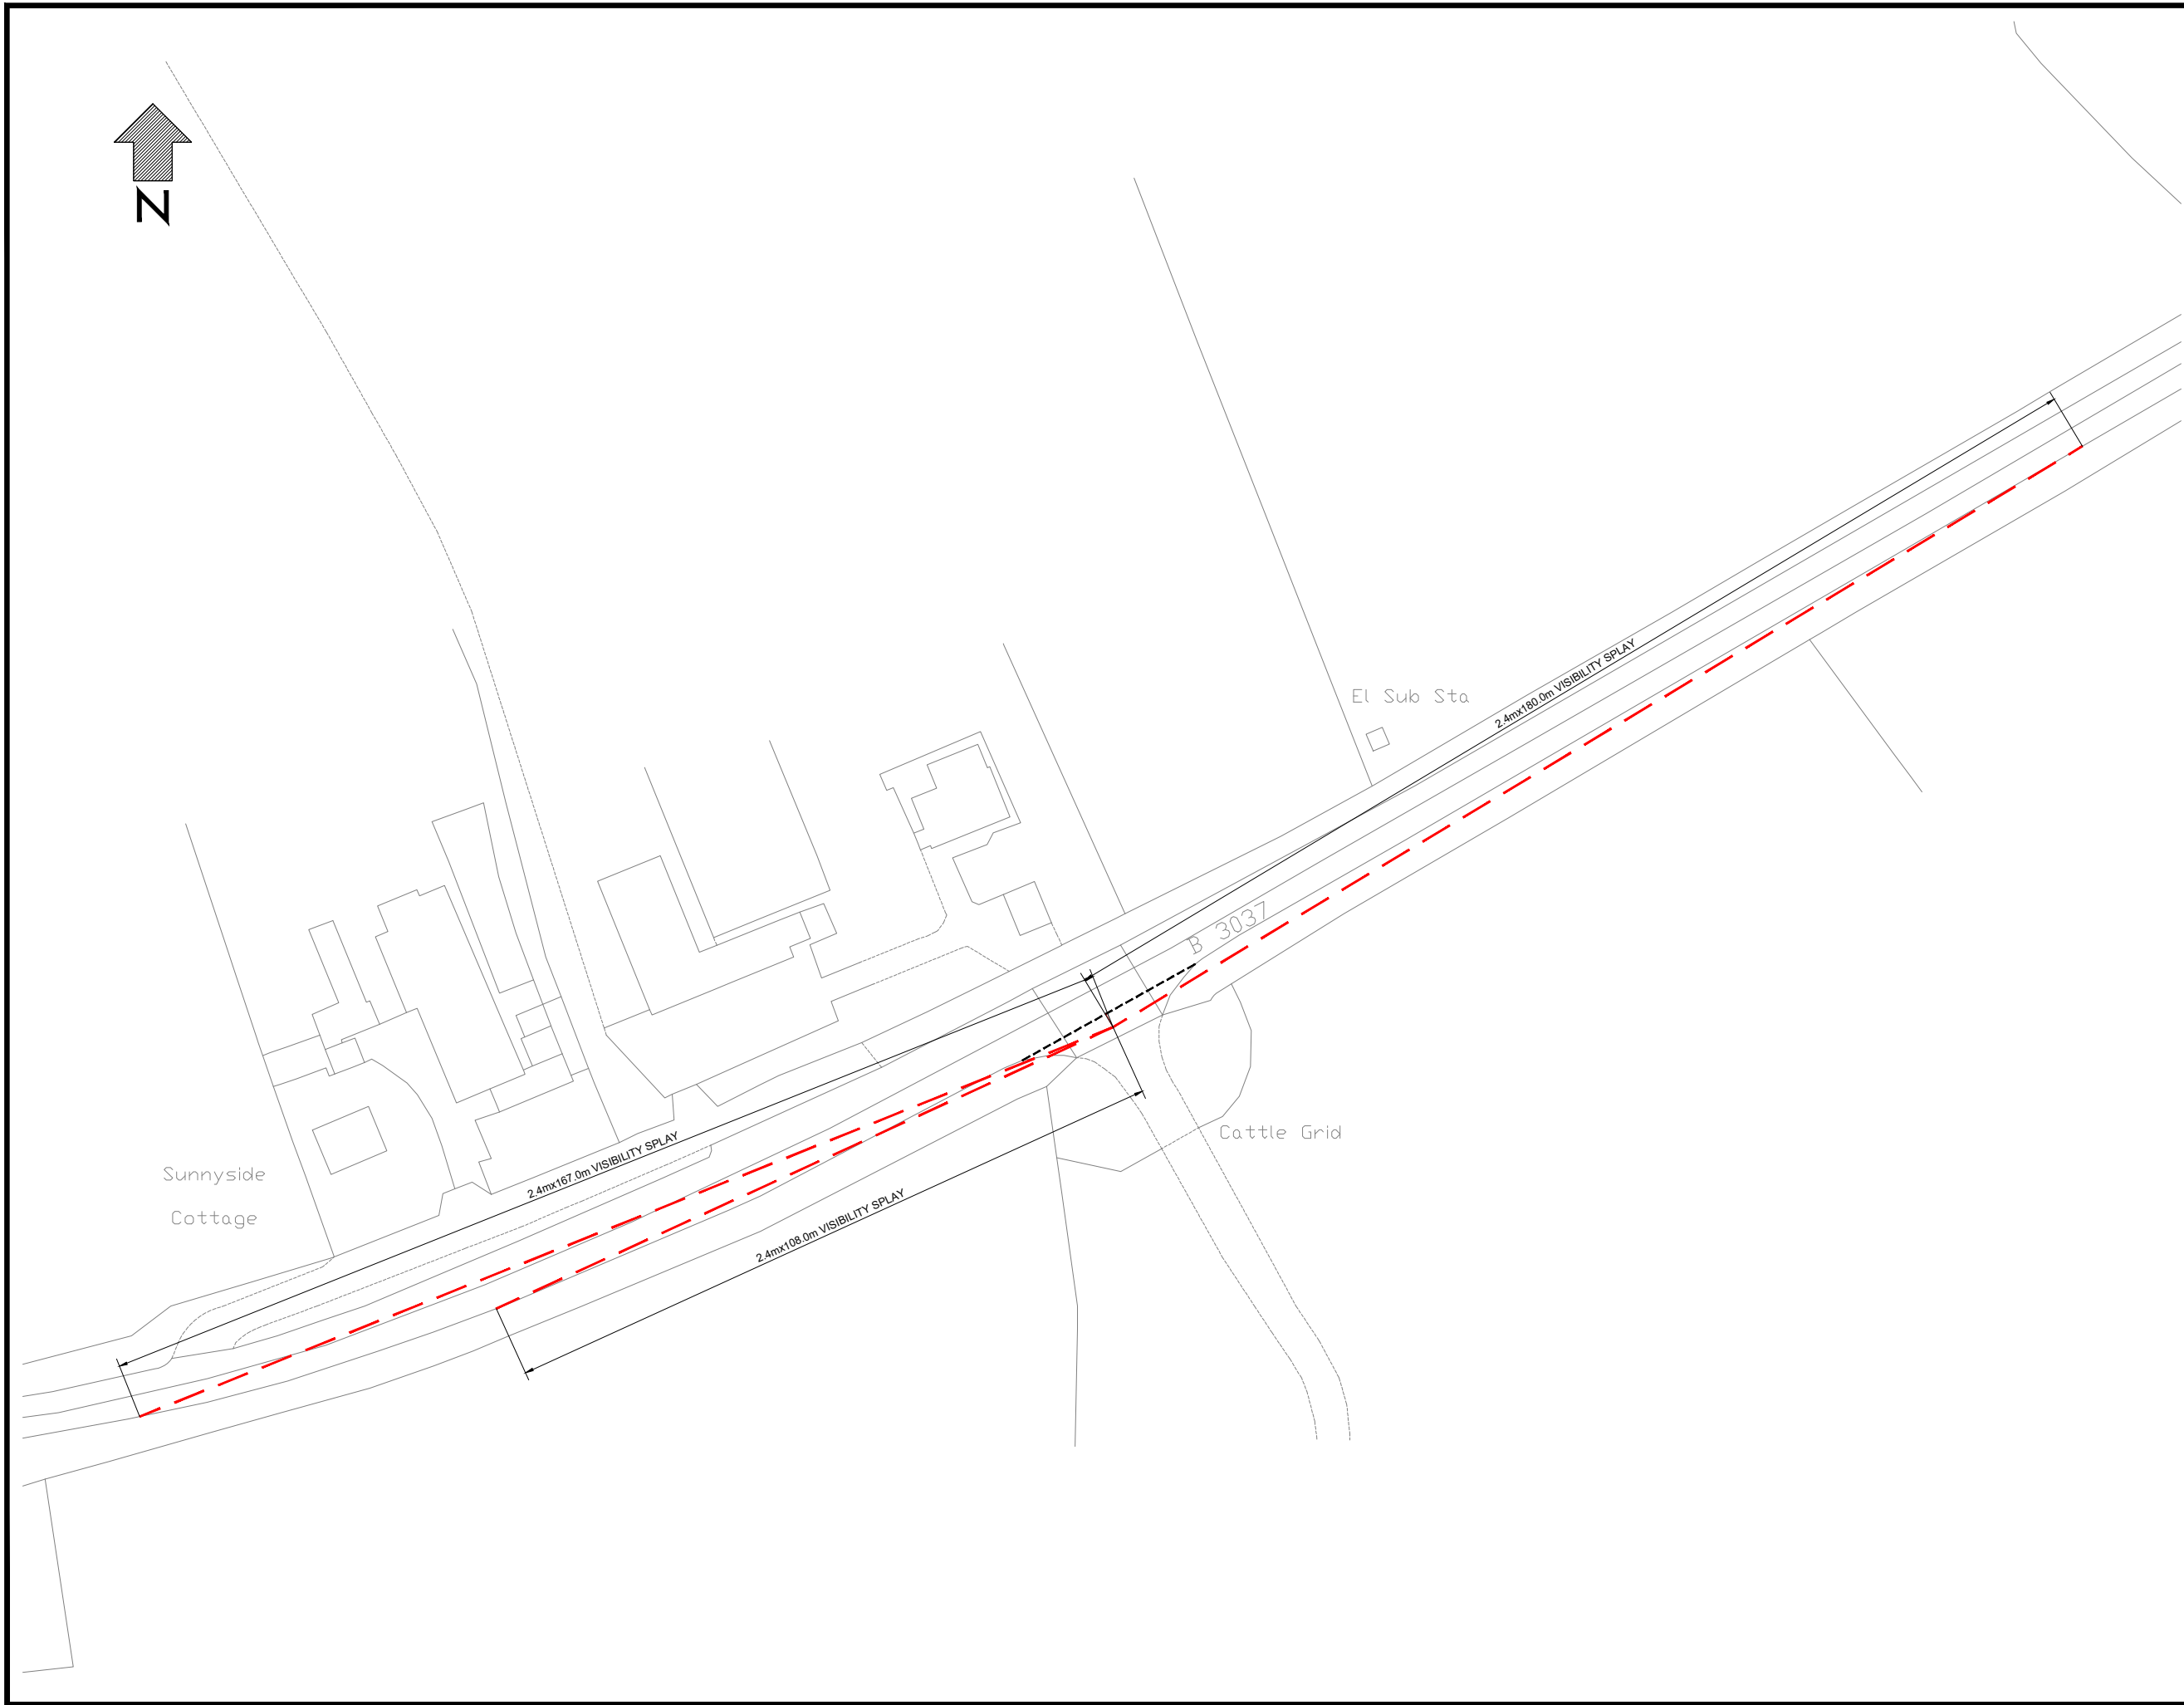
- 7.5. Drawing numbered NJC-001 is included as [Appendix 3](#) to this Statement which shows the existing access together with the required visibility splays. Given the wide verges fronting the site, together with the relatively straight nature of Mortimers Lane, the minimum visibility splay requirement can be easily achieved and, in this case, exceeded.

### **Access and Visibility**

- 7.4. Using the formular set out within the Hampshire County Council Sight Stopping Distance Calculator where a reaction time of 2 seconds is applied together with a deceleration rate of 0.25g, a Y distance of 167.0m is required to the west and a distance of 180.0m required to the east.
