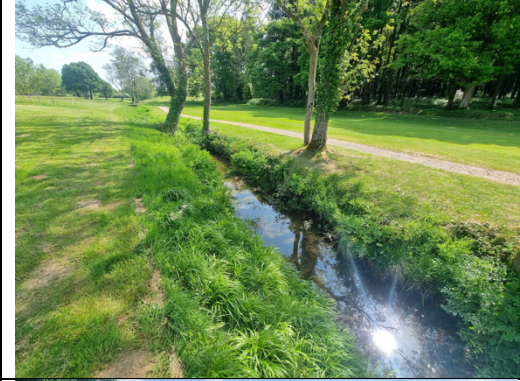
| | <p>The images taken on the 8<sup>th</sup> May 2025 show the route of the watercourse from the southern corner of the site to the northern corner of the site.</p> <p>The images show the extent of management at the bank tops of the watercourse.</p> <p>The watercourse will be enhanced through the reduction of riparian encroachment currently resulting from intensive vegetation management, particularly the regular mowing of grassland right up to the bank tops. The cessation of this activity along both banks will allow for the establishment of a more natural vegetated buffer, restoring marginal habitat and supporting improved ecological function.</p> |

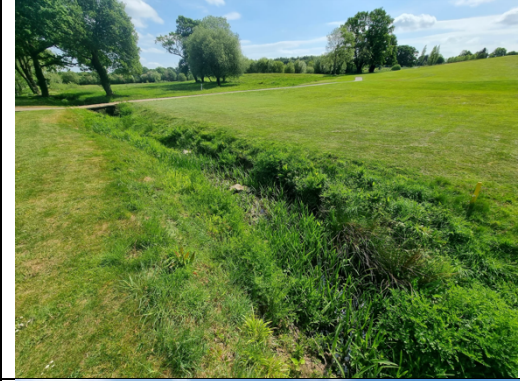
| | <p>According to the Statutory Biodiversity Metric User Guide, “<i>Watercourse encroachment can be any feature or action that adversely affects the natural function of the watercourse, or results in localised changes in habitat, species and migratory pathways.</i>” The current management regime qualifies as such, by restricting the development of riparian habitat and contributing to ecological simplification.</p> |
