Project Navigator Quarter, Southampton

## Technical Memo

# Additional Personal Injury Collision (PIC) Analysis

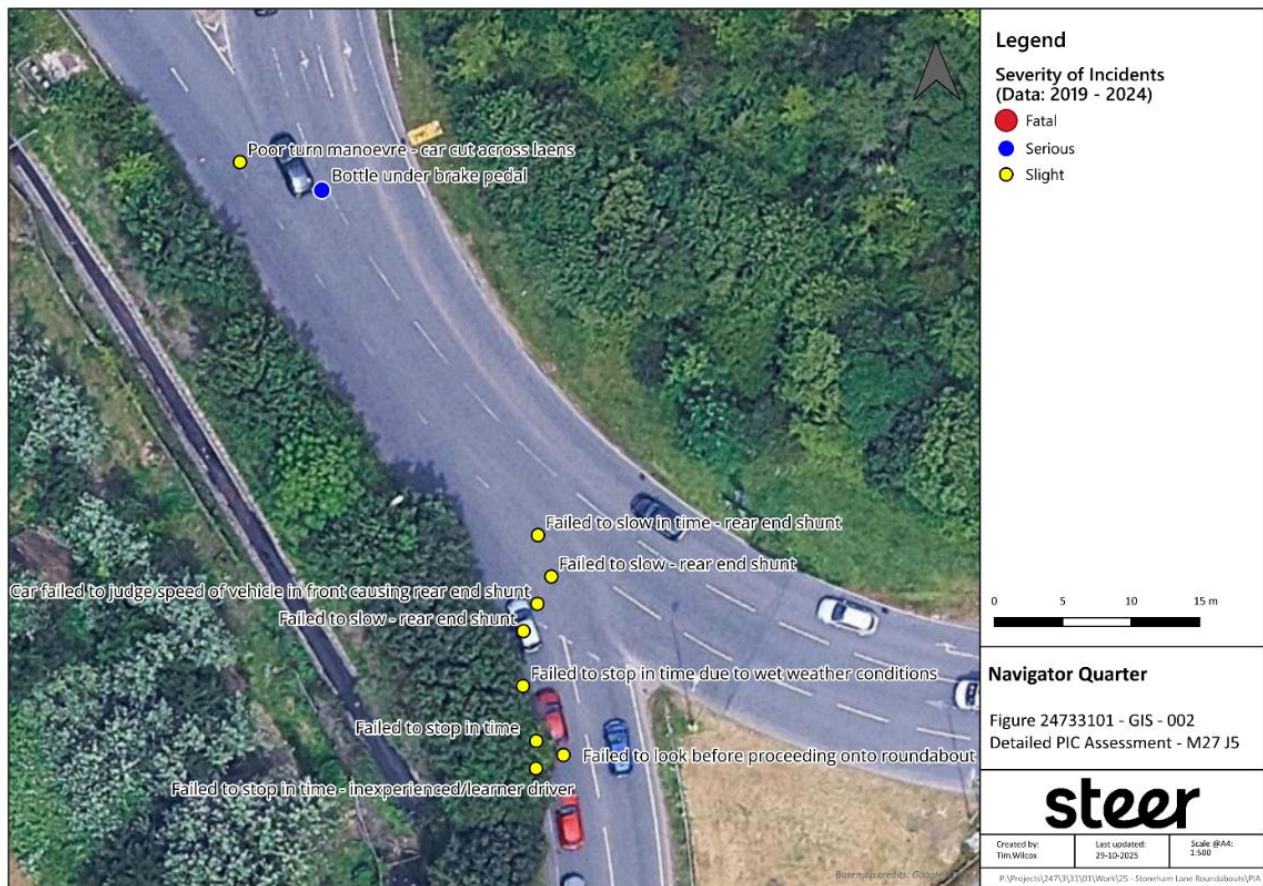
**Figure 1: M27 Junction 5 PIC Analysis**

4. The initial analysis showed a cluster of incidents at the junction between the A335 Northbound and the roundabout forming the M27 Junction 5. These incidents, alongside a summary of their causes (extracted from Hampshire Constabulary data) is shown in **Figure 1**.

5. As can be seen in the above, there is a cluster of eight incidents which were all recorded as 'slight'. Whilst one of these is attributed to poor road conditions, the other incidents are all related to vehicles failing to slow and stop in time, and resultant rear end shunting cars in front.

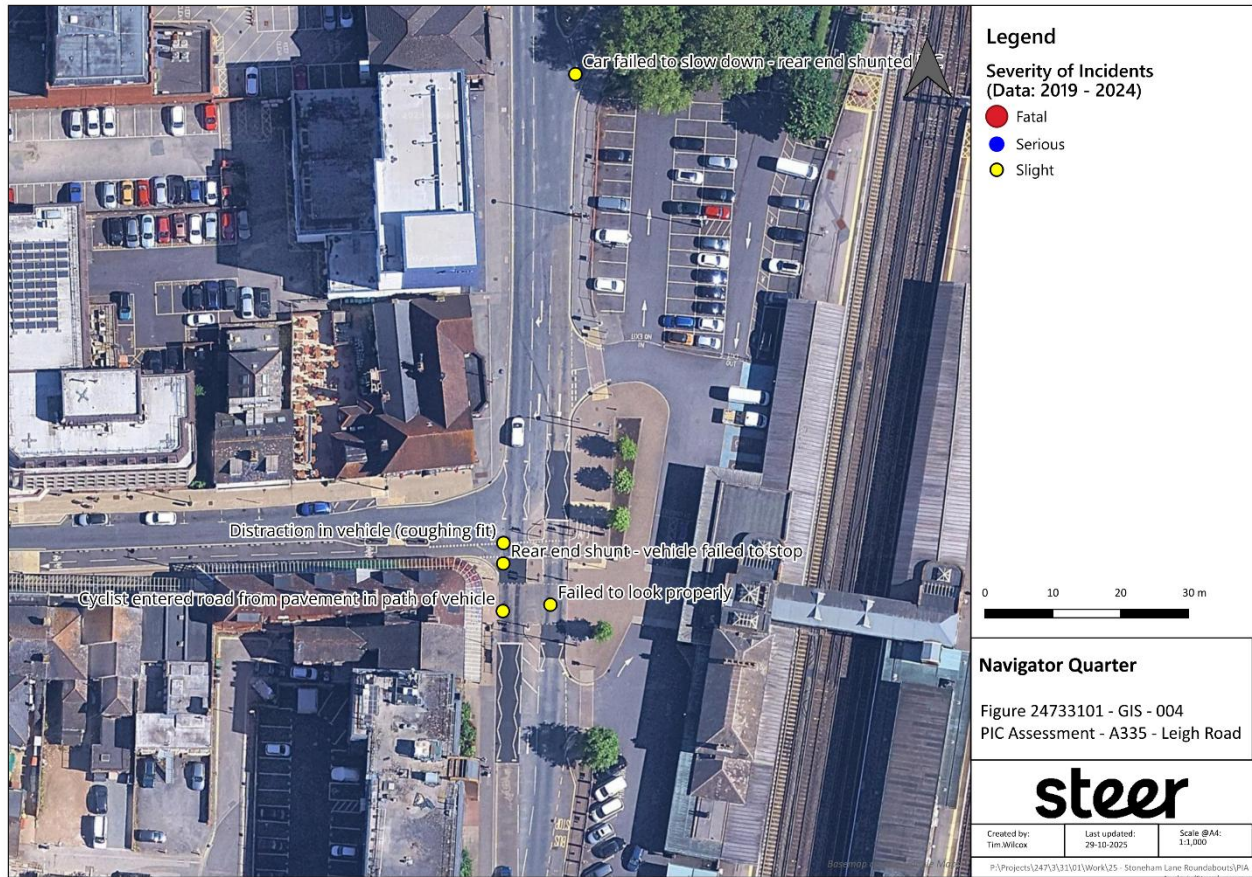
Figure 3: A335 / Leigh Road Junction PIC Analysis

13. The Leigh Road Junction, immediately outside Eastleigh Station, had four incidents (all classified as 'slight') recorded near to it in the study period as shown in **Figure 3**. Each of these had different contributing factors, and therefore it is not believed that there is a tangible link between these incidents representative of a wider highway safety concern.

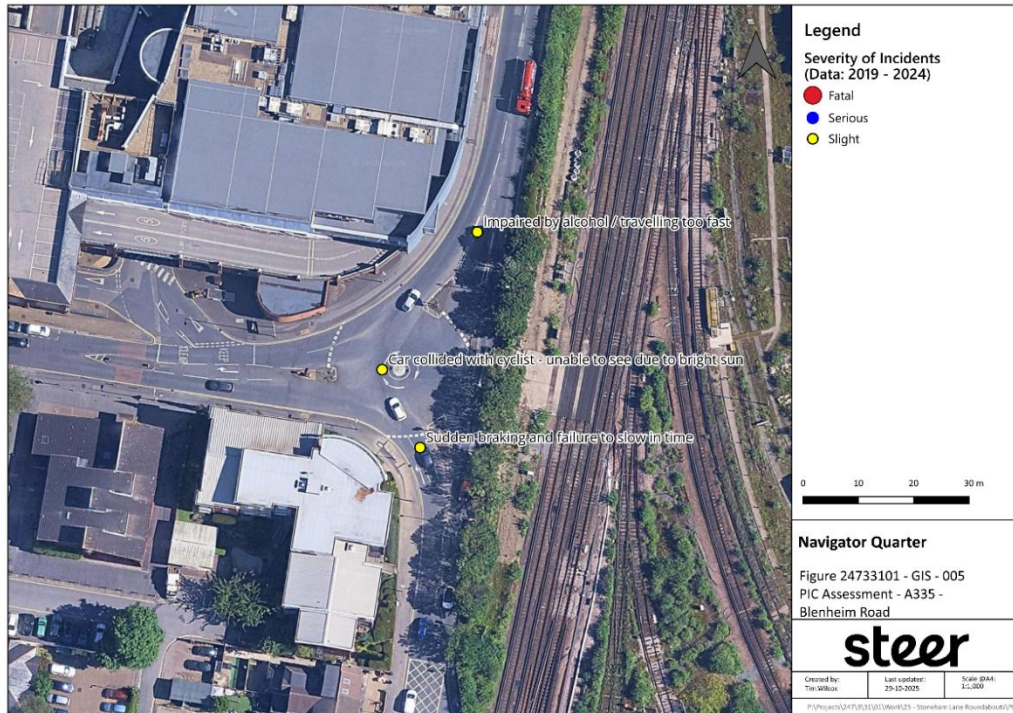
Figure 4: A335 / Blenheim Road Junction PIC Analysis

14. The Blenheim Road Junction had three incidents (all classified as 'slight') recorded near to or immediately on the roundabout in the study period as shown in **Figure 4**. Each of these had different contributing factors, and therefore it is not believed that there is a tangible link between these incidents representative of a wider highway safety concern.

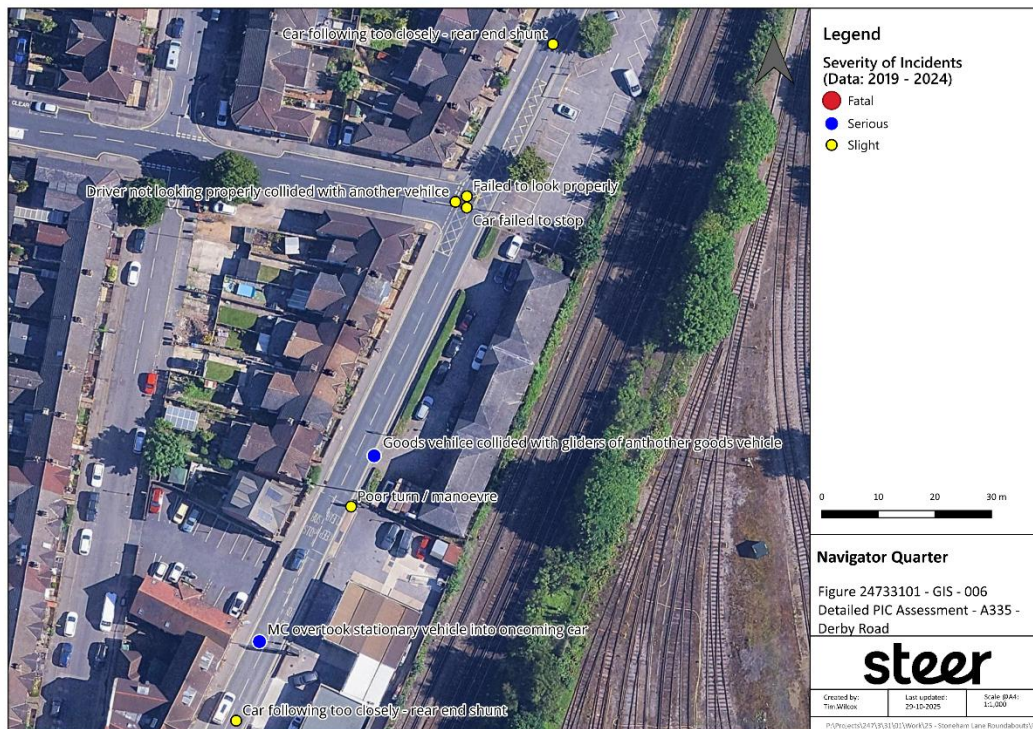
Figure 5: A335 / Derby Road Junction PIC Analysis

15. The Derby Road Junction and the surrounding elements of the A335 had eight incidents recorded near to it in the study period as shown in **Figure 5**.

16. Three of these occurred at the junction itself, all of which were classified as 'slight', with human error the primary factor identified in each of these incidents.

17. Two incidents near to the junction resulted in incidents were injuries were classified as 'serious'. The first of these occurred at approximately 07:54 in the morning in fine conditions, and involved a southbound HGV impacting the gliders of a parked vehicle. The impact shunted the parked vehicle onto the footway, seriously injuring a pedestrian on the footway.

18. The second incident occurred at approximately 08:02 in the morning in fine but damp conditions, and involved a car waiting to turn right into the service station. A motorcycle attempted to pass the waiting vehicle, and the car did not see the motorcycle and turned into it resulting in the front of the motorcycle colliding with the nearside of the turning car. This resulted in injuries classified as 'serious' to the rider of the motorcycle.

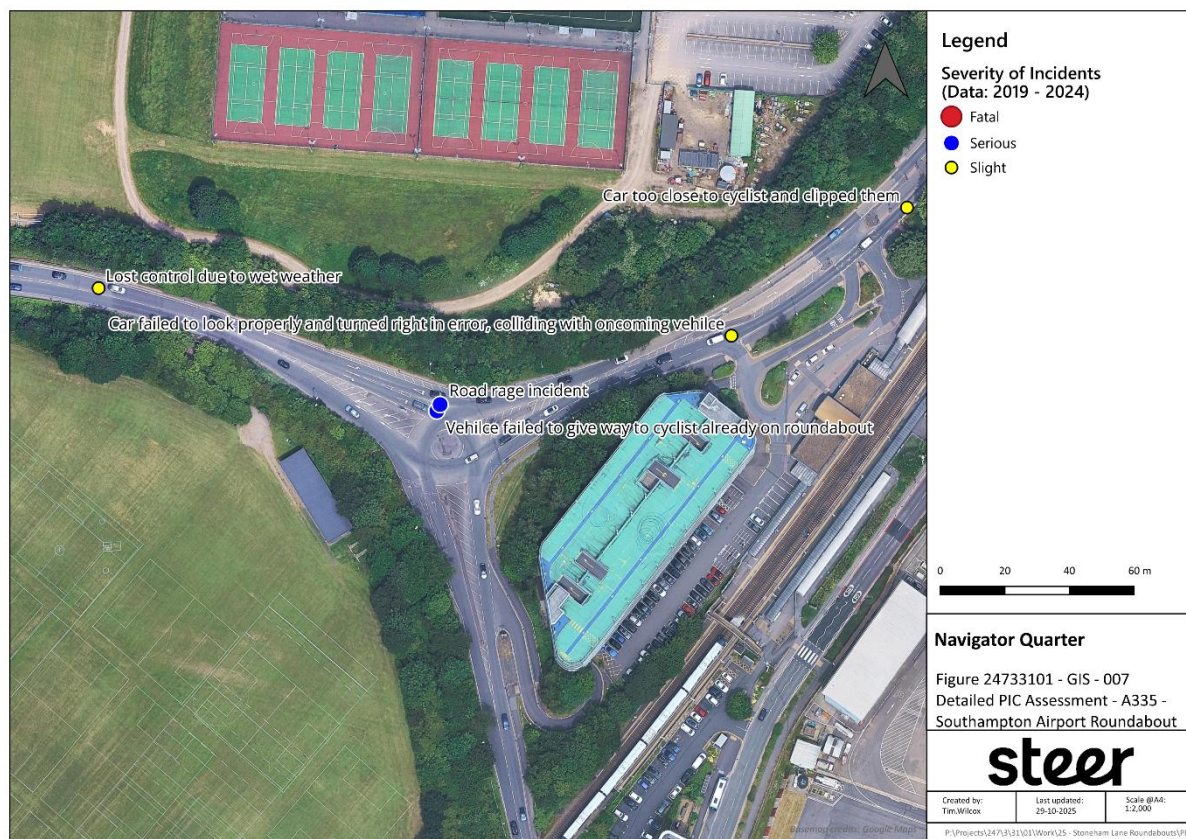
**Figure 6: A335 Airport Roundabout PIC Analysis**

20. The Southampton Airport Roundabout and the immediate surroundings had five incidents recorded near to it in the study period, of which two occurred at the roundabout itself, as shown in **Figure 3**.
21. The two incidents classified as 'serious' both occurred at the entrance point of the western arm onto the roundabout. The first of these was attributed to 'road rage' by the constabulary, and occurred at 11:55 in the morning in fine conditions. A car was waiting in traffic to head to the south-east, when it pulled out around a stationary vehicle to enter the roundabout and collided with a vehicle already on the roundabout. The driver of the second vehicle received injuries classified as 'serious'.

22. The second incident occurred at the same arm but involved a car travelling to the south-east pulling out onto the roundabout in front of a bicycle which was already on the roundabout. The cyclist was unable to stop and impacted the side of the exiting vehicle, resulting in injuries classified as 'serious' to the rider of the bicycle.
23. Whilst both incidents occurred at the same arm of the same roundabout, each incident had vastly different contributing factors, and therefore it is not believed that there is a tangible link between these incidents representative of a wider highway safety concern.
