**PRIVATE HARDSTANDING AS  
BUILT APPRAISAL REPORT  
PHASE 9 STONEHAM, EASTLEIGH**

**HIGHWOOD GROUP LIMITED**

NOVEMBER 2022

PROJECT NAME: Phase 9 Stoneham, Eastleigh  
PROJECT NUMBER: 5020063  
DOCUMENT REFERENCE: 5020063-RDG-XX-XX-DOC-C-S22-3008  
DOCUMENT STATUS: S2 – Suitable for Information

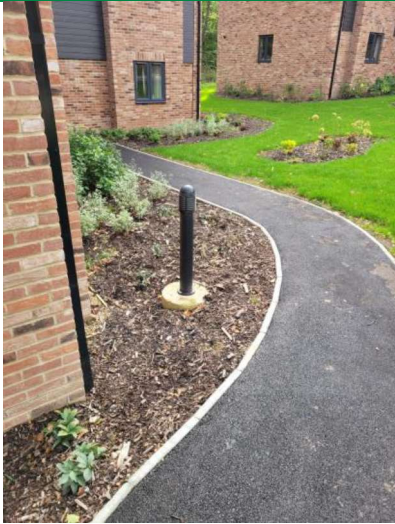
Photo 13

In one instance bollards were not installed, this is the case in front of plots 30 and 31. In some instances, the bollards have been replaced with fence posts; however, it is understood that this is as per the approved landscaping layout. The fence posts installed work well aesthetically with the adjoining hedges and do not negatively impact the functionality/safety of the street.

**Photo 13 – Bollards Substituted for Fence Posts**

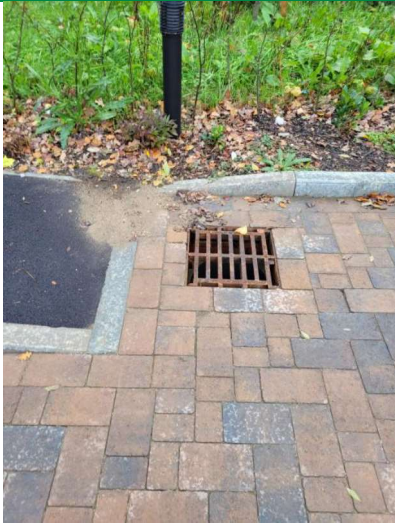
Photo 16

**Photo 16 – Evidence of Sediment Accumulation**
