**BISHOPSTOKE MEMORIAL HALL**

**17 RIVERSIDE, BISHOPSTOKE**

**STRUCTURAL SURVEY & APPRAISAL**

**EXISTING COMMUNITY HALL**

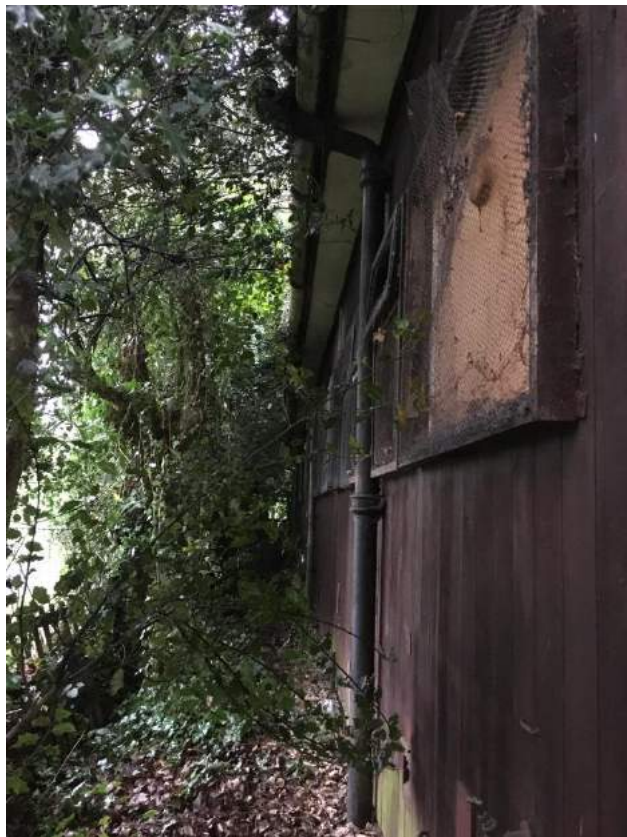
Photograph 4:- Western elevation

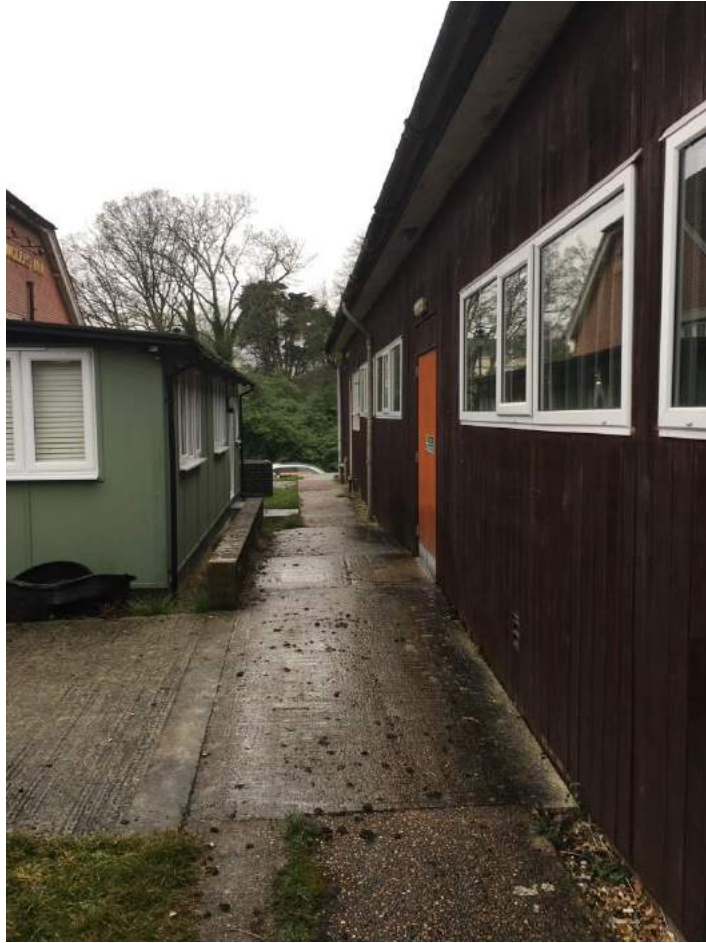
Photograph 5:- Eastern Elevation

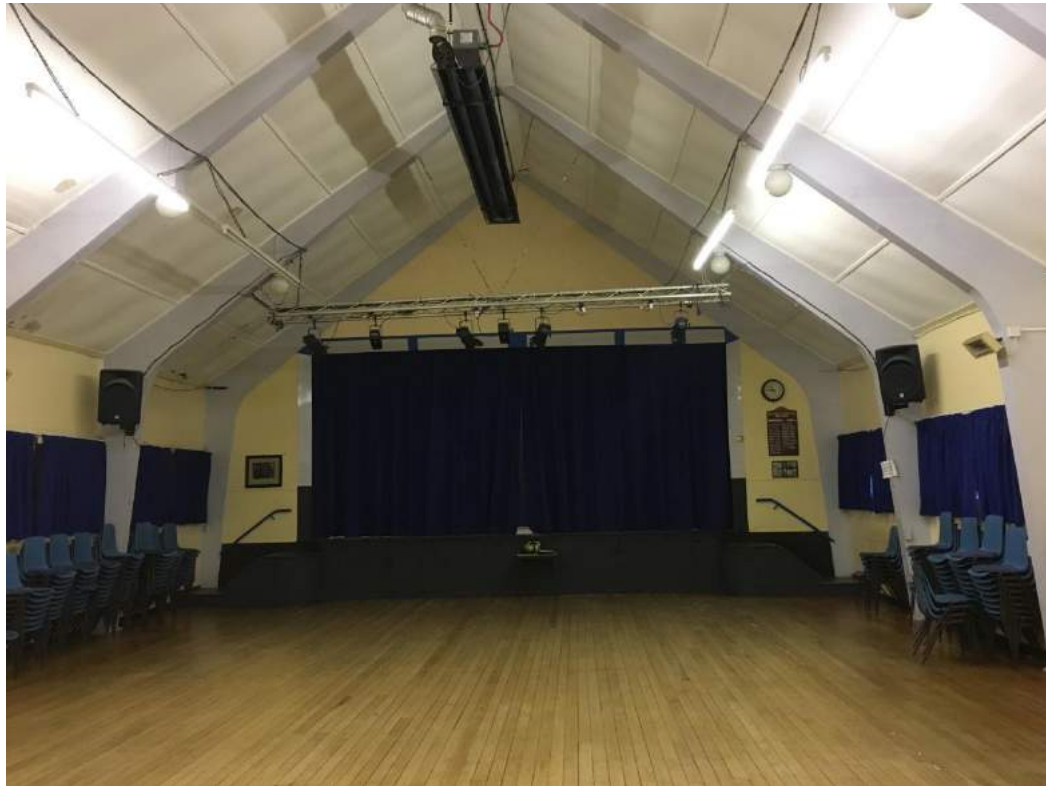
Photograph 7:- Hall viewed towards stage

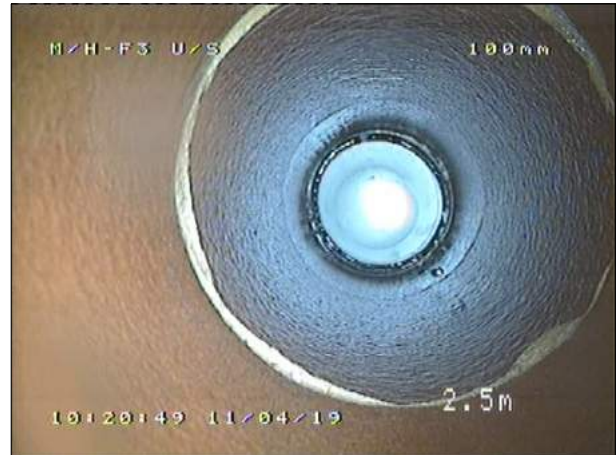
Photo: 4\_4\_42\_A.JPG  
2.5m, Finish survey

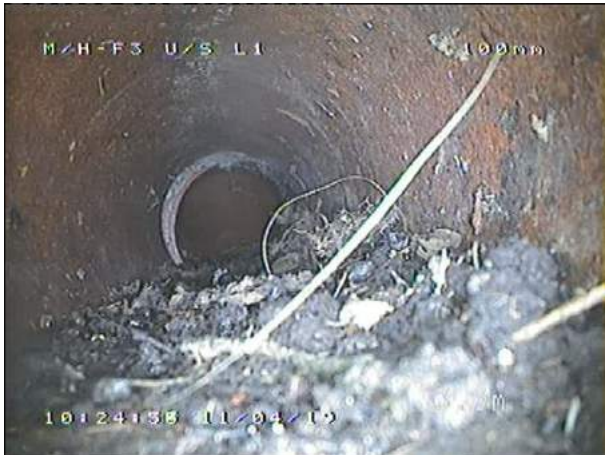
Photo: 5\_5\_45\_A.JPG

0.1m, Debris silt, 10% cross-sectional area loss, Start

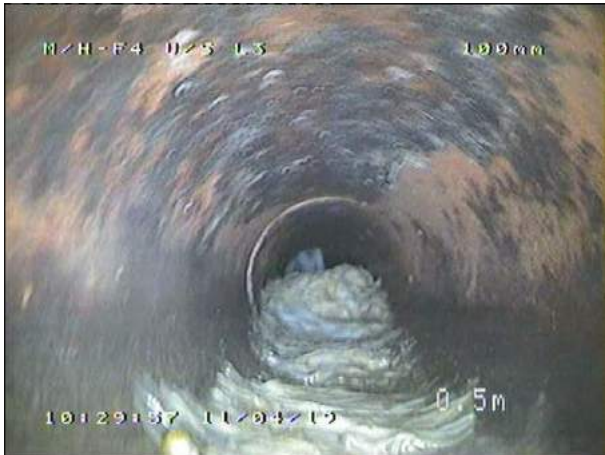
Photo: 8\_8\_59\_A.JPG

0.5m, Debris, 10% cross-sectional area loss, Start

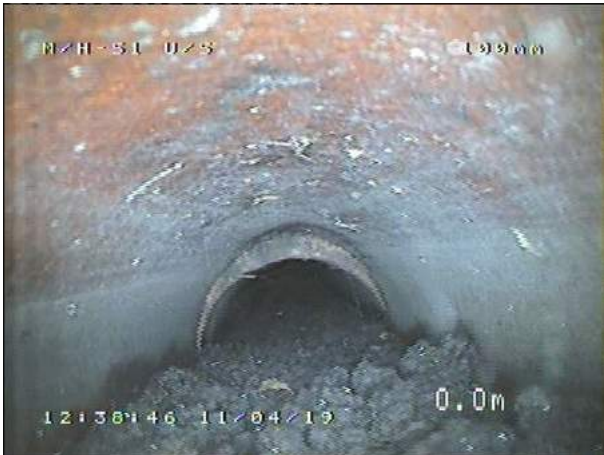
Photo: 19\_19\_151\_A.JPG

0.1m, Debris silt, 15% cross-sectional area loss, Start
