**VERIFICATION REPORT**

**PLOTS 29-35 & 47-55**

**HAMBLEWOOD, HEATH HOUSE LANE,  
HEDGE END, HAMPSHIRE, SO30 0LE**

| Reference: | GE20045/VR/PLOTS 29-35 & 47-55/APR24 |

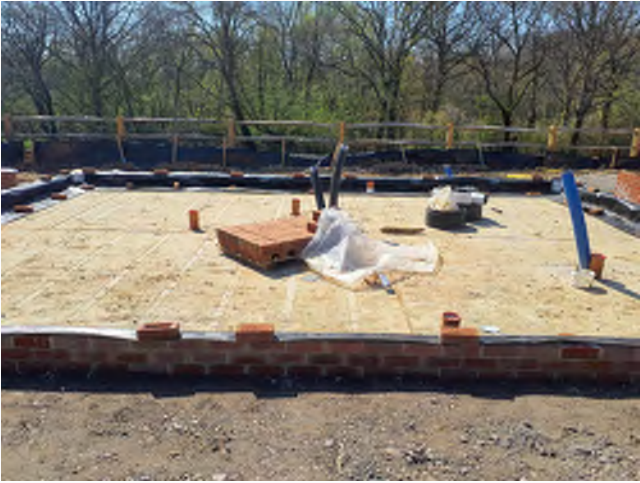
| Photograph | Photograph Title |
|---|---|
| | Plot 55 overview |

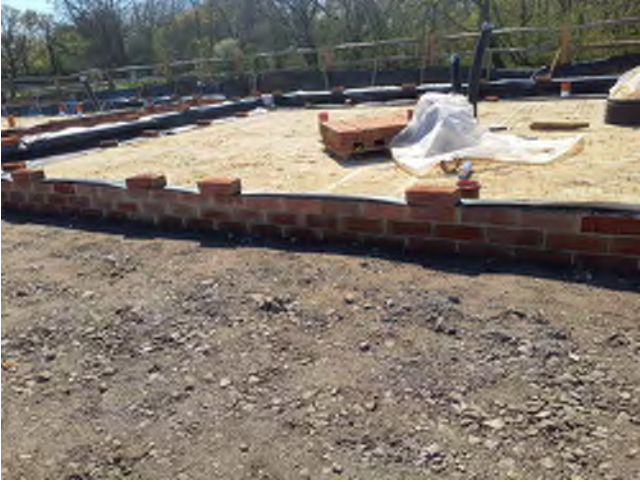
| Photograph | Photograph Title |
|---|---|
| | Plot 55 airbricks |

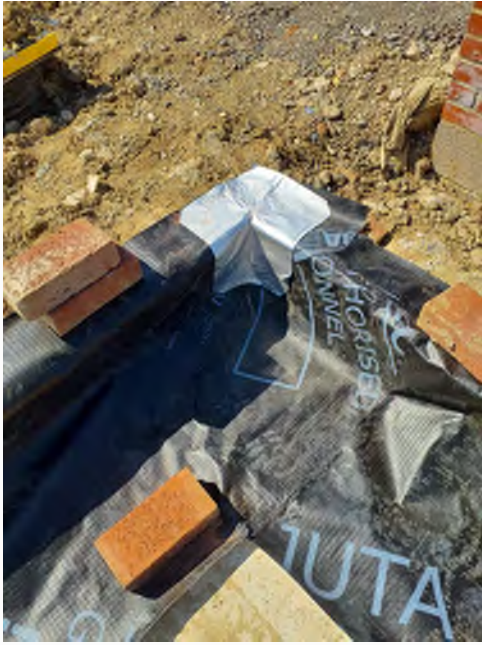
Plot 55 corner

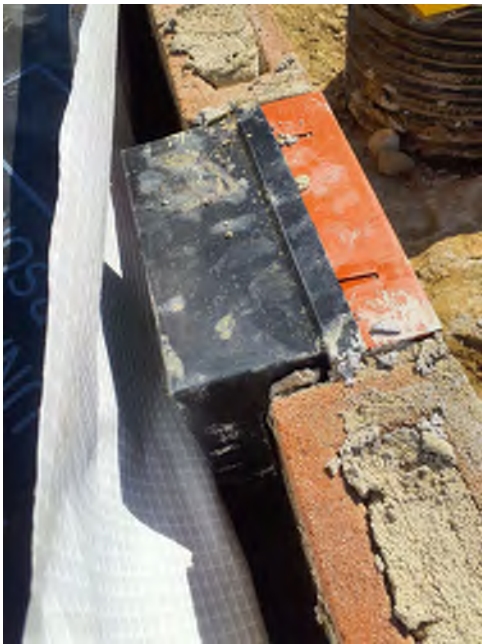
Plot 55 airbrick connection

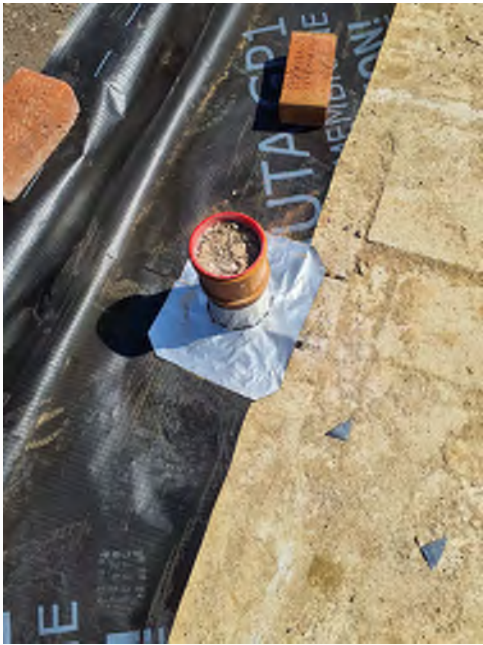
| A close-up photograph of a gas service pipe on a roof. The pipe is orange and has a red cap. It is surrounded by a white plastic bag and a brick. The roof is made of concrete and has some black waterproofing material. | Plot 55 service |

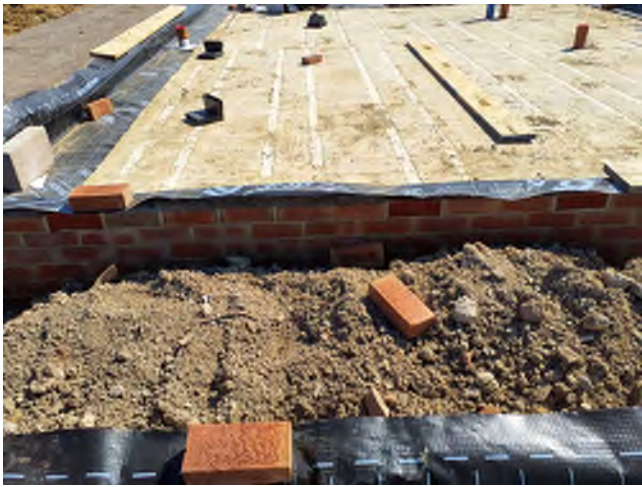
| A close-up photograph of airbricks on a roof. The airbricks are red and are placed on a concrete roof. There is a pile of dirt and some bricks in the foreground. | Plot 56 airbricks |

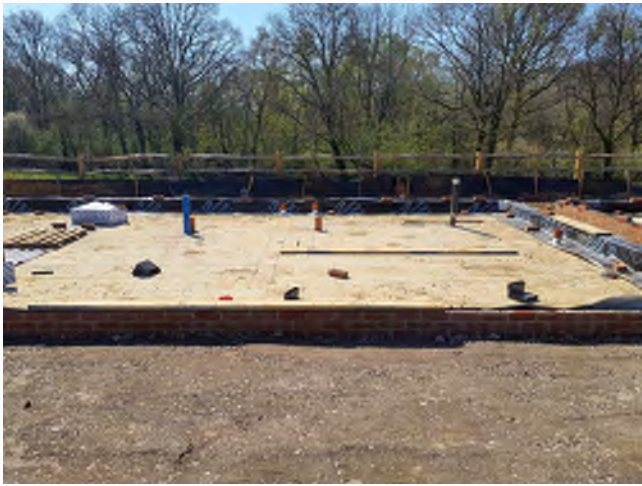
| A wide-angle photograph of Plot 56. The plot is a large, flat area with a concrete floor. There are some trees and a fence in the background. The plot is surrounded by a brick wall. | Plot 56 overview |

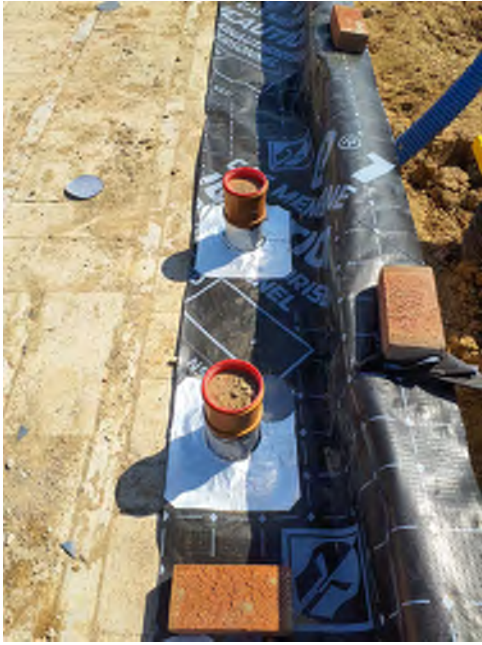
Plot 56 services

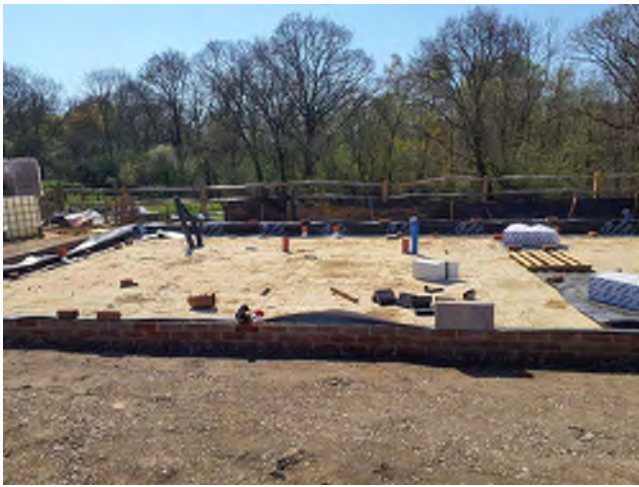
Plot 57 overview

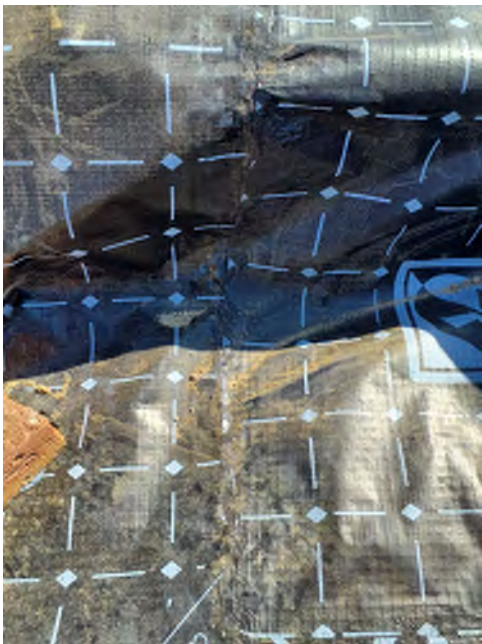
Plot 57 membrane join

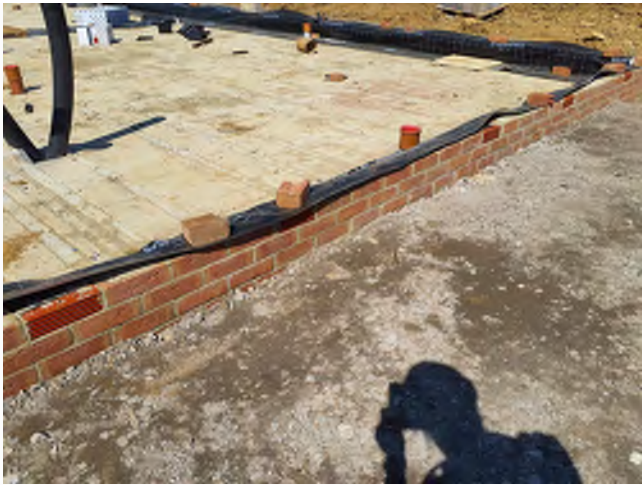
| | | Plot 57 airbricks |

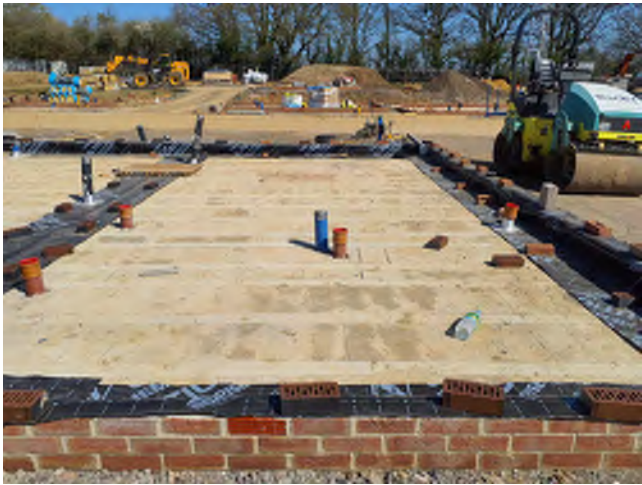
| | | Plot 59 overview |

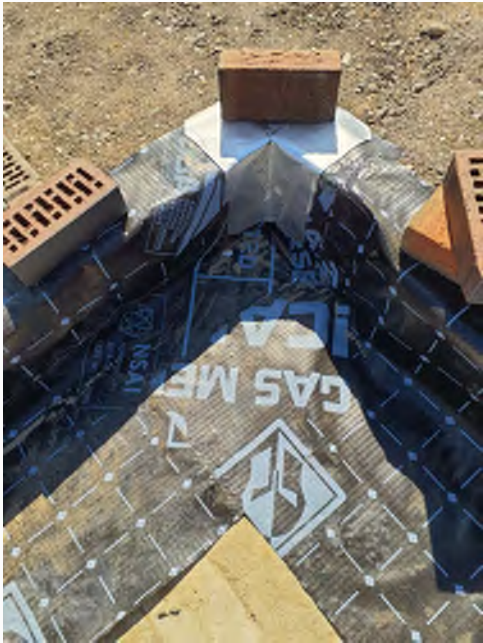
| | | Plot 59 corner |

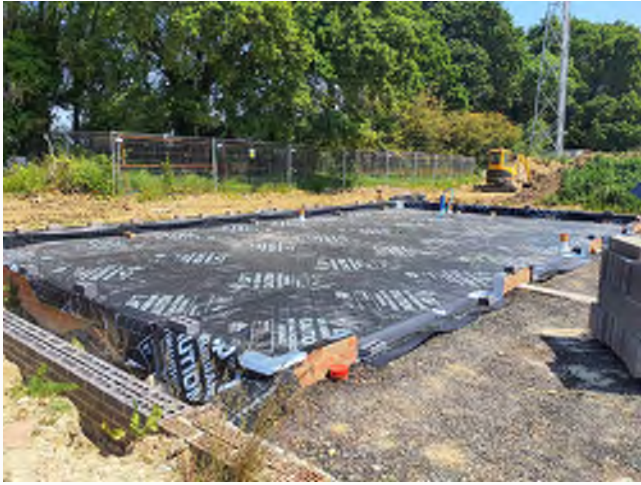
Plot 43 over view

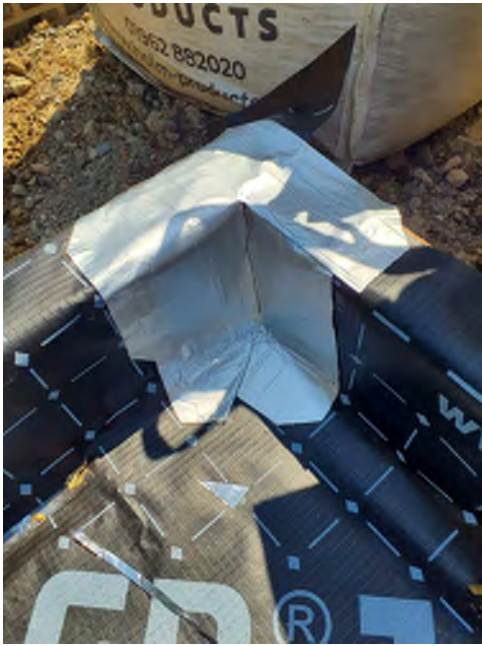
Plot 43 corner

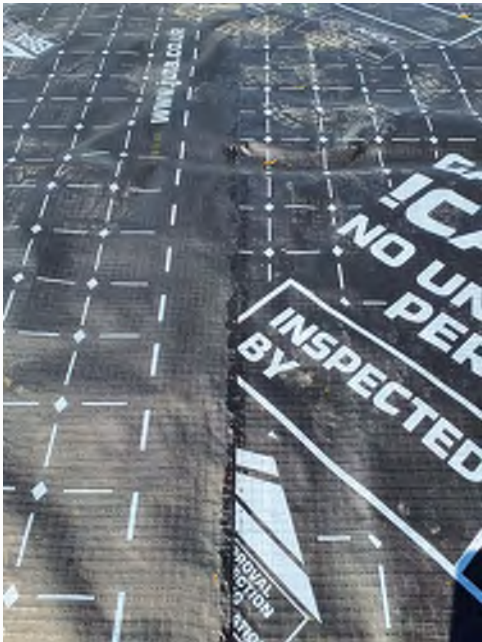
Plot 43 membrane join

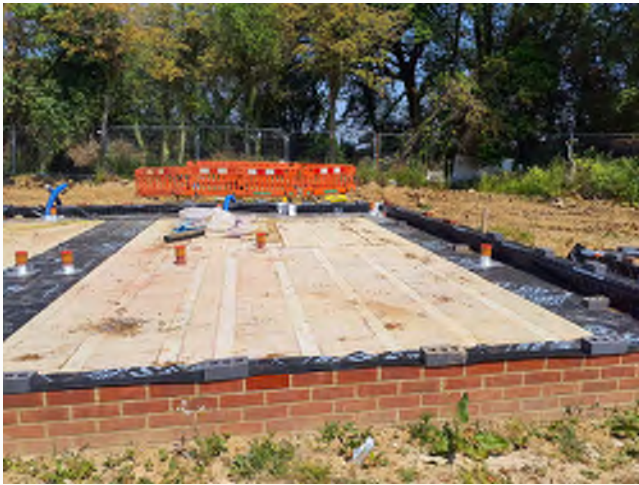
Plot 33 overview

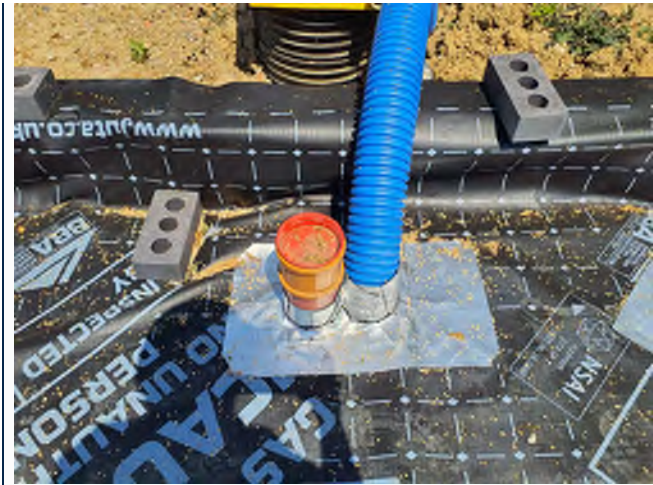
Plot 33 services

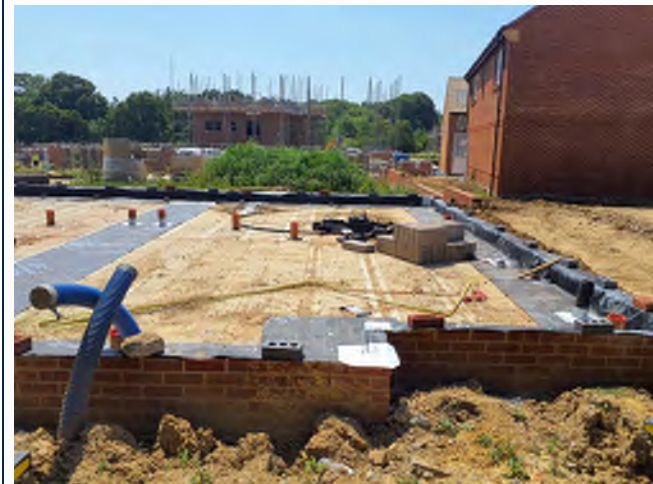
Plot 34 overview

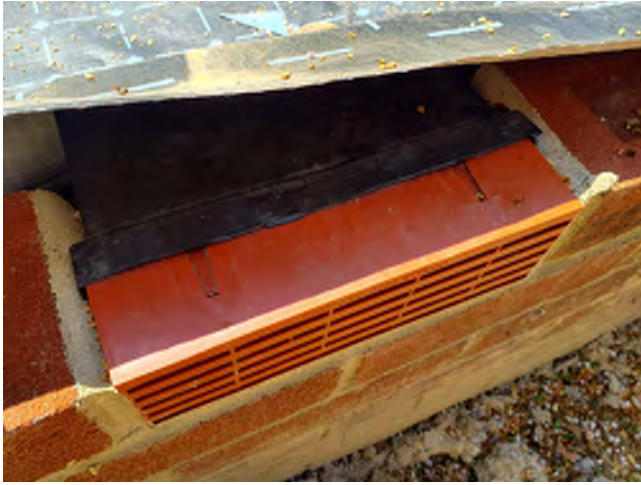
Plot 34 airbrick

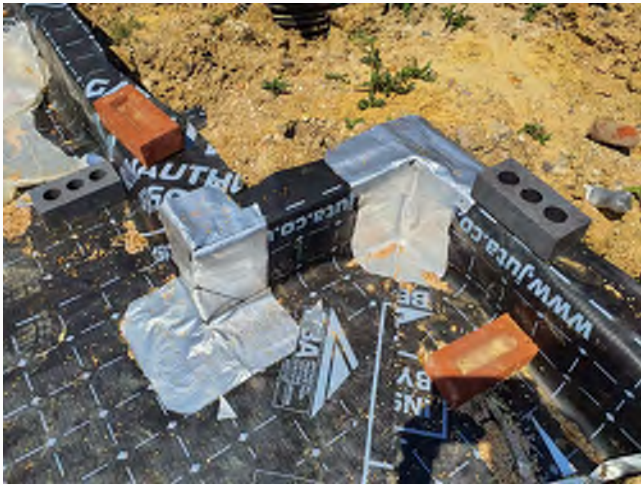
Plot 34 corners

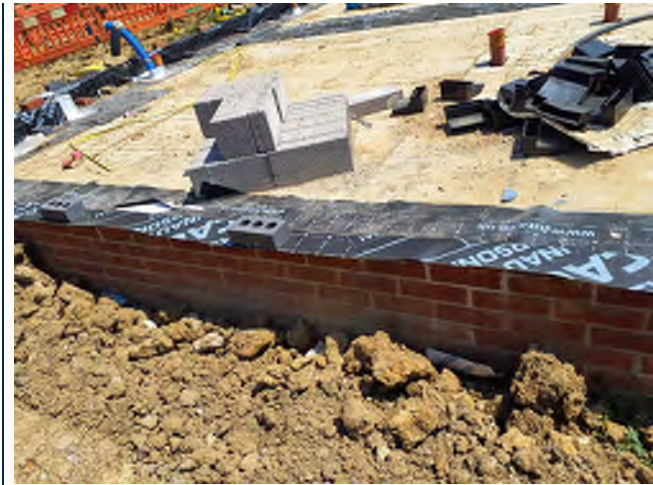
Plot 34 airbricks

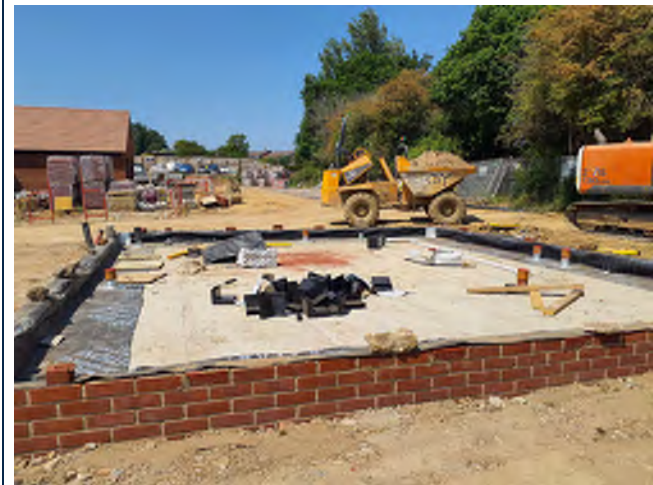
Plot 35 overview

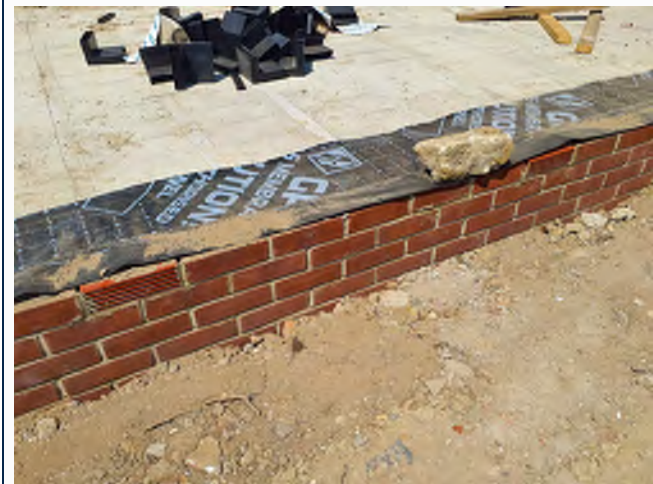
Plot 35 airbricks

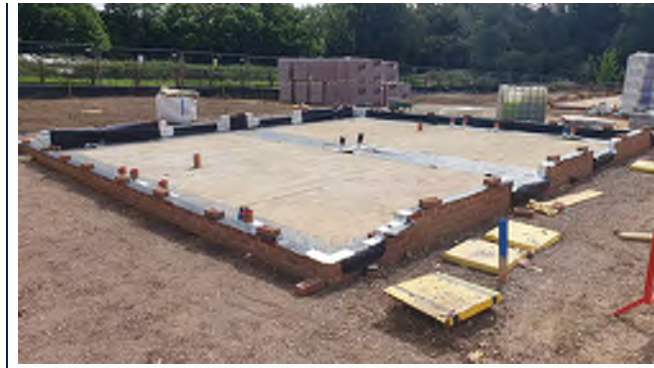
Perimeter membrane in place

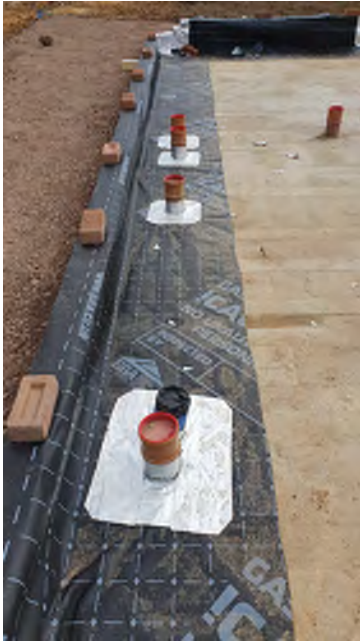
Bespoke service seals and corner detailing

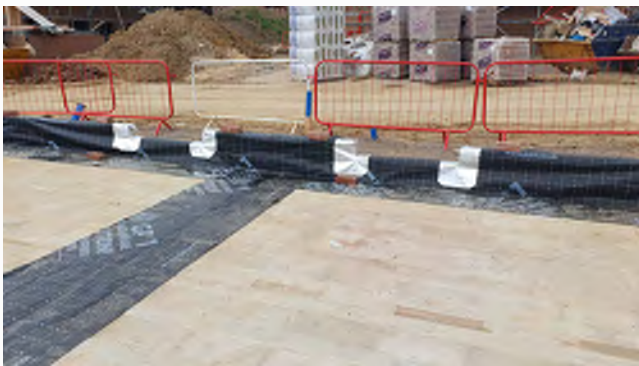
Front door thresholds and party wall strip

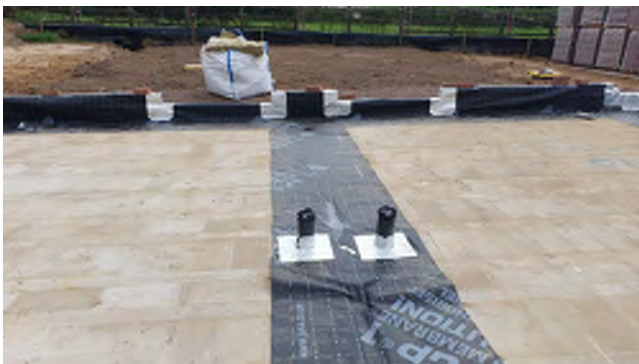
Party Wall strip, service seals and rear thresholds

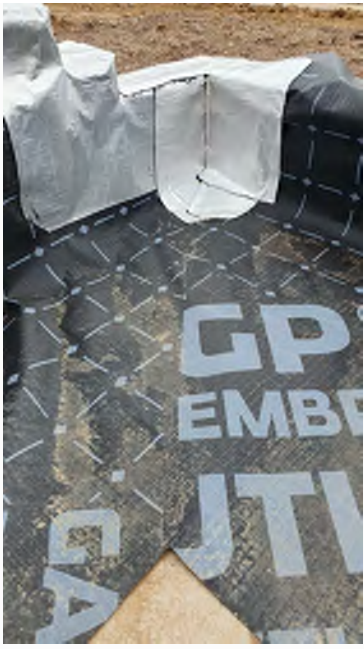
| | | Corner weld and wall step detailing |

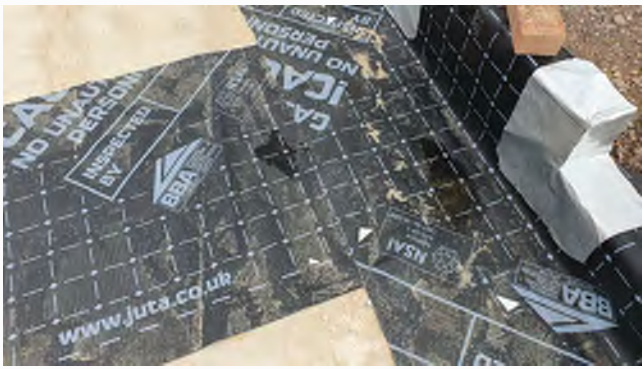
| | | Weld line |

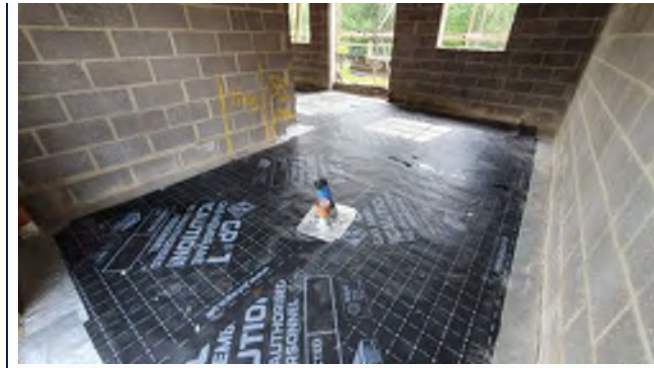
Plot 55 Western end (kitchen?)

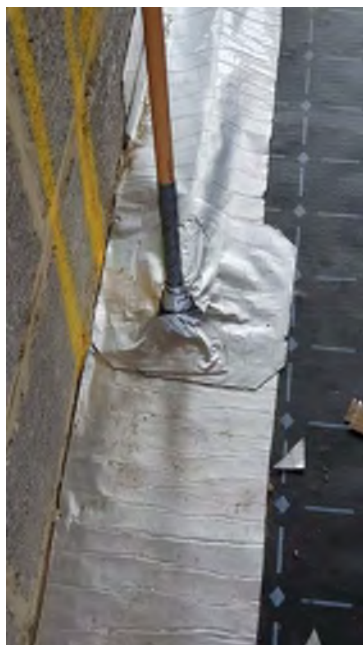
Plot 55 membrane weld

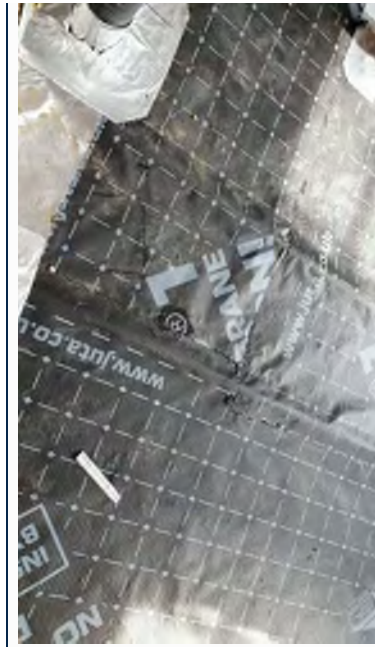
Plot 55 gas pipe seal

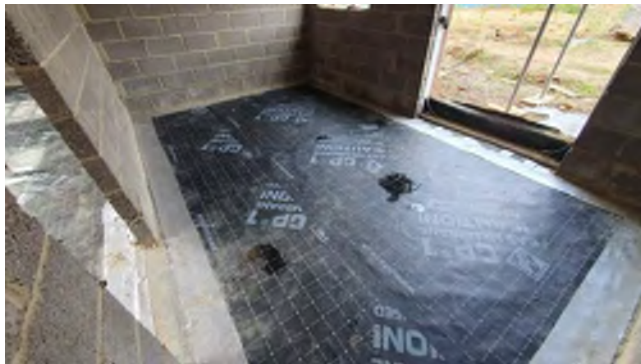
Plot 55 membrane welds

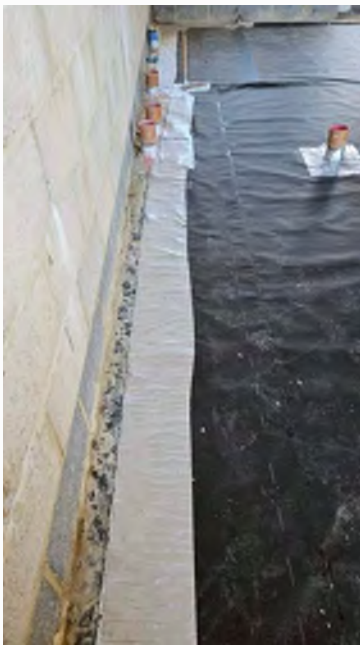
Long patch to perimeter lap

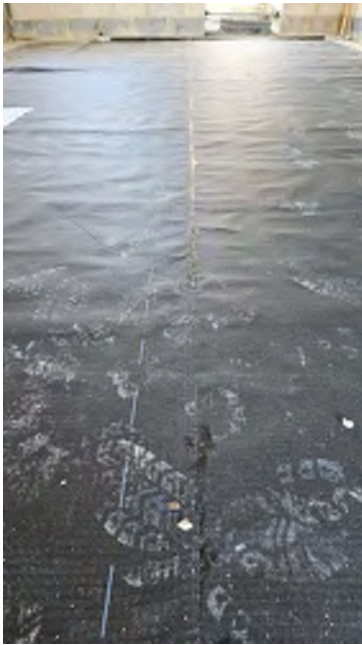
| | Welded lap |

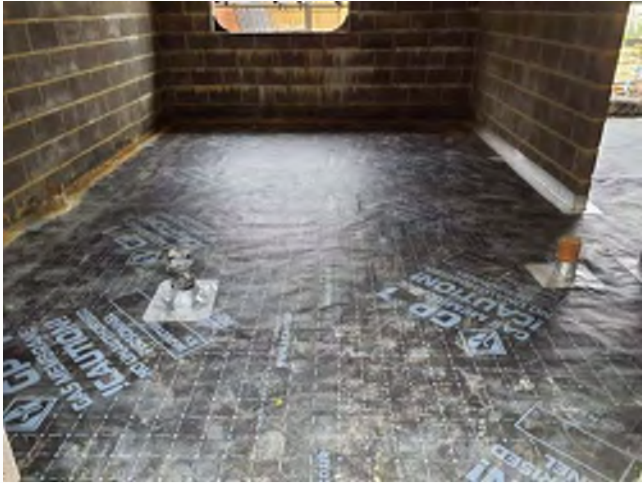
| Photograph | Photograph Title |
|---|---|
| | Plot 30 overview |

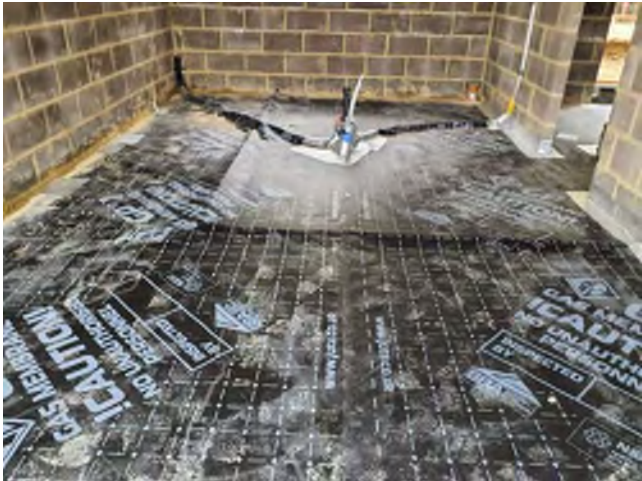
| Photograph | Photograph Title |
|---|---|
| | Plot 30 overview |

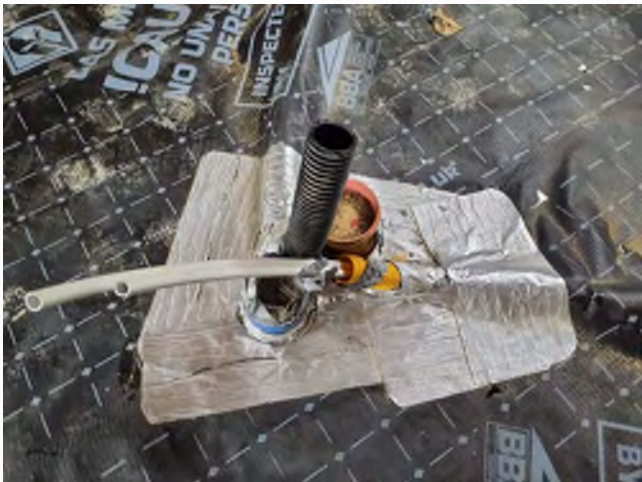
| Photograph | Photograph Title |
|---|---|
| | Plot 30 services |

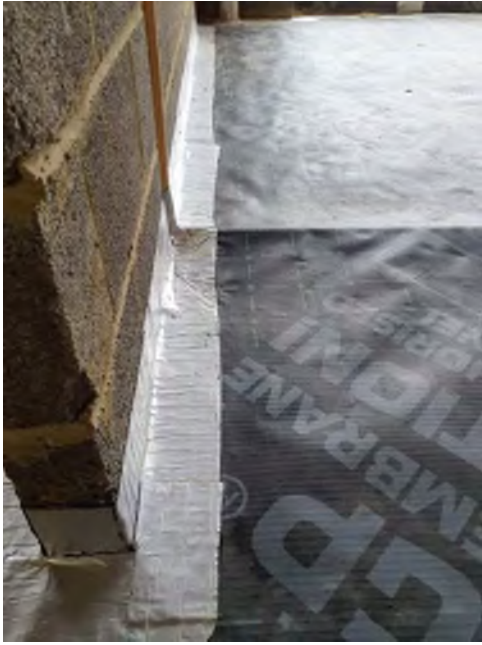
Plot 30 edge detail

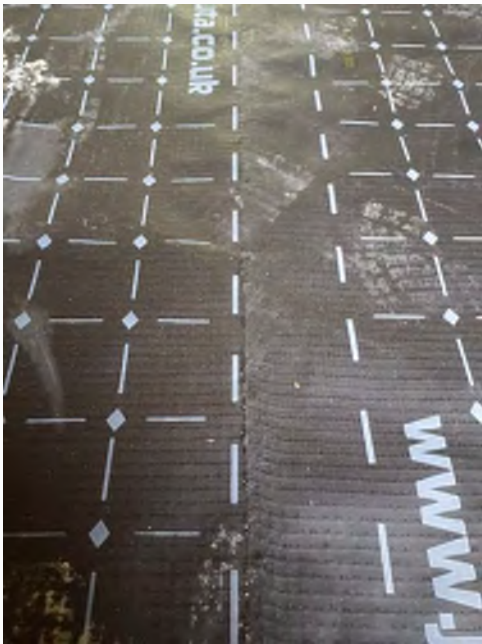
Plot 30 membrane joint

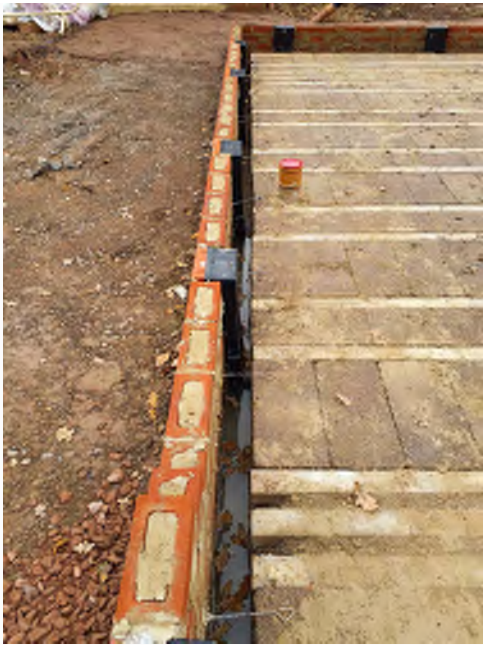
| | | Plot 30 air bricks and telescopic vents |

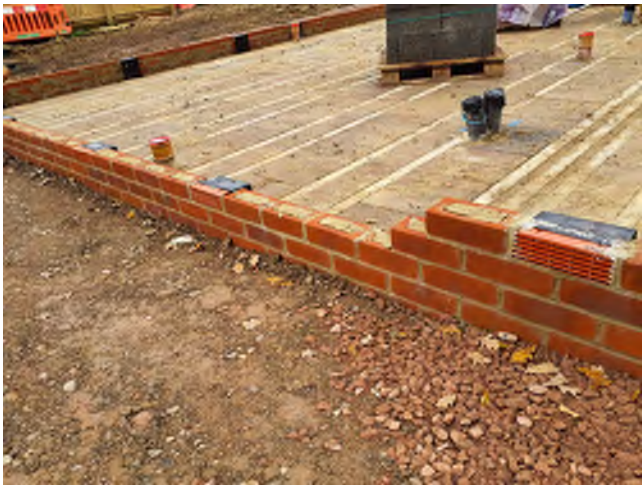
| | | Plot 30 airbricks |

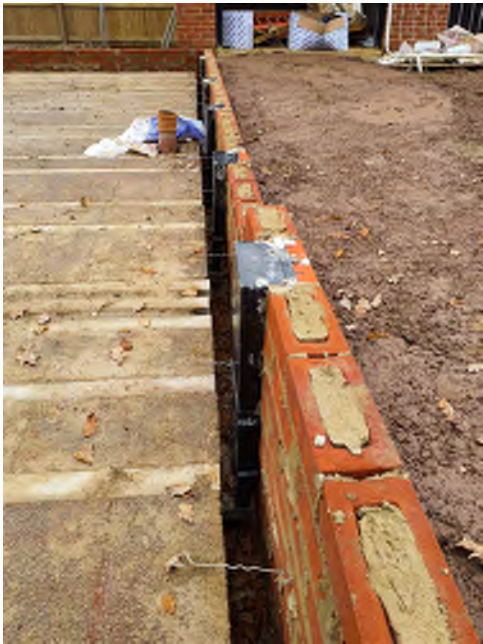
| | | Plot 29 airbricks and telescopic vents |

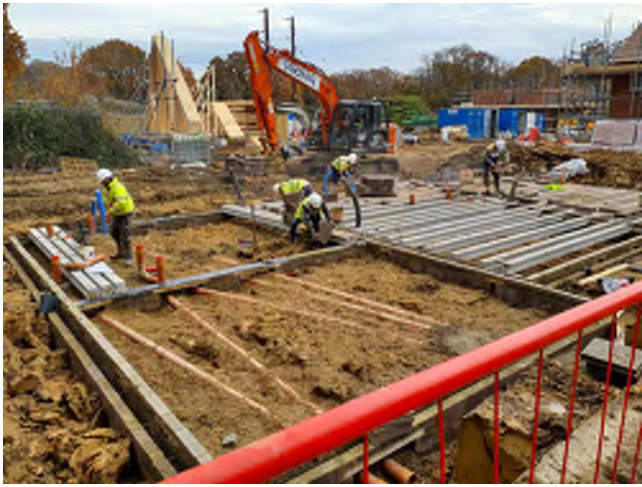
| | | Floor construction in progress |

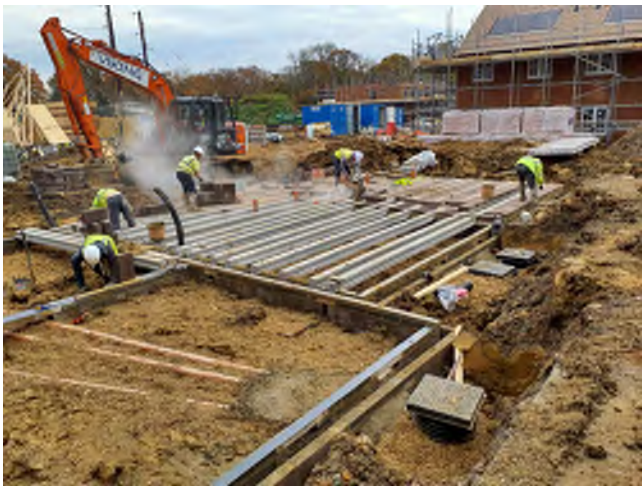
| | | Floor construction in progress |

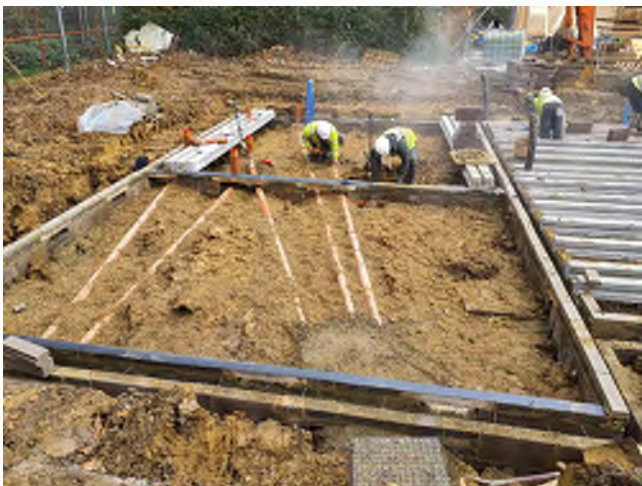
| | | Floor construction in progress |

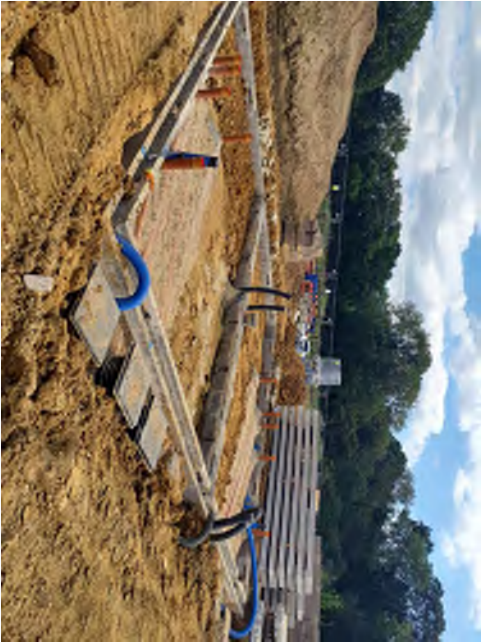
| Photograph | Photograph Title |
|---|---|
| | Plots 50-51 floor construction |

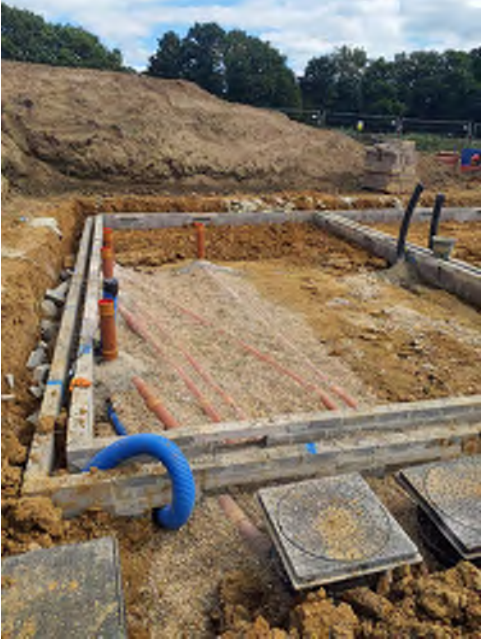
| Photograph | Photograph Title |
|---|---|
| | Plot 50 floor construction |

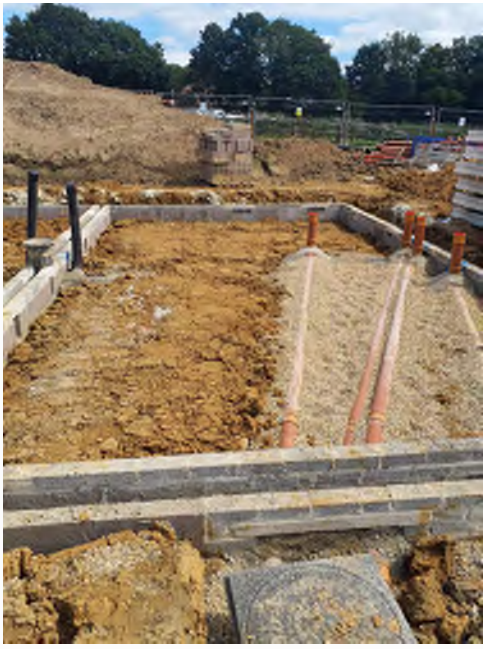
| | | <p>Plot 51 floor construction</p> |
