Gas Membrane Installation  
Validation Report  
Elivia Homes  
2 Grange Road  
Abbey Fruit Farm  
Phase 2  
Netley  
SO31 5HZ  
V2 30/04/2024

## Appendix 1 – Site Survey Sheets

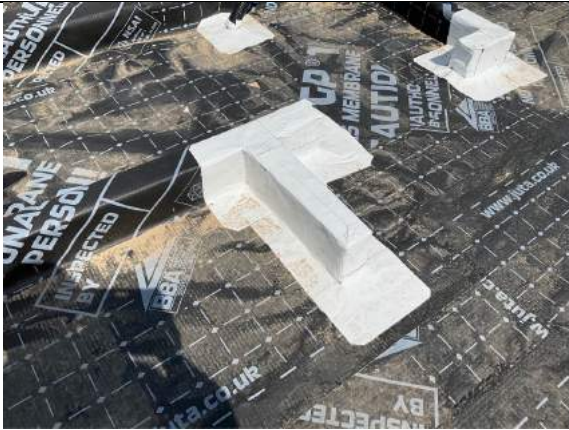
Plot 12. Corner details sealed with SAGM.

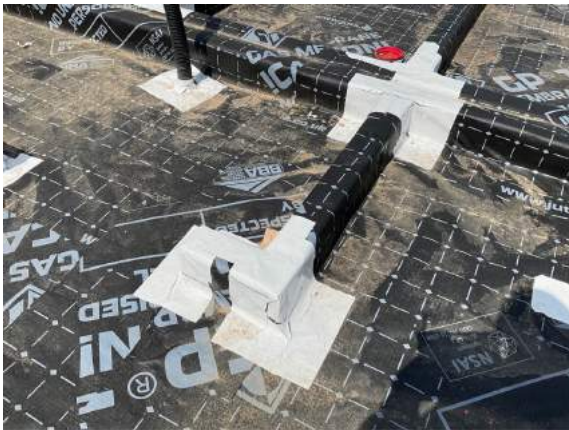
Plot 13. Corner details and pipe penetration seal3d with SAGM.

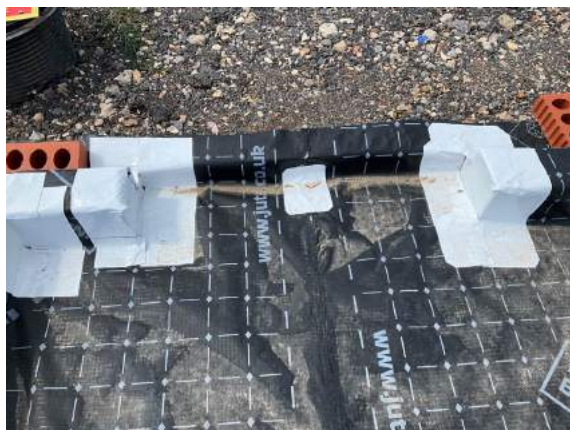
Plot 14. Threshold detail sealed with SAGM.

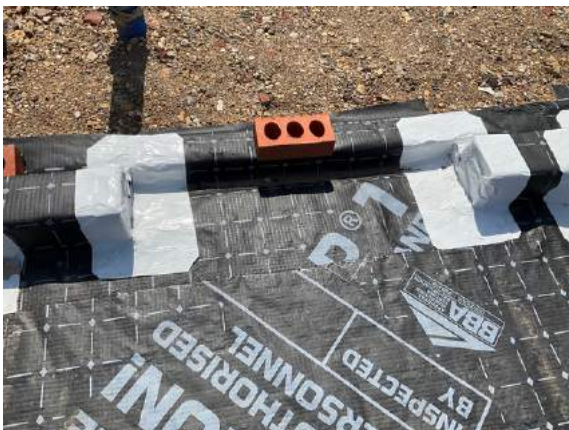
Plot 17. Threshold detail sealed with SAGM.

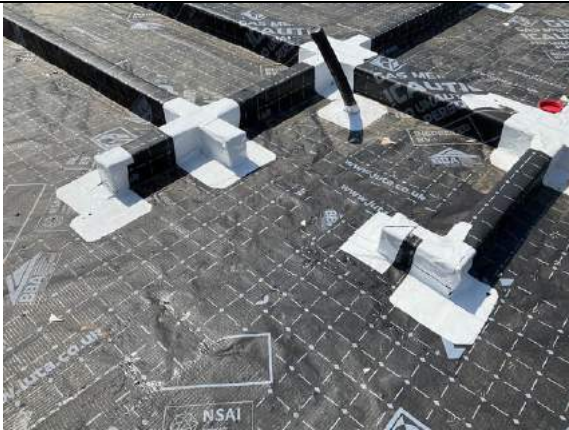
Plot 18. Multiple details sealed using SAGM.

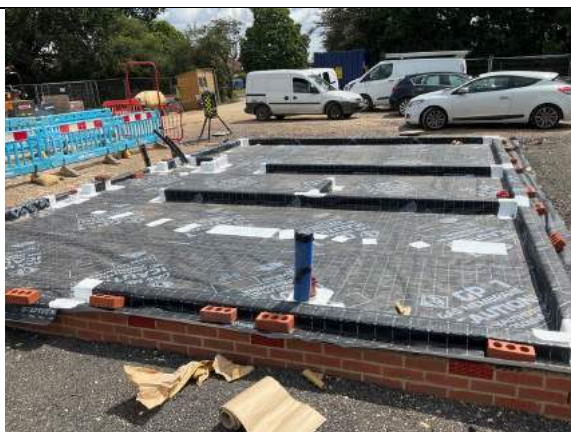
Overview of the full footprint installation to Plot 22.

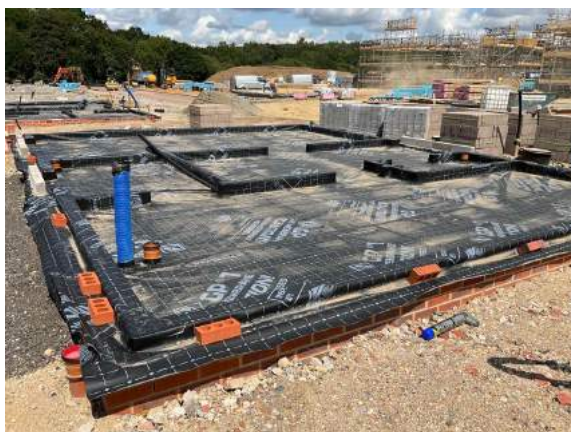
Overview of the full footprint installation to Plot 25.

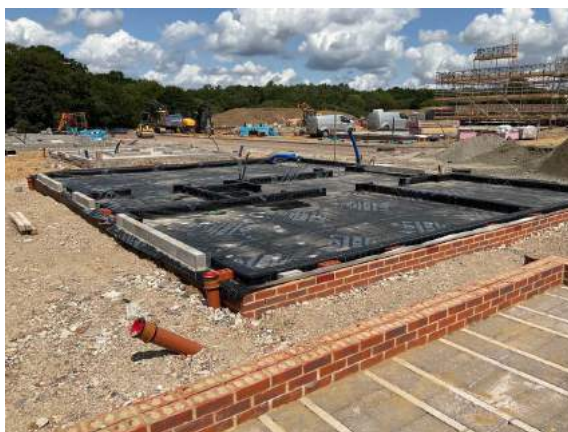
Overview of the full footprint installation to Plot 26.

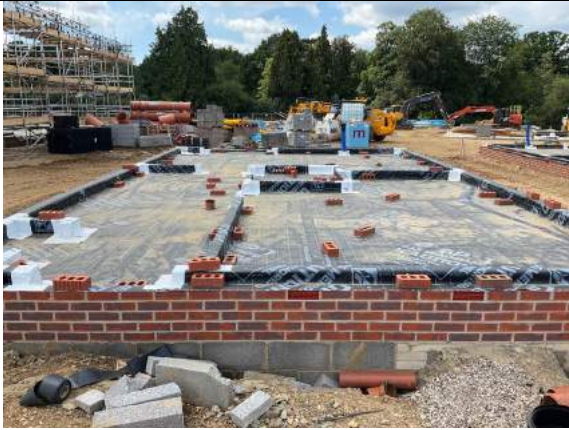
Overview of the full footprint installation to Plot 50.

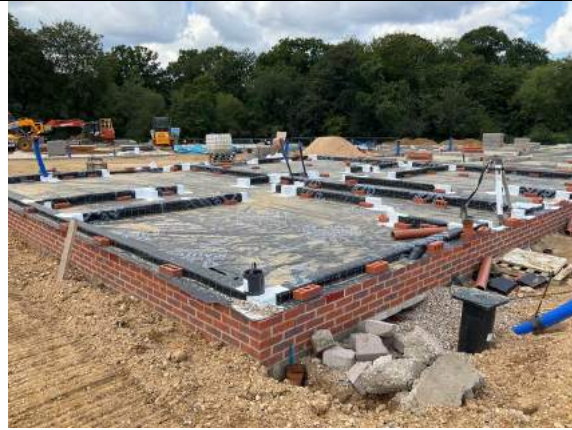
Overview of the full footprint installation to Plot 51-52.

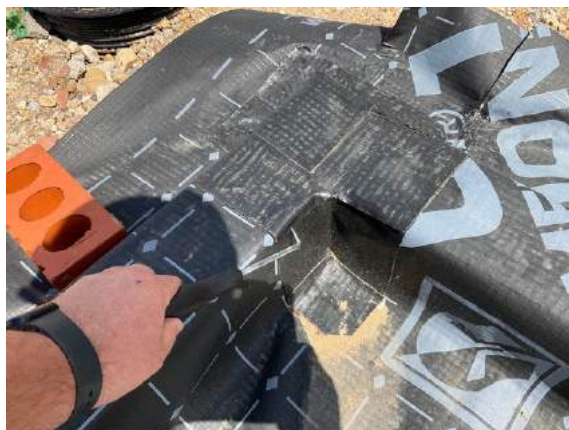
Plot 25. Pick testing to sealed corner detail.

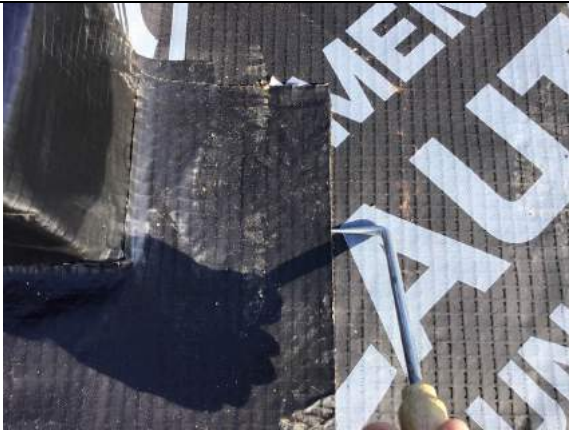
Pick testing all SAGM detailing in plot 28.

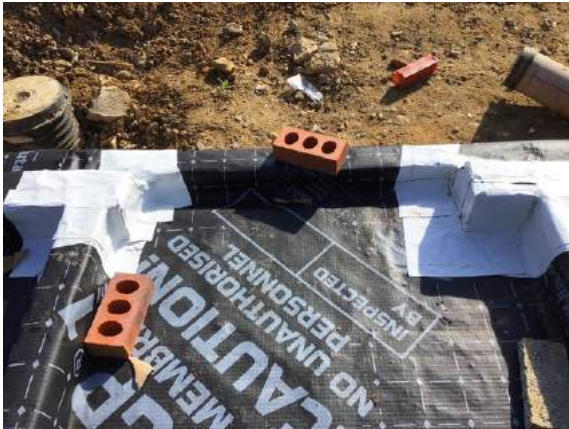
Sealed door threshold detail using SAGM in plot 30.

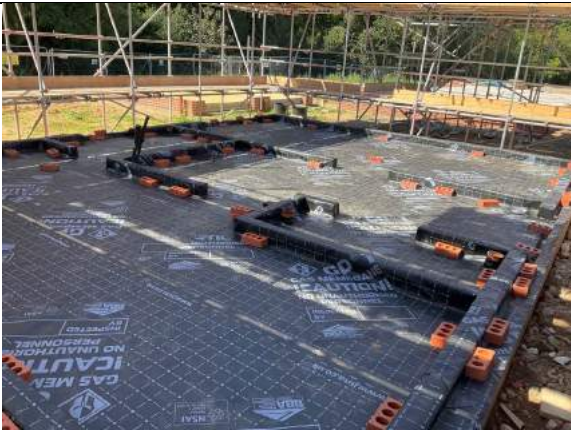
Overview of the full footprint installation to Plot 27.

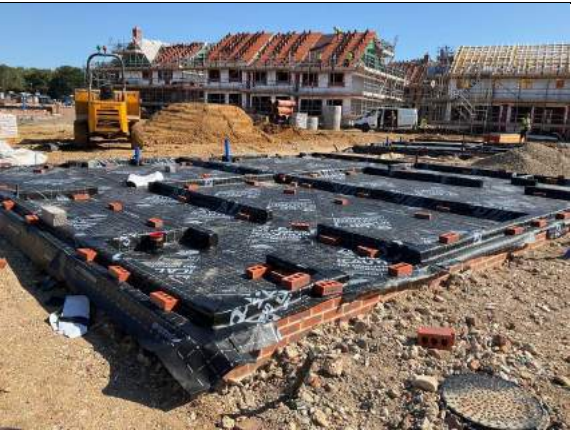
Overview of the full footprint installation to Plots 38-39.

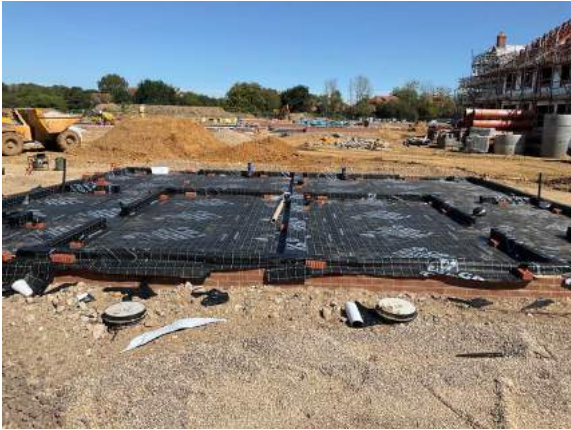
Overview of the full footprint installation to Plots 40-41.

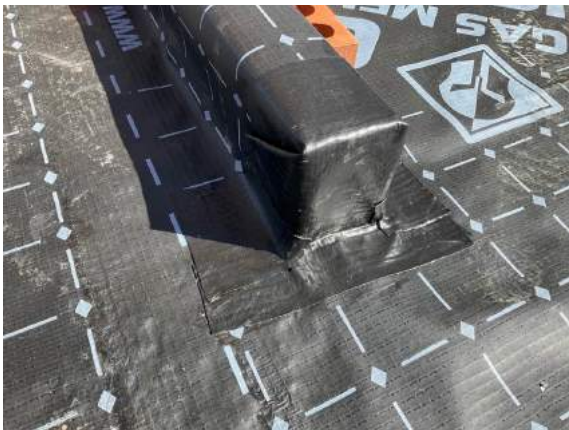
Plot 27. Typical internal wall corner details sealed with SAGM.

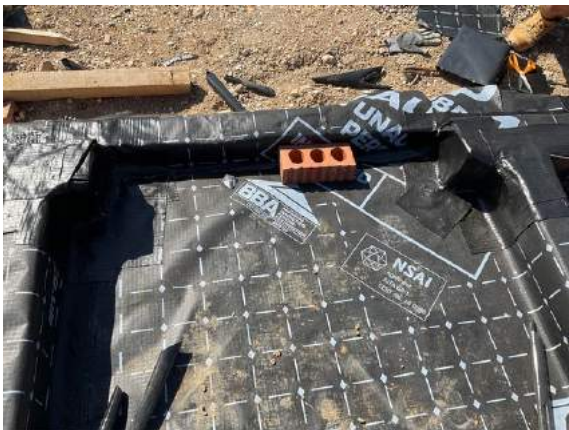
Plot 41. Typical door threshold detail sealed with SAGM.

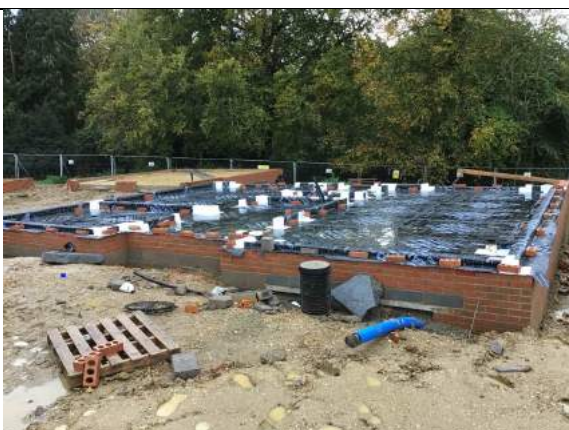
Overview of plot 31.

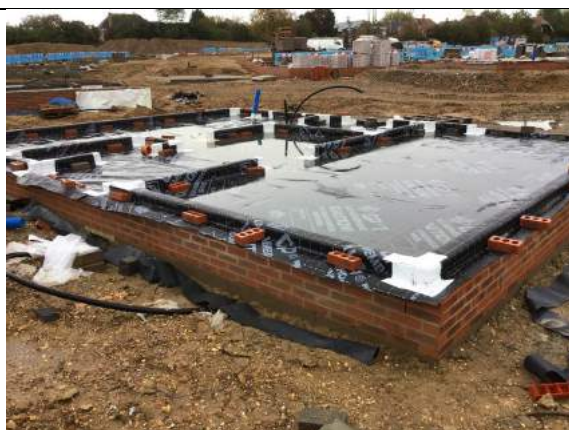
Overview of plot 36.

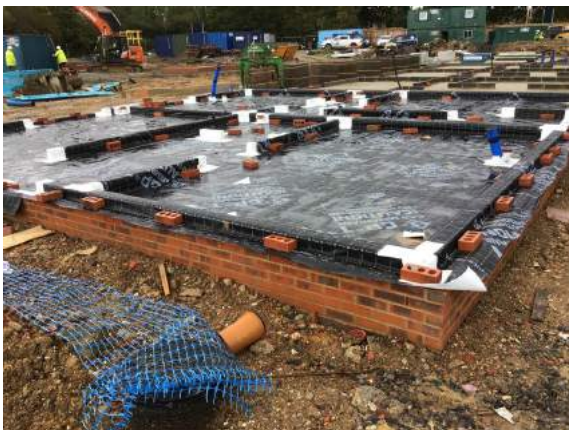
Overview of semi detached plots 77 & 78.

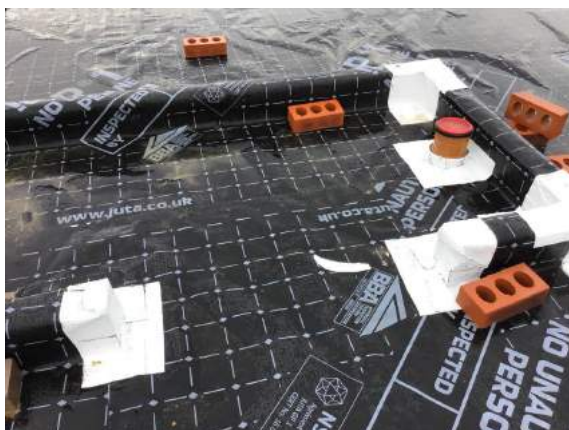
Typical internal door threshold seal using SAGM in plot 36.

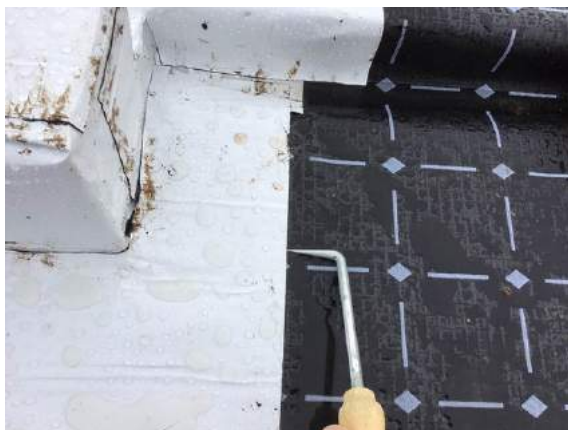
Pick testing all SAGM in plot 78.

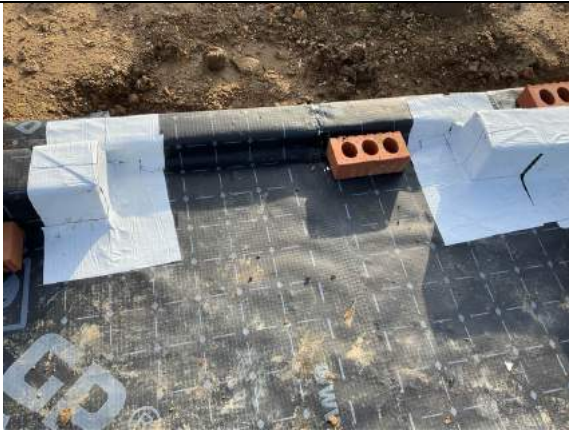
Plot 34. Typical door threshold detail sealed with SAGM.

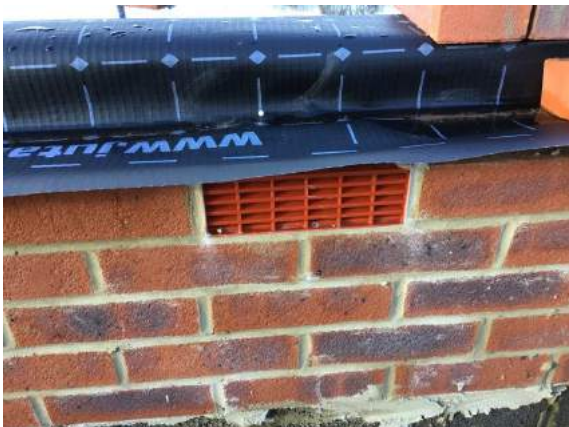
Air brick in place under the membrane at the time of our inspection.

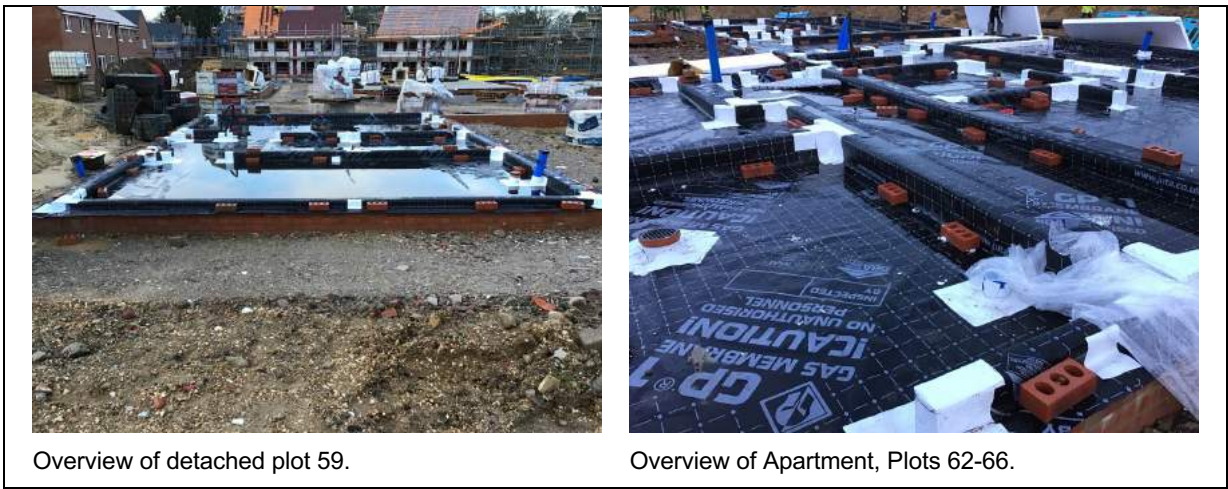
Overview of detached plot 59.

Overview of Apartment, Plots 62-66.

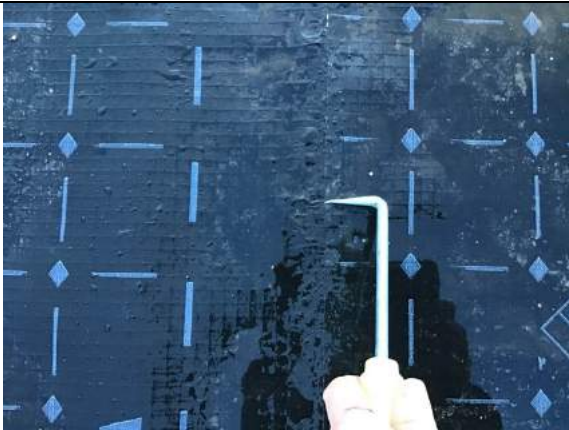
Pick testing all hand welded membrane laps in apartment plots 62-66.

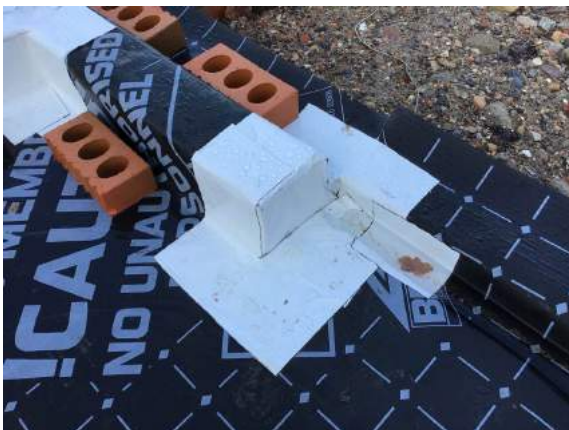
Typical door threshold detail, sealed using SAGM in plot 59.

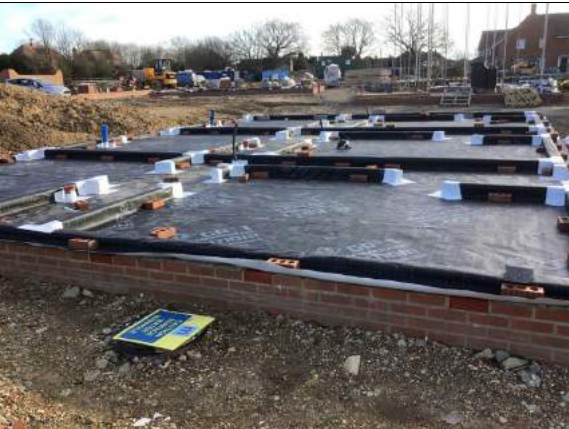
| Overview of Terrace plots 56,57 & 58. | Overview of semi detached plots 60 & 61. |

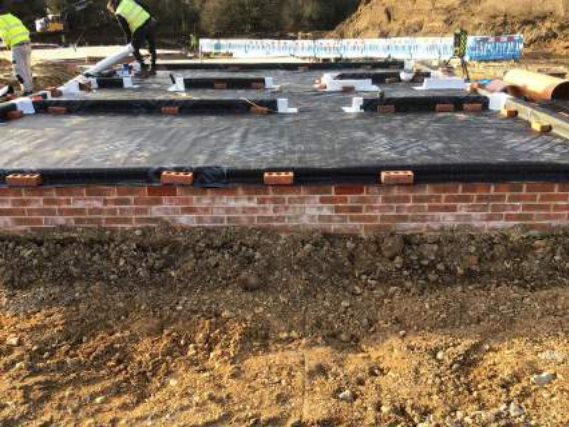
| Overview of detached plot 69. | |

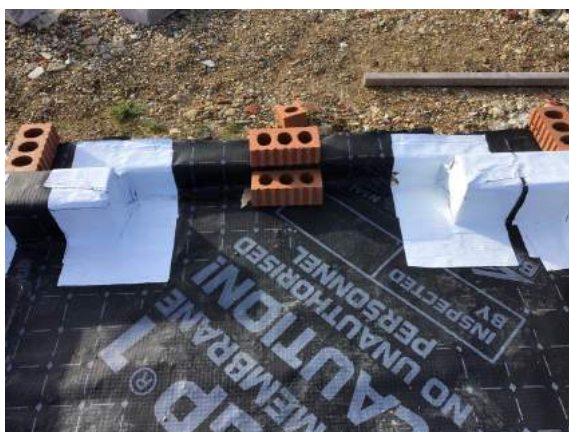
Typical door threshold seal using SAGM in plot 57.

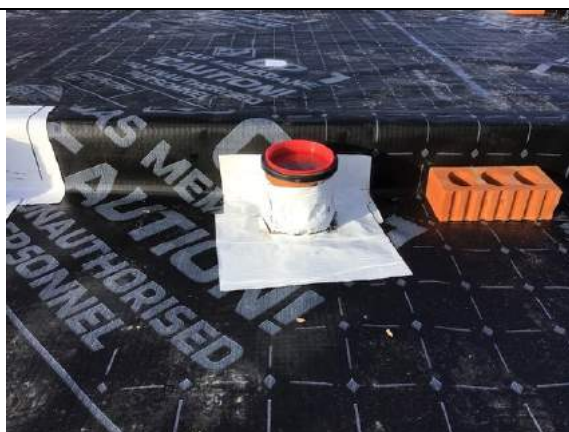
Typical pipe penetration seal using SAGM in plot 60.

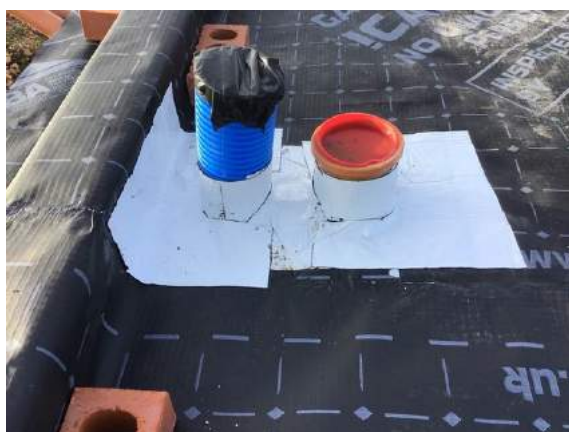
Typical double pipe penetration seal using SAGM in plot 69.

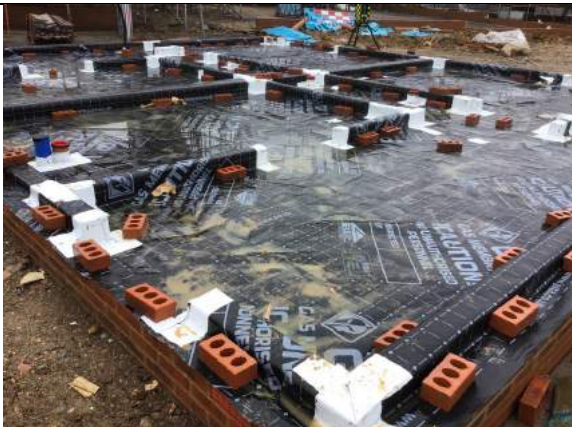
| <p>Overview of Semi detached plots 67 &amp; 68.</p> | <p>Overview of Apartment plots 73-76.</p> |

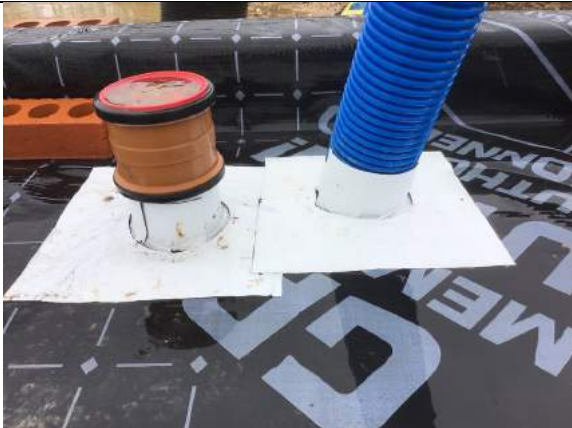
| <p>Typical double pipe penetration seal using SAGM in plots 73-76.</p> | <p>Pick testing all SAGM detailing in plots 73-76.</p> |

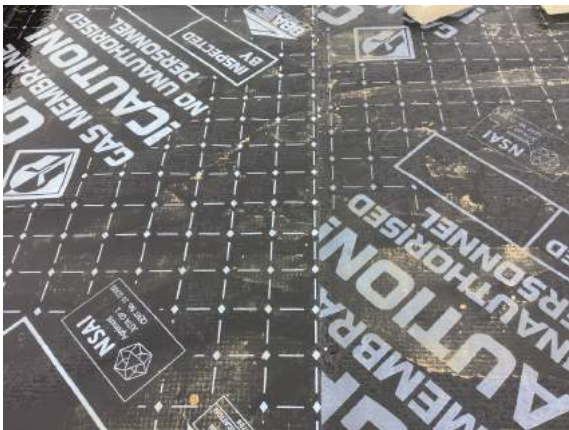
All membrane laps have been hand welded using a hot air gun and rolled using a neoprene roller in plots 73-76.

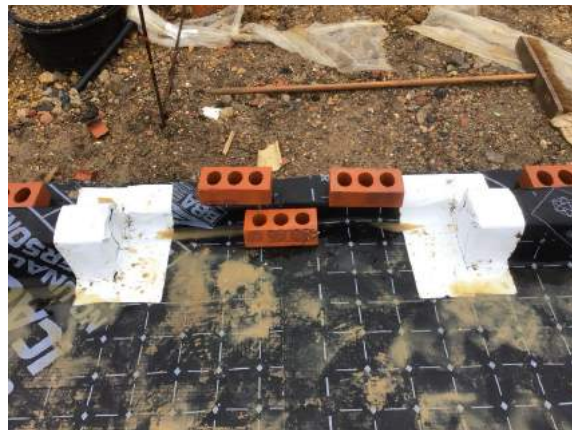
Typical door threshold seal using SAGM in plot 67.

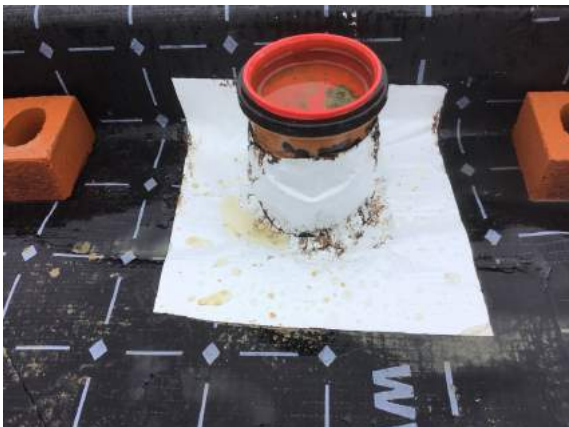
Typical pipe penetration seal using SAGM in plot 67.

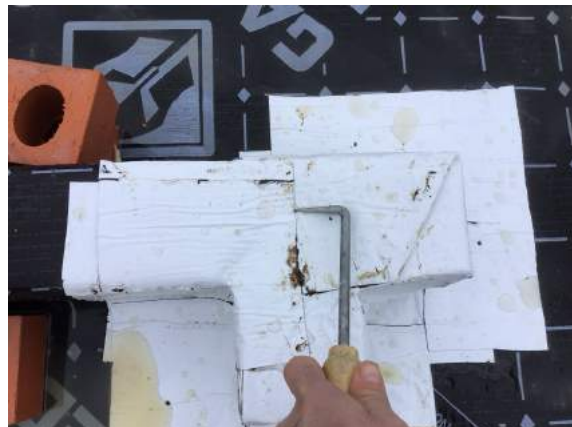
Pick testing all SAGM detailing in plot 67.

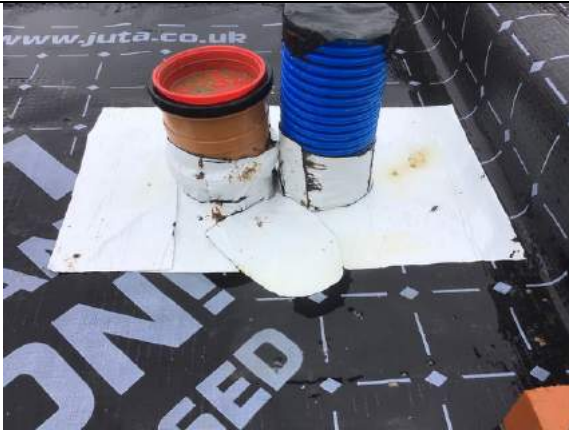
Typical double pipe penetration seal using SAGM in plot 68.

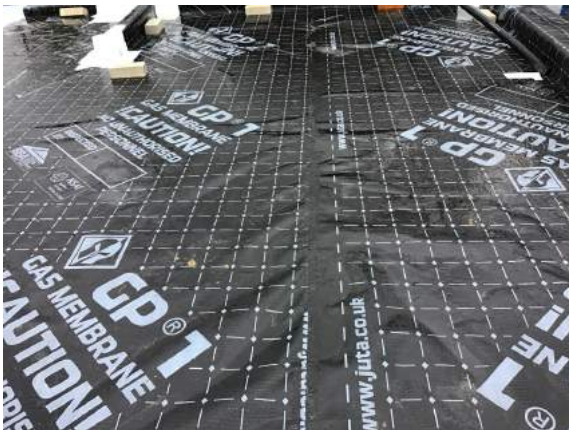
All membrane laps have been hand welded using a hot air gun and rolled using a neoprene roller in plot 72.

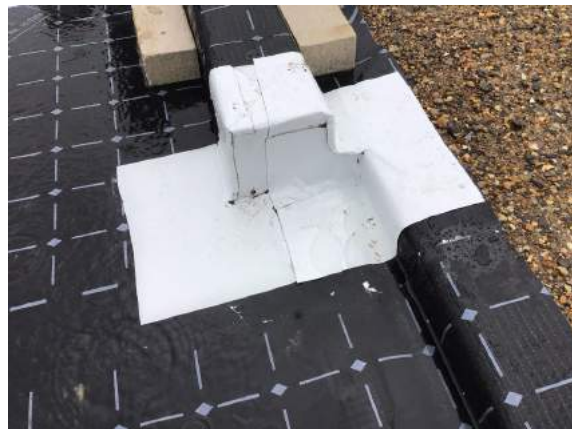
Sealed door threshold detail using SAGM in plot 81.

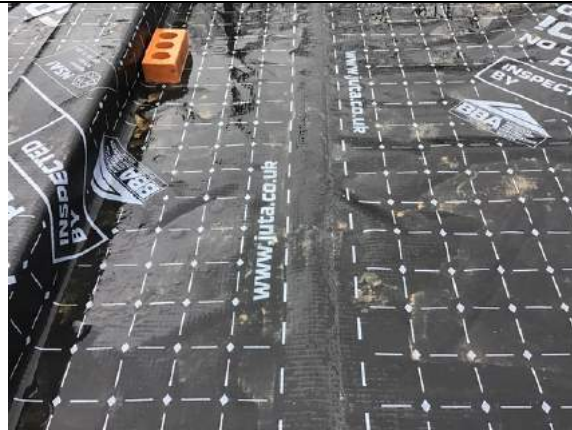
All membrane laps have been hand welded using a hot air gun and rolled using a neoprene roller in plot 83.

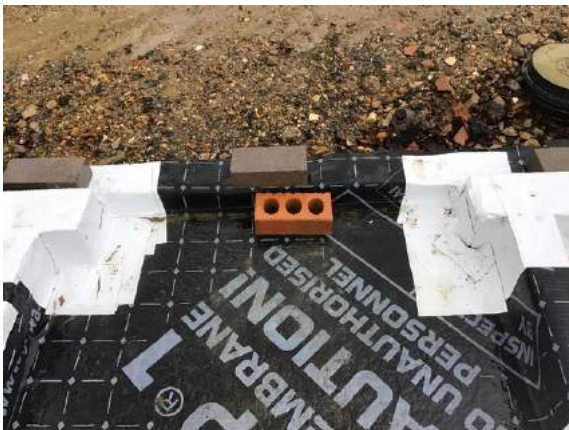
Sealed door threshold detail using SAGM in plot 84.

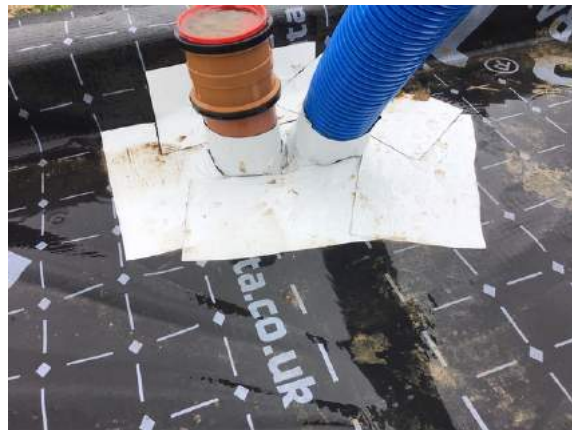
Typical double pipe penetration seal using SAGM in plot 84.
