## SITE VISIT REPORT

**Project:** Kestrel Park, Bursledon

**Client:** Taylor Wimpey UK Ltd (Southern Counties)

**Contract No.:** C-08162-C

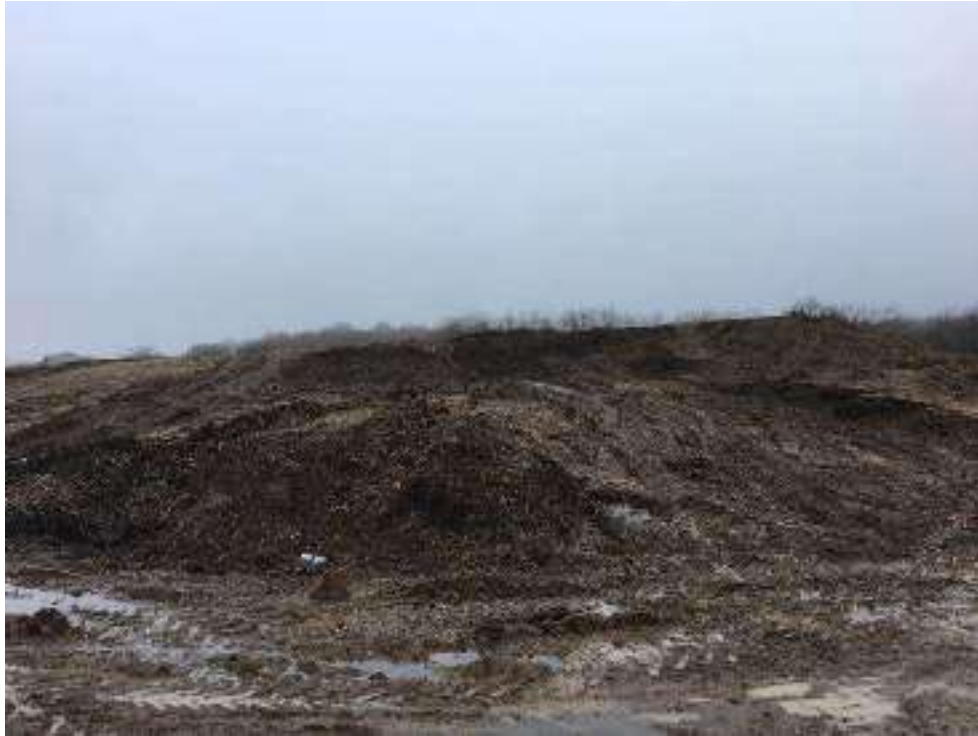
**Photograph 1: topsoil stockpile**

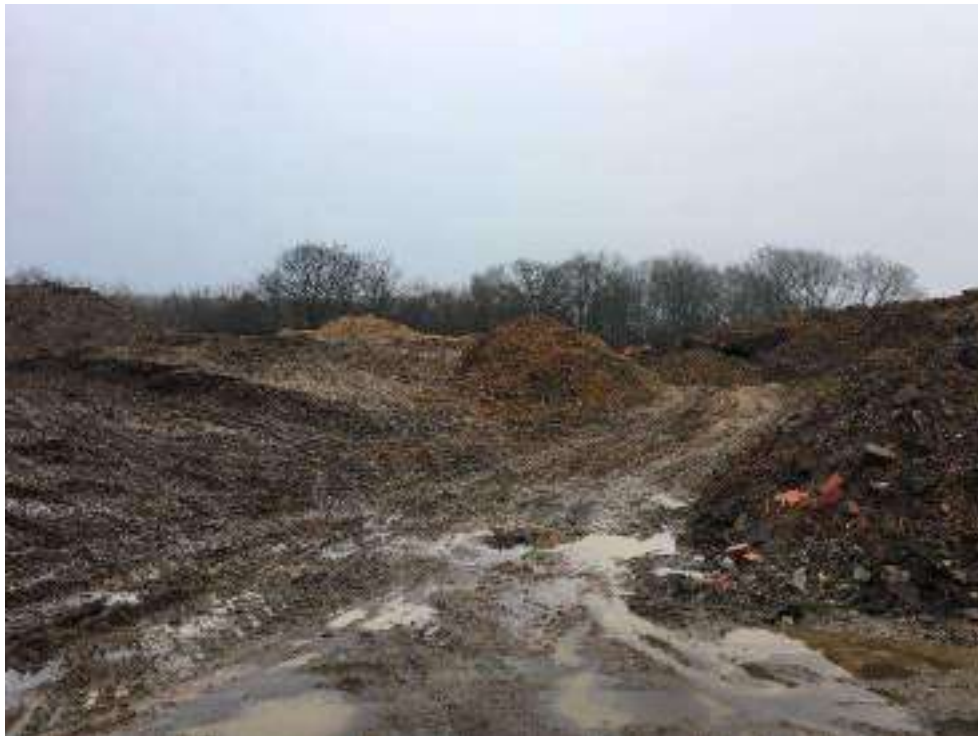
**Photograph 2: Stockpile area showing no clear segregation between topsoil (left), sand/gravel arisings (centre) or "muckaway" (right).**

- Any materials to be reused on site should be won from the main stockpile of drainage basin, road construction and foundation excavation arisings.
- Surveying of the existing stockpiles must be done on a regular basis to provide tracking data for materials management – Gracelands to arrange detailed survey next week.

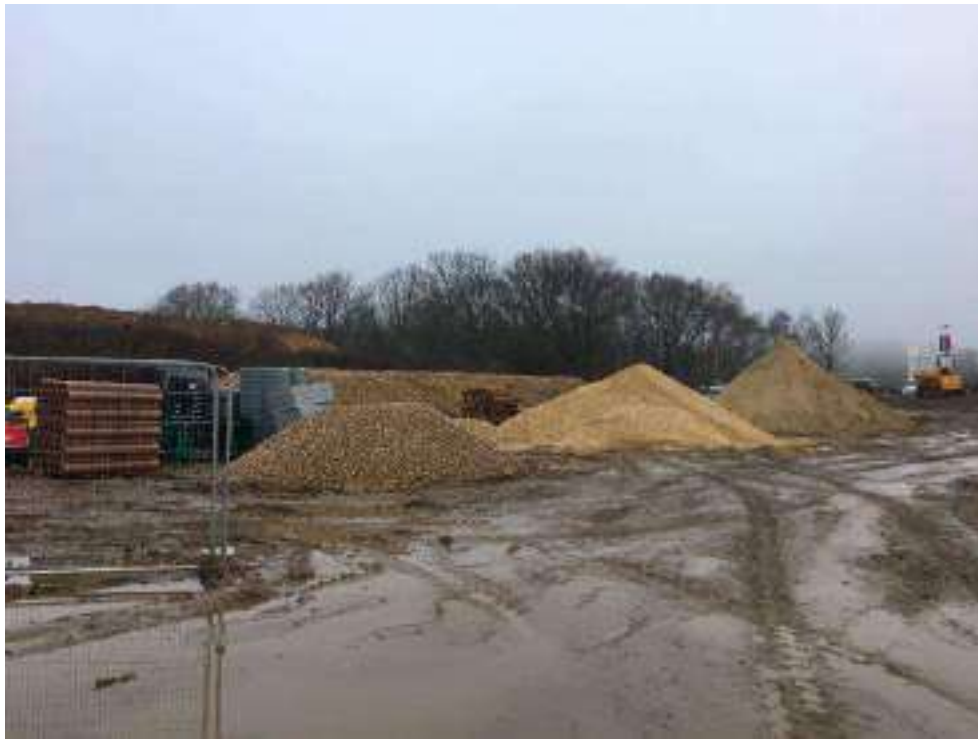
**Photograph 5: sporadic natural soil arisings and imported materials stockpiles**

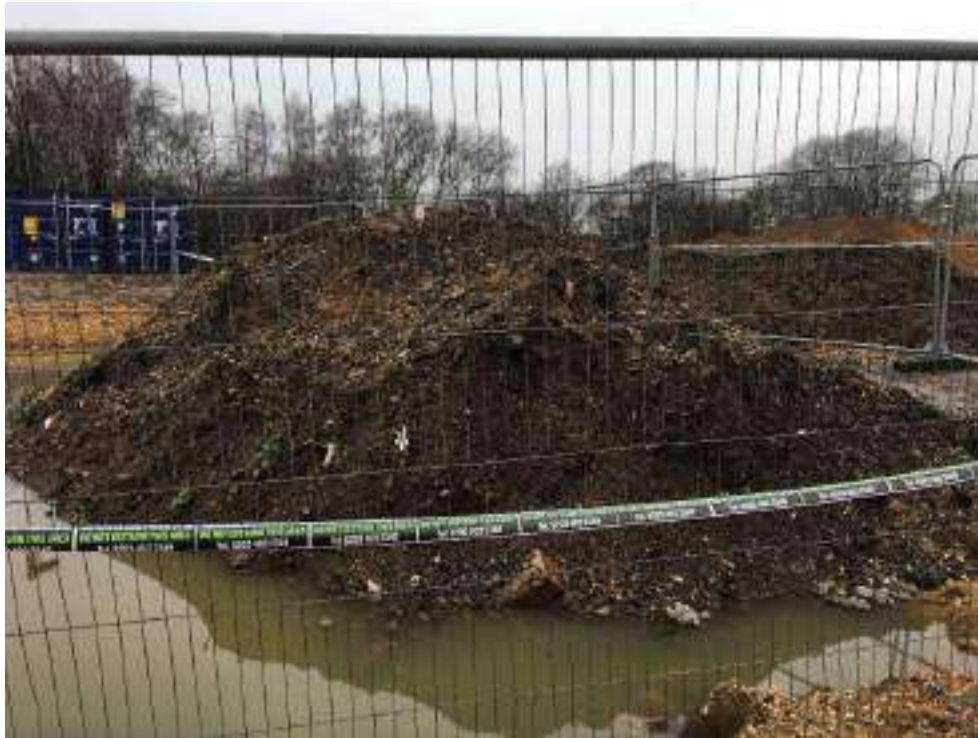
**Photograph 7: asbestos impacted soils awaiting disposal off-site**

- Asbestos impacted soils should be disposed off-site.
- Excavation works for the new borrow pit must be halted and no further excavation undertaken.
- Any materials to be reused on site should be won from the main stockpile of drainage basin, road construction and foundation excavation arisings.
- Surveying of the existing stockpiles must be done on a regular basis to provide tracking data for materials management.
- Site meeting to be held between TW, Gracelands and Hydrock to determine way forward with materials management.

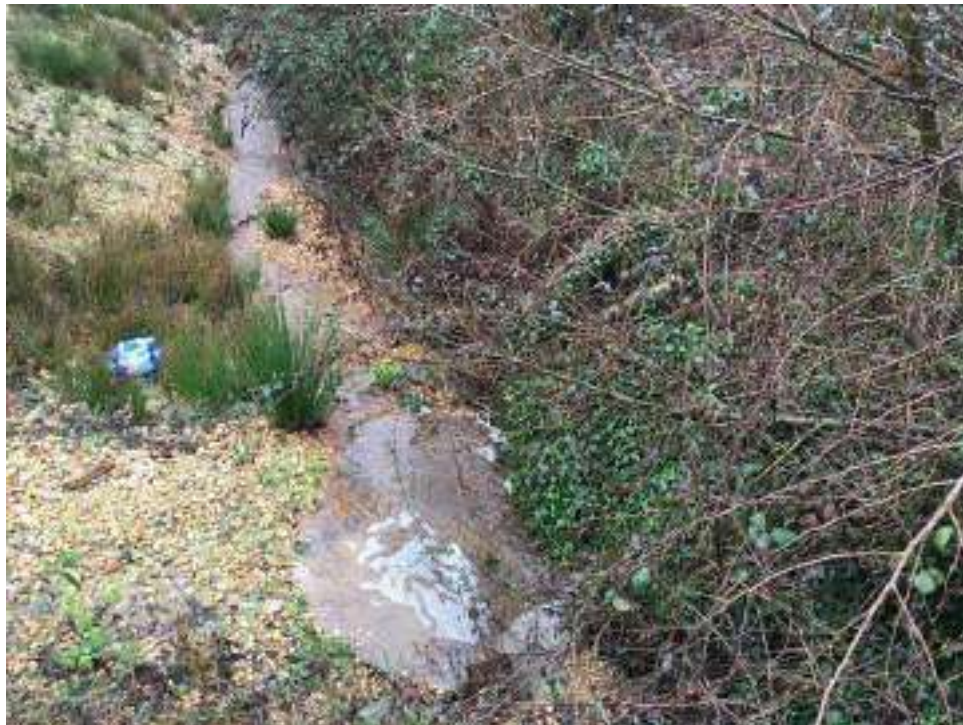
**Photograph 8: view into stream, waters are clear and not silted**

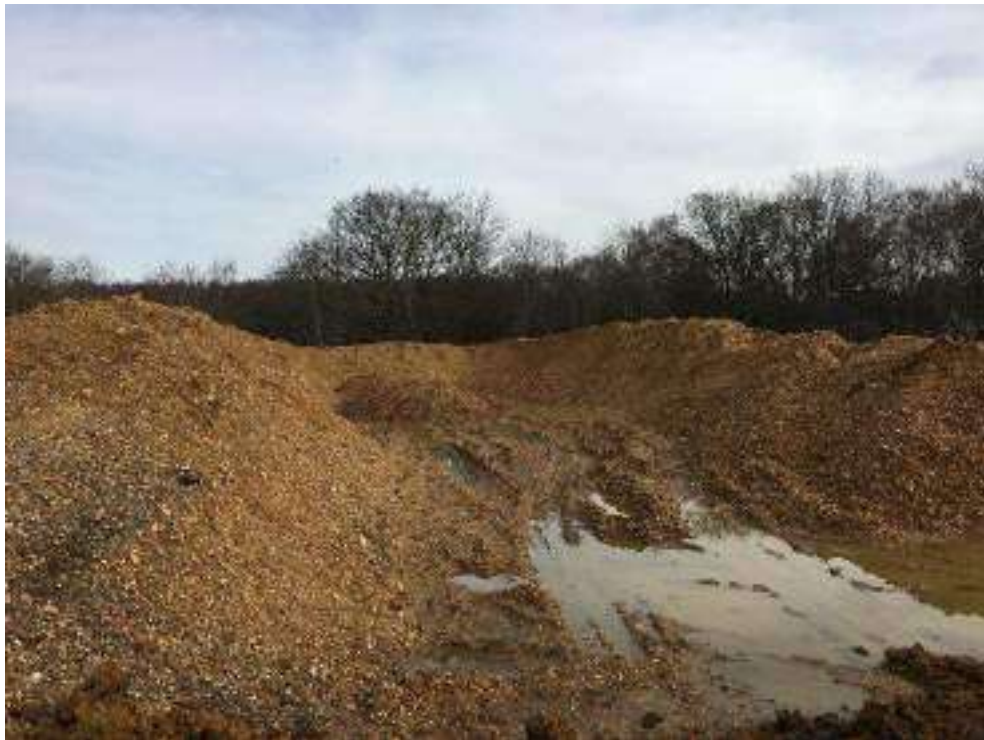
**Photograph 2: Sand and gravel stockpiled south east of topsoil stockpile**

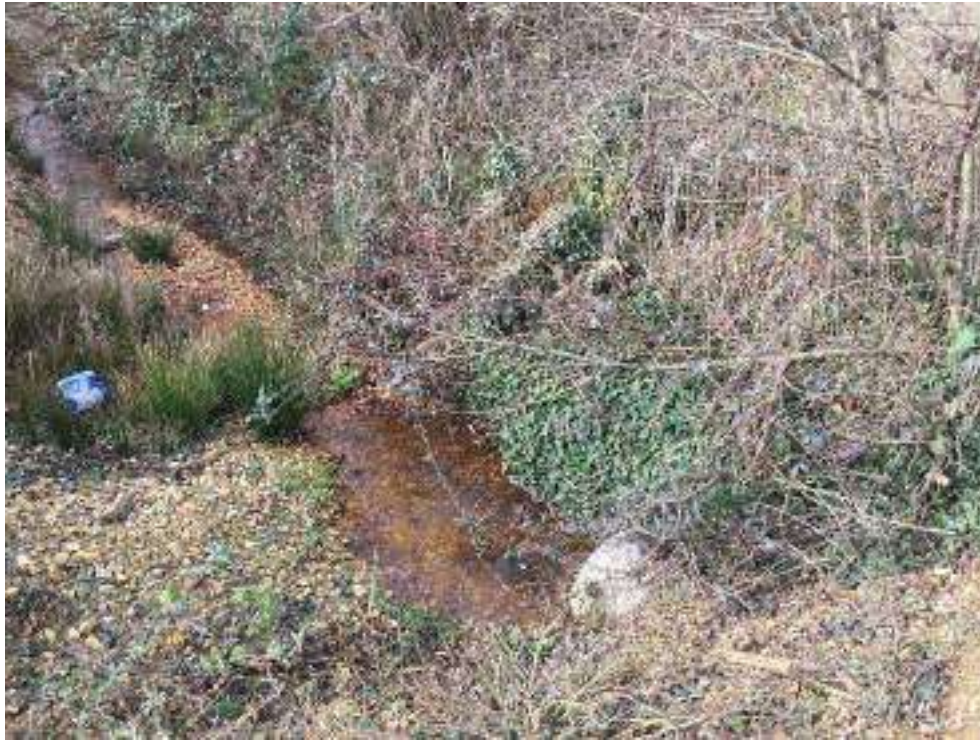
**Photograph 7: view looking south west at stream running through site, waters are clear and not silted**

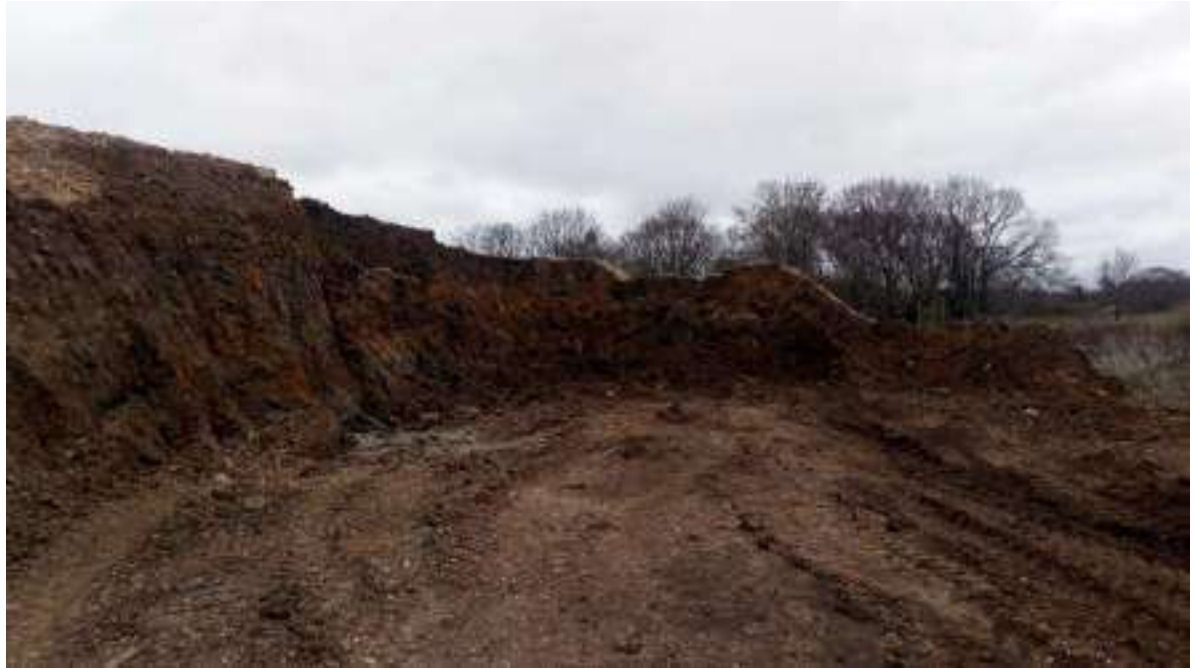
**Photograph 3: Topsoil stockpile being reused for capping**

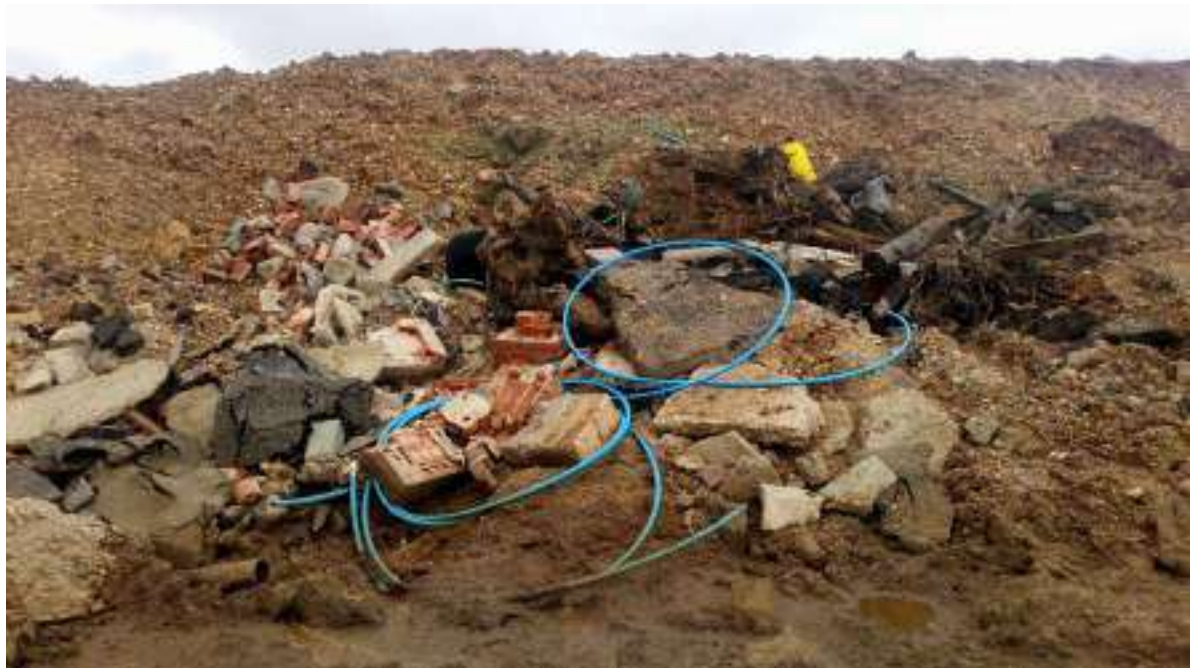
**Photograph 4: anthropogenic waste materials remain placed on mixed stockpile**

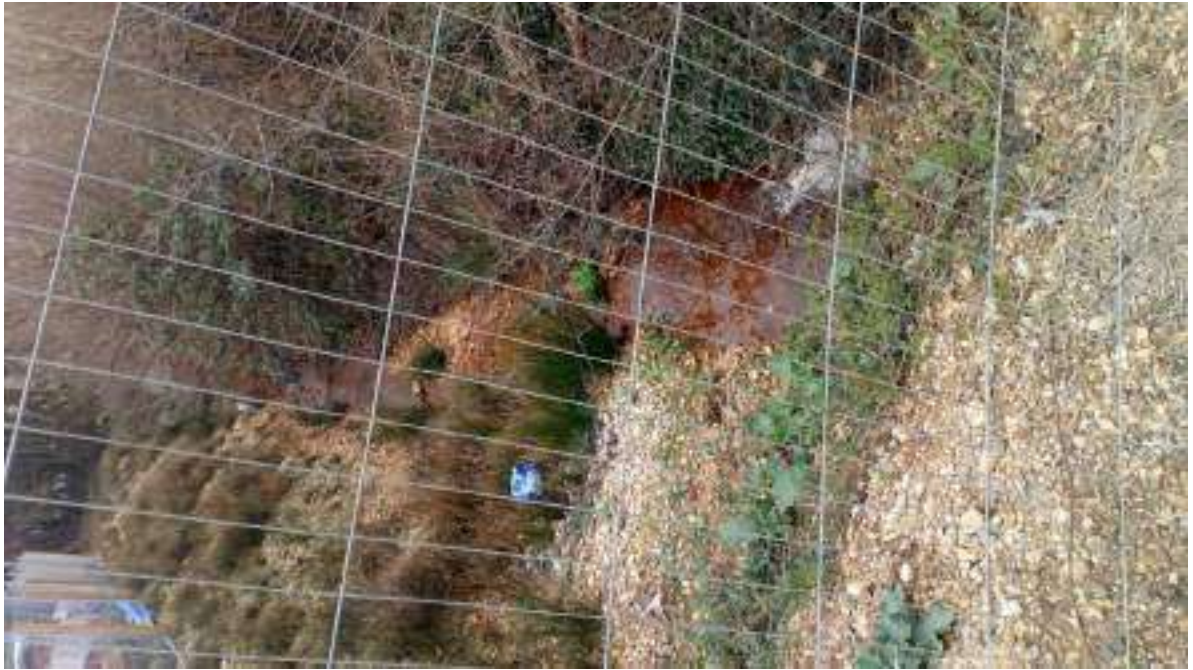
**Photograph 7: view looking south west at stream running through site, waters are clear and not silted**

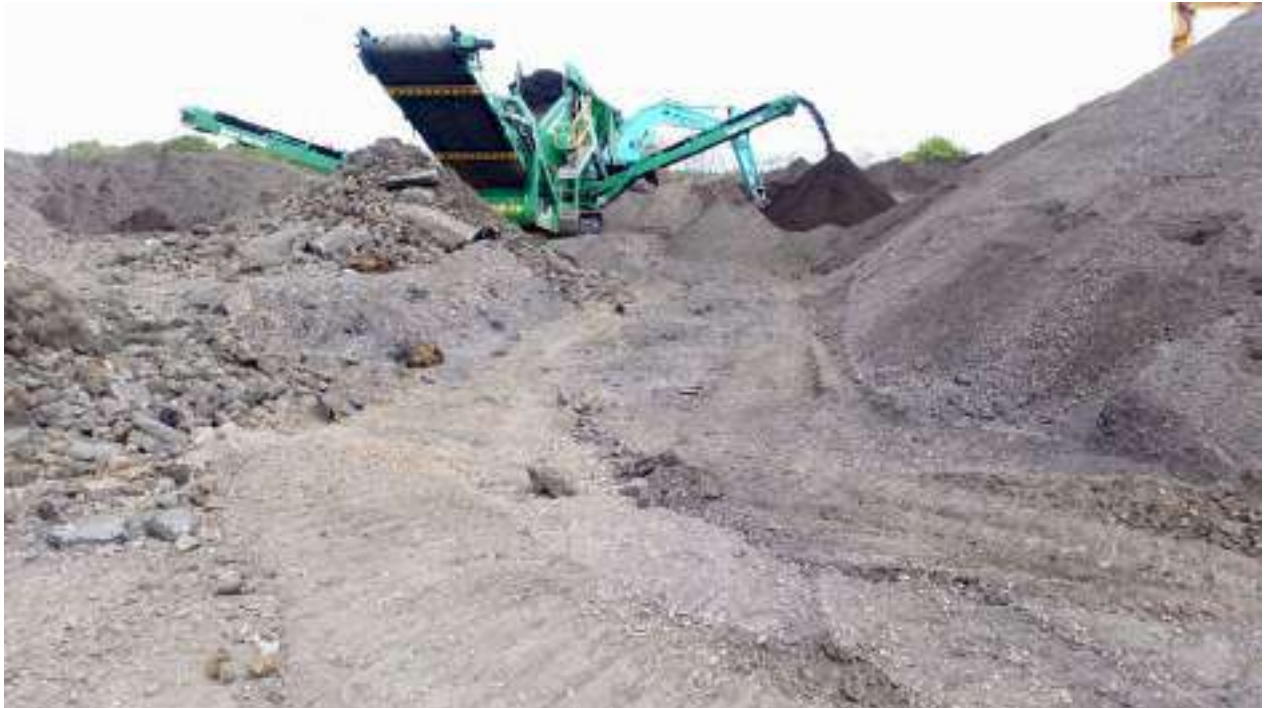
**Photograph 1: Ongoing screening of Topsoil stockpiles**

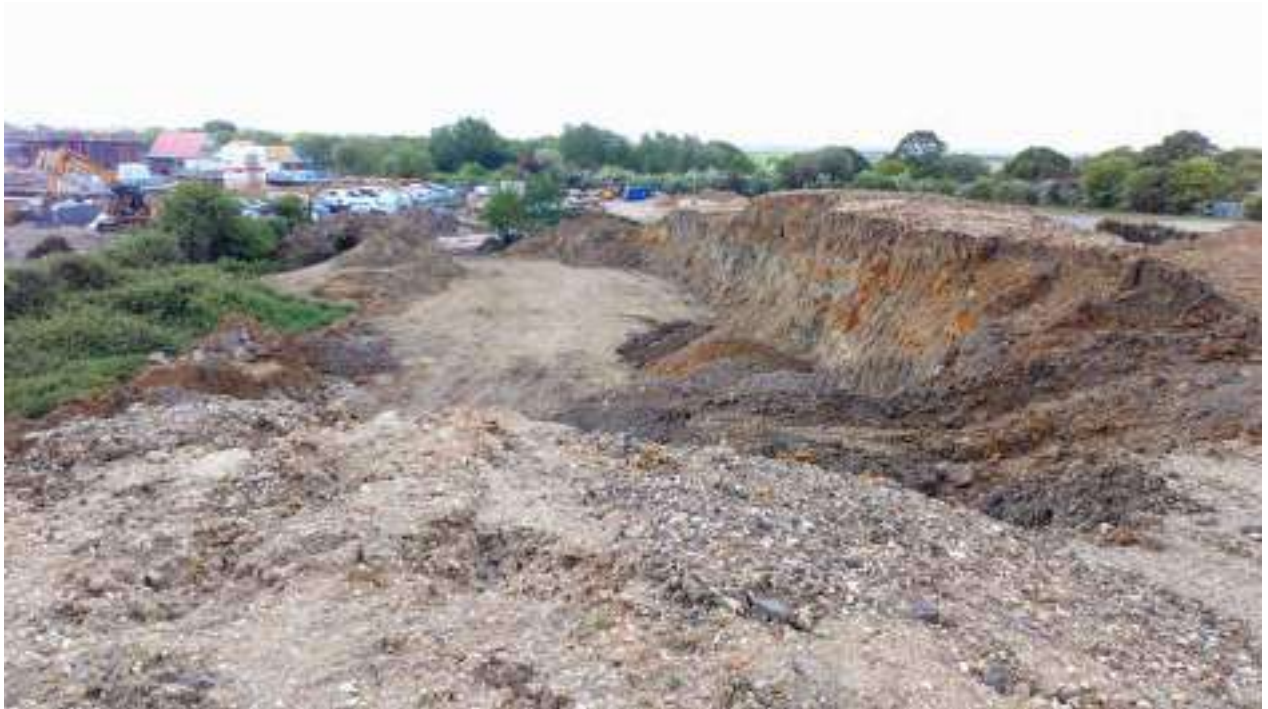
**Photograph 5: View of utilised stockpiled materials**

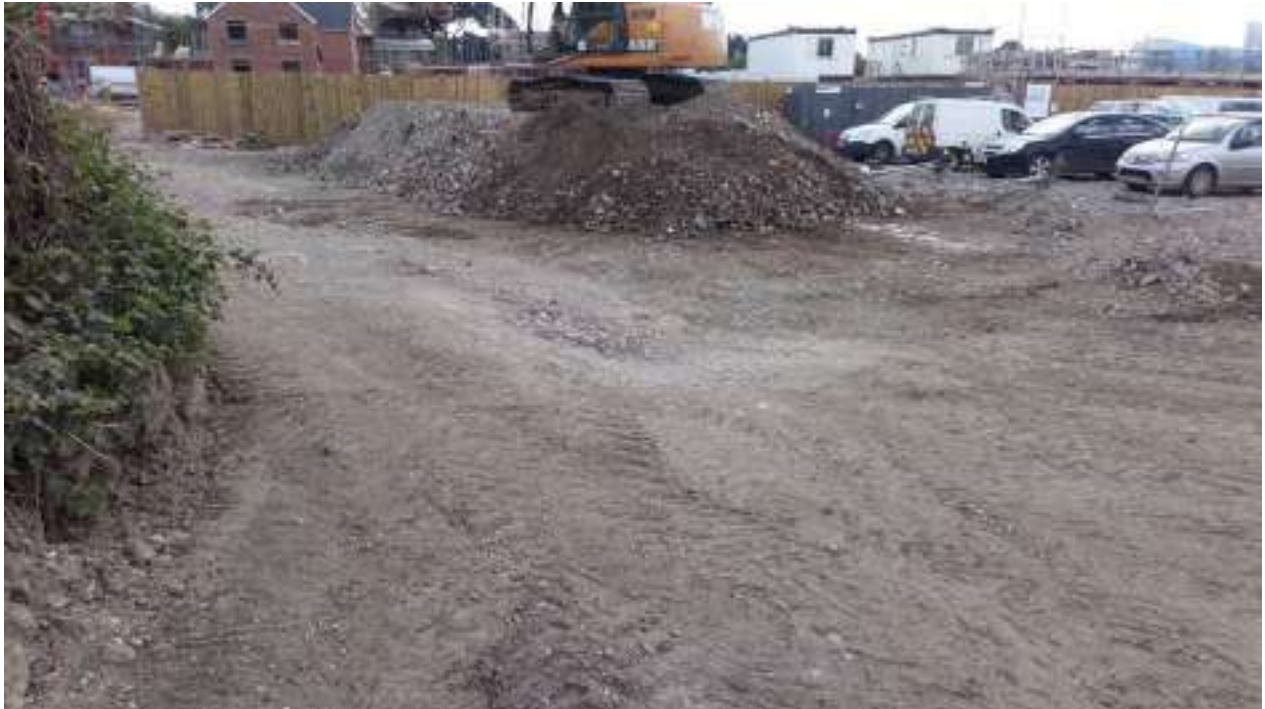
**Photograph 7: Stockpiled imported crush material**

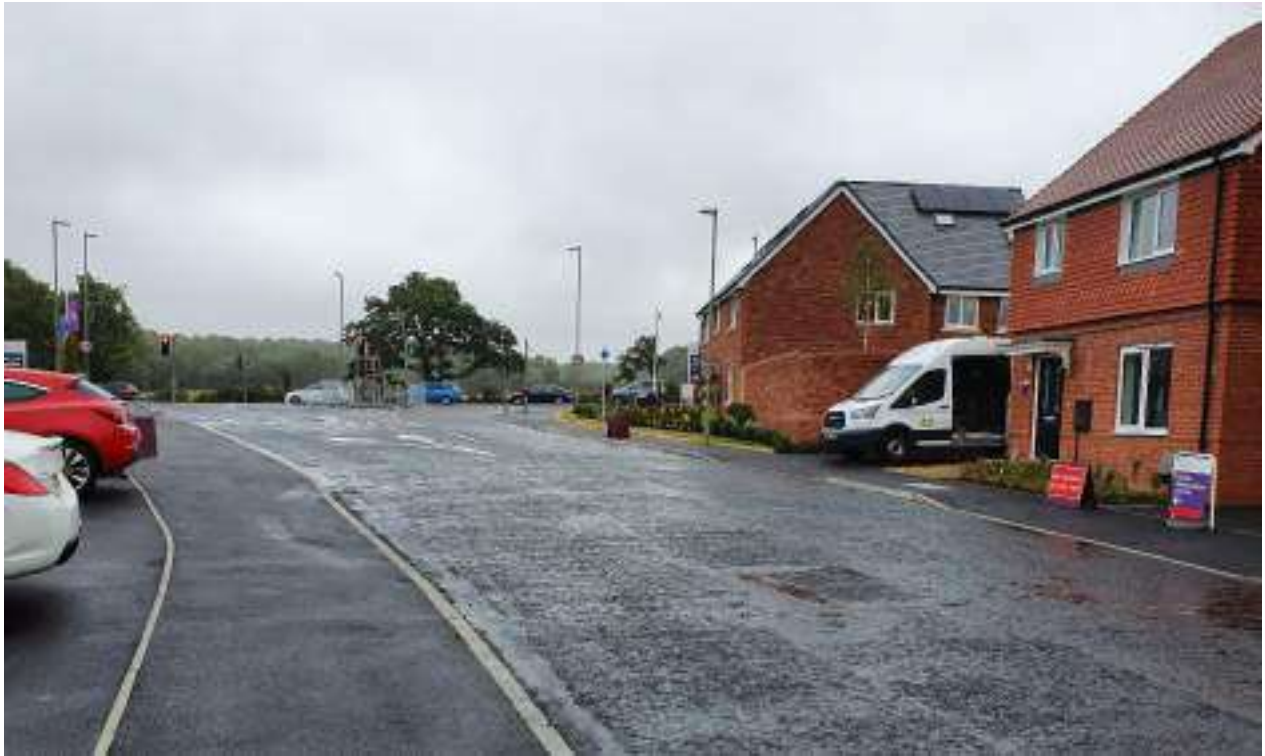
**Photograph 7: Junction with Bursledon Road and show homes in north of the site**

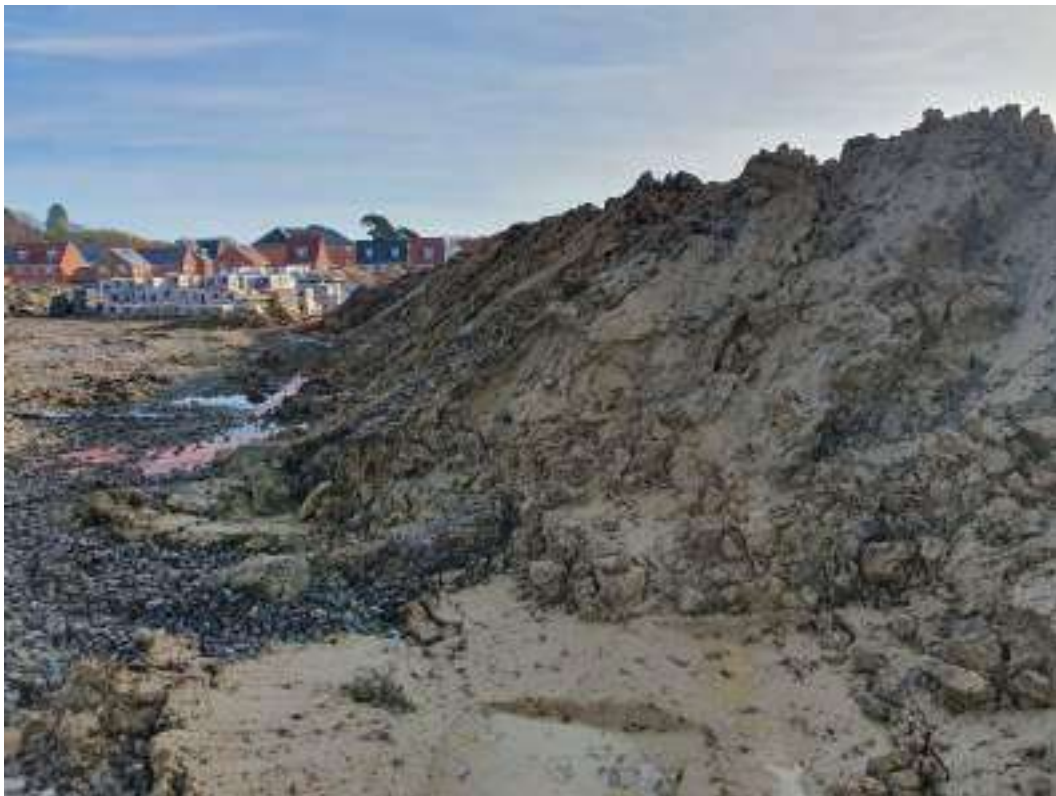
**Photograph 2: Looking along stockpile of soil from Burr ridge Green, facing east.**

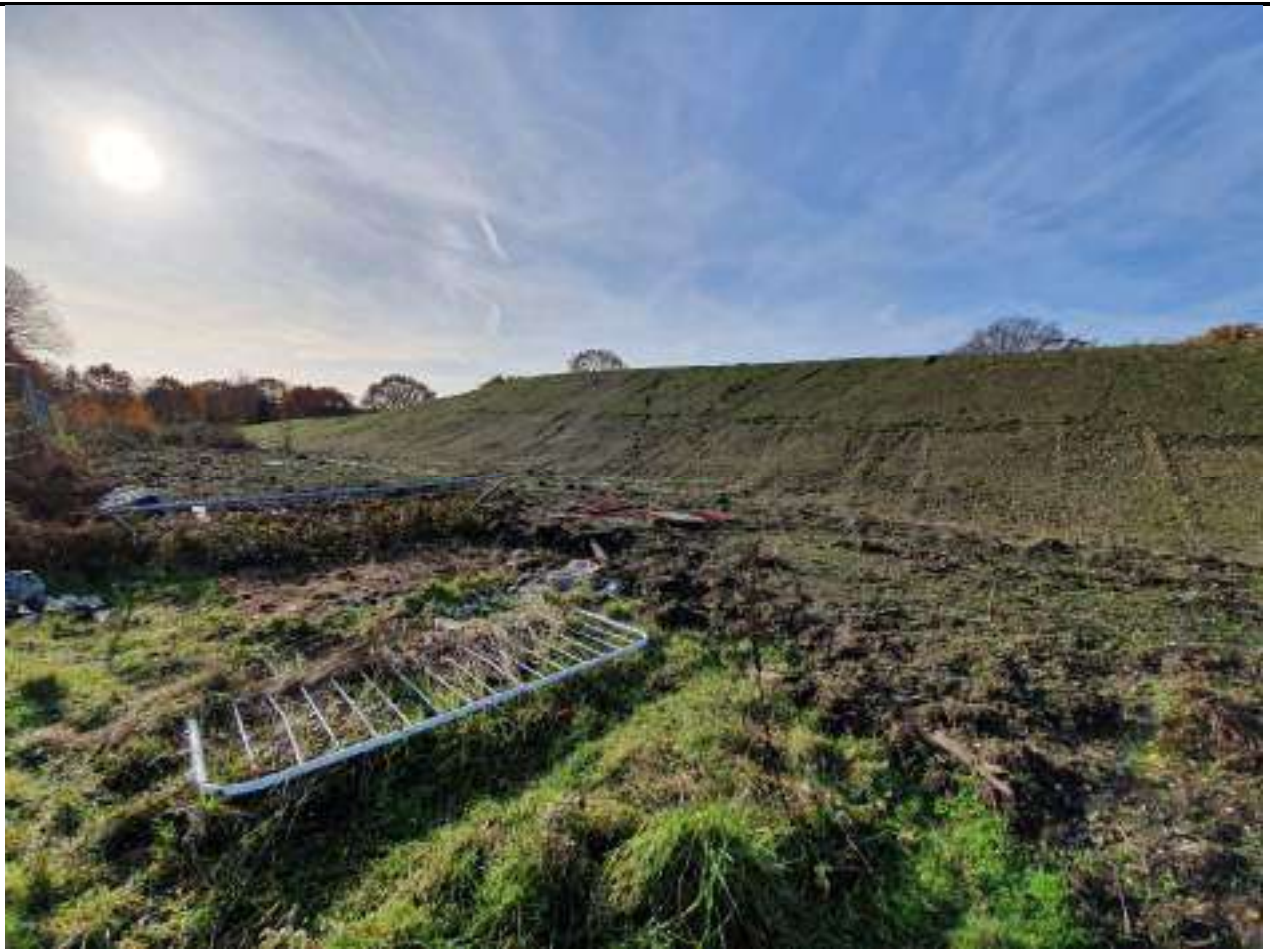
**Photograph 7: Overview of the bund, facing southeast.**

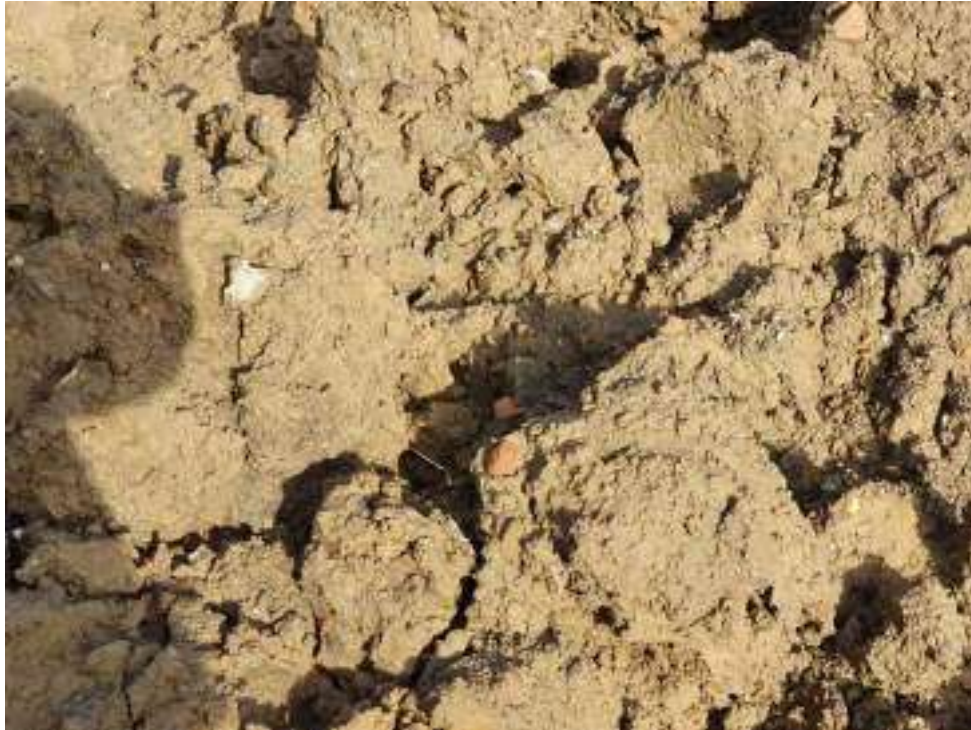
**Photograph 3: Sporadic anthropogenic materials within imported Burridge Green subsoil stockpile.**

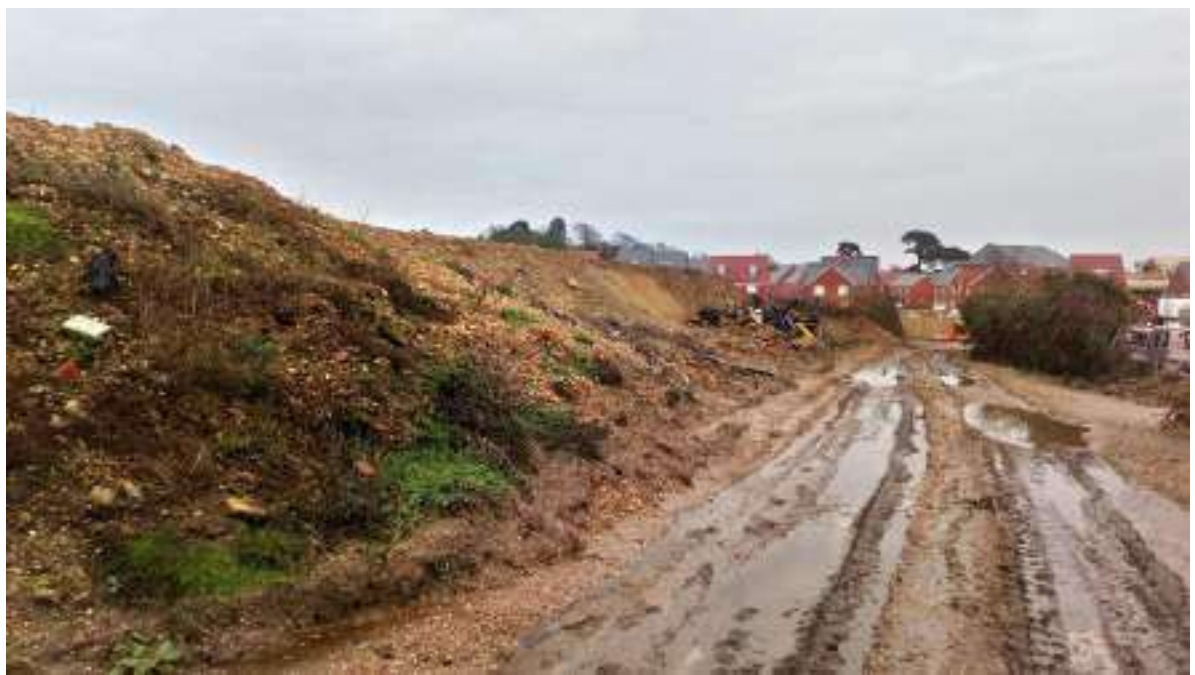
**Photograph 1: Southern side of the mixed materials (subsoil) stockpile, facing east.**

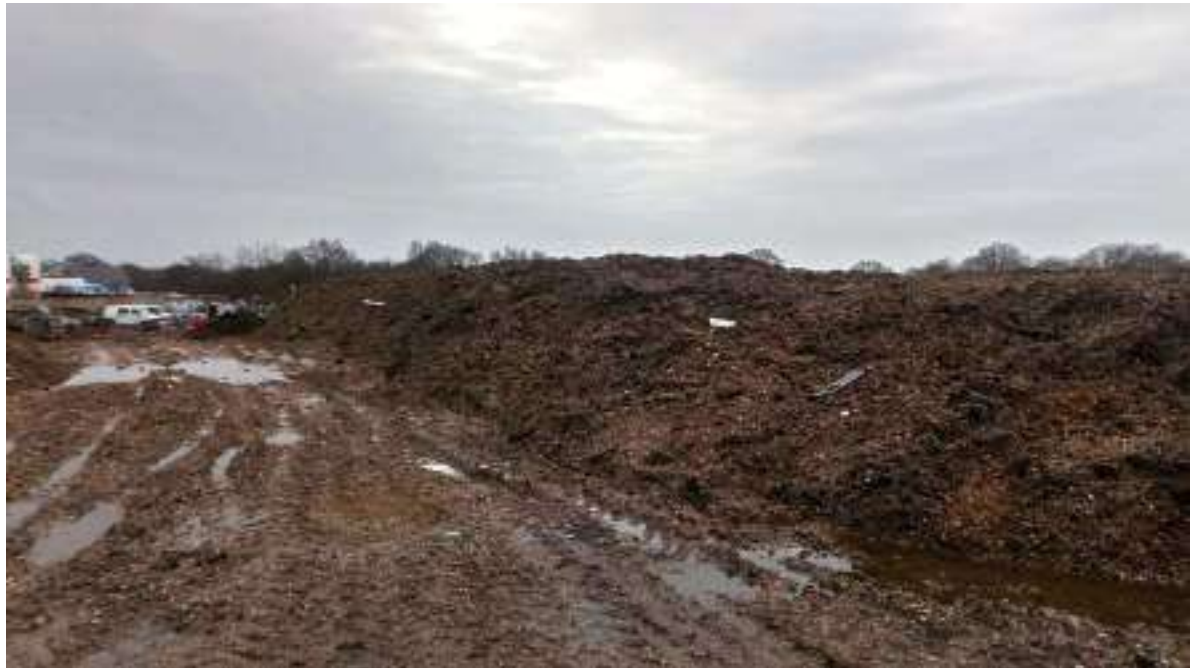
**Photograph 2: Western side of the mixed materials (subsoil) stockpile, facing south.**

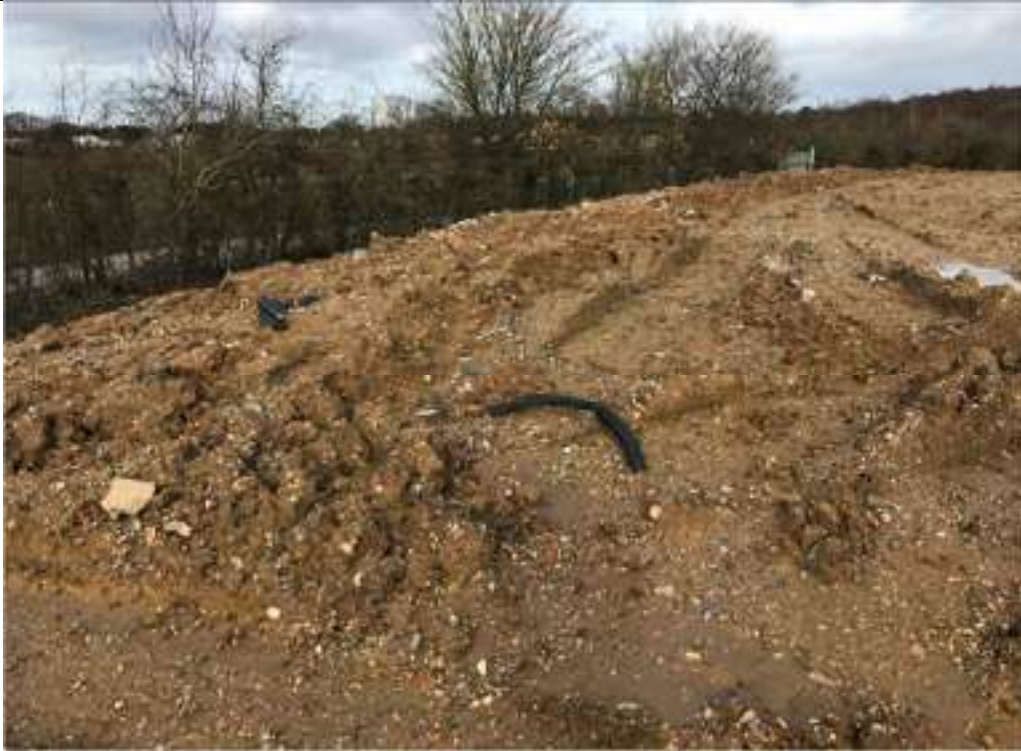
**Photograph 1: Burridge Green Stockpile**

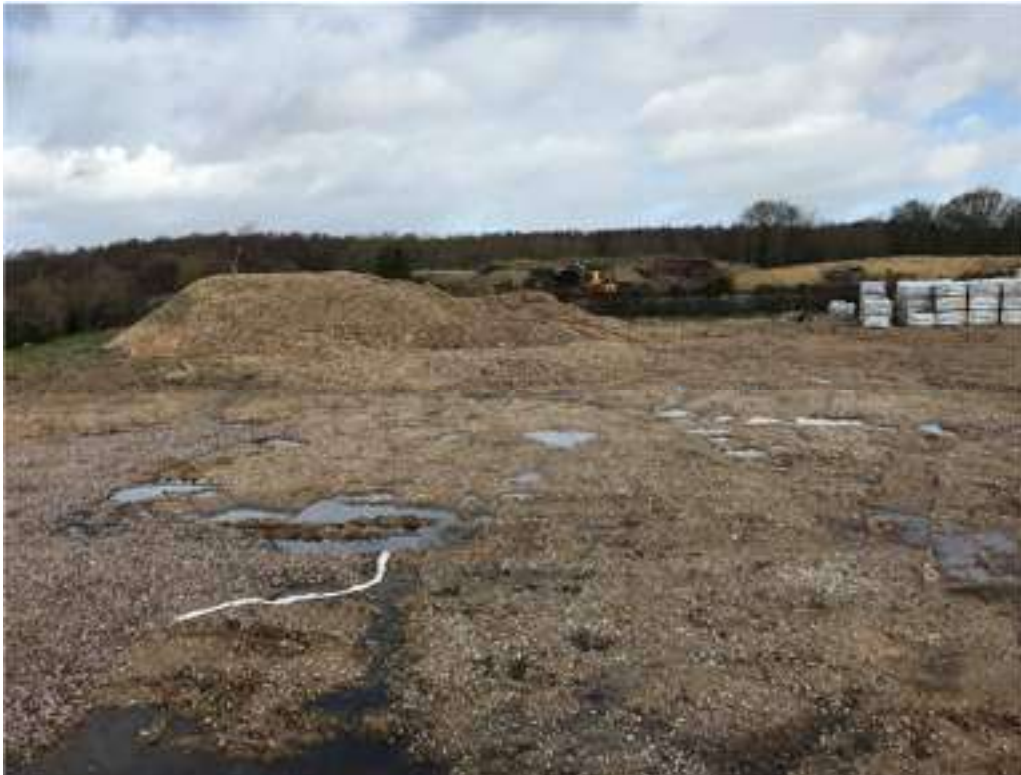
**Photograph 2: Granular material stockpile**

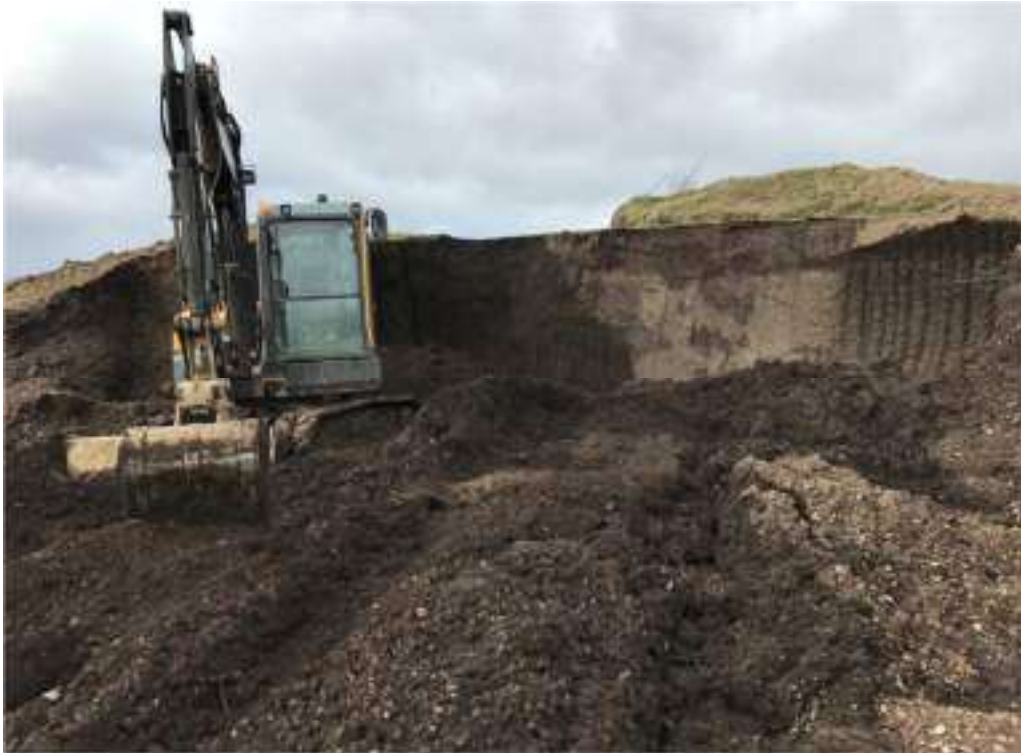
**Photograph 3: Topsoil Stockpile**

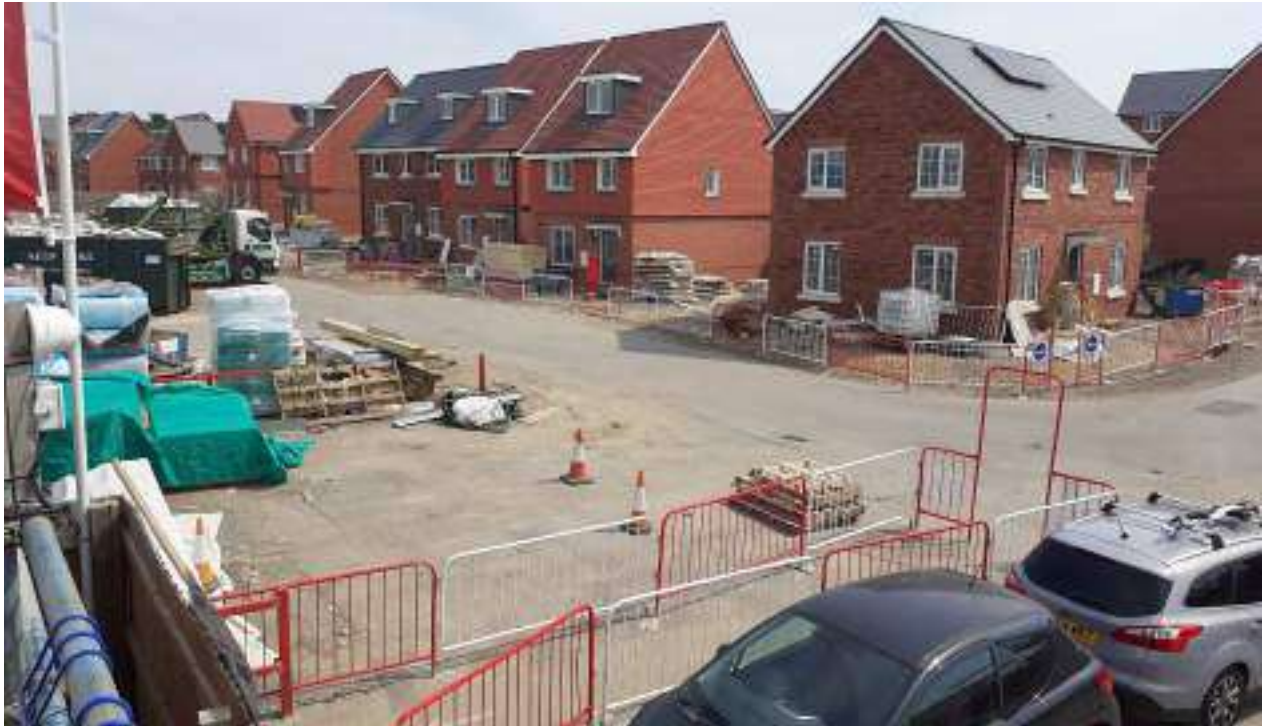
**Photograph 1: Looking north east from TW site compound.**

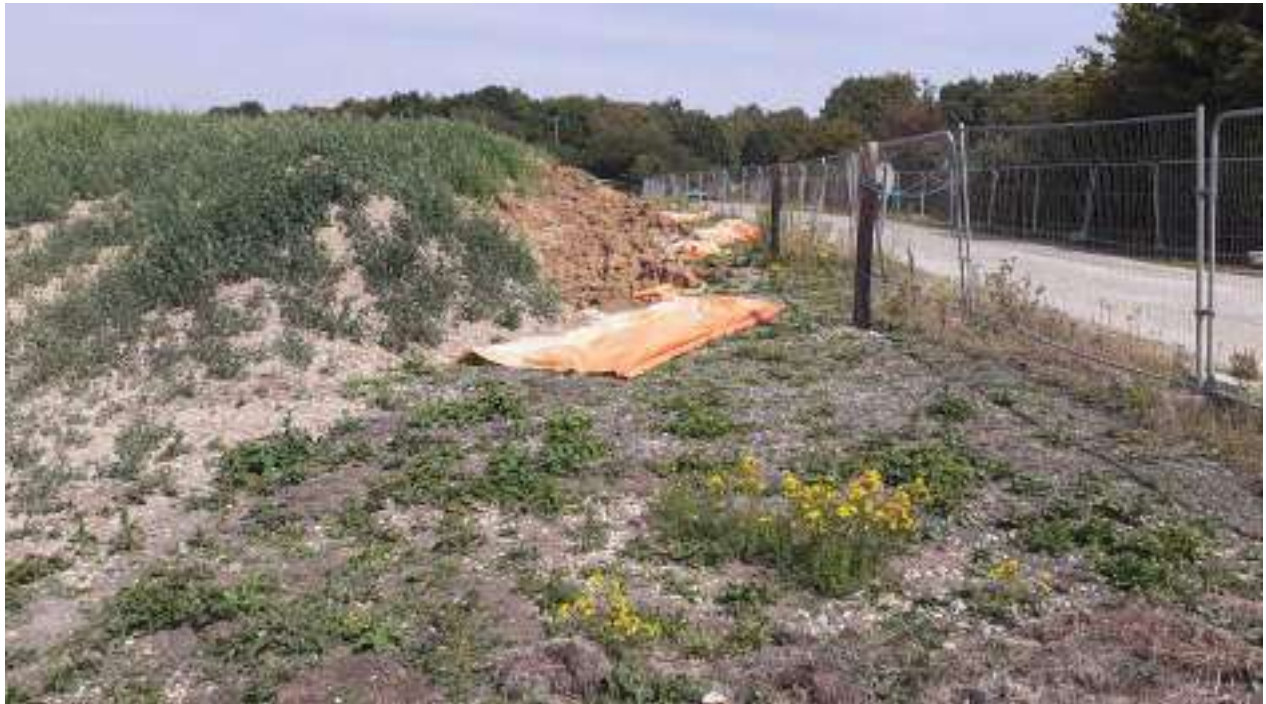
- Stockpiling of materials imported from the BurrIDGE Green has been ongoing. Stockpiles and soil bunds are vegetated where not recently placed.
- Soils are noted to have been placed to the north of the site compound.

**Photograph 3: Eastern flank of stockpile in north of country park area**

- Stockpiles should be appropriately managed to ensure retention of good quality materials for reuse and no cross-contamination.
- Waste soils and materials noted in the vicinity of the Japanese Knotweed burial pit should be disposed of appropriately.
- Materials management tracking info on soil import from Burr ridge Green must be provided e.g. consignment notes. Some records have been provided to date. Details of where soils are being placed should be provided to Hydrock.
- Monitoring of the bund to ensure that cracks do not increase which could potentially cause bund failure.
- Tracking info to be provided for movement of topsoil from Heron Walk.
- Membrane to be placed beneath capping layer prior to placing clean soils in the former landfill area – Hydrock to be informed in advance of capping layer construction to allow for inspections and testing.
