**VERIFICATION REPORT**

**BLOCK B & PLOTS 22-28, 83-85 & 92-94,**

**BARGATE HOMES**

| Reference: | GE20045/VR/BLOCK B & PLOTS 22-28, 83-85 & 92-94/JAN23v2 |

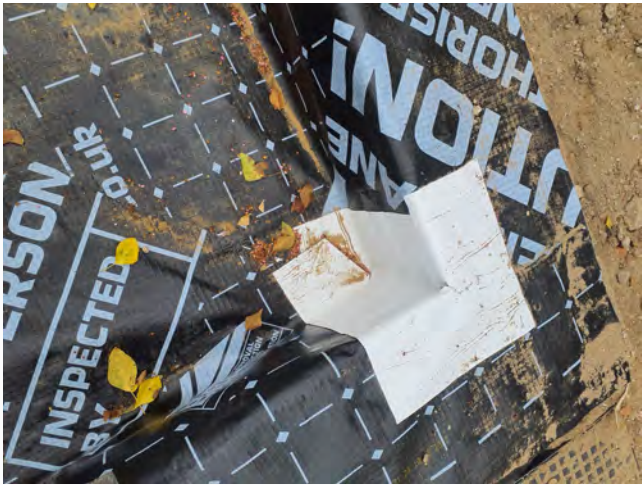
| | Corner detail |

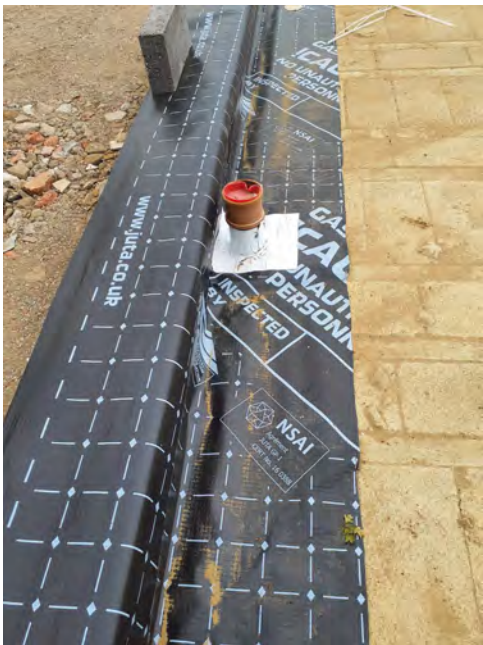
| | Service |

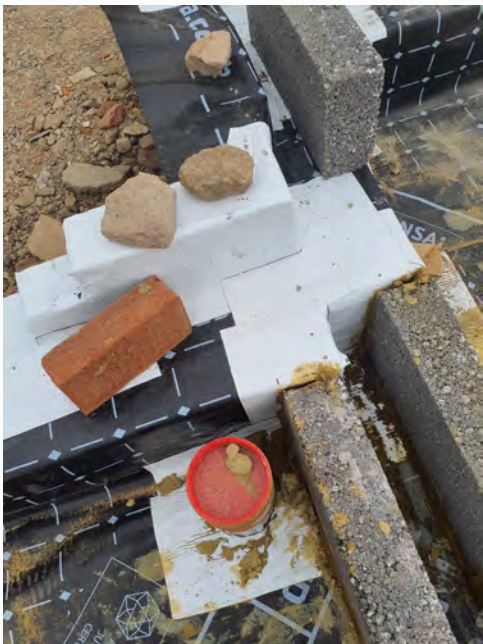
| | Corner |

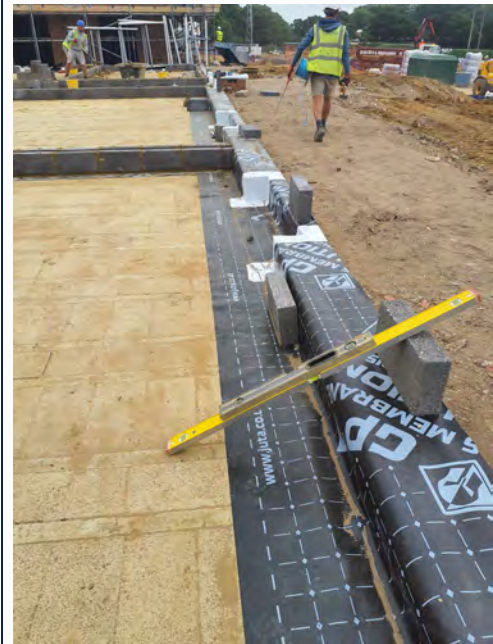
Edge detail

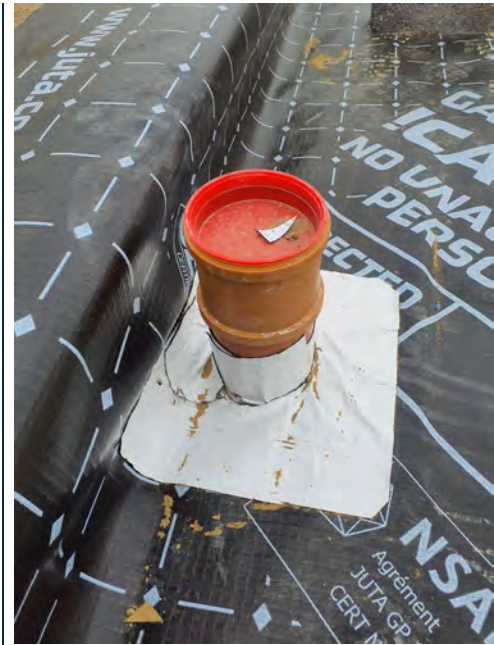
Service

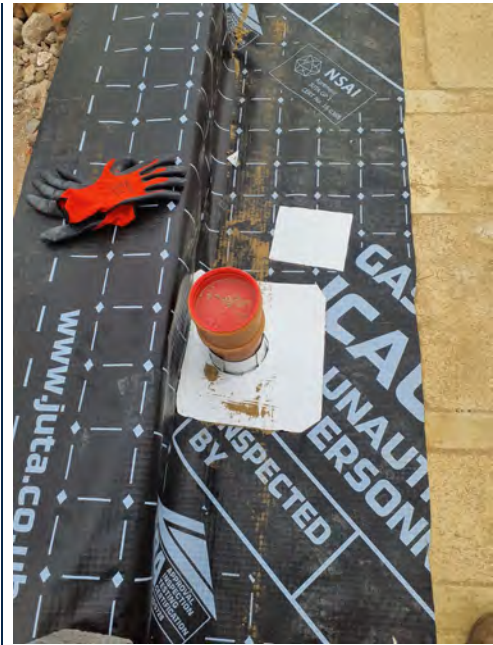
Service

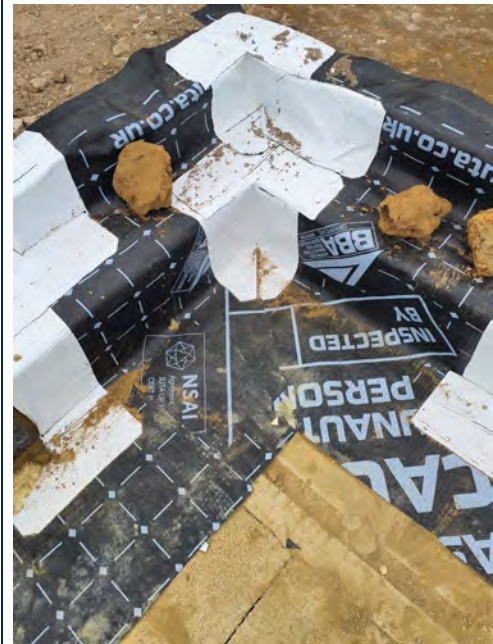
Corner

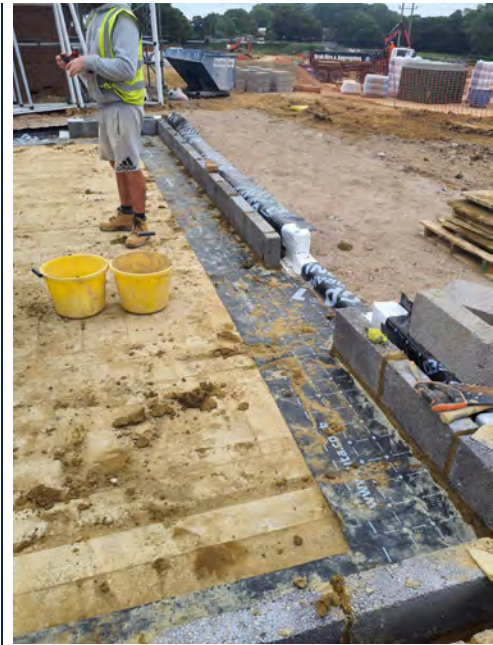
Edge

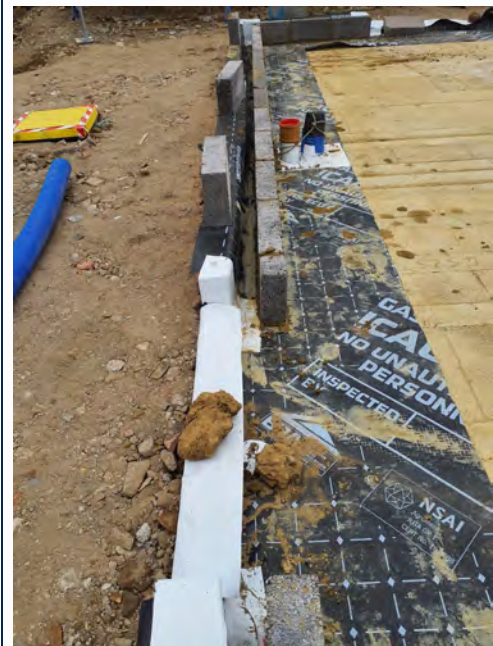
Double skin

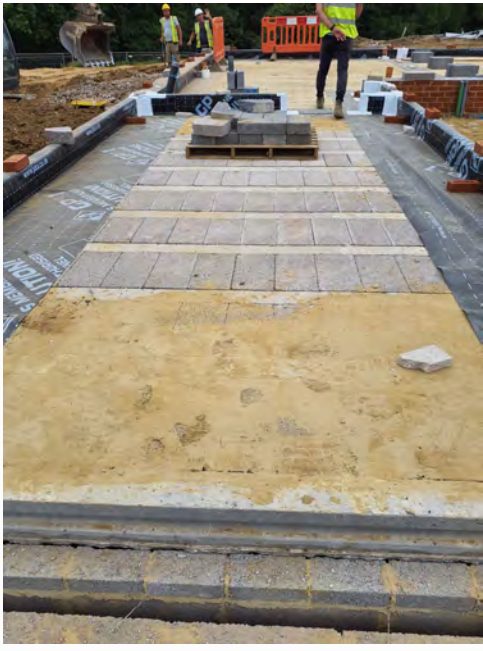
| | | <p>Plot 94 garage</p> |

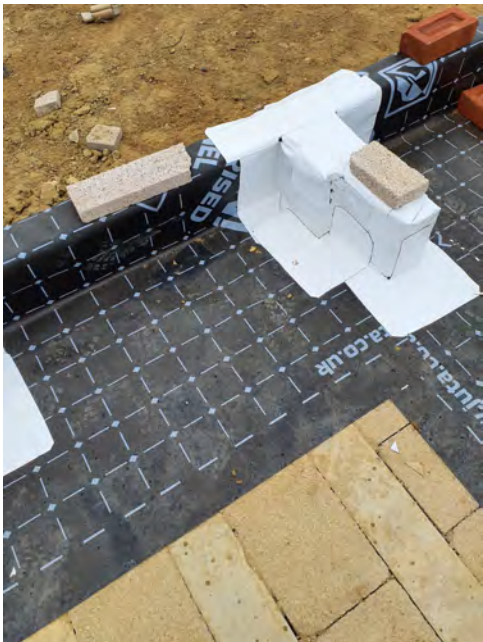
| | | <p>Plot 94 corner</p> |

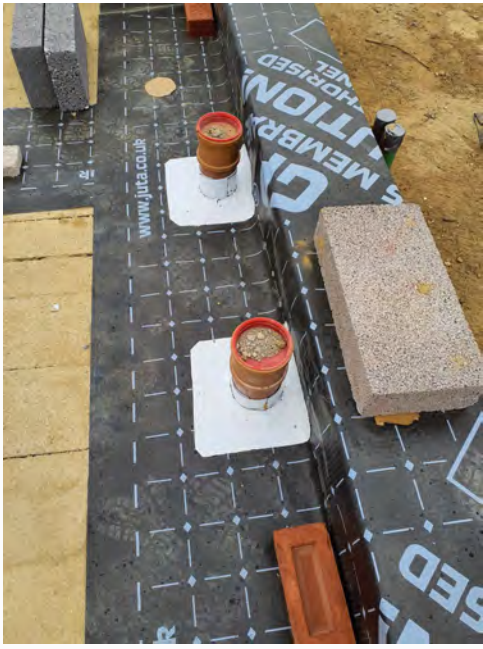
| | <p>Plot 94 services</p> |

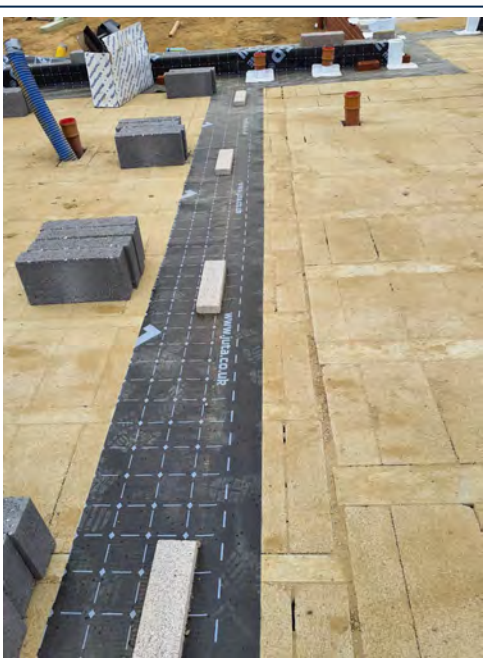
| | <p>Plot 94 Cavity</p> |

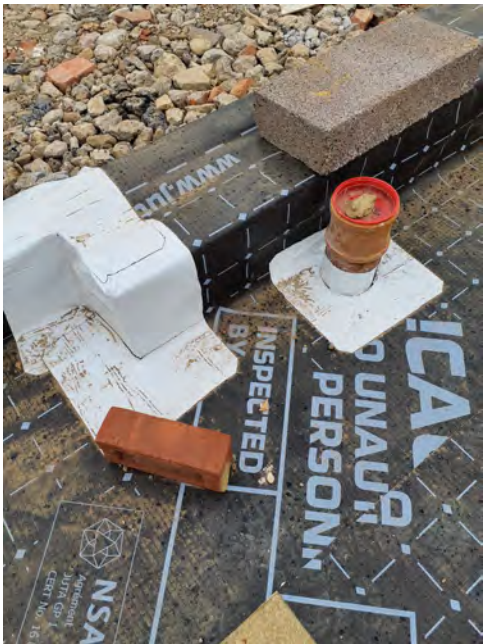
| | | Plot 93 details |

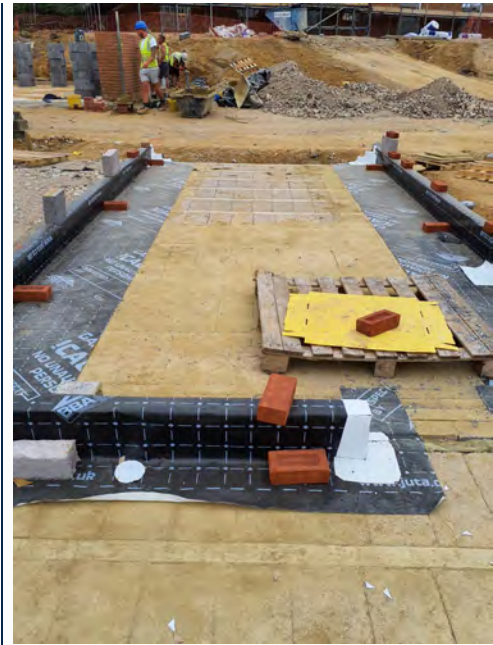
Plot 93 garage

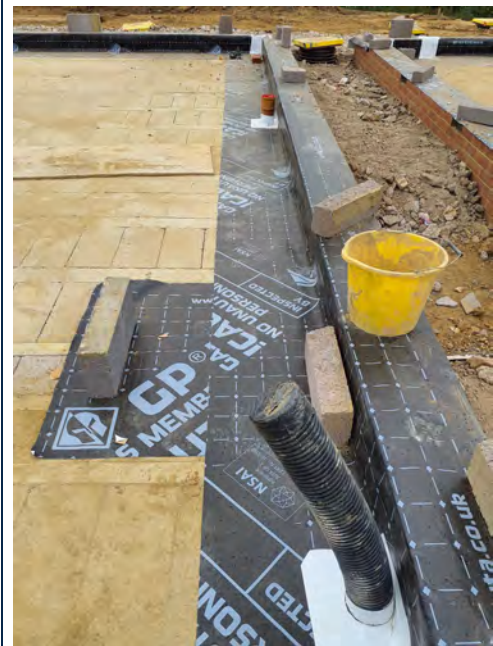
Plot 93 edge

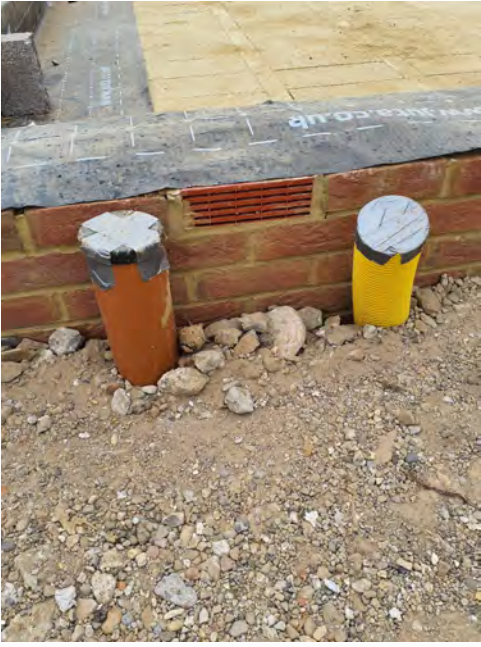
| | | Plot 92 airbrick |

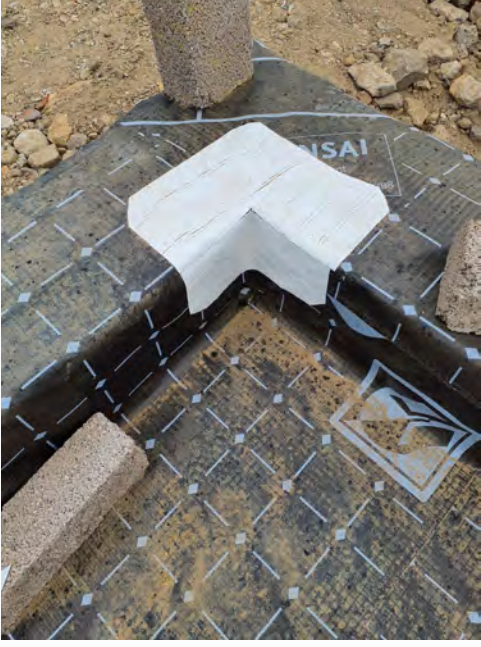
| | | Plot 92 corner |

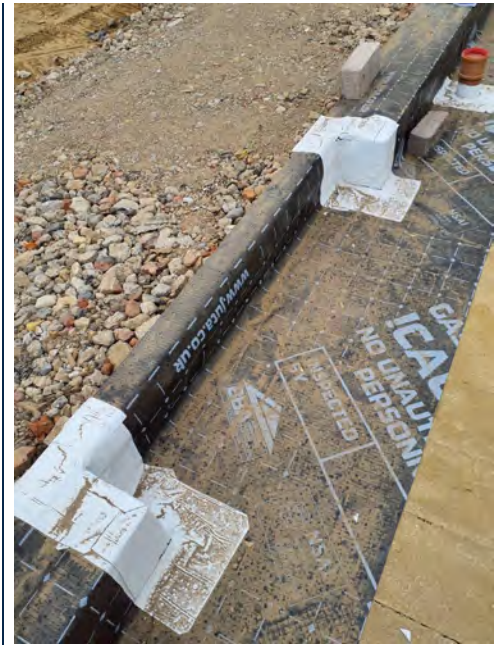
Plot 92 threshold

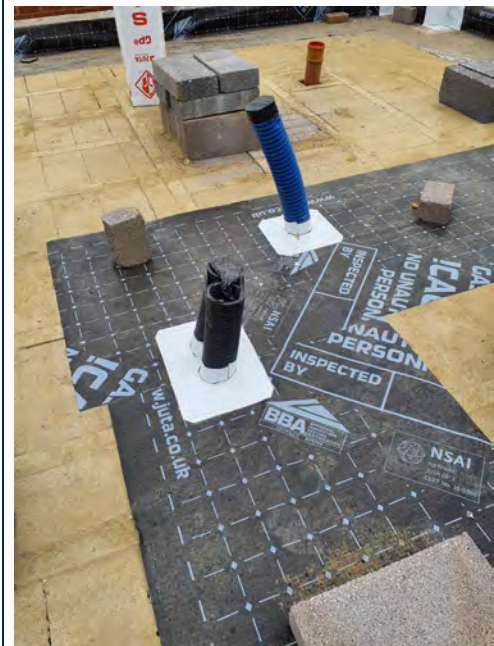
Plot 92 services

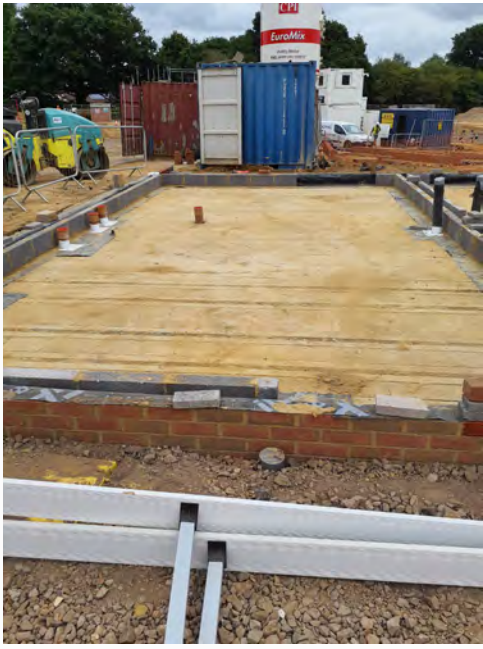
| | | <p>Plot 20 overview</p> |

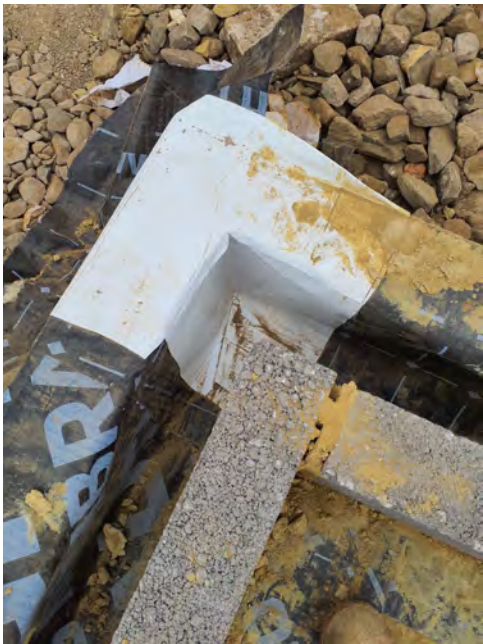
| | | <p>Plot 20 corner</p> |

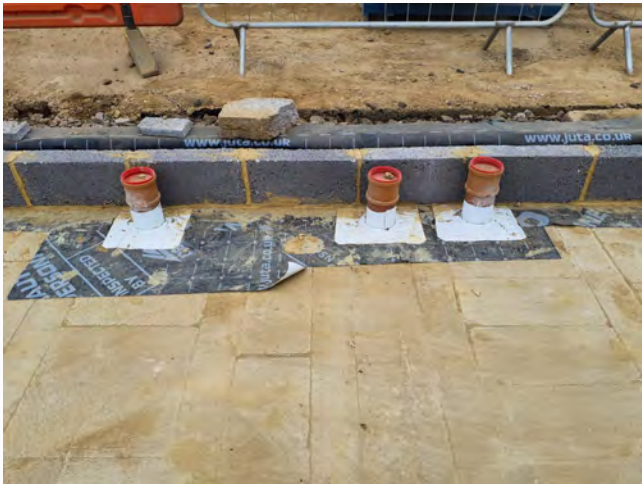
| | | <p>Plot 20 services</p> |

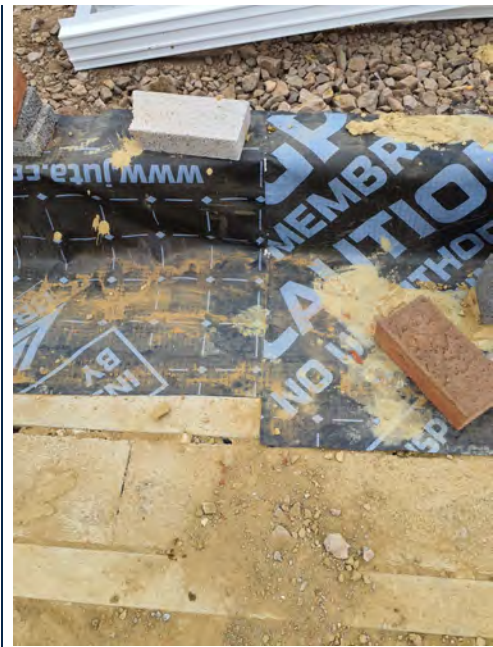
Plot 20 membrane join

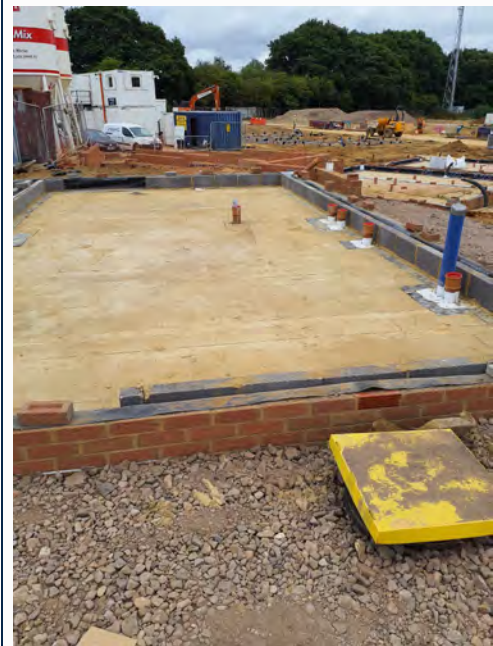
Plot 21 overview

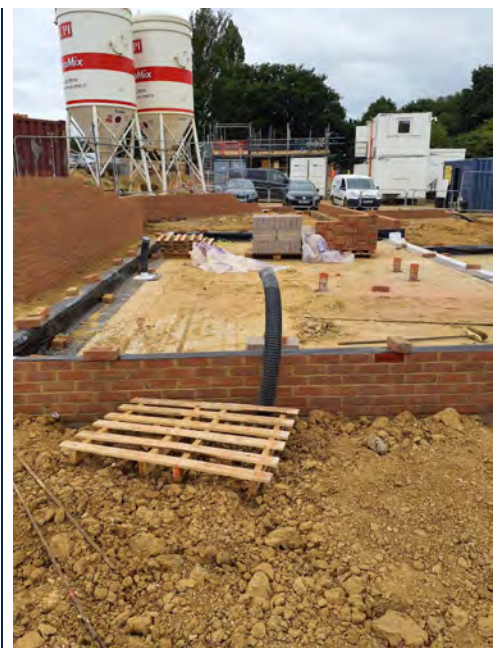
Plot 22 overview

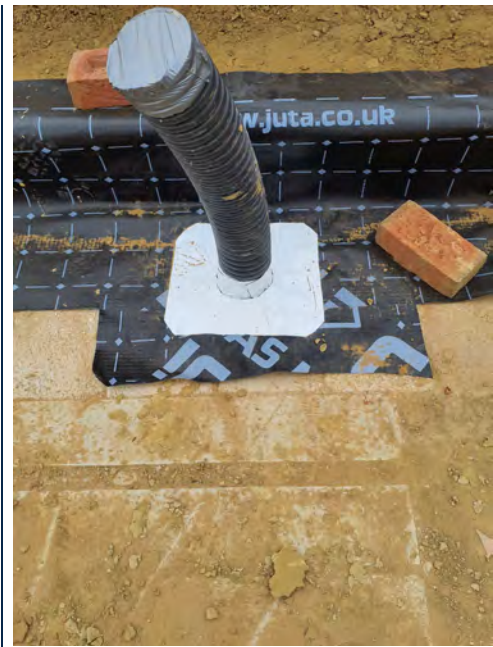
Plot 22 service

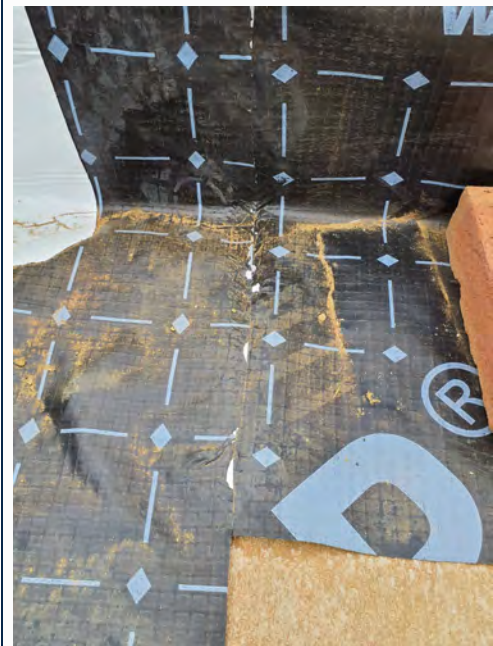
Plot 22 membrane join

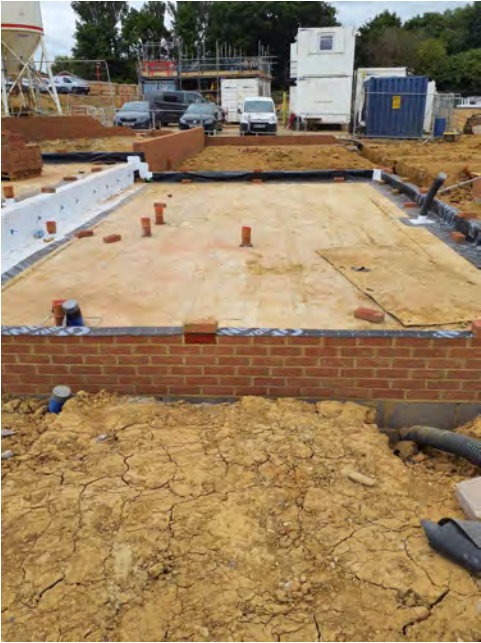
| | Plot 23 overview |

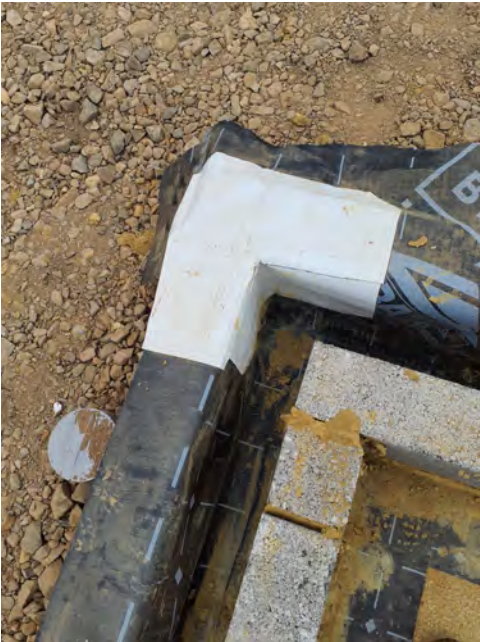
Plot 83 corner

| 1.3 Gas membrane condition | One defect noted in the corner of Plot 83, this was repaired in the presence of the engineer and deemed suitable, otherwise no visible defects but mortar around edges |

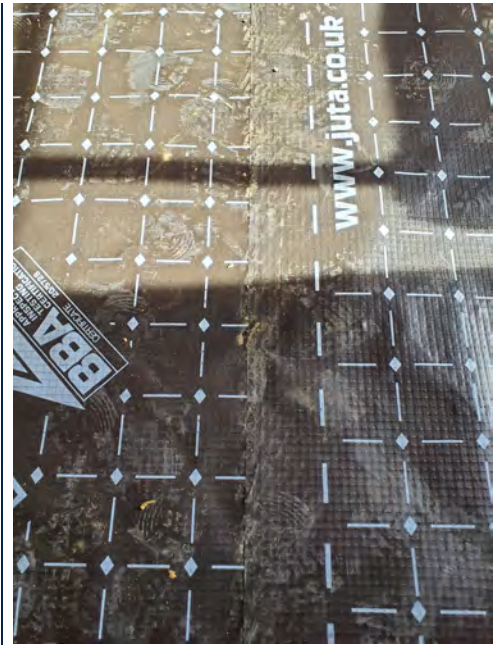
Membrane join - store 1

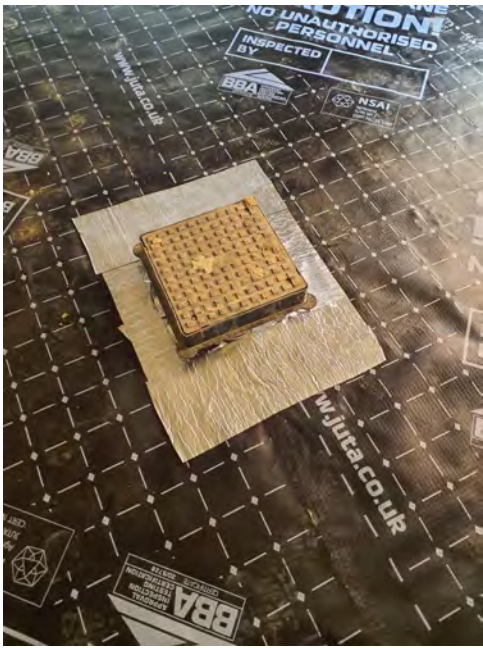
| | Service seal - store 3 |

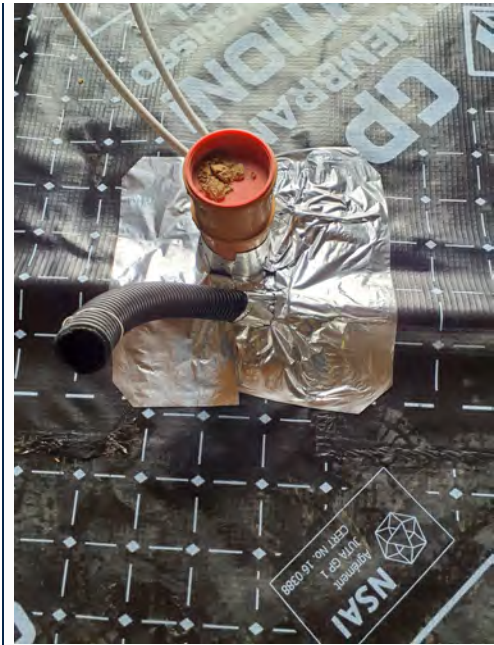
Plot 92 service seal

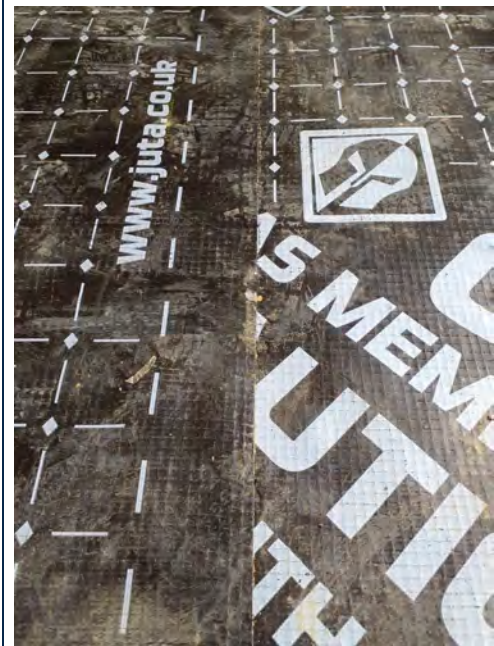
Plot 92 membrane join

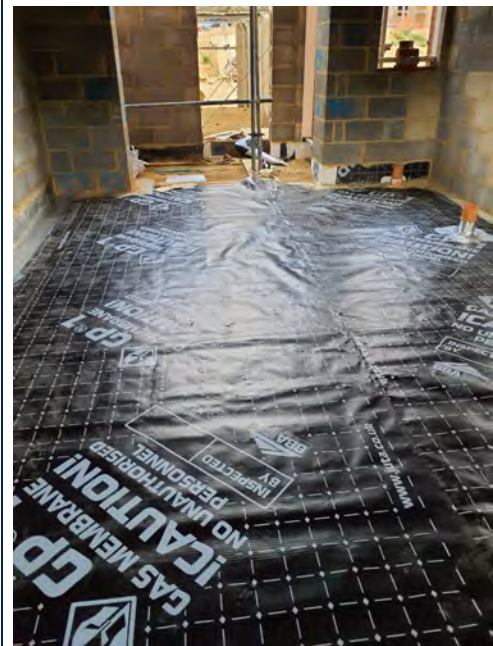
| 1.3 Gas membrane condition | Generally good condition some signs of foot traffic and mortar. Membrane installation incomplete in Plots 93 and 94 due to scaffolding being present. Membrane installed elsewhere across these Plots is deemed suitable |

Plot 93 incomplete

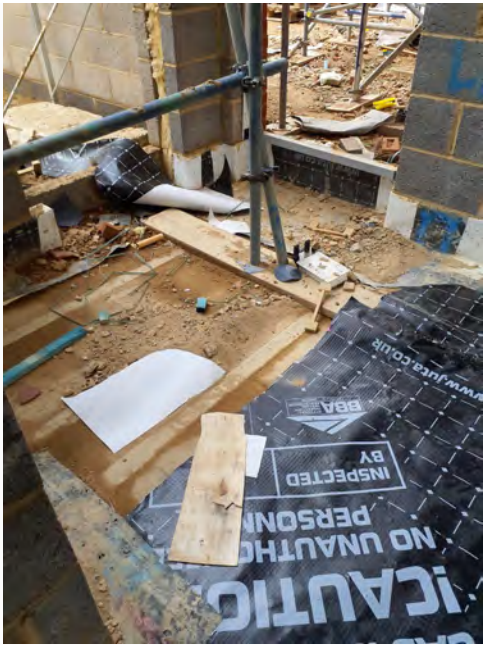
| | Plot 93 scaffolding preventing completion |

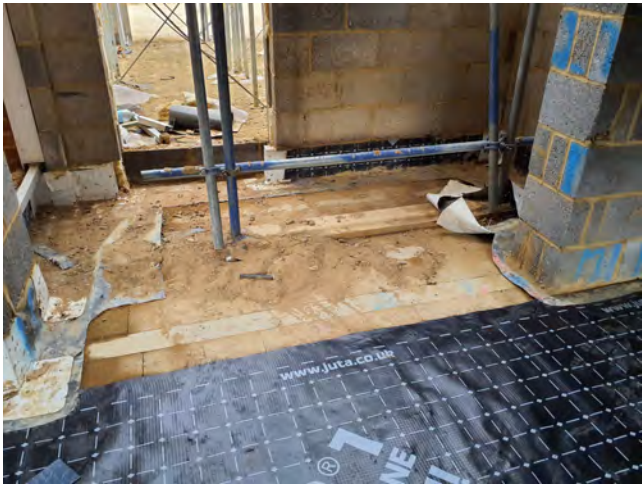
| | Plot 94 incomplete |

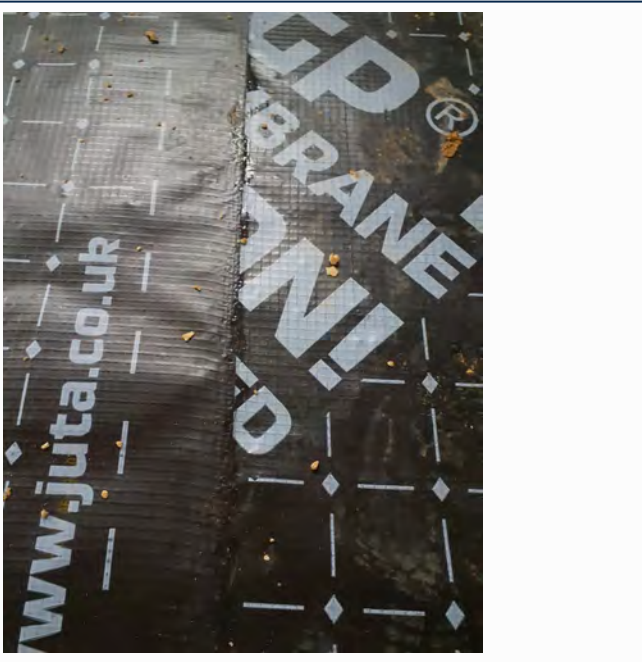
| A close-up photograph of a joint in the black waterproofing membrane. The joint is sealed with a white and orange cap. The membrane has some printed text, including 'www.juta.co.uk' and 'MEMBRANE'. | | Plot 24 membrane joins |

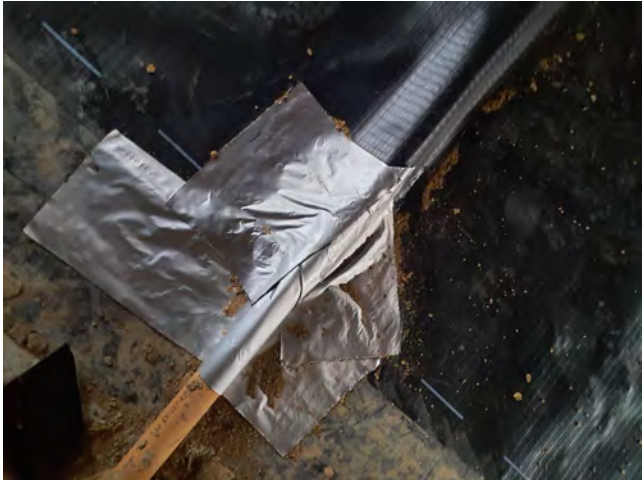
| <p>The image is a close-up of a pipe where the black gas membrane is being sealed. A piece of silver tape is being applied over the membrane to create a watertight seal around the pipe.</p> | <p>Plot 25 pipe seal</p> |

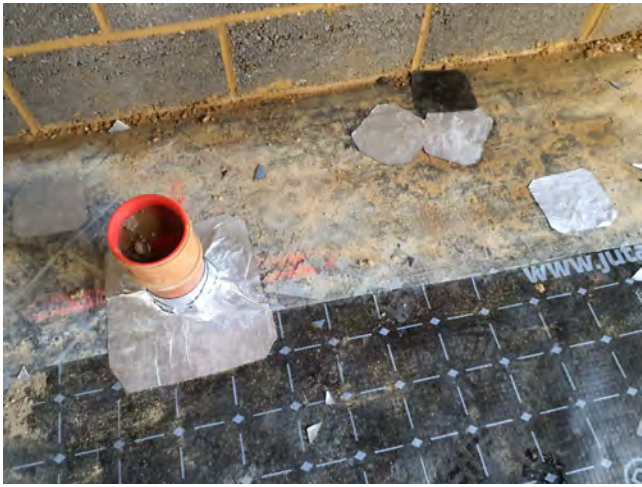
| | Plot 28 service and patch |
